Special Protection Area Program Annual Report 2003

PREPARED BY THE MONTGOMERY COUNTY DEPARTMENT OF ENVIRONMENTAL PROTECTION IN COOPERATION WITH THE DEPARTMENT OF PERMITTING SERVICES AND THE MARYLAND-NATIONAL CAPITAL PARK & PLANNING COMMISSION

SPECIAL PROTECTION AREA PROGRAM ANNUAL REPORT FOR 2003

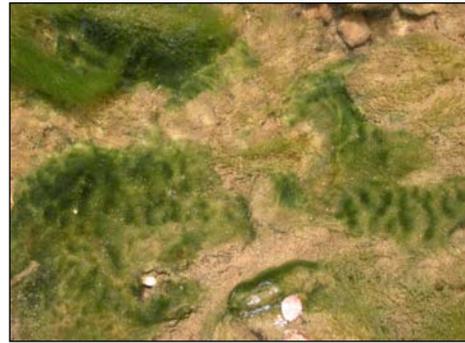
Figure 31 Algae growth in Right Fork

Four other development projects have since begun construction in the Right Fork. Fine sediments washed off from construction sites have been observed in the Right Fork. There appears to also have been an increase in algae growth that may be related to the fine sediment (Figures 30 and 31). Sediment washing off the land often carries with it nutrients, particularly from areas previously under agricultural use, which supply nourishment for algae growth in the receiving stream. The sediment and algae fill in the spaces under and around the stones on the stream bottom restricting biological colonization in this important stream habitat.

The extent to which changes in the benthic community are a reflection of drought or development impact is hard to say with certainty. What is certain is that impacts from development projects, thus far, are construction related and have more to do with increased sediment input to the stream. The increased level of sediment control required in SPA's may have reduced the amount of sediment getting into streams but has not completely eliminated it. Construction related impacts, although significant, are temporary. Sediment that enters the stream from construction sites will move through the stream channel network. A true assessment of how well the SPA program, along with zoning laws, protect the Right Fork can not be made until several years after construction is complete and stormwater management has had time to function as designed. At that point in time, program assessment will depend on how the streams biological health compares to baseline conditions established between 1995 and 1998.

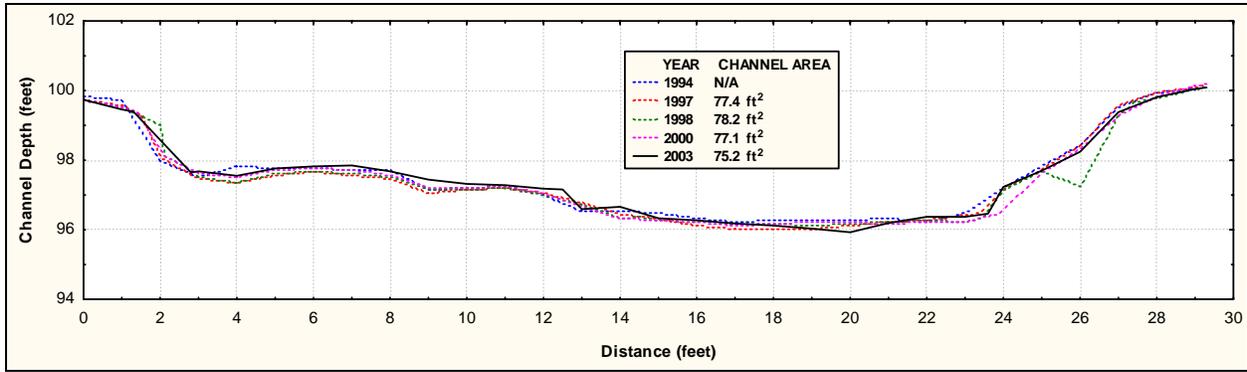
Figure 33 Stream channel cross section surveys from PBRF117, located in the Right Fork

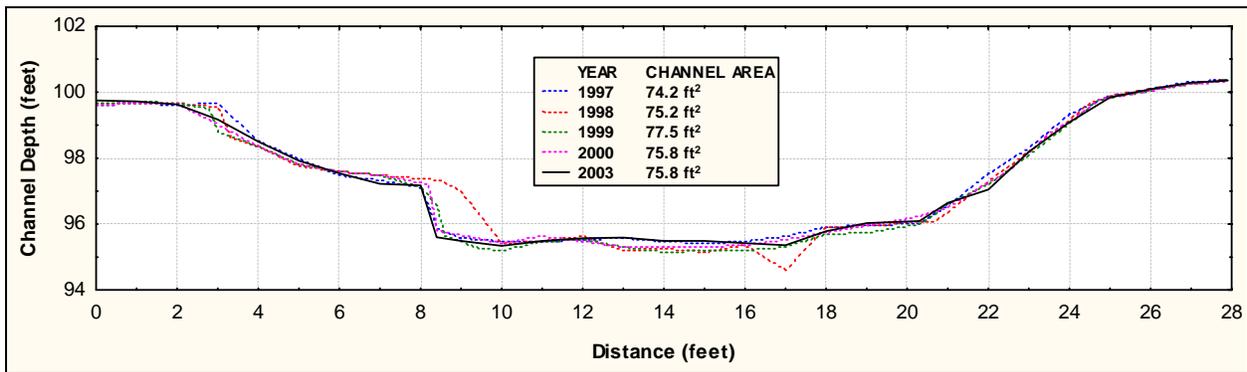
Figure 34 Stream channel cross section surveys from PBRF204, located on the Right Fork

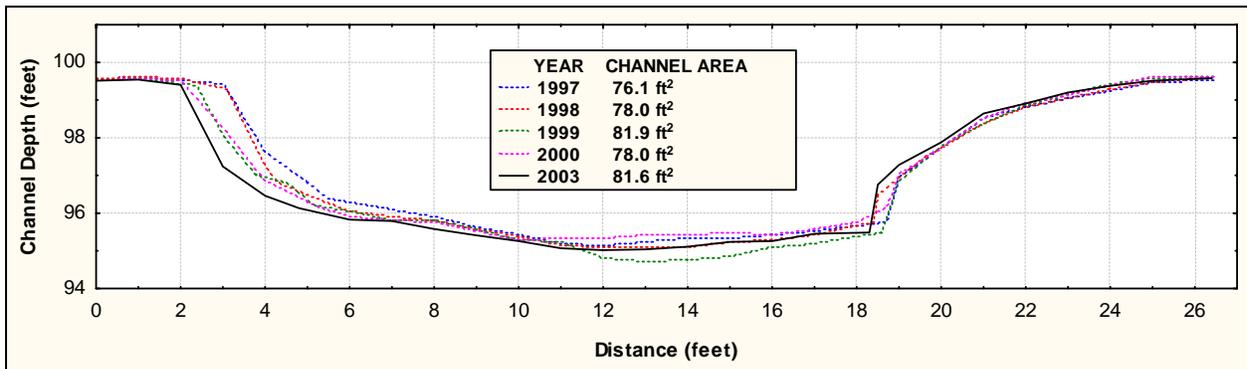
Figure 35 Stream channel cross sections surveys from PBRF206, located in the Right Fork

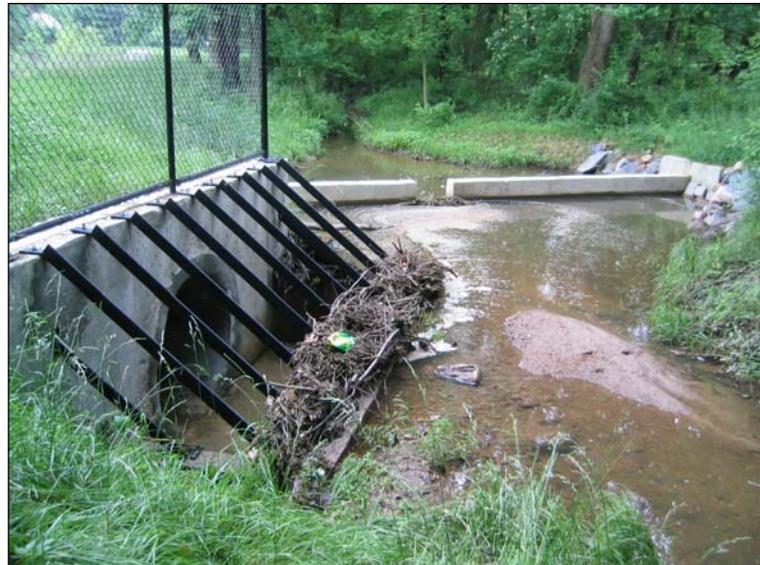
Figure 45 Piping Rock trash rack

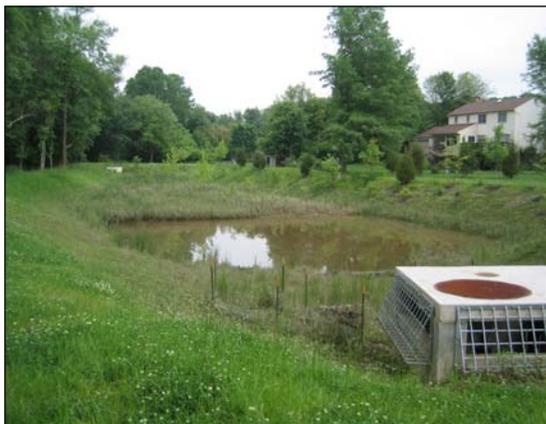
Figure 46 Piping Rock pond from outlet

The pond has two small permanent pools located near the inlet and outlet (Figure 46 and Figure 47). The area in between is vegetated with various wetland plants. Because of the small permanent wet pools there were concerns that they may cause thermal problems in the Good Hope as warm water from these pools is flushed out during storm events.

During the summer of 2003 temperature loggers were placed immediately upstream and downstream of the Piping Rock Road storm water management pond to determine if the pond is a thermal impact to the Good Hope tributary. Results from the temperature loggers indicate that there is no thermal impact on Good Hope from this pond. Average water temperature is cooler downstream of the pond and maximum temperature is considerably cooler downstream (Figure 48).

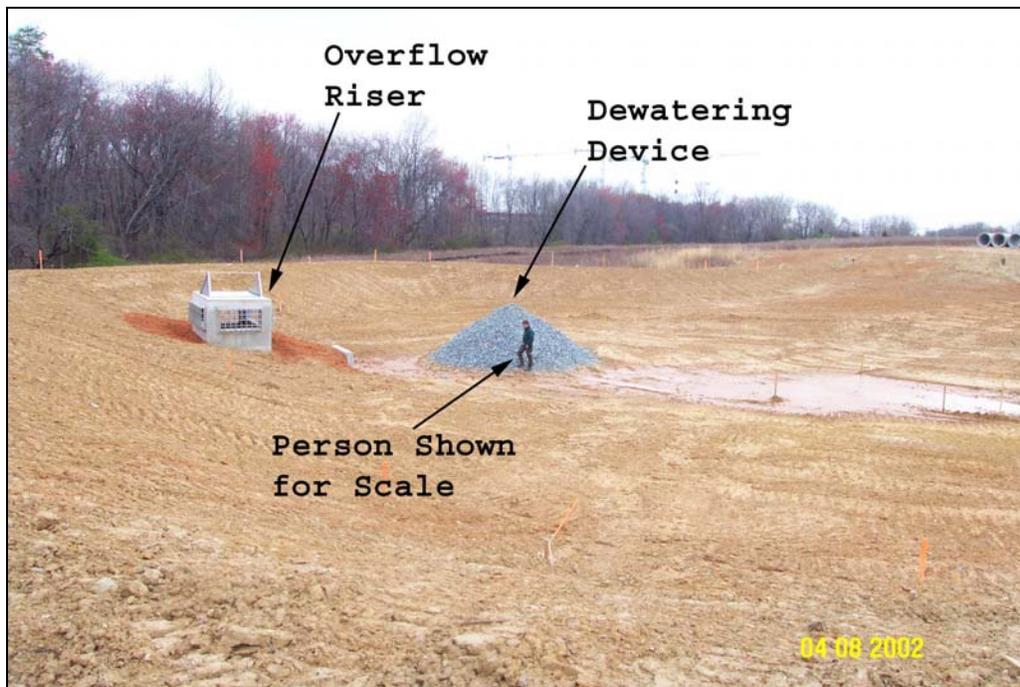
Figure 65 Sediment Control Structure, Traville

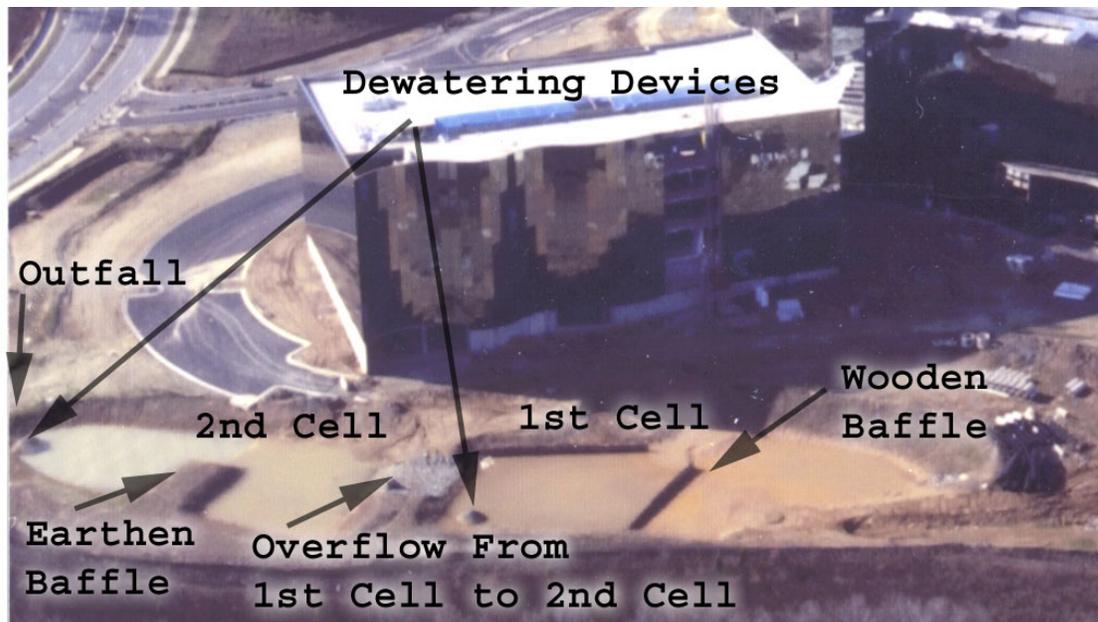
Figure 66 Two Celled Sediment Control Structure

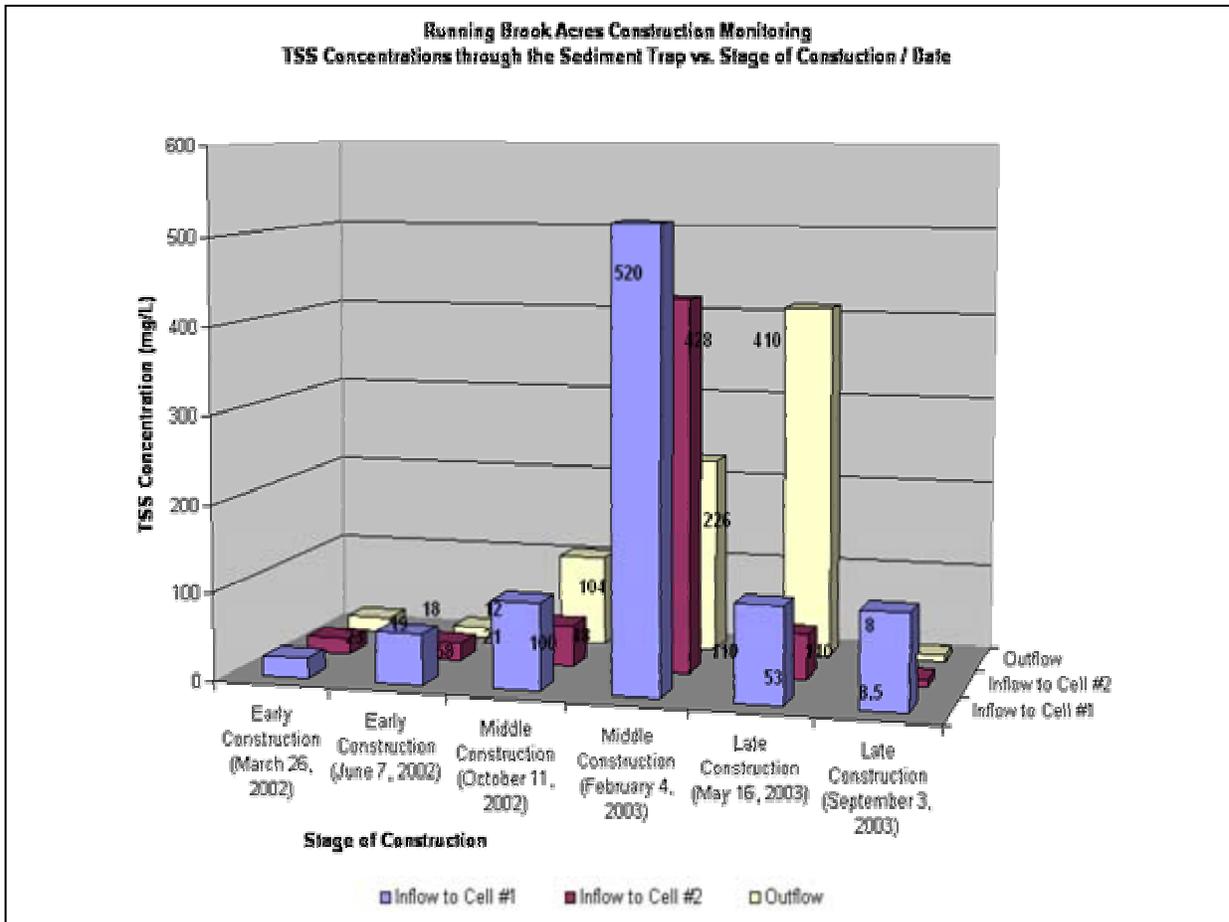
Figure 67 Running Brook Sediment Trap Efficiency

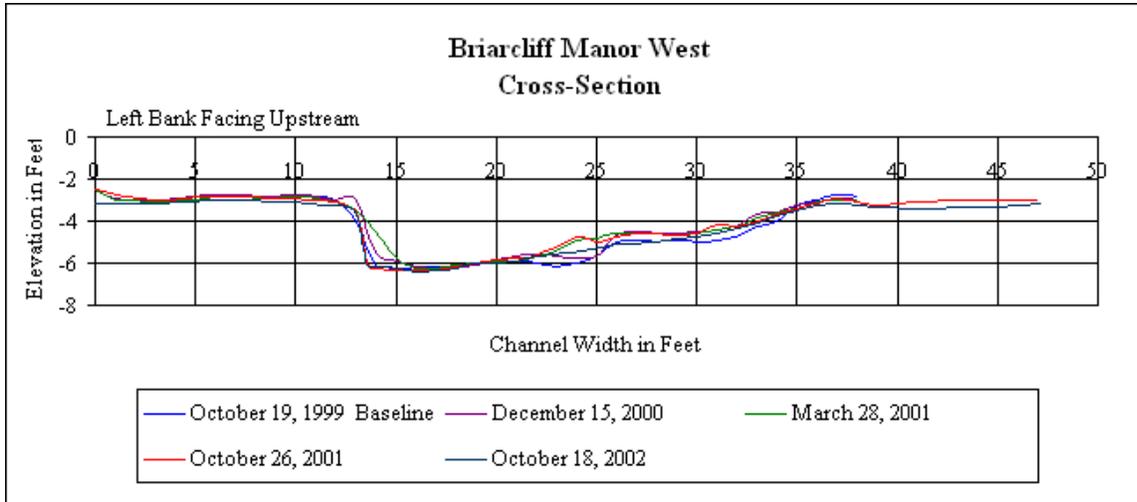
Figure 74 Briarcliff Manor West Cross Section

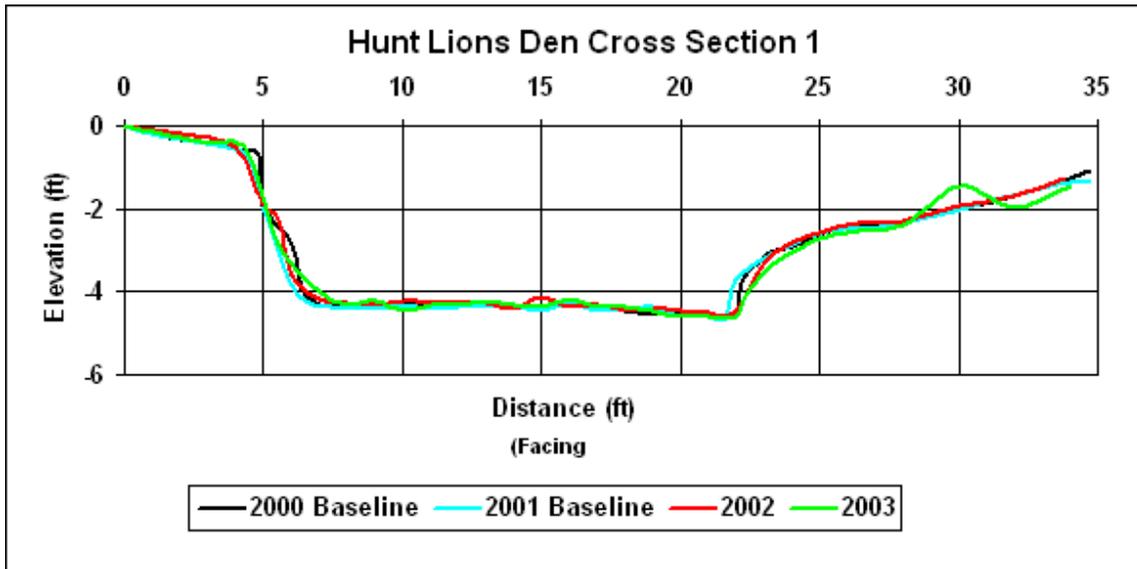
Figure 75 Hunt Lions Den Cross Section
