National Pollutant Discharge Elimination System Municipal Separate Storm Sewer System Permit

Montgomery County, Maryland

FY23 Annual Report
July 1, 2022 to June 30, 2023

Published by the Montgomery County, Maryland, Department of Environmental Protection for the Maryland Department of the Environment

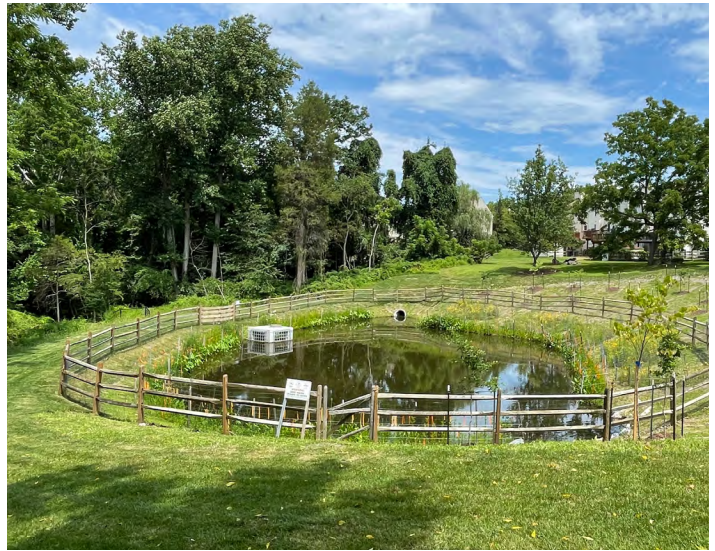
Quail Valley Stormwater Pond Retrofit.

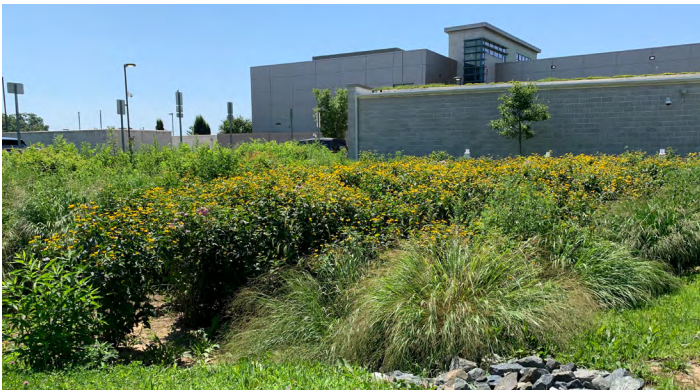
SWM BMP at Third District Police Station maintained by DEP in FY23.

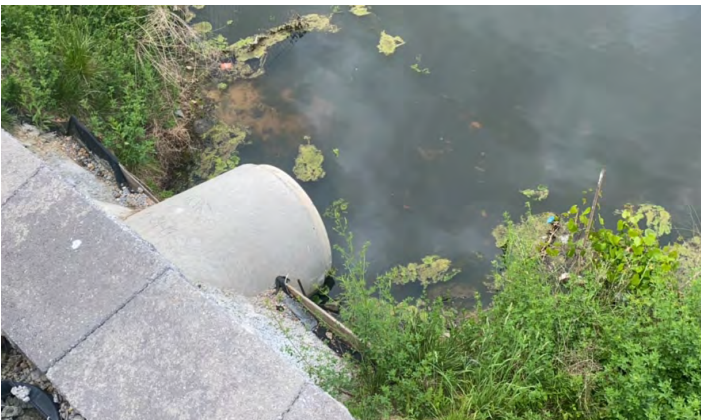
Storm drain outfall inspected in 2023.

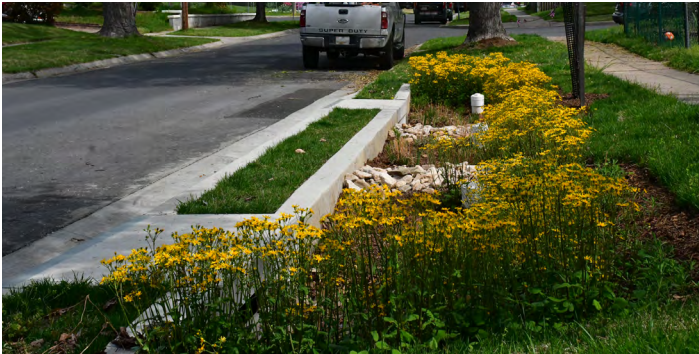
ESD BMP installed with the Glenmont Forest Green Street project completed in July 2022.

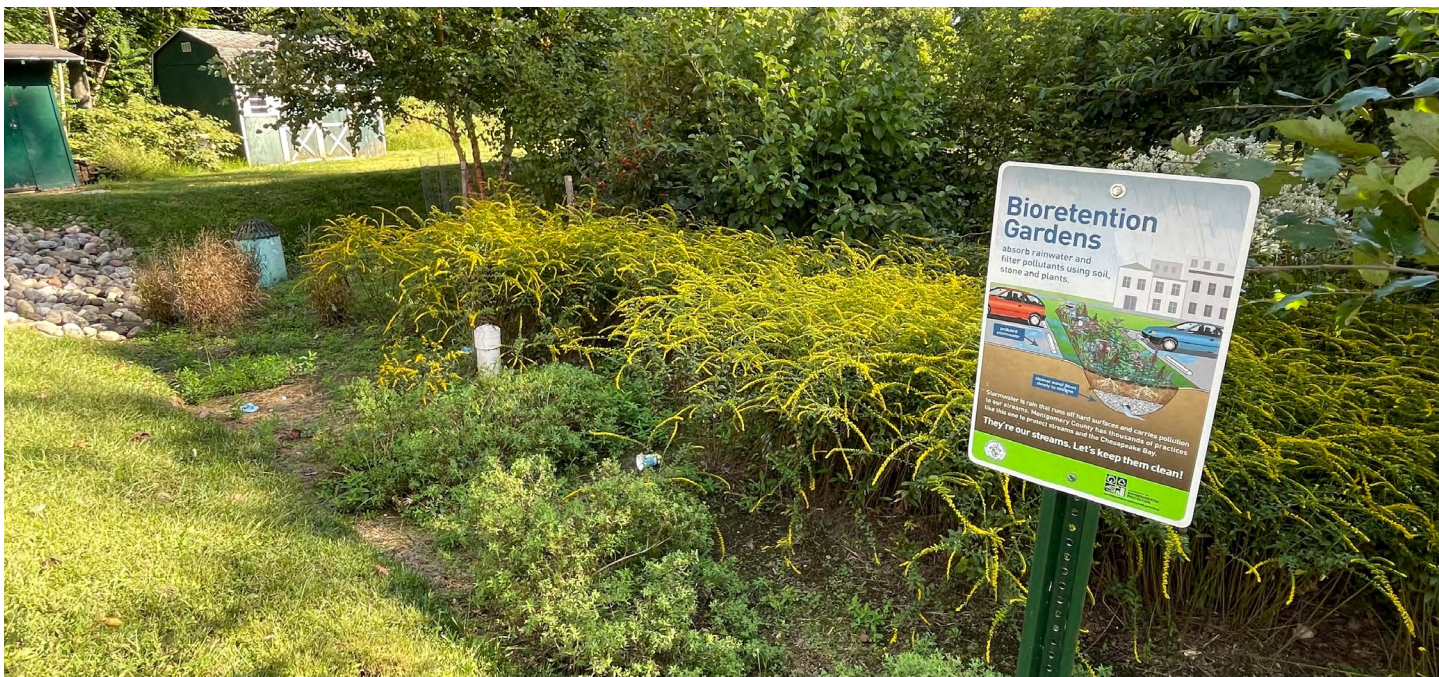
Bioretention garden installed at Northwood Presbyterian Church as part of the Breewood Tributary Restoration Project.

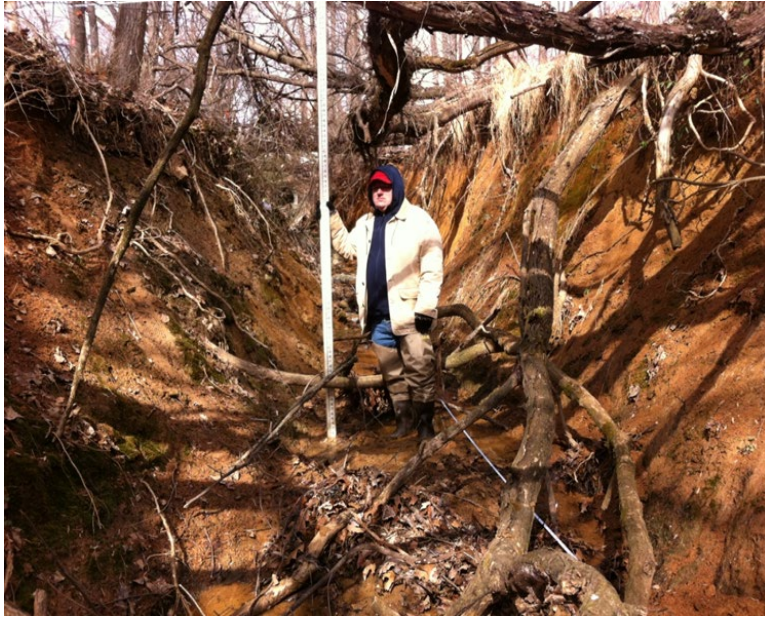
Figure 2.G-16. Pre-restoration Upstream View of Sligo Creek Breewood Tributary Study Area 1, 2013

Restoration has resulted in a more stable channel, with lower erosion potential. Erosive stormflows that were once confined and concentrated in an entrenched channel with erodible soils now have space in the floodplain to spread out and slow down. The design intends for water to filter through the hyporheic zone to reduce surface-flow volumes and improve water quality. Figure 2.G-16 represents a cross-section within Study Area 1, demonstrating the severe down-cutting that was prevalent pre-restoration in this part of the Breewood Tributary. Figure 2.G-17 shows the Breewood Tributary post-restoration.

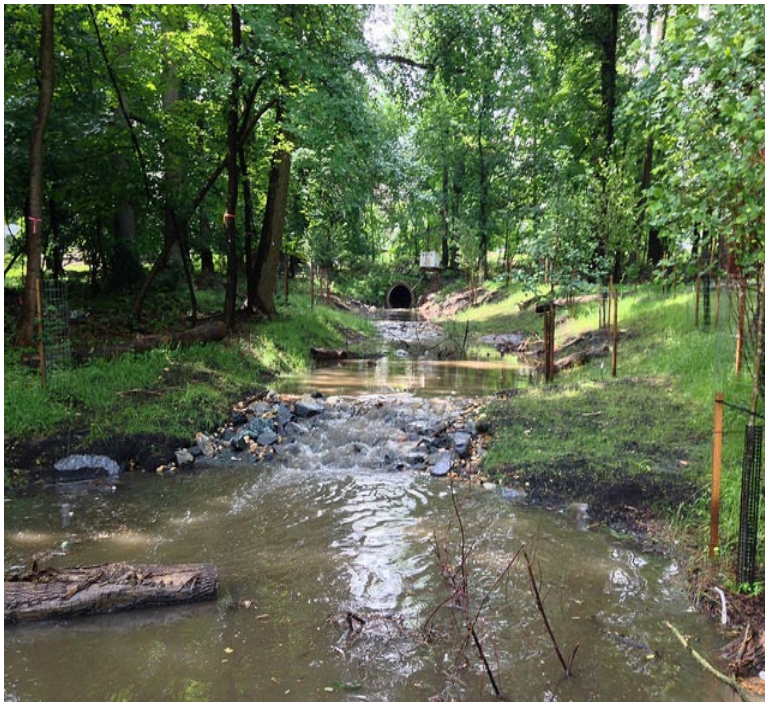
Figure 2.G-17. Post-restoration Upstream View of Sligo Creek Breewood Tributary Study Area 1, 2015

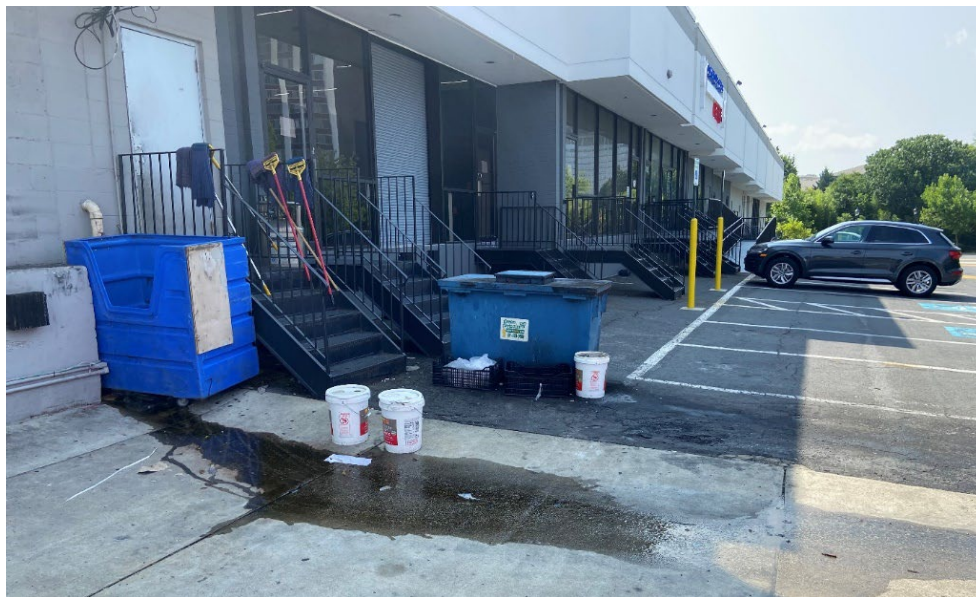
Figure A-2. Poor Housekeeping at Businesses

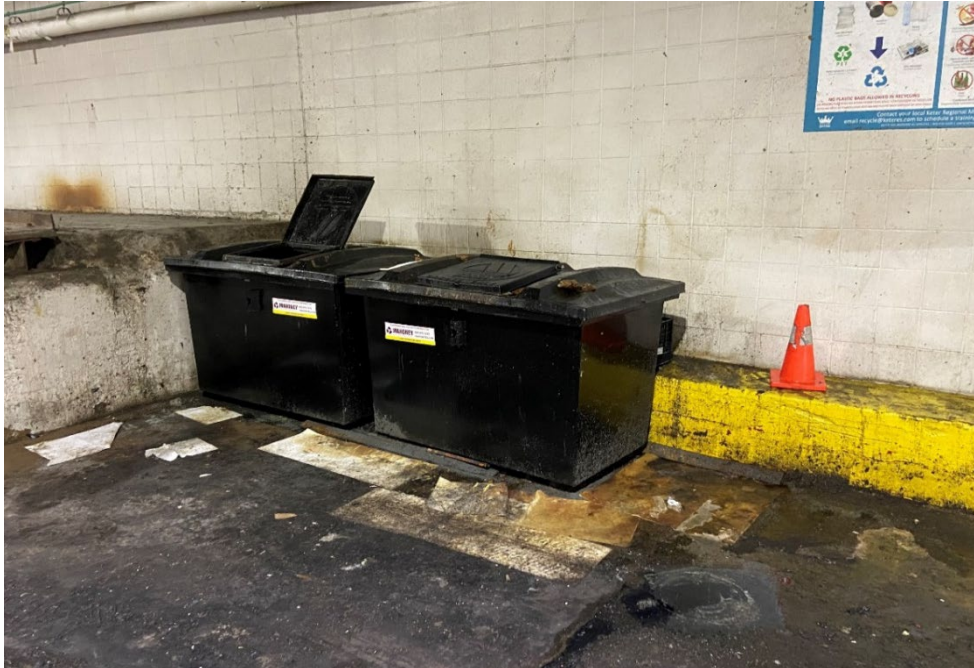
Figure A-3. Grease Spills and Poorly Maintained Used Grease Containers
