WRE 12-28 CONCEPT DESIGN

Montgomery County, Maryland

Clearspring Tributary

Bank Stabilization & Stream Restoration Factsheet

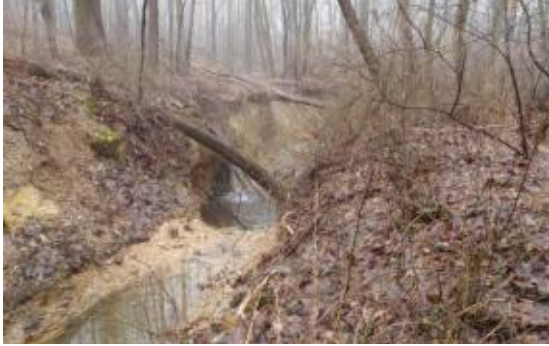
Severe Head Cut Moving Up-stream

Land use within the Clearspring watershed is a mix of low-density and medium-density residential. Development in the area began in the early 1960's when land use transitioned from mainly agriculture and forested lands to residential developments. As a result the headwaters of the Clearspring tributary have been piped and outfall into the project area from a culvert under Conrad Court.

During rain events, runoff from rooftops, roads, parking lots and other impervious surfaces is directed toward area storm drains. In the Clearspring drainage area no stormwater facilities are present upstream of the project site to provide water quality or quantity treatment. Stormwater is collected and conveyed directly to the Clearspring Tributary at an increased, erosive velocity.

The high flashy flows seen at Clearspring are typical in most post development tributaries. The combination of untreated and piped flows, and characteristics of the local soils within the Clearspring stream valley continue to degrade channel conditions and impair water quality downstream.

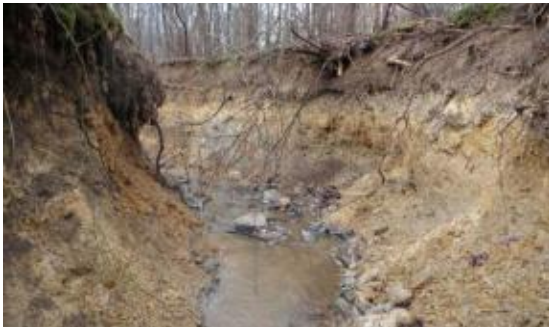
Bank Erosion Ranging From 6-8 Feet

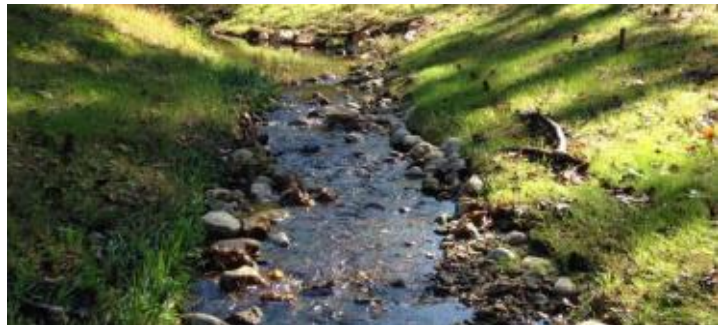
Example of Riffle Grade Control

Grade Control

In-stream grade control structures are implemented to reduce vertical instability and bank erosion. Grade controls such as cross vanes, step pools and v-drops, direct flow to the center of the channel, dissipating energy and reducing erosional stress along the stream banks.

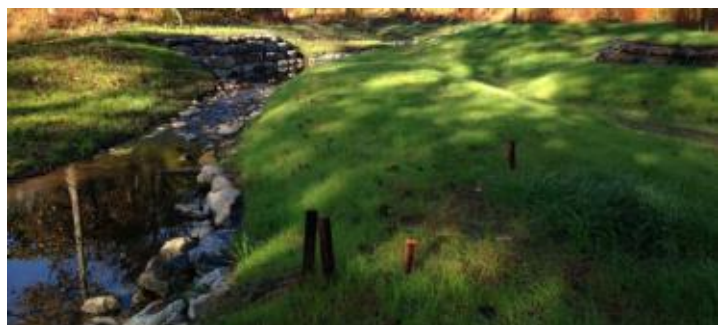
Example of Riffle / Pool Sequence

Increases flood control and directs damaging flows away from existing trees and channel banks. Restores channel sinuosity and allows for the creation of shallow aquatic habitat (riffles) and deep aquatic habitat (pools) to re-establish macroinvertebrates and fish communities.

Riffles, step pools and other design interventions reproduce natural stream conditions by directing and dissipating flows.
