Grosvenor Site GL 07 - RY 22 Stream Restoration Project

Stream Restoration Techniques

Grosvenor Site GL 08 Stream Restoration Project

Grosvenor Site SP 13 Stream Restoration Project

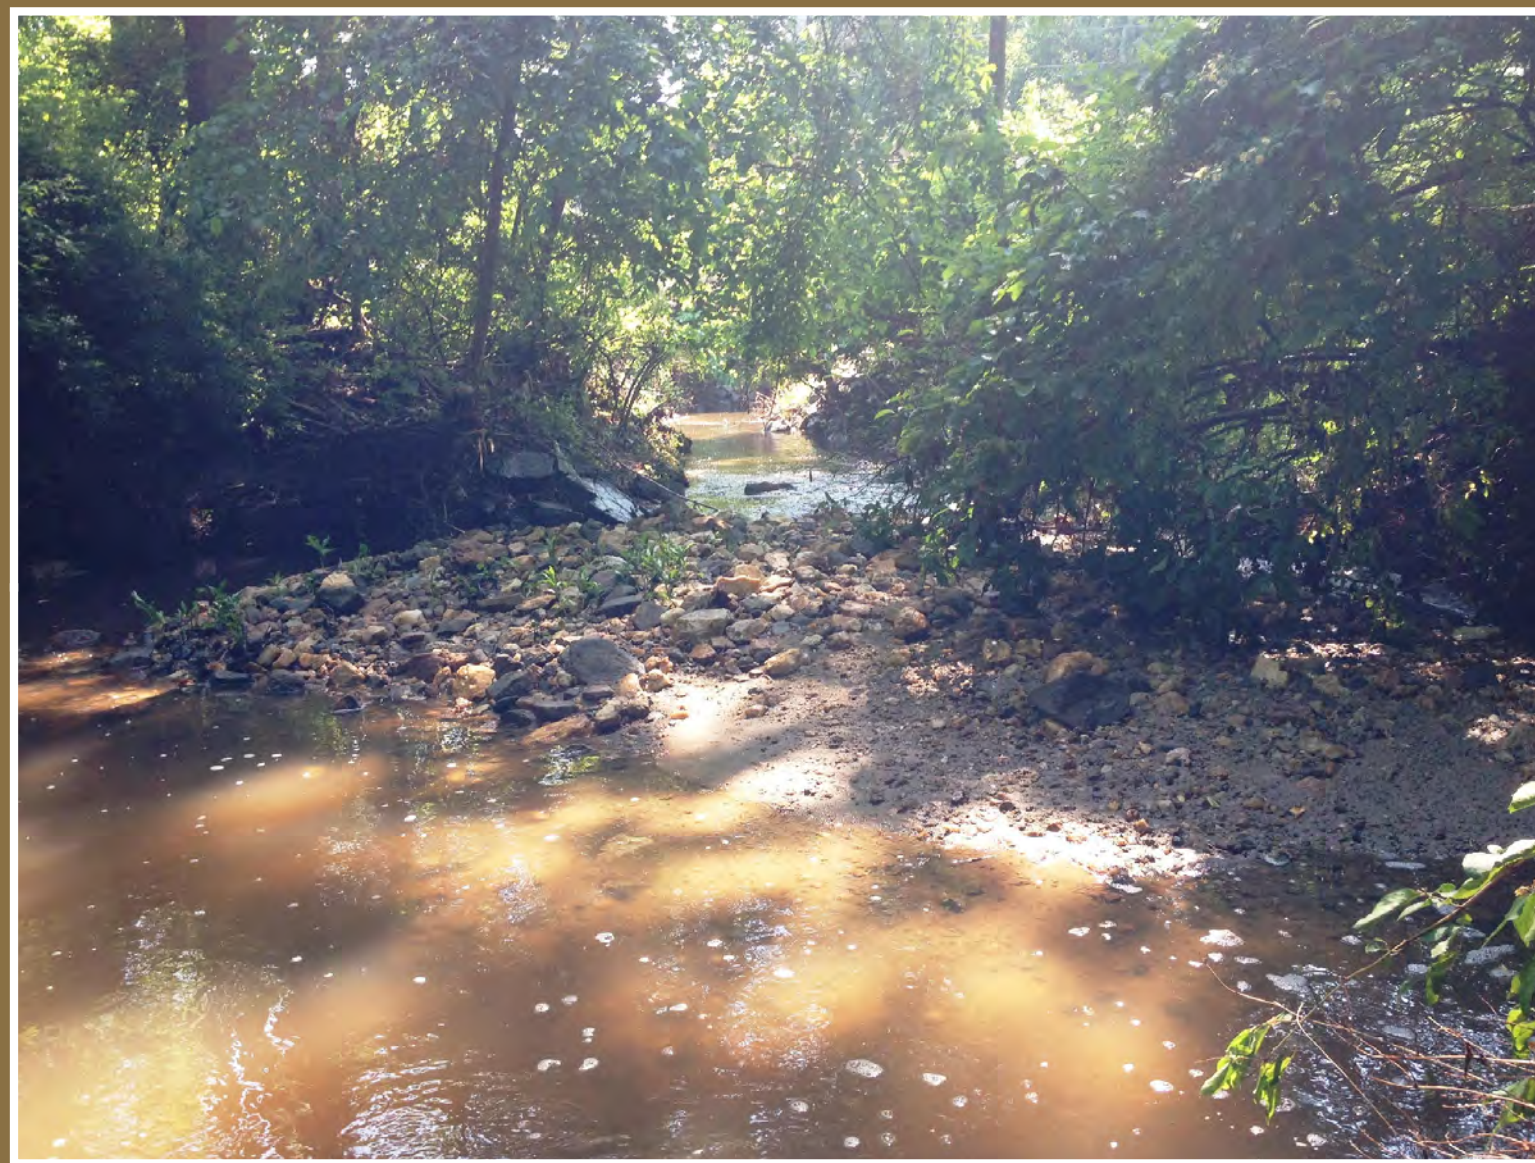
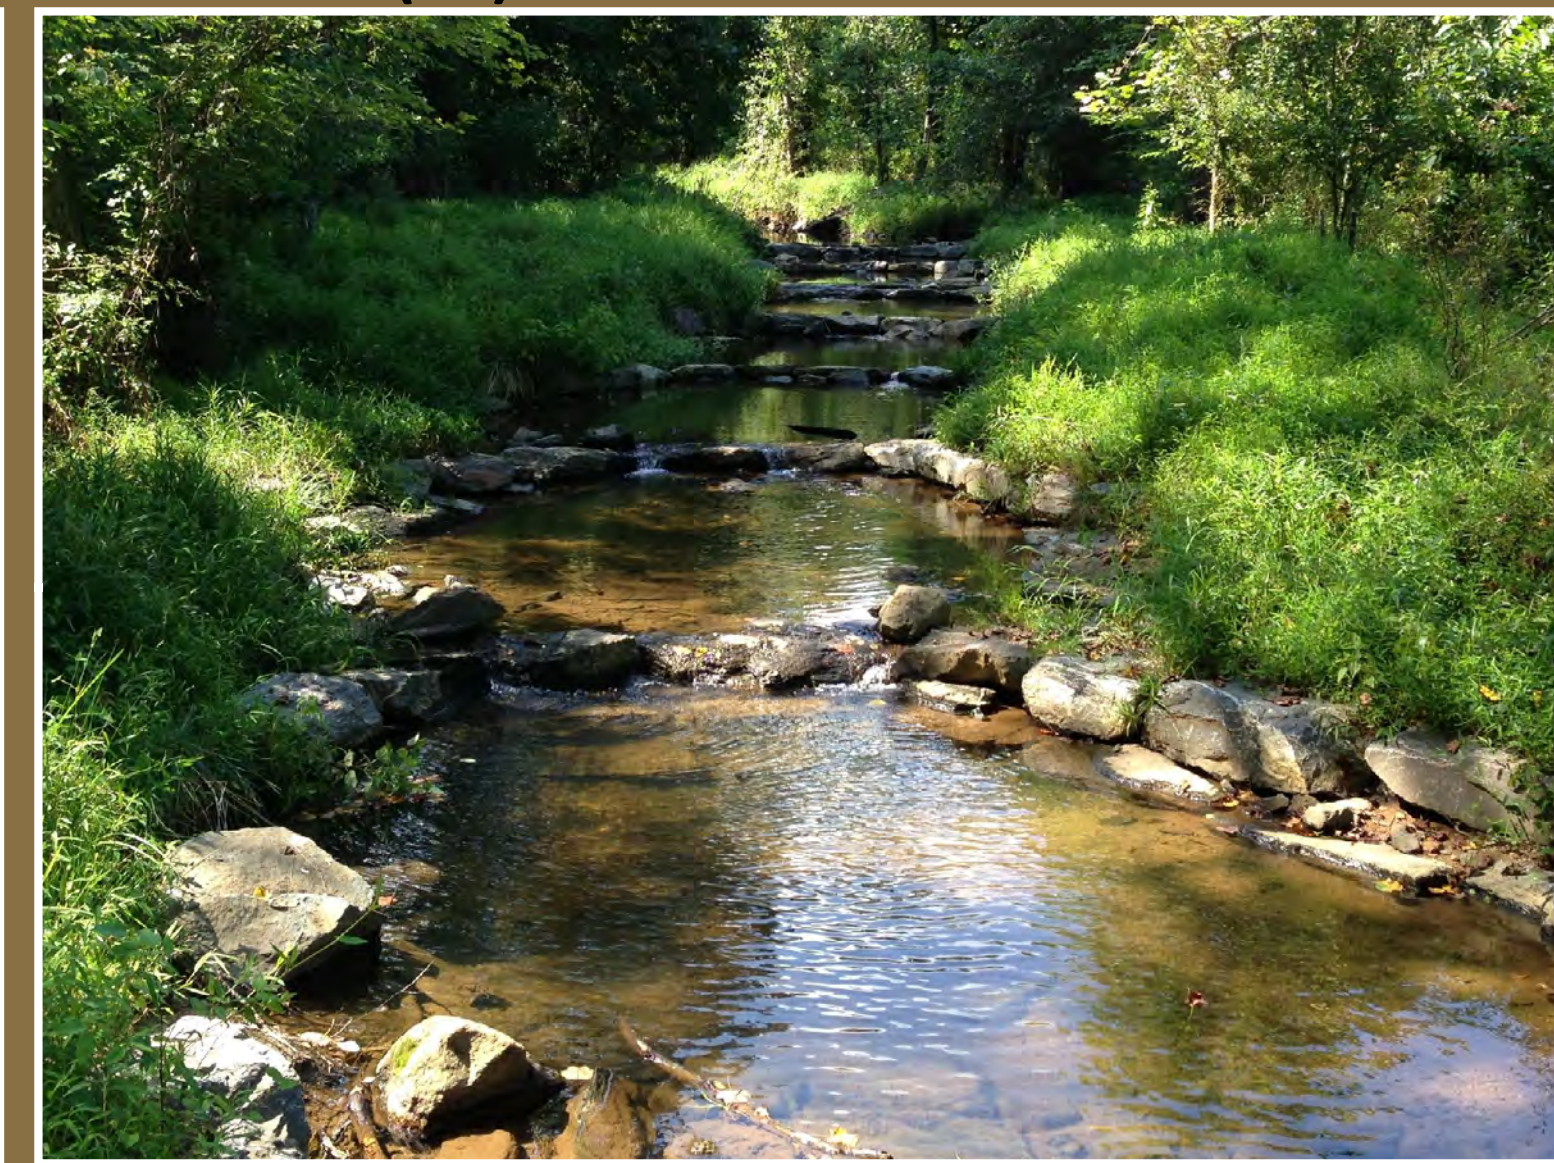
STEP POOL (SP)

Before

After

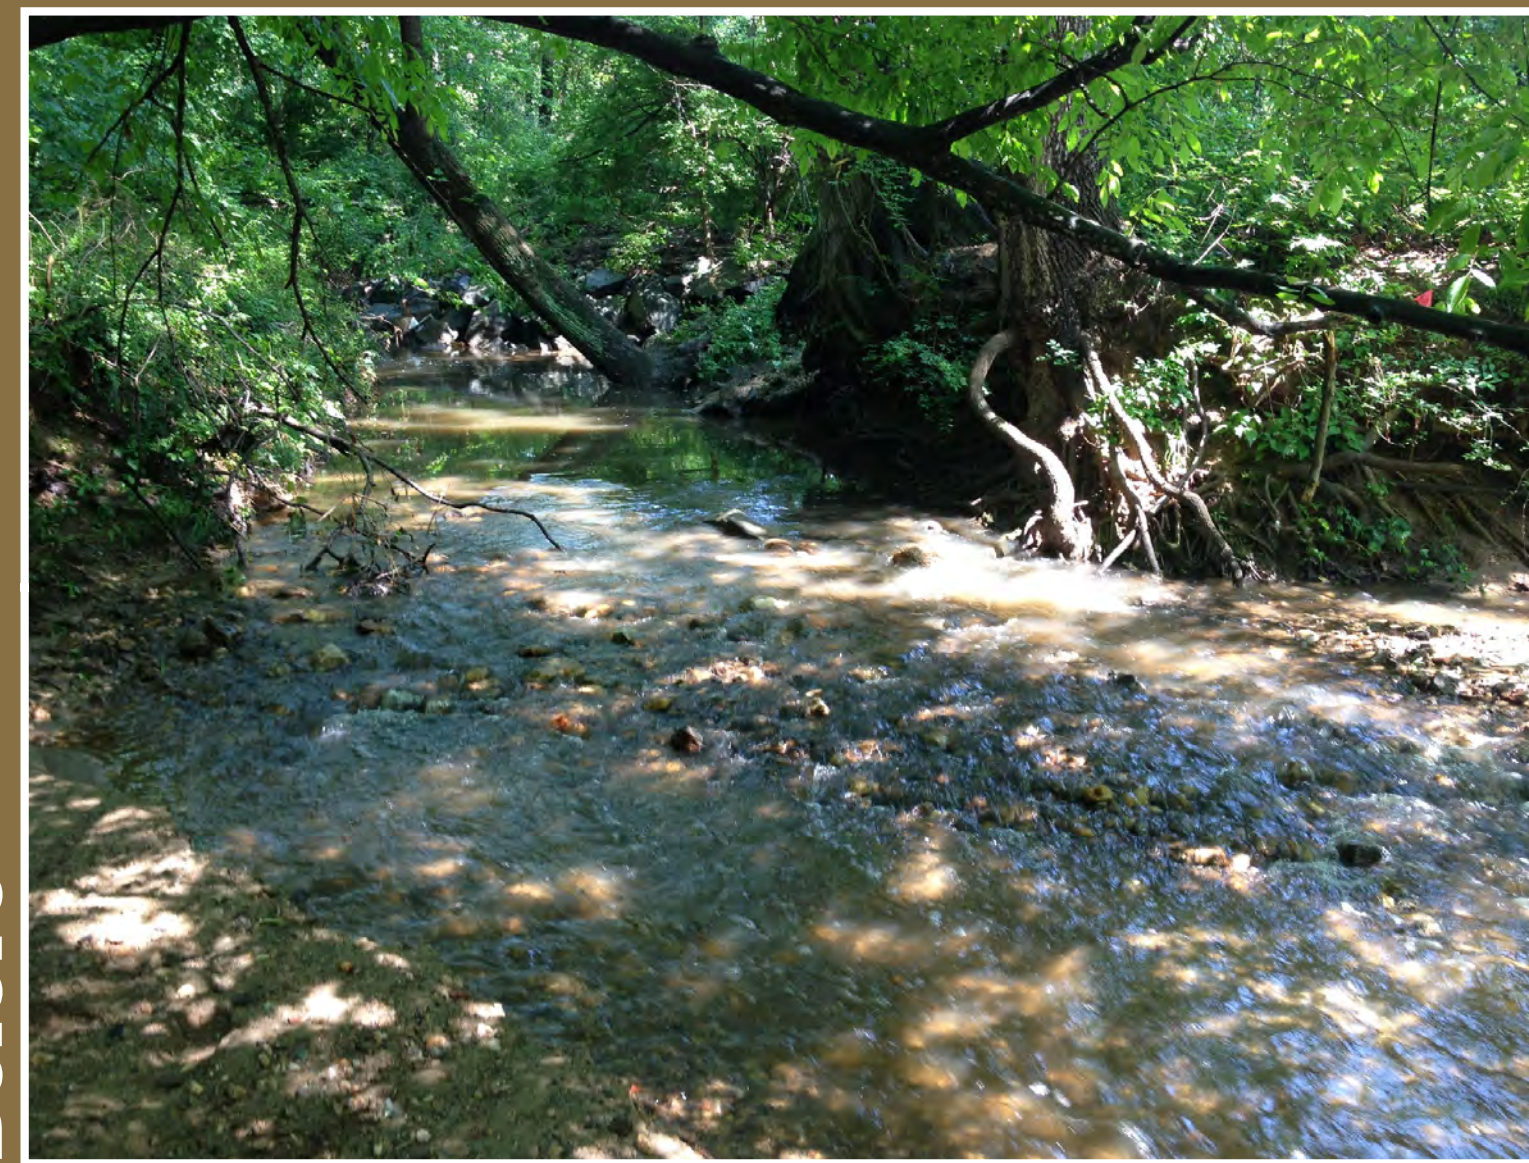
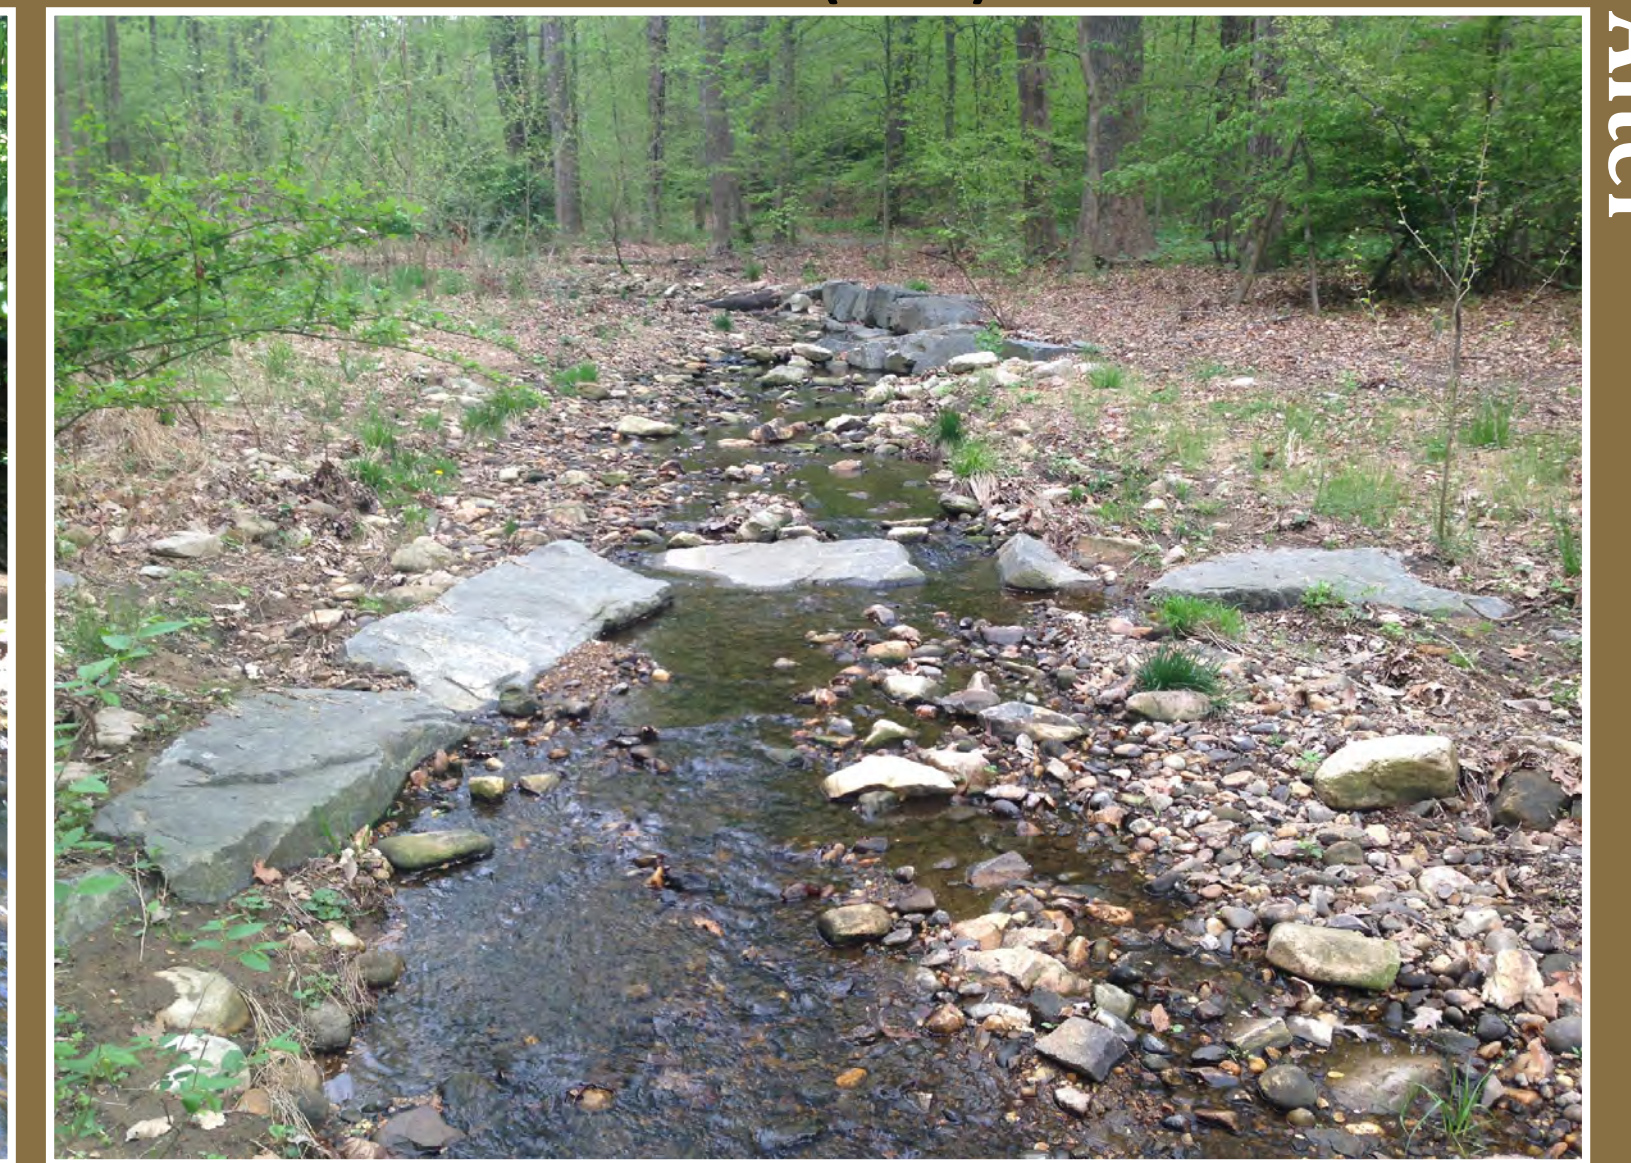
RIFFLE GRADE CONTROL (RGC)

Before

After

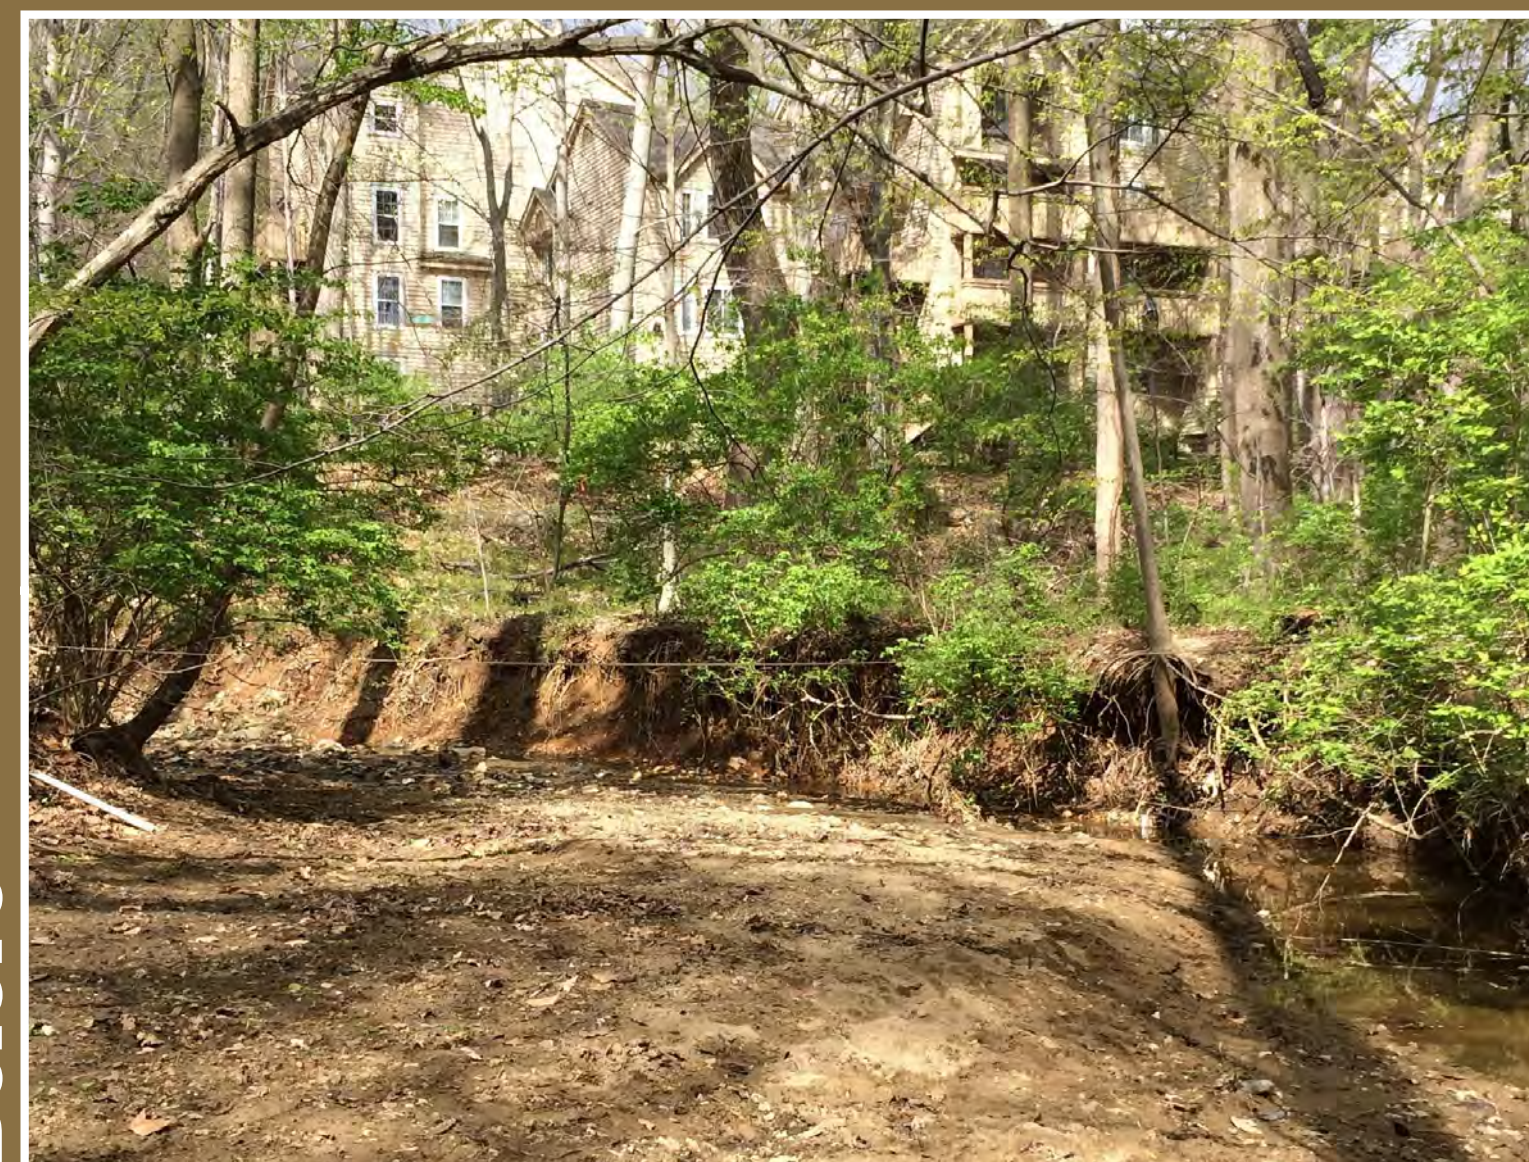
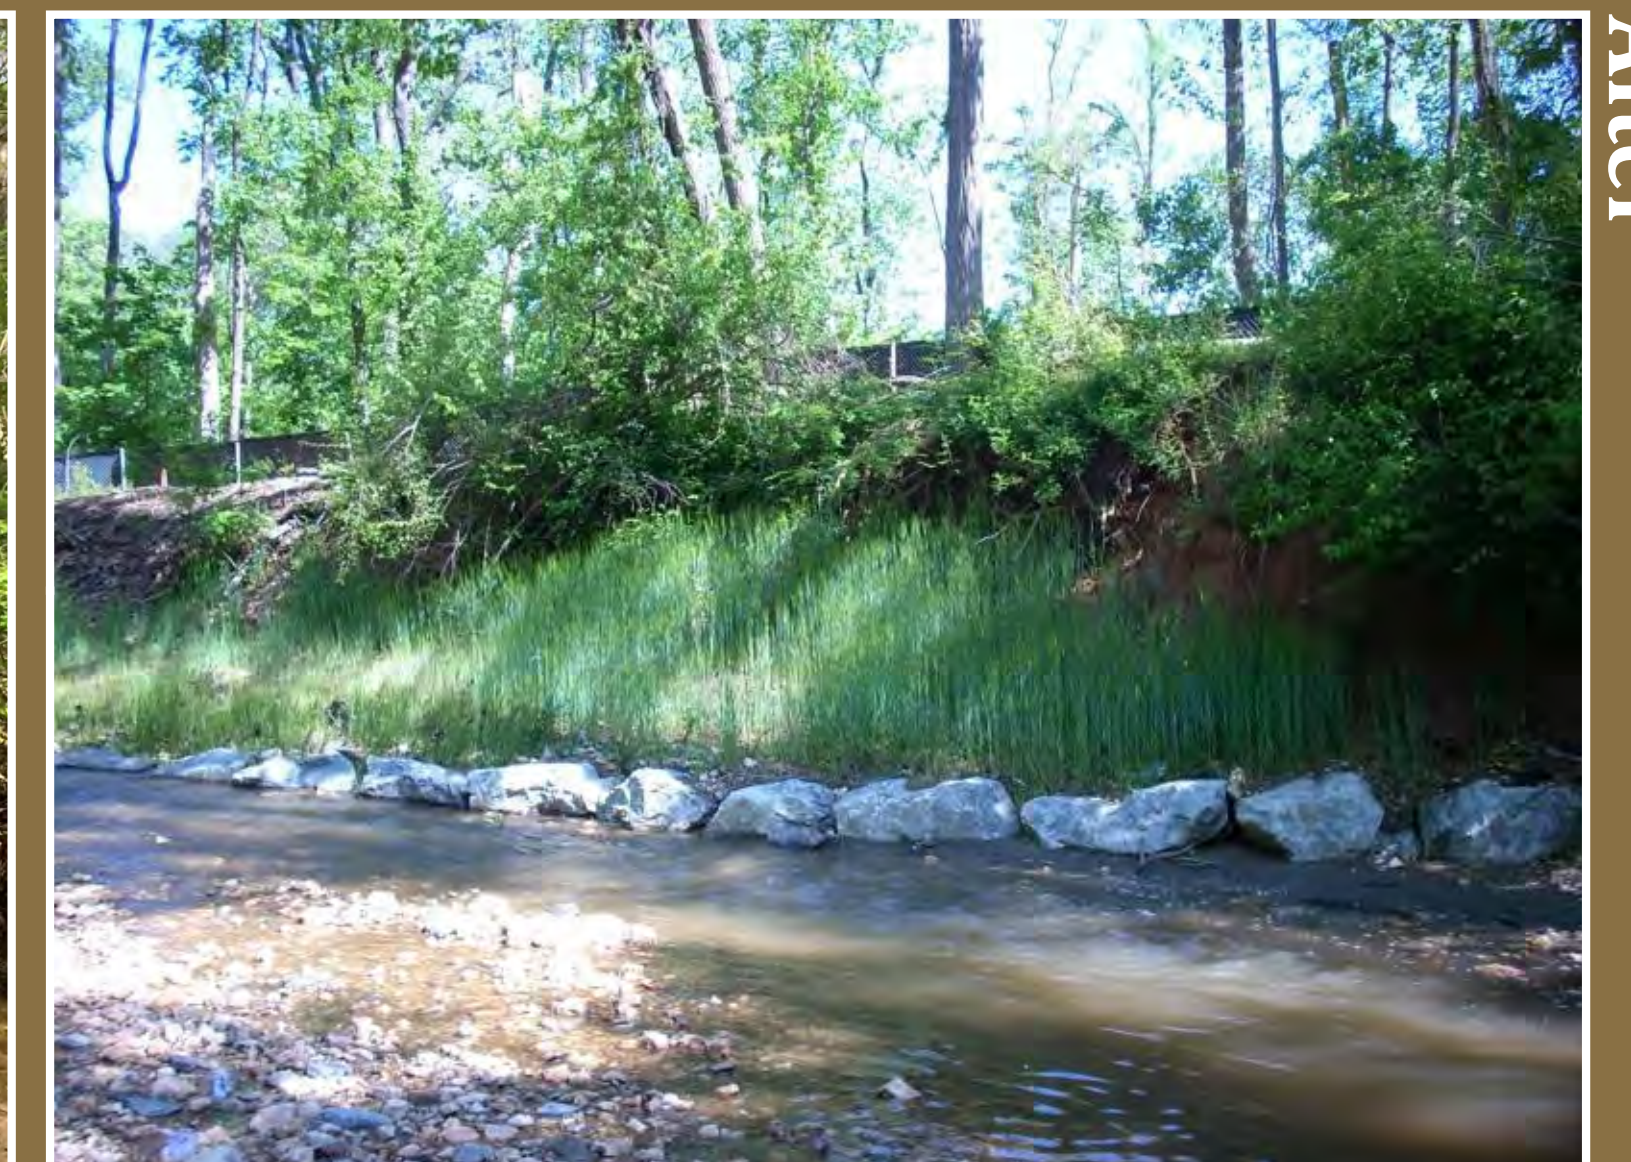
ROCK TOE (RT)

Before

After

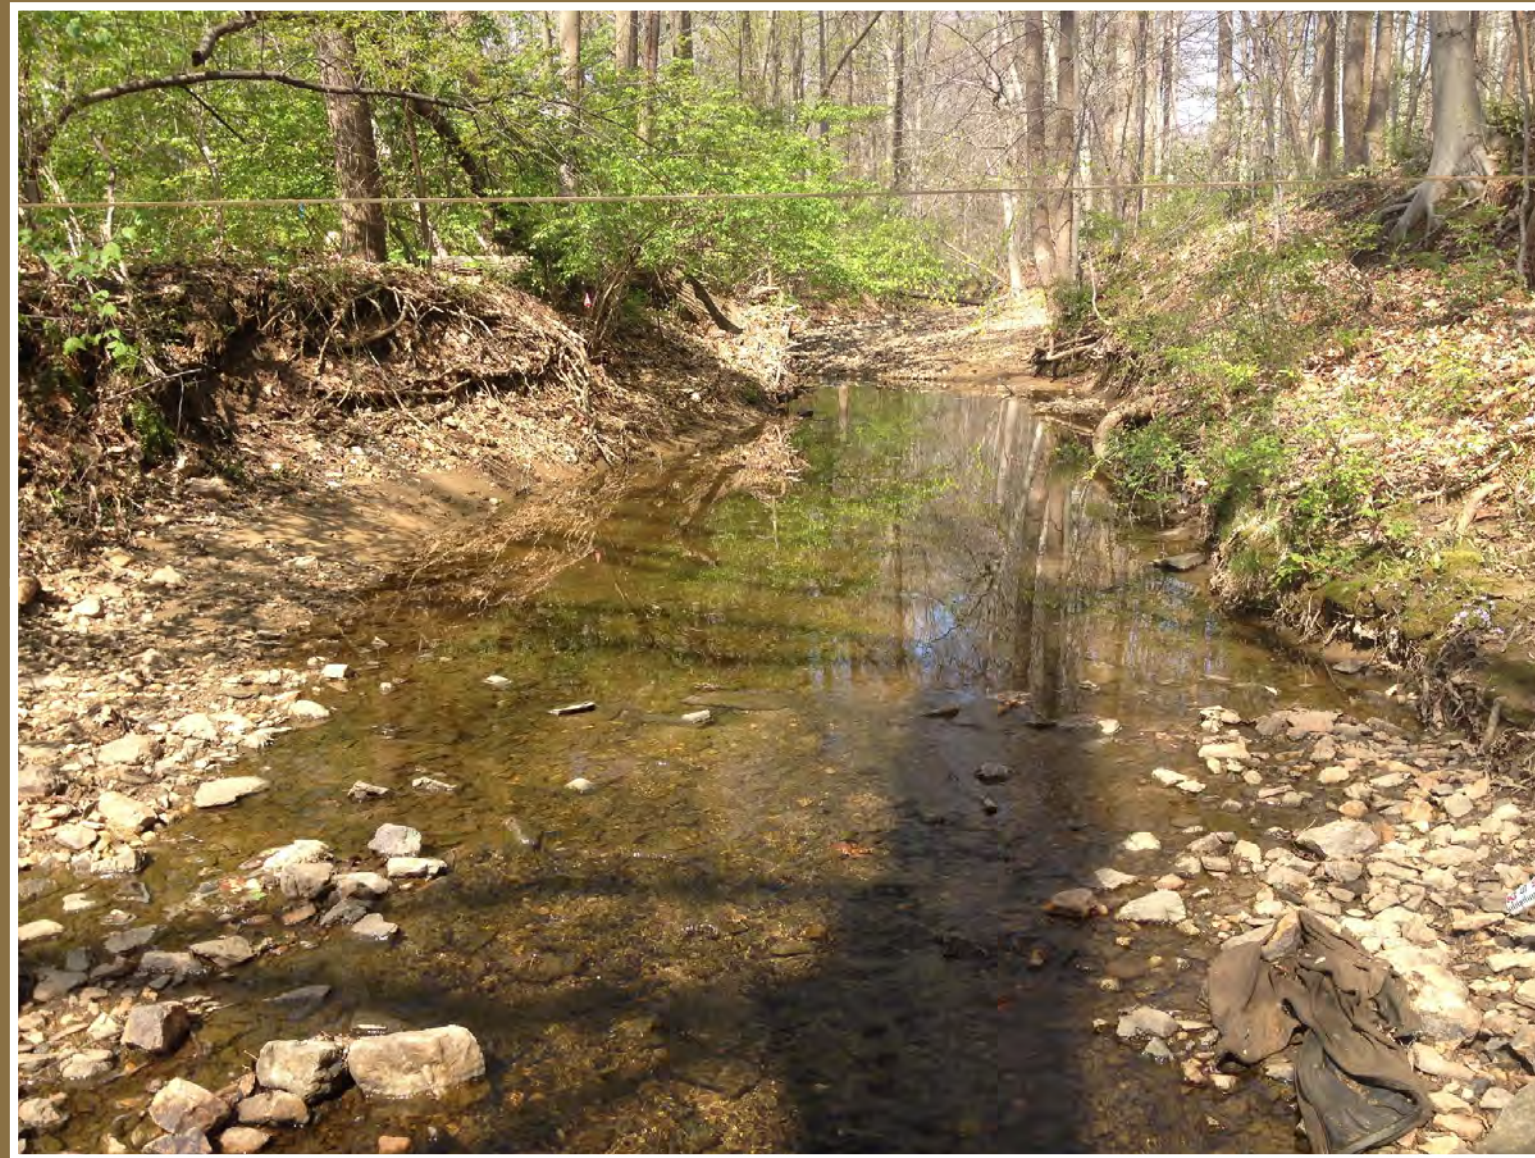
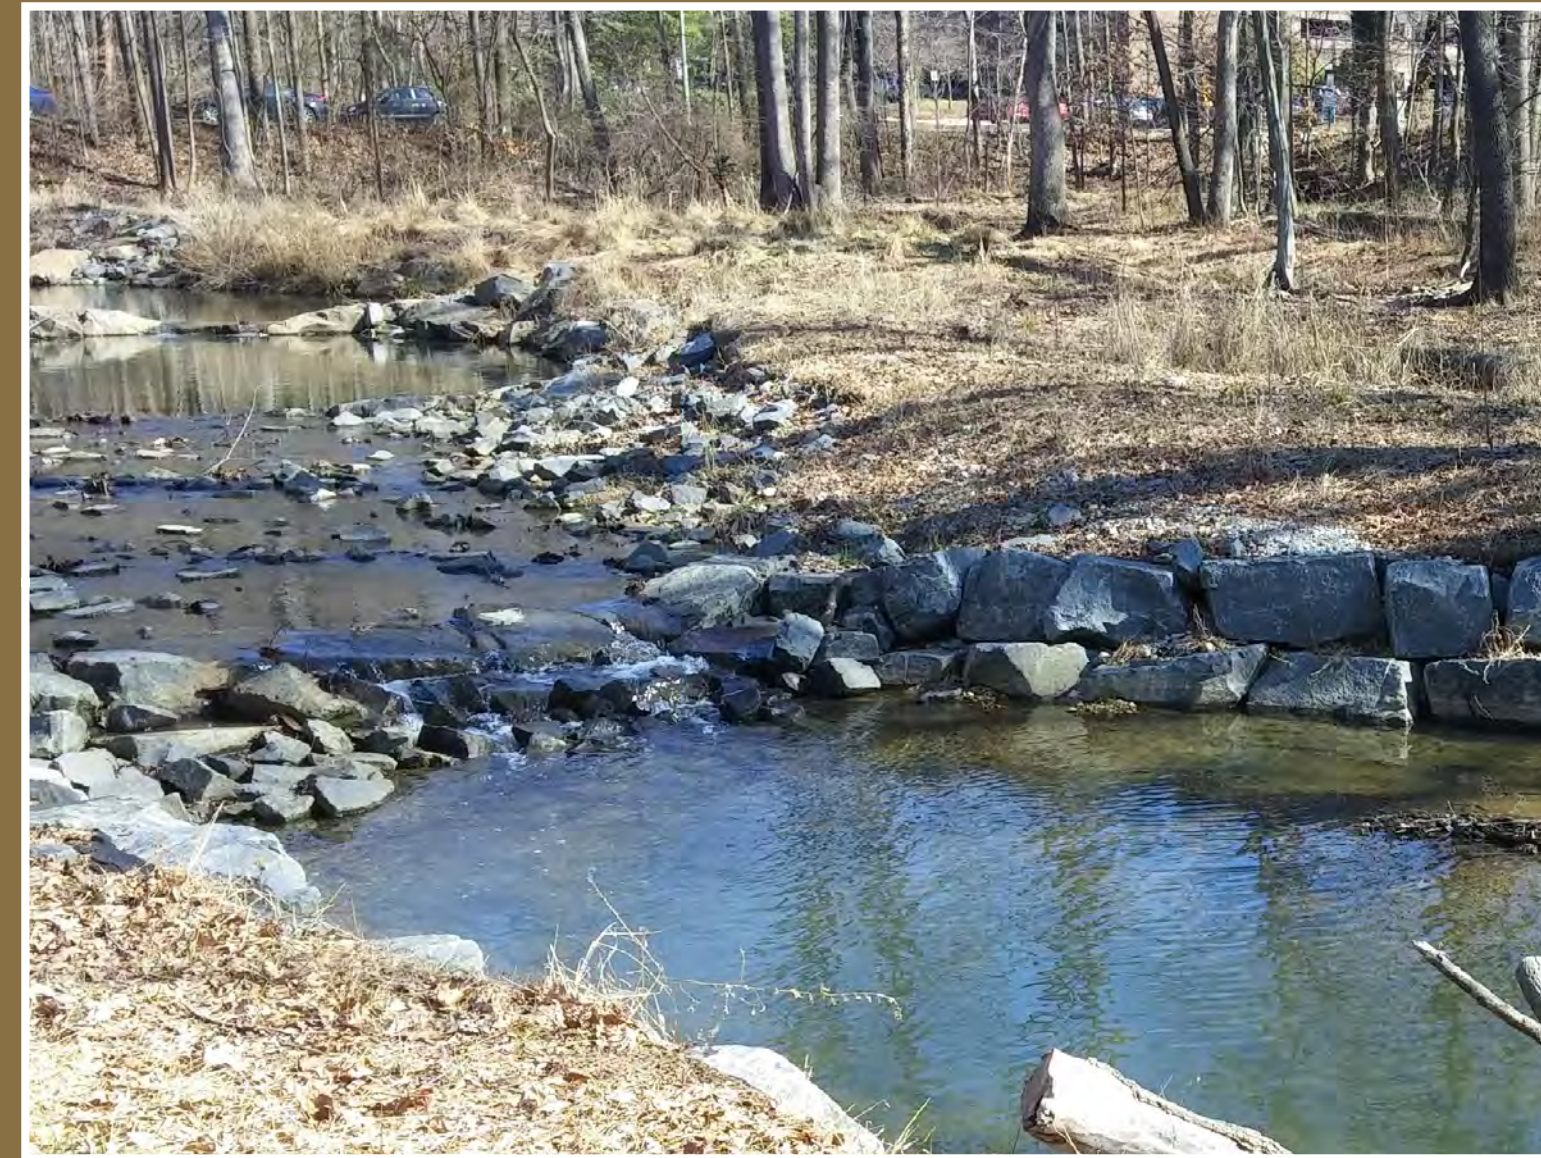
CROSS VANE W/ RIFFLE GRADE CONTROL (CV/RGC)

Before

After

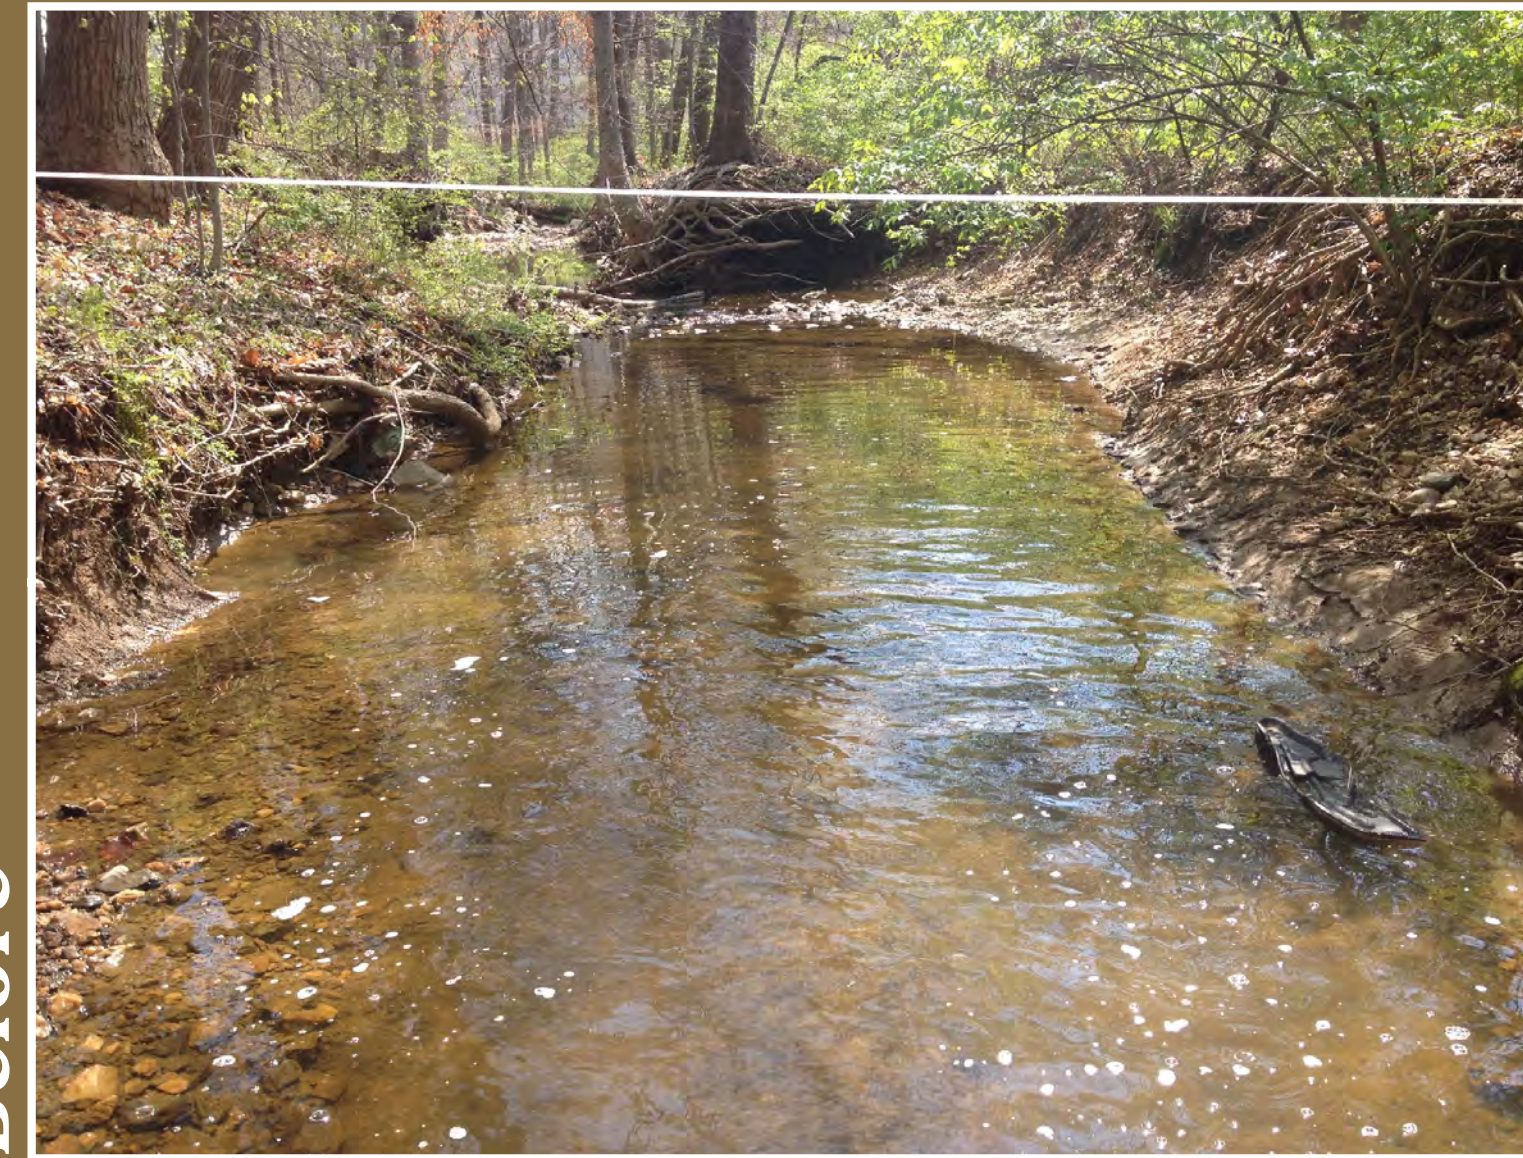
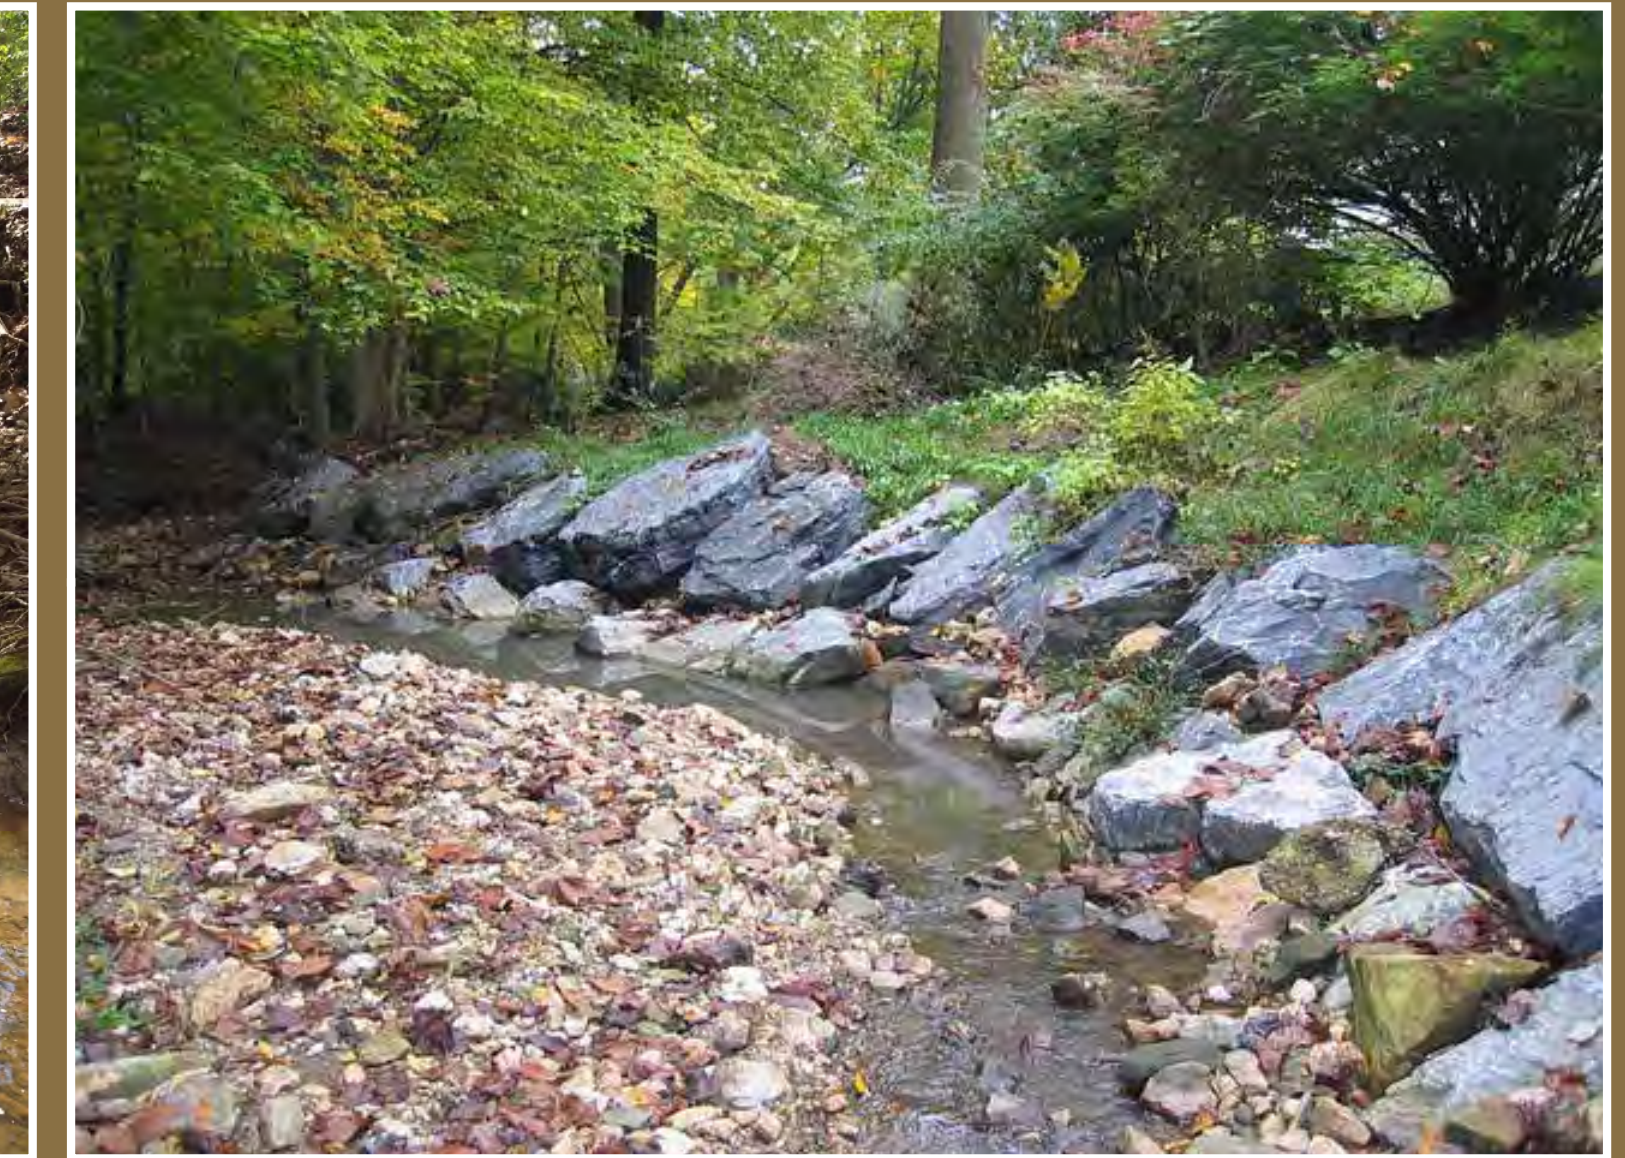
ROCK TOE (RT)

Before

After

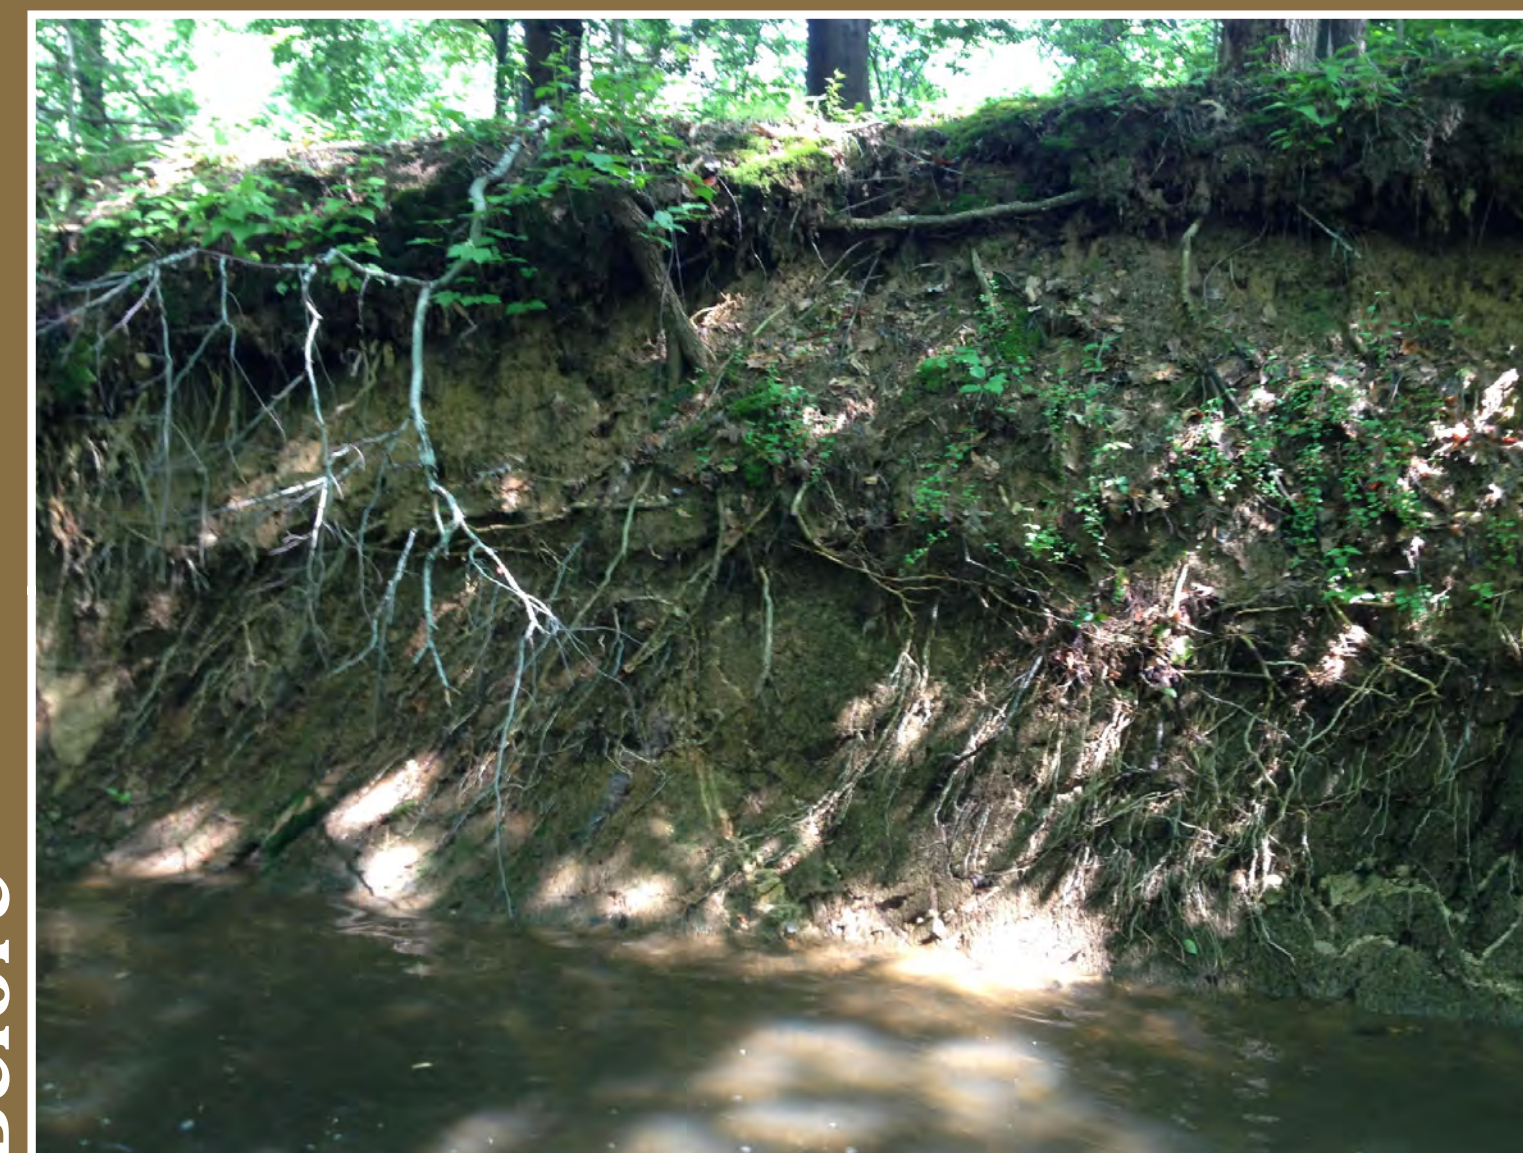
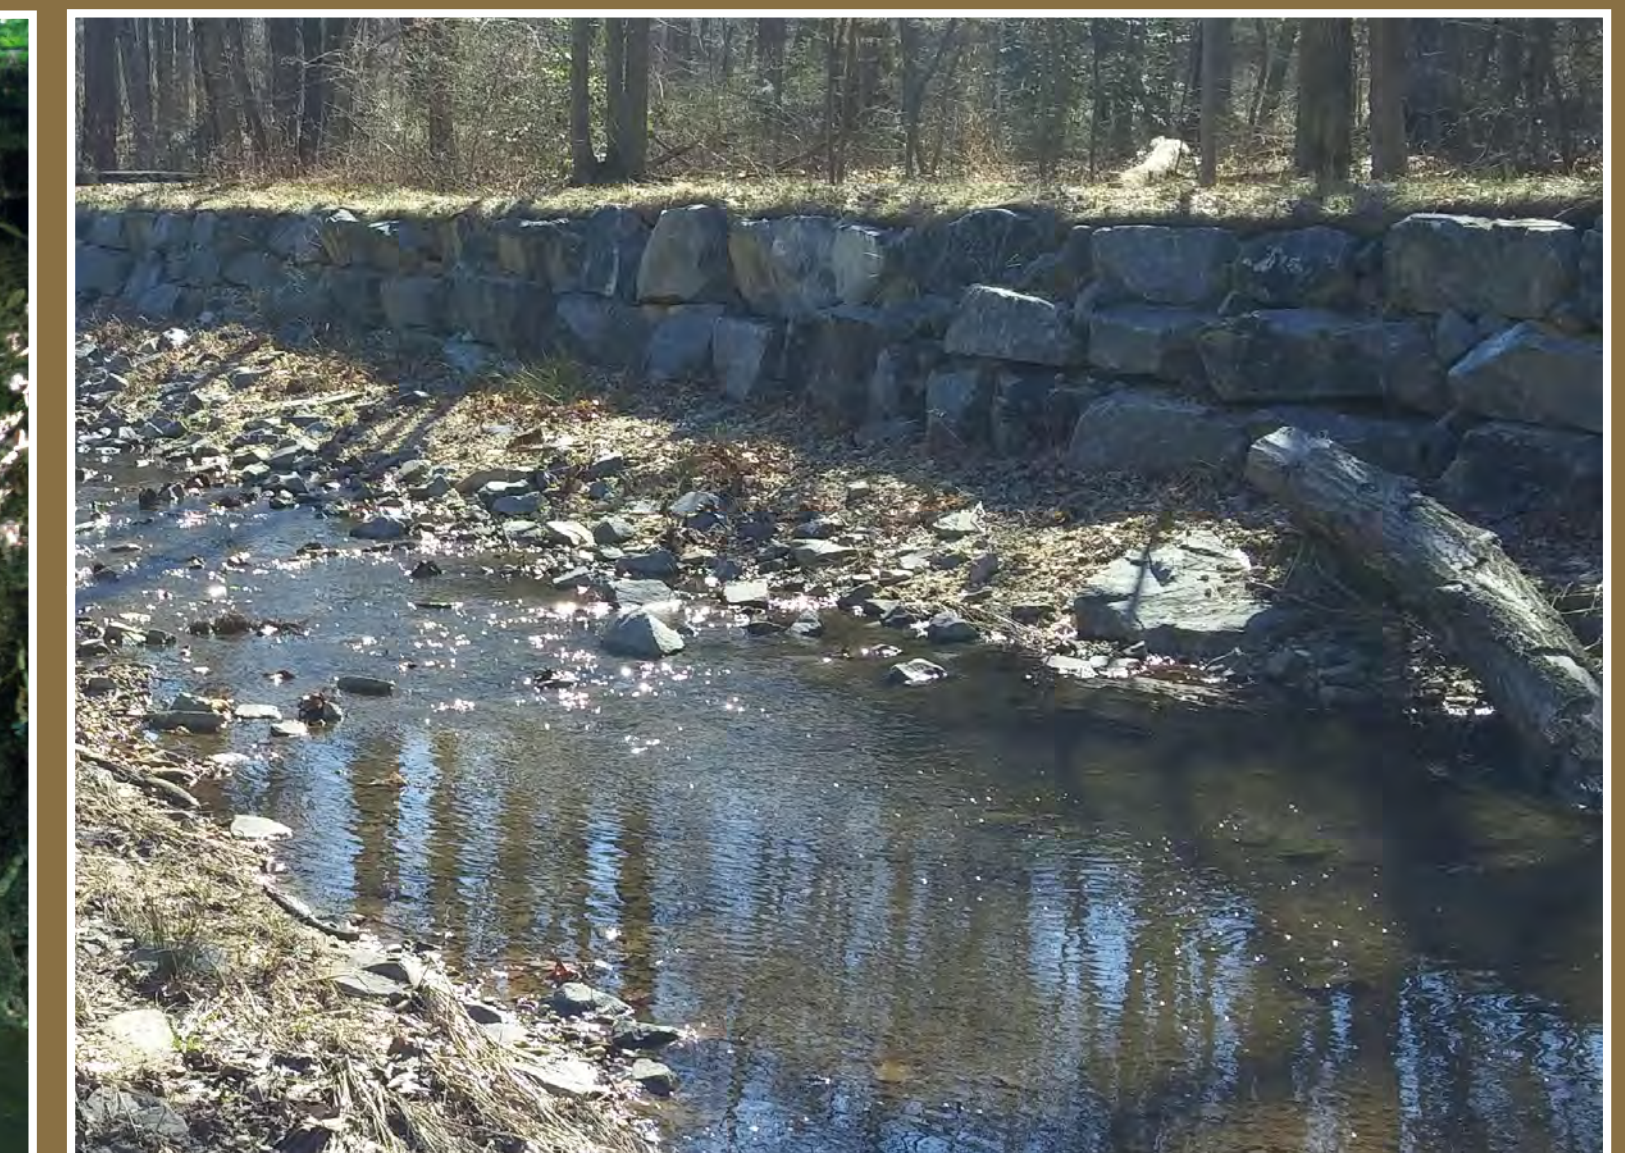
IMBRICATED ROCK WALL (IR)

Before

After
