Grosvenor Site GL 07 - RY 22 Stream Restoration Project

Stream Restoration Techniques

Grosvenor Site GL 08 Stream Restoration Project

Grosvenor Site SP 13 Stream Restoration Project

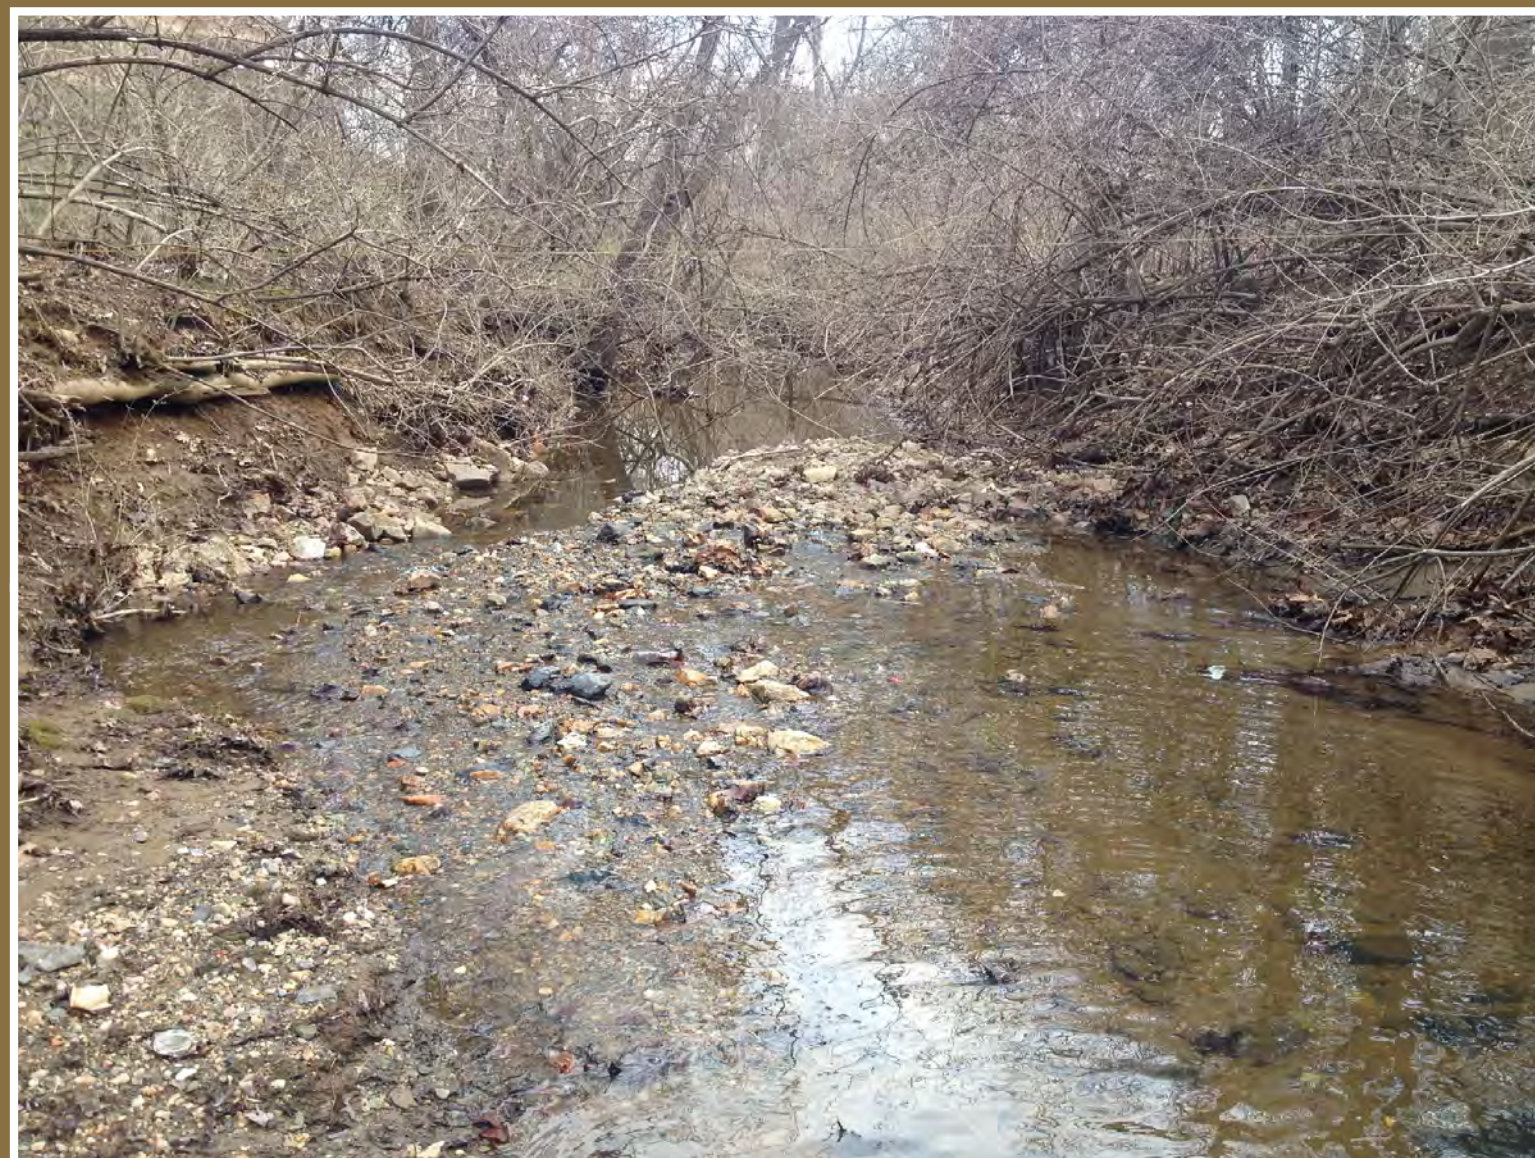
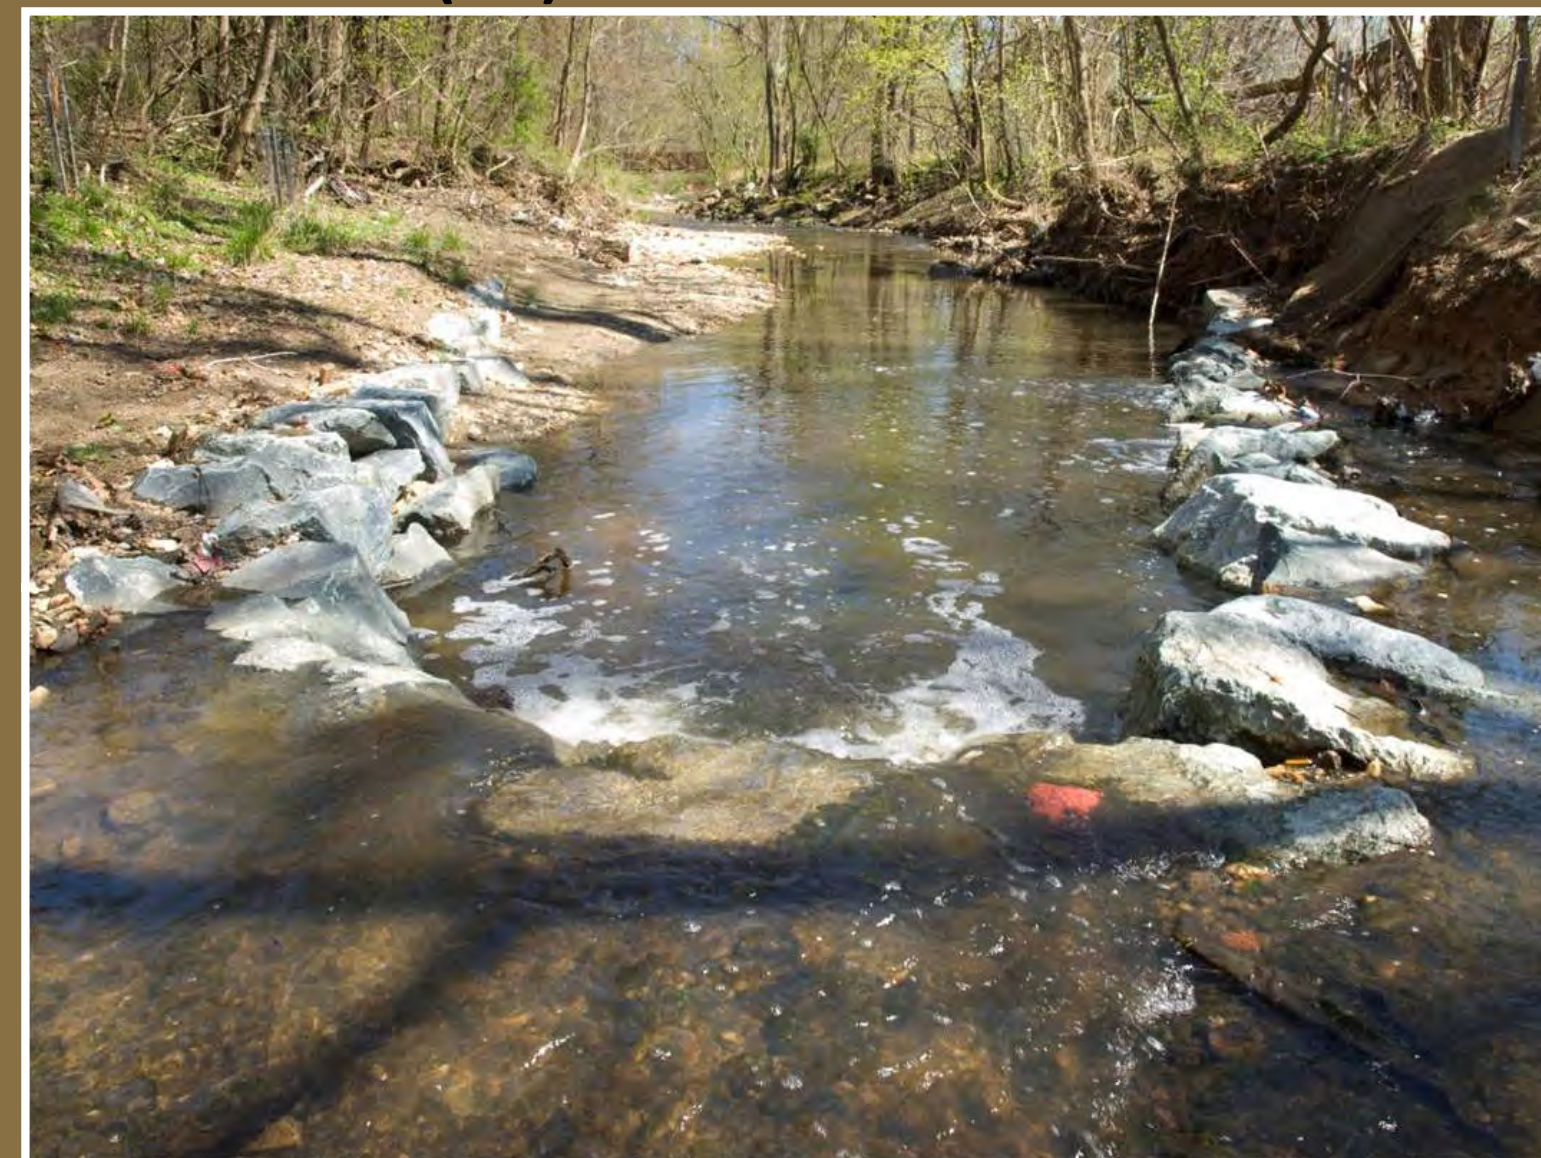
CROSS VANE (CV)

Before

After

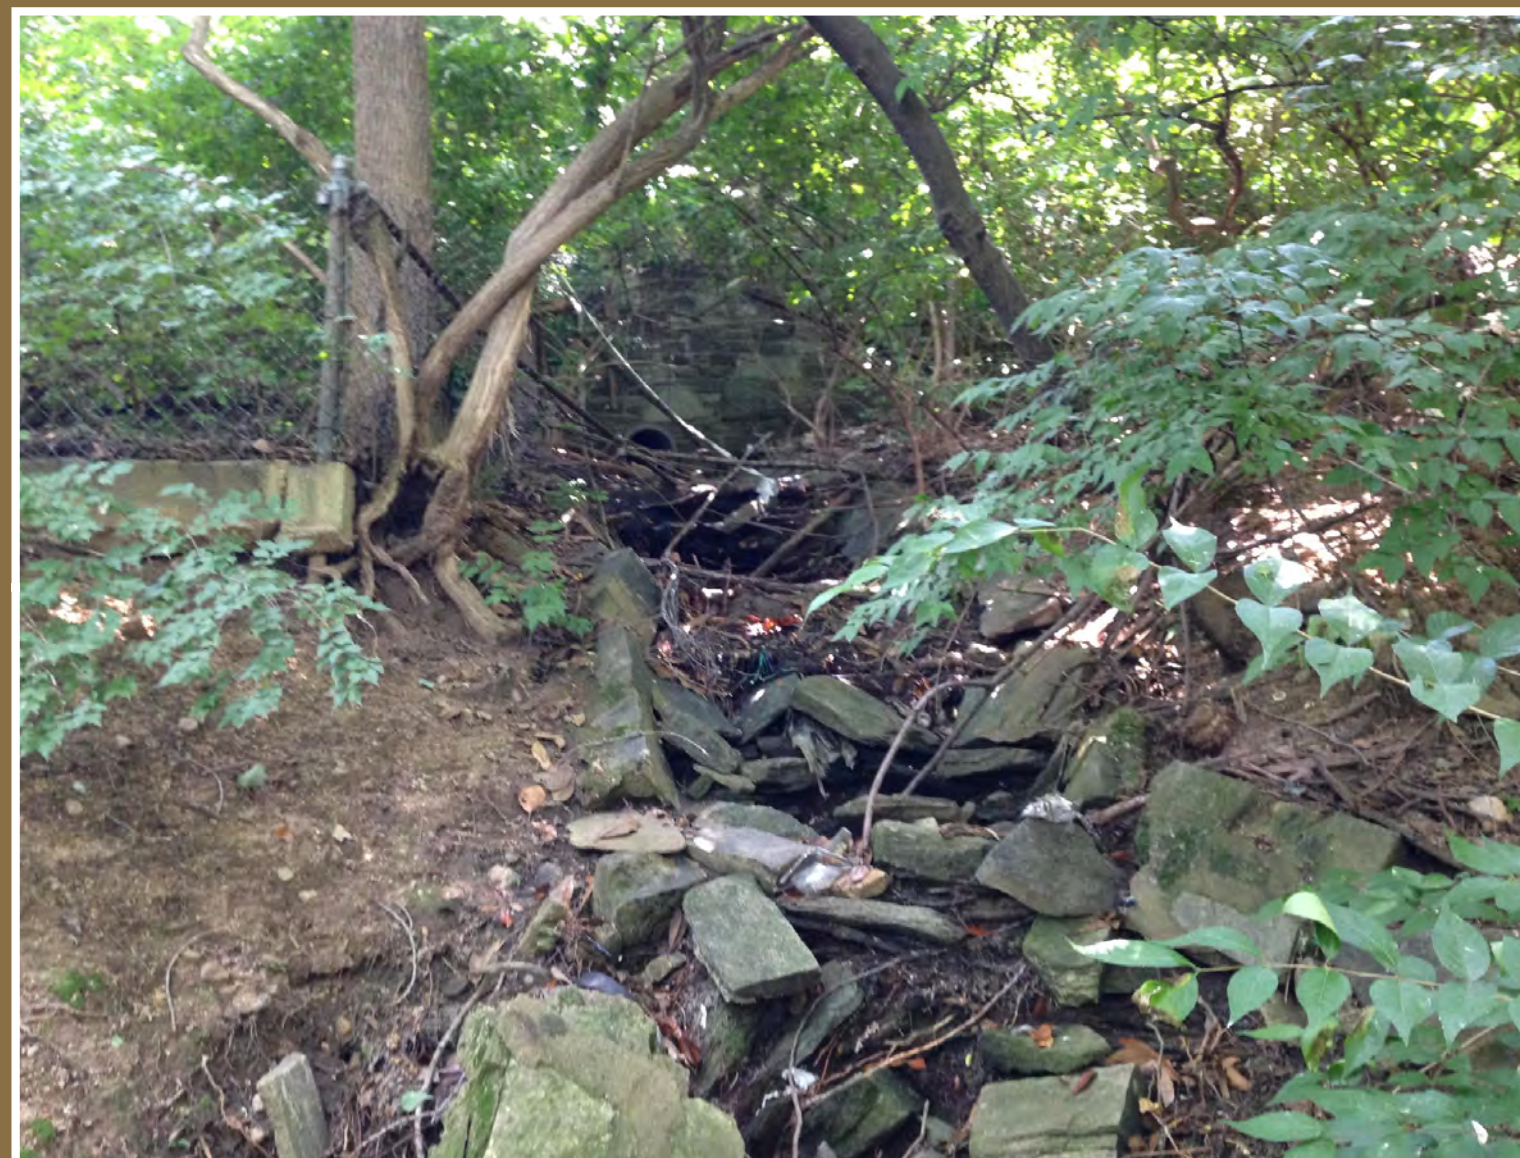
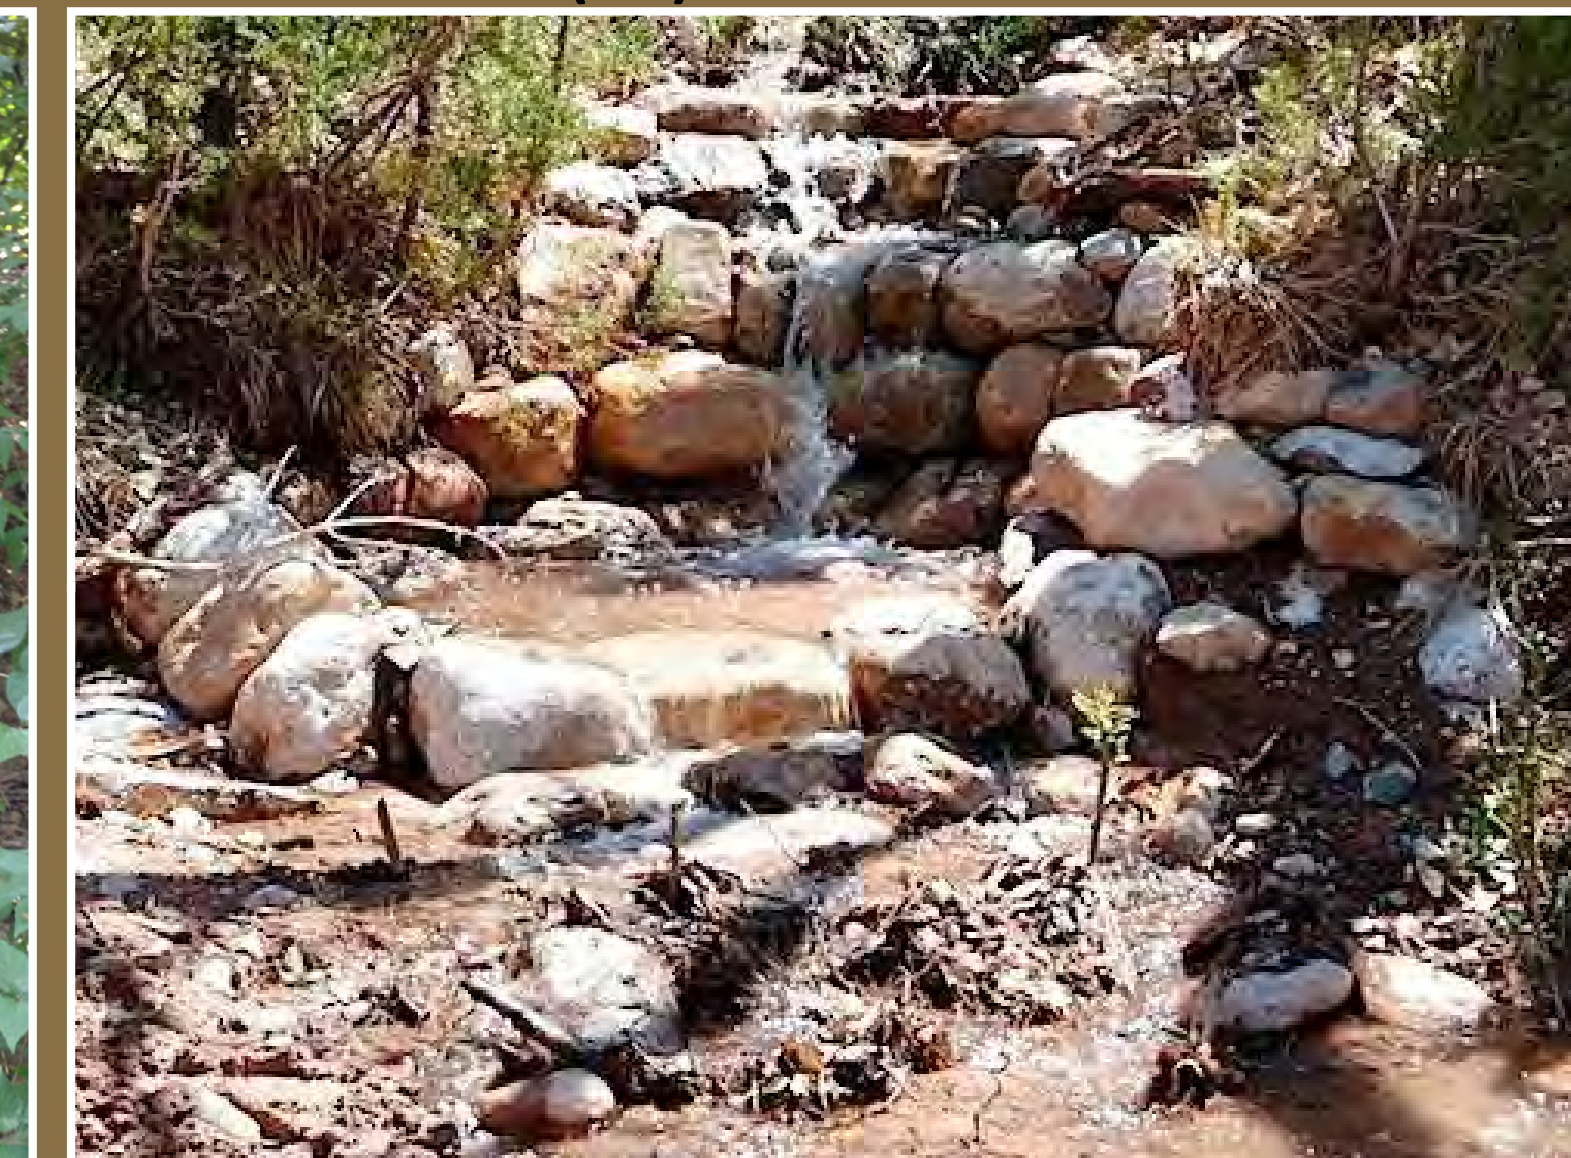
ROCK CASCADE (RC)

Before

After

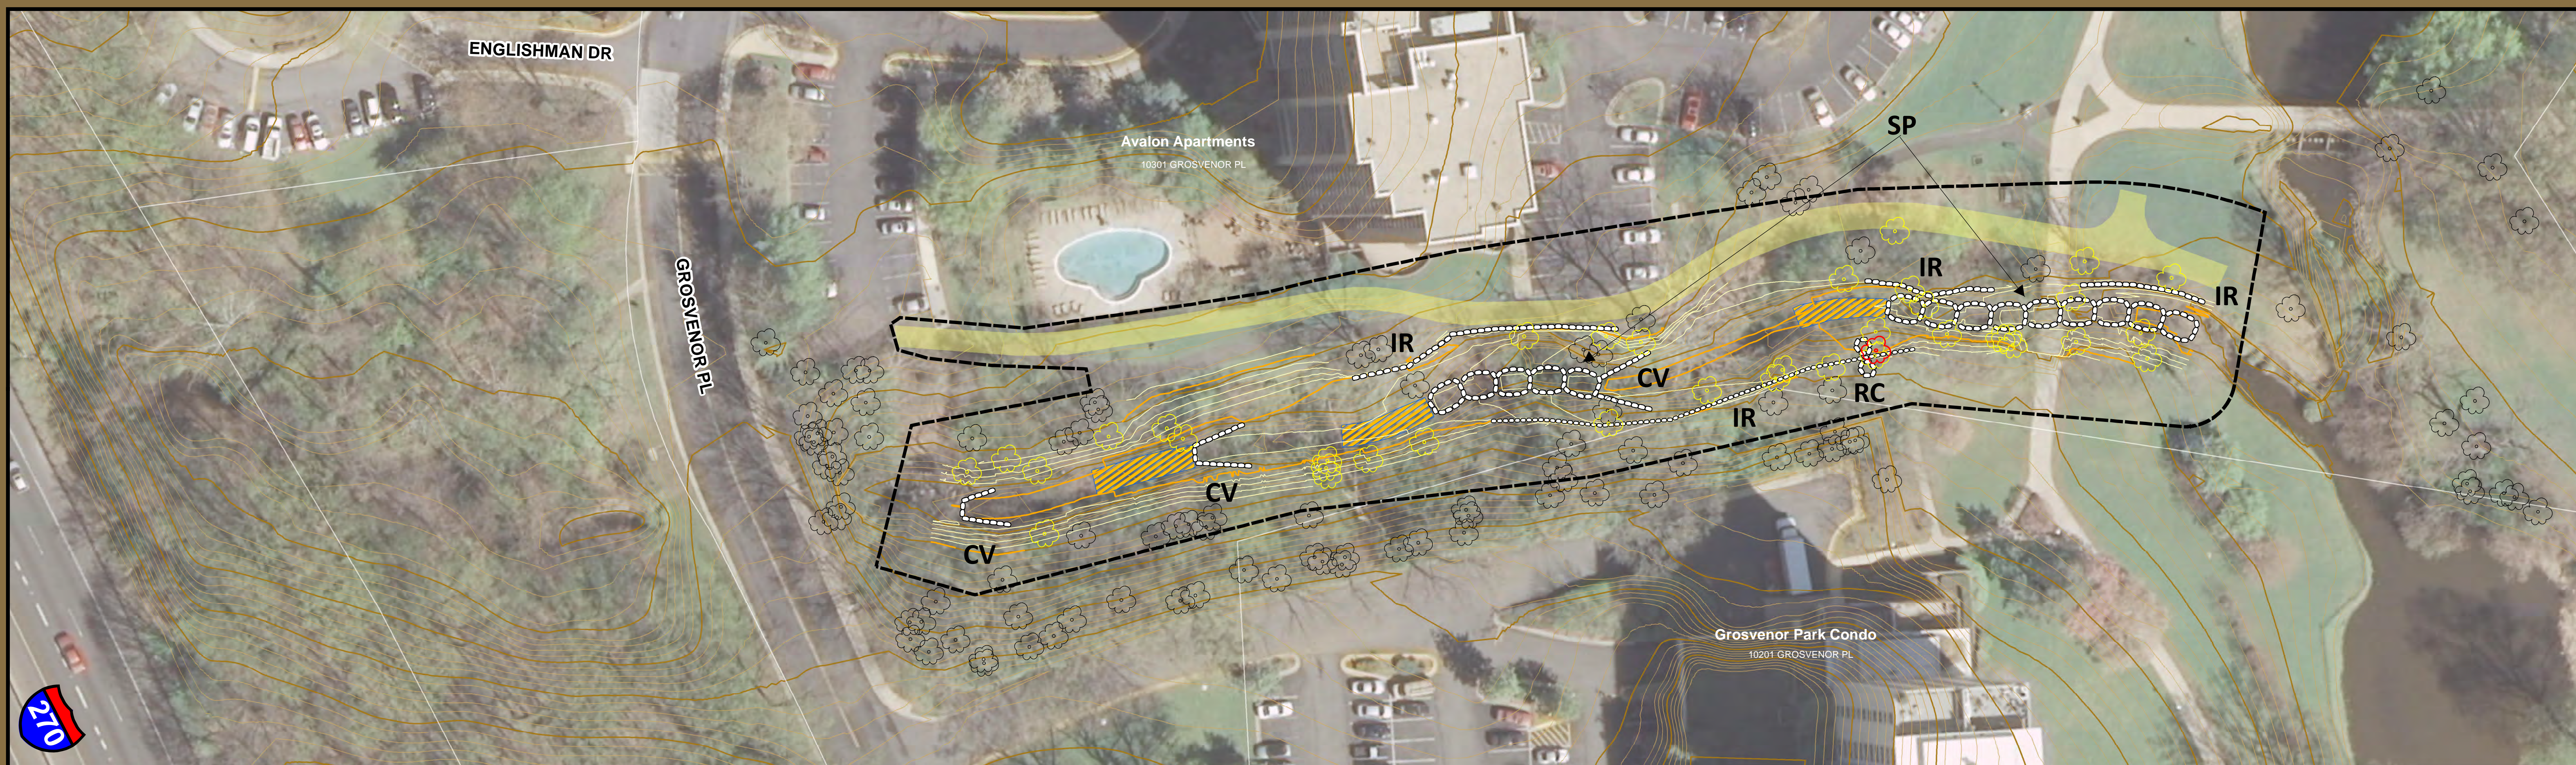
Stream Restoration Techniques

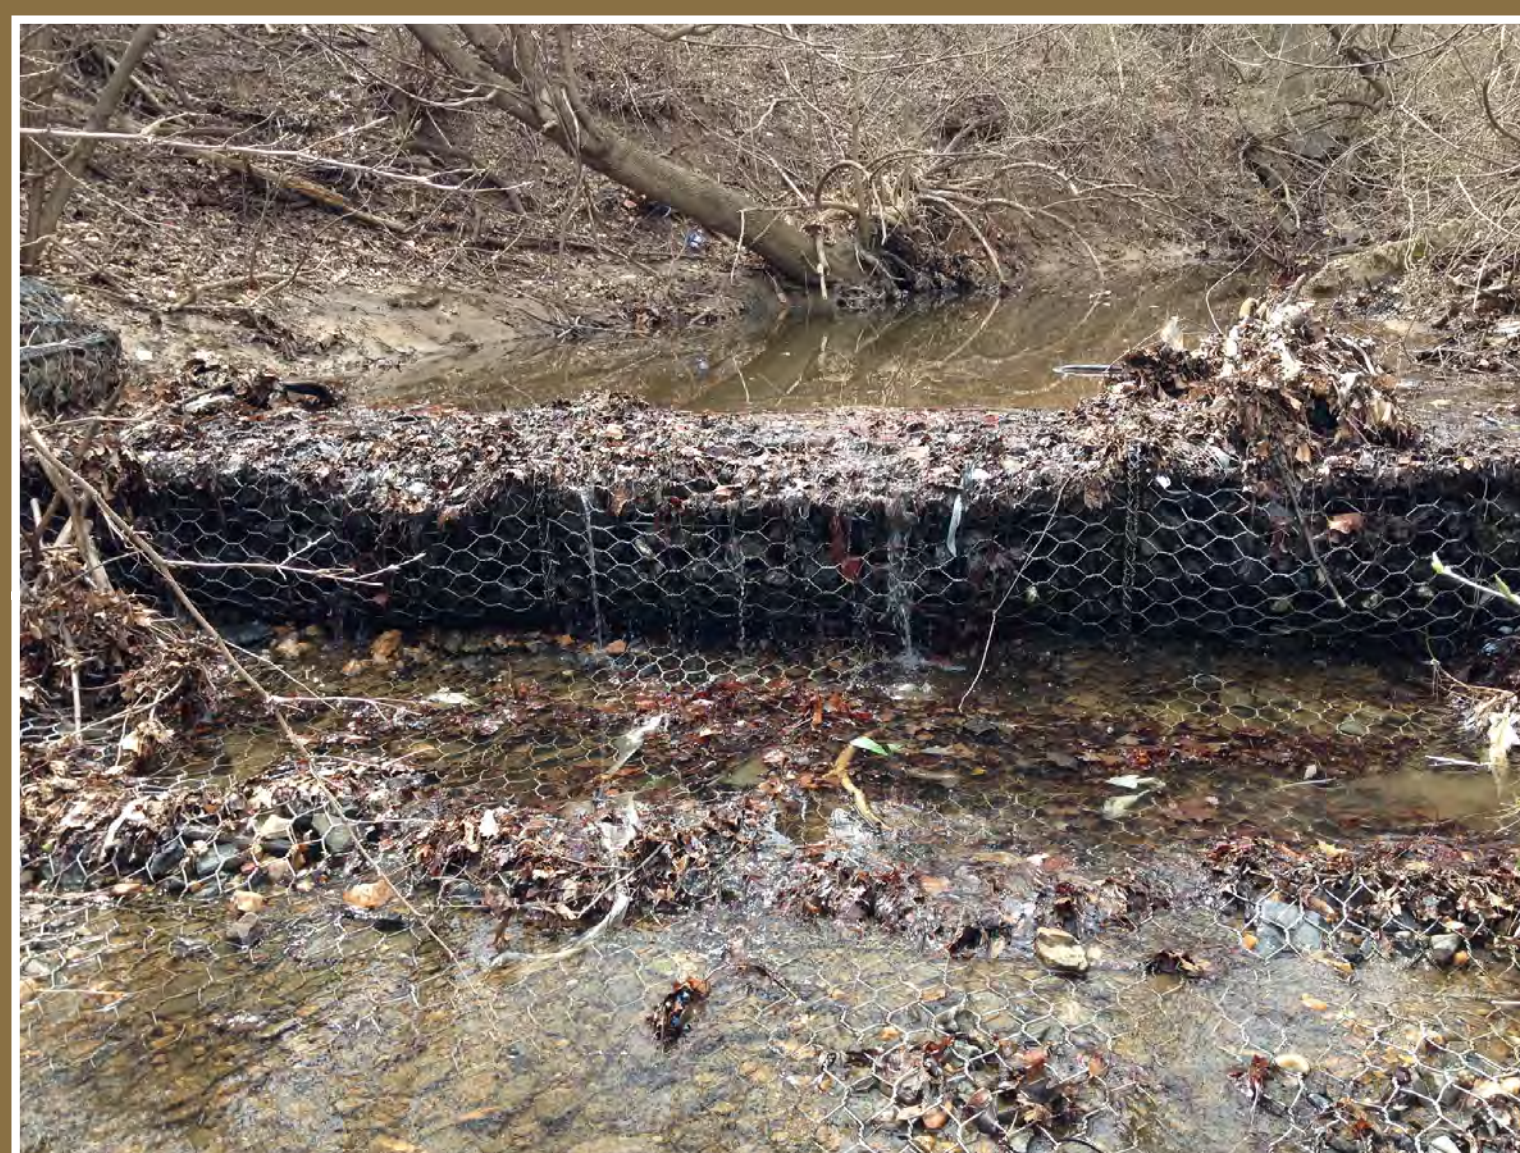
STEP POOL (SP)

Before

After
