Grosvenor Stream Restoration

Virtual Public Meeting

June 14, 2021

Tuckerman Station/ Gables, South of
Tuckerman Ln & Grosvenor Park Areas

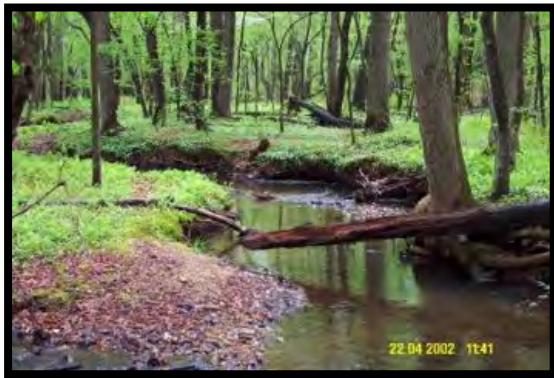
Stream in a Watershed with 8% impervious cover.

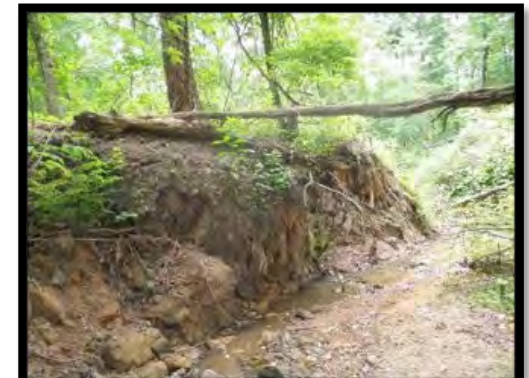
Stream in a Watershed with 30% impervious Cover

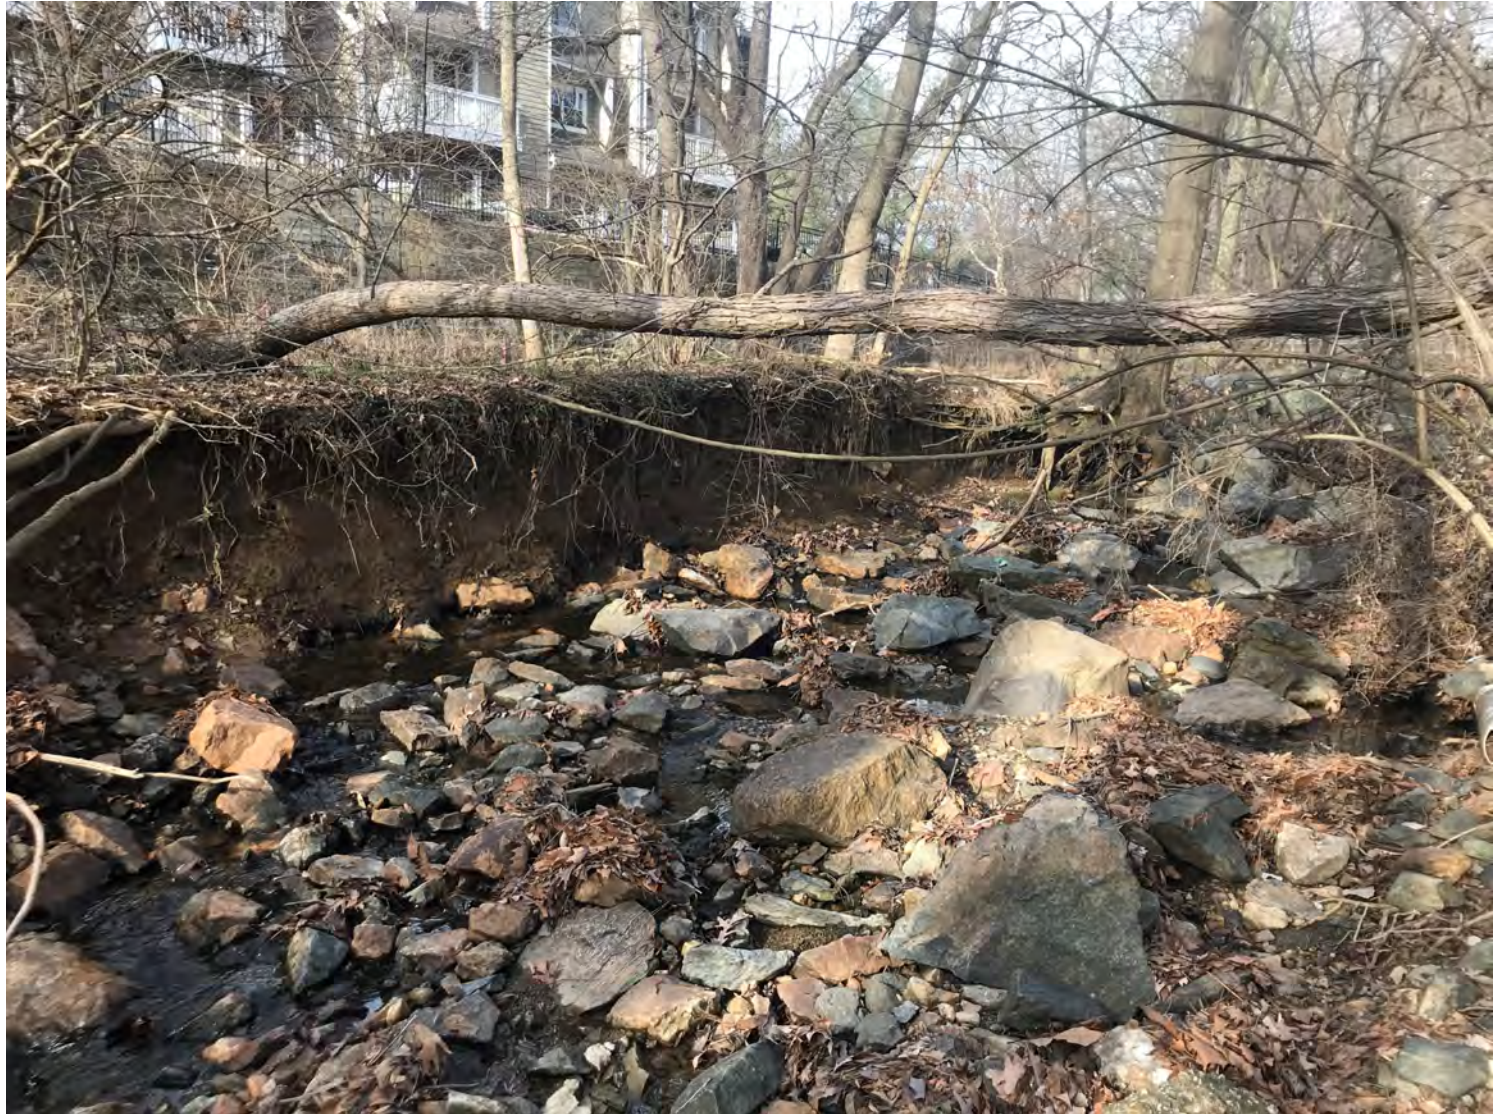
Current Stream Condition (Tuckerman Station/ Gables)

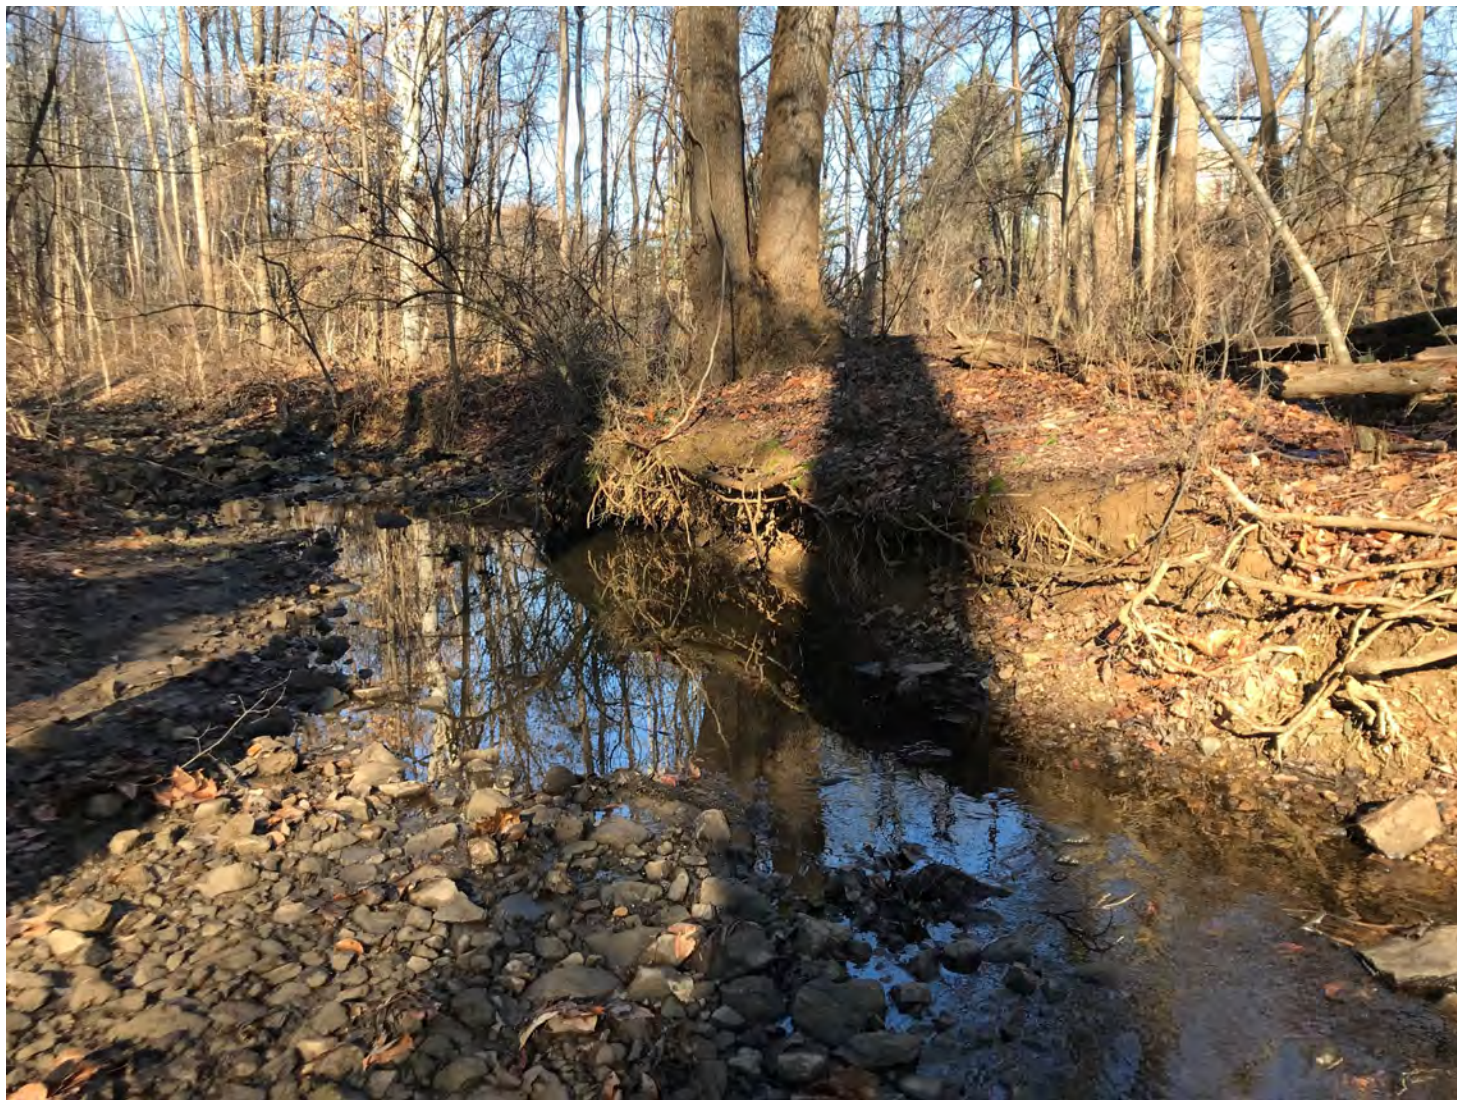
Current Stream Condition (Tuckerman Station/ Gables)

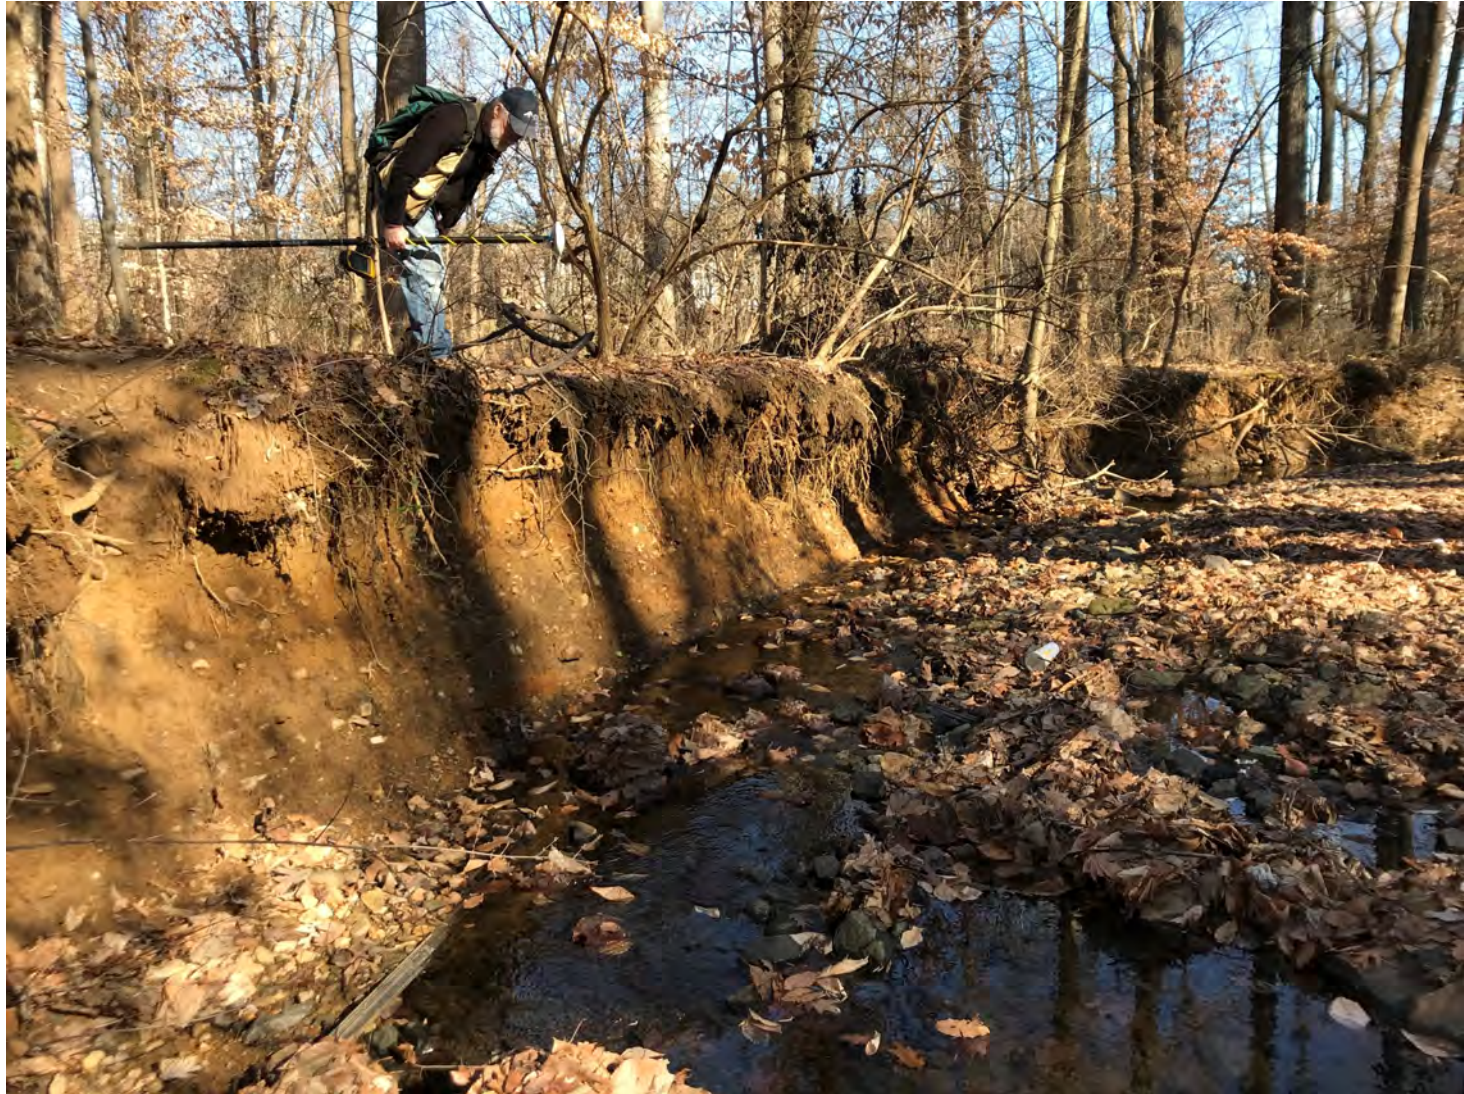
Current Stream Condition (South of Tuckerman Ln)

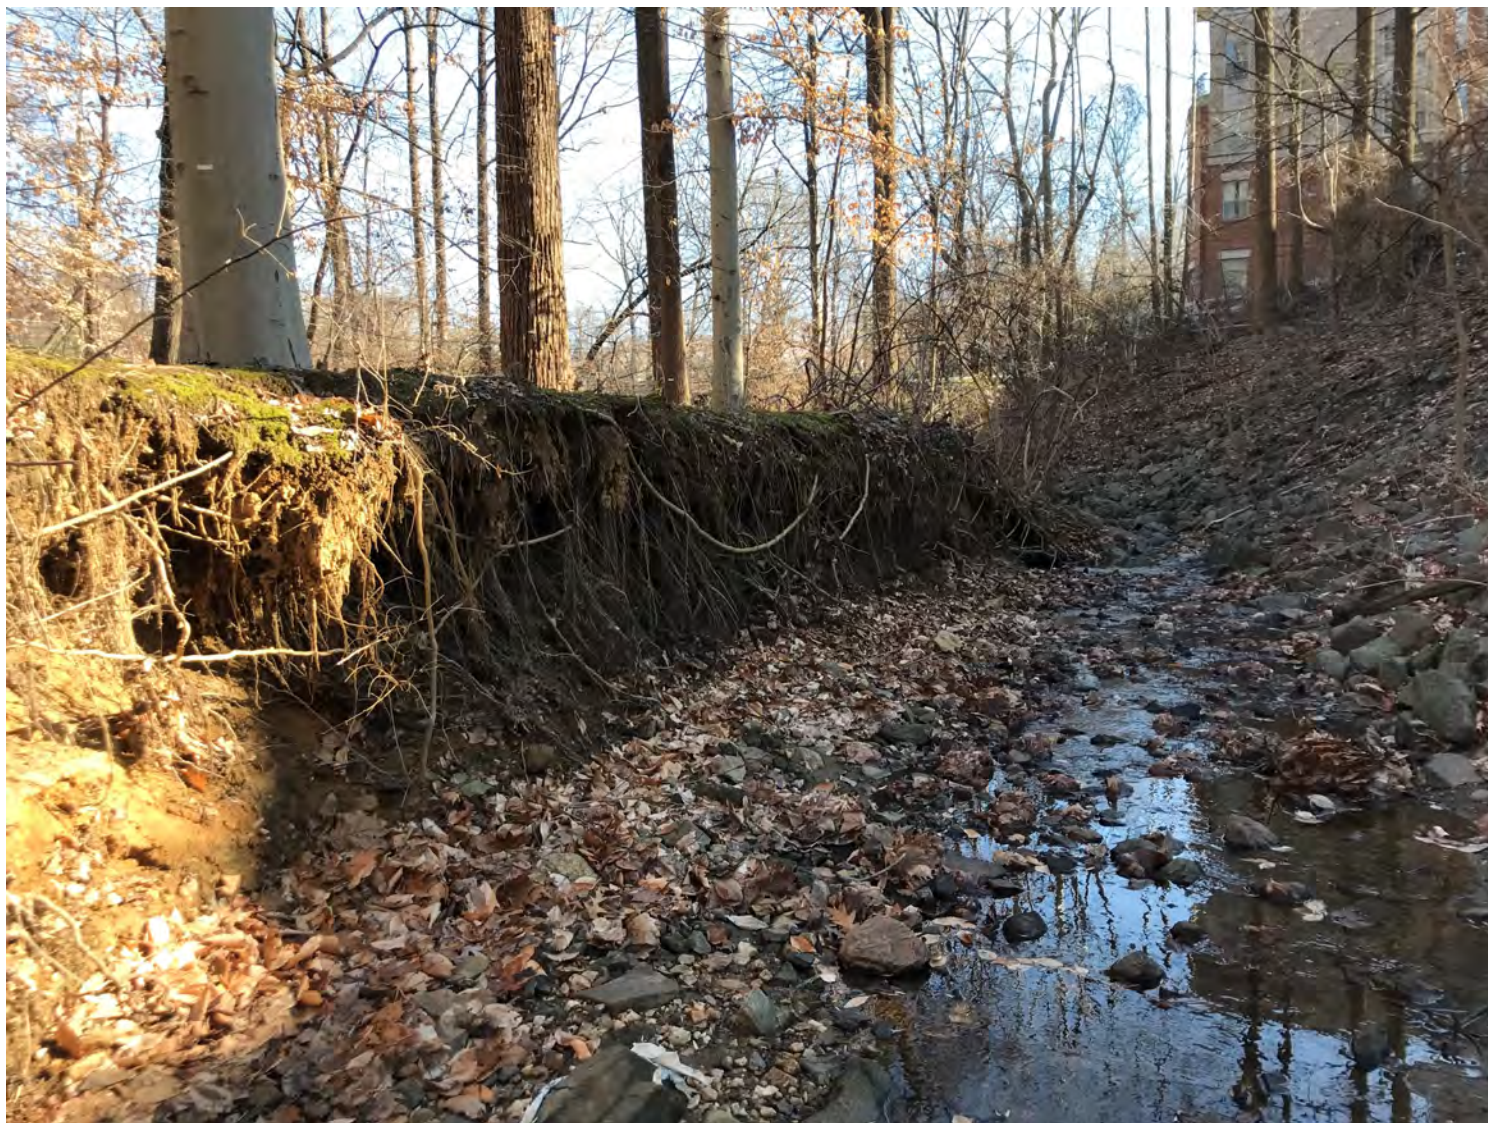
Current Stream Condition (South of Tuckerman Ln)

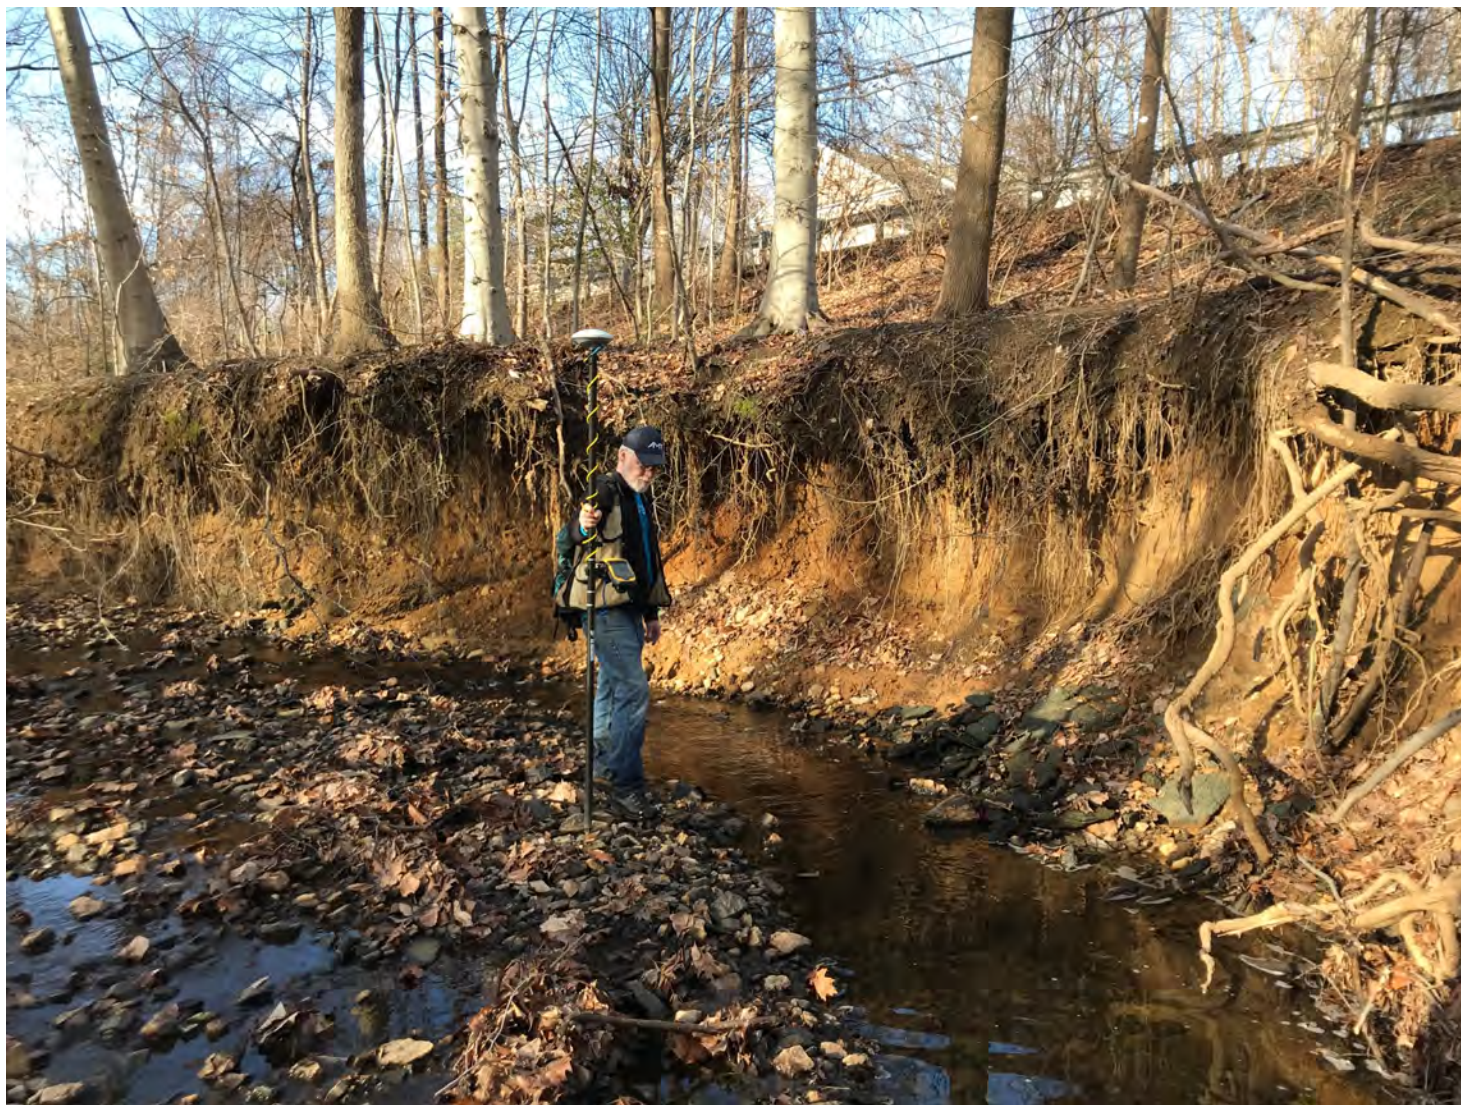
Current Stream Condition (Grosvenor Park Area)

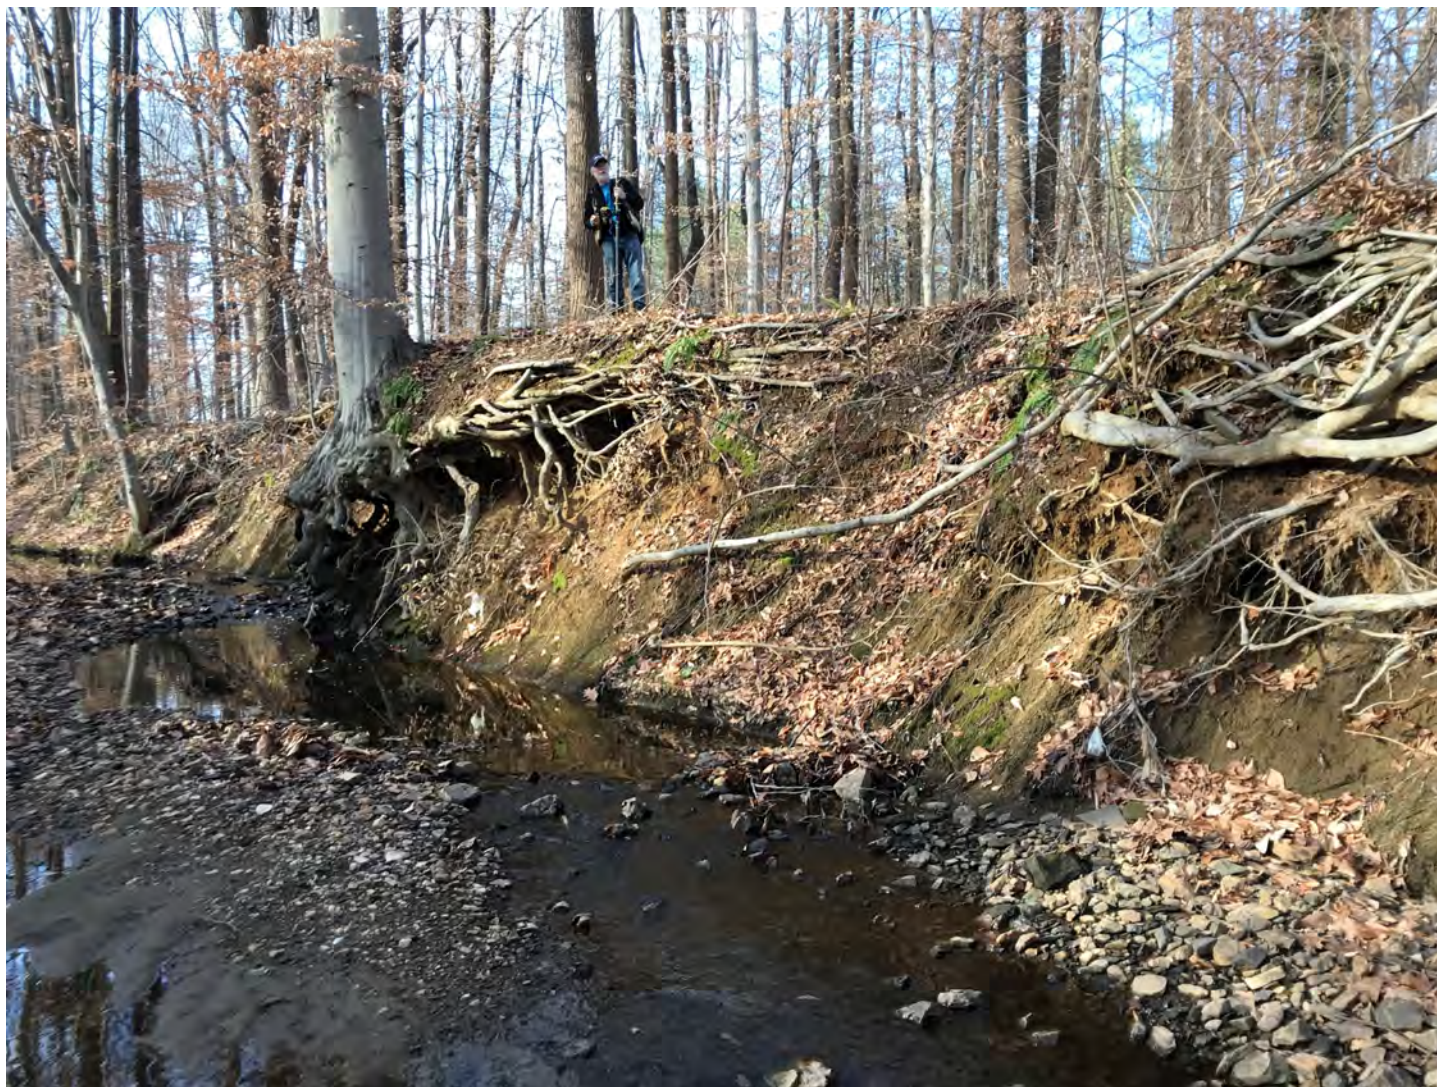
Current Stream Condition (Grosvenor Park Area)

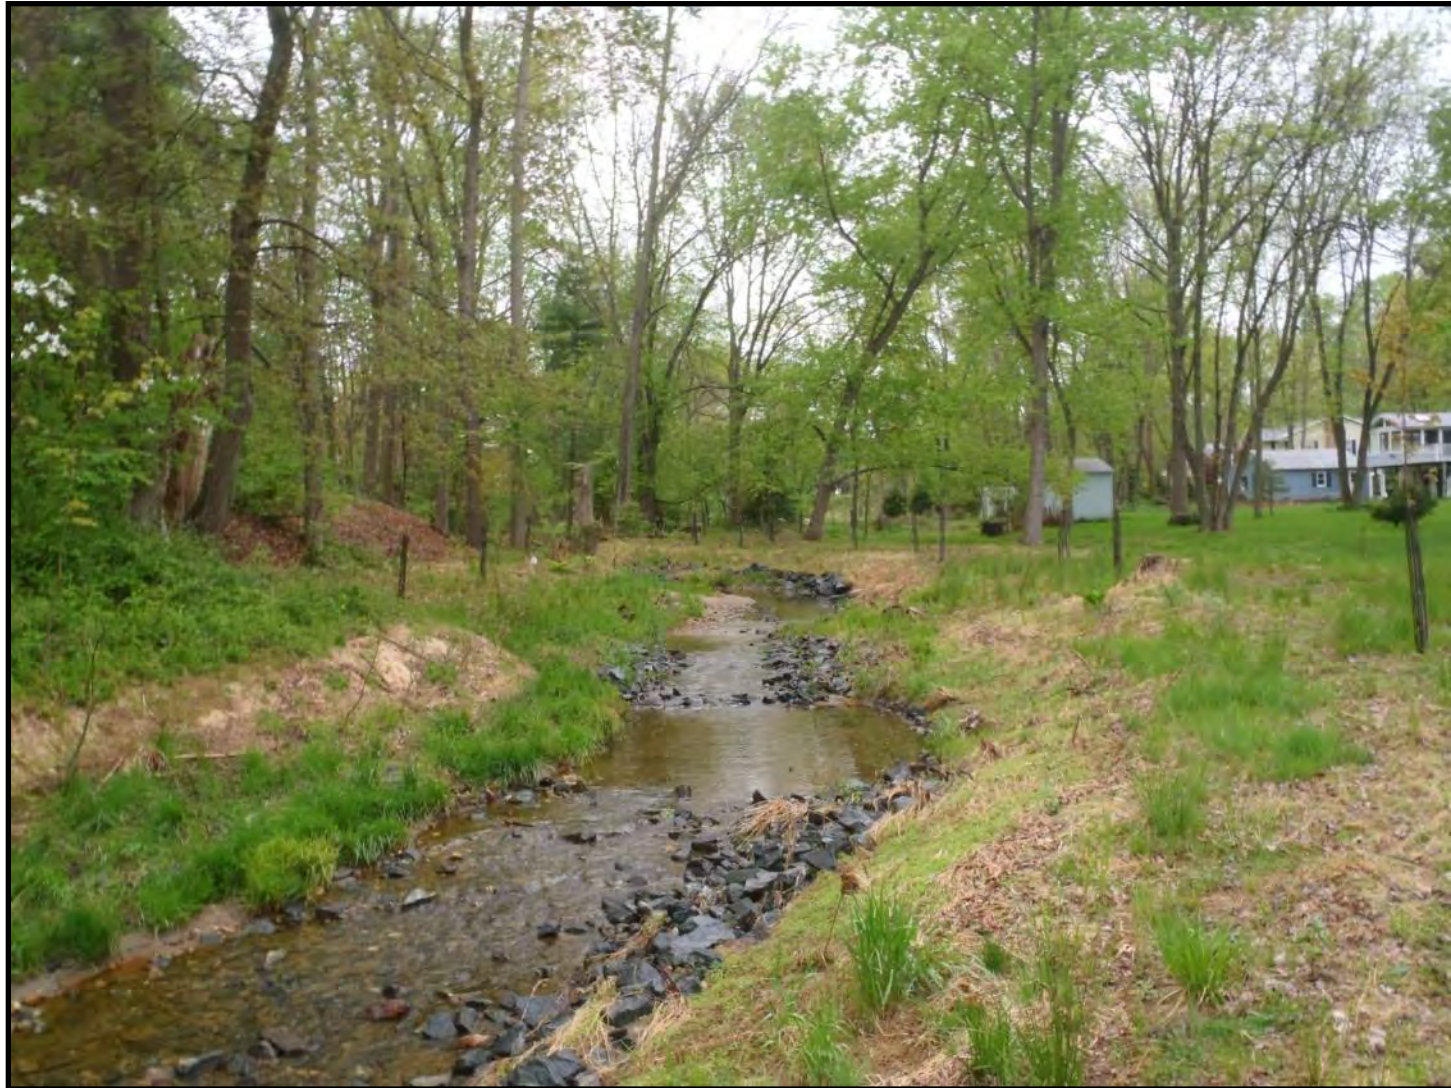
Riffle/ Pool Sequence

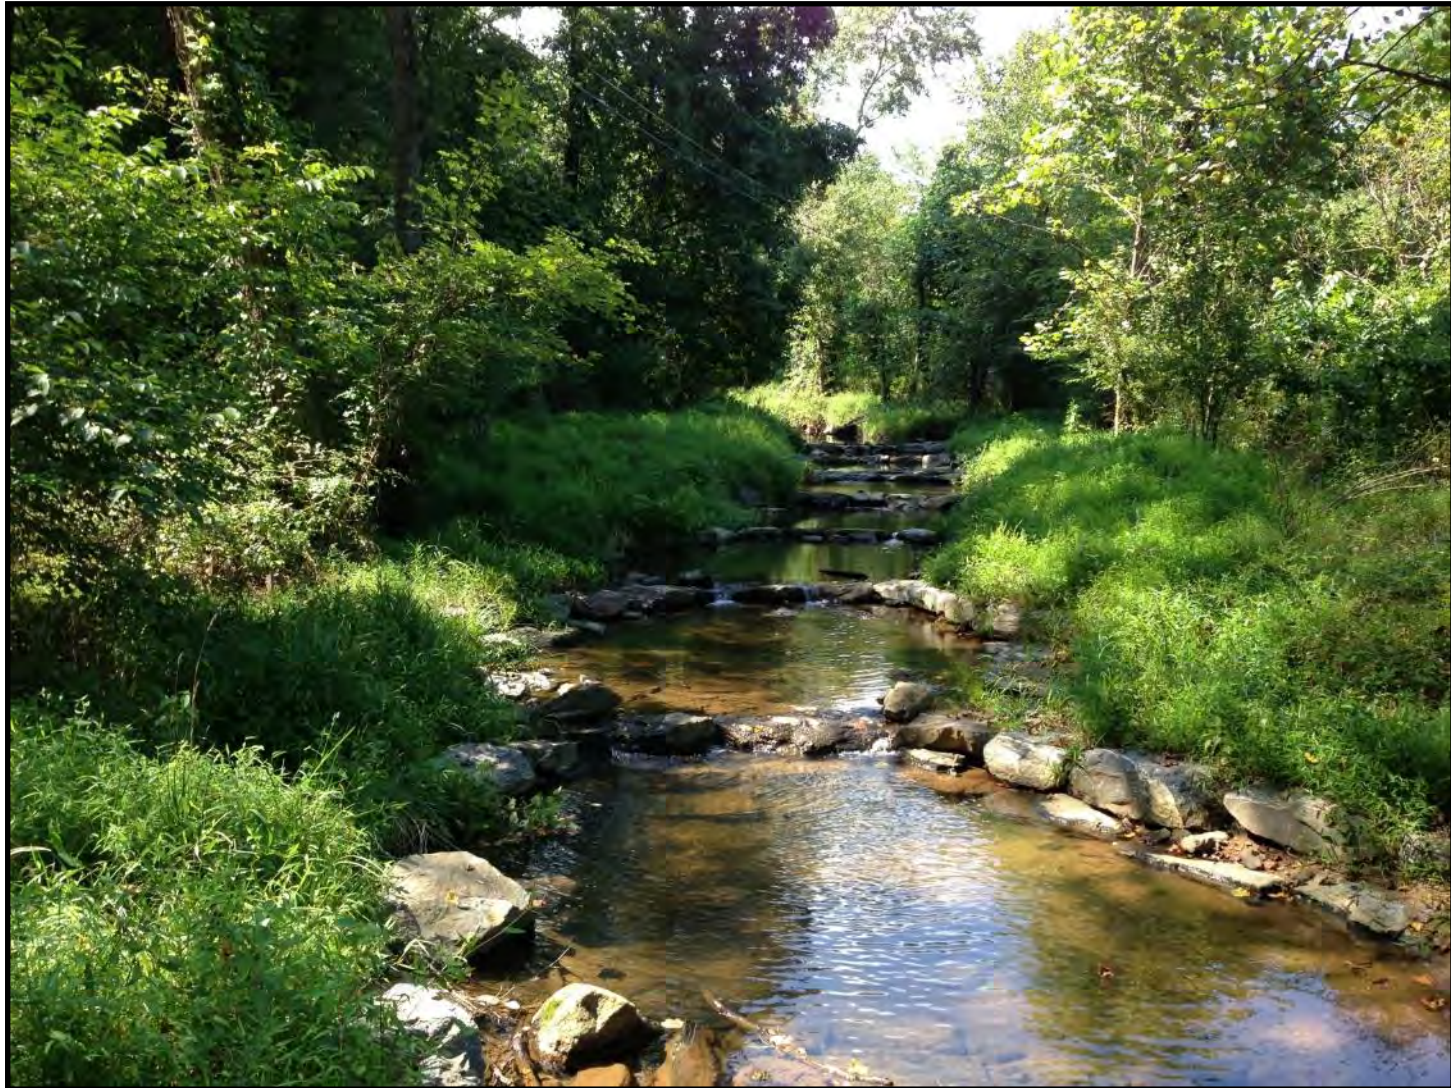
Step Pool System

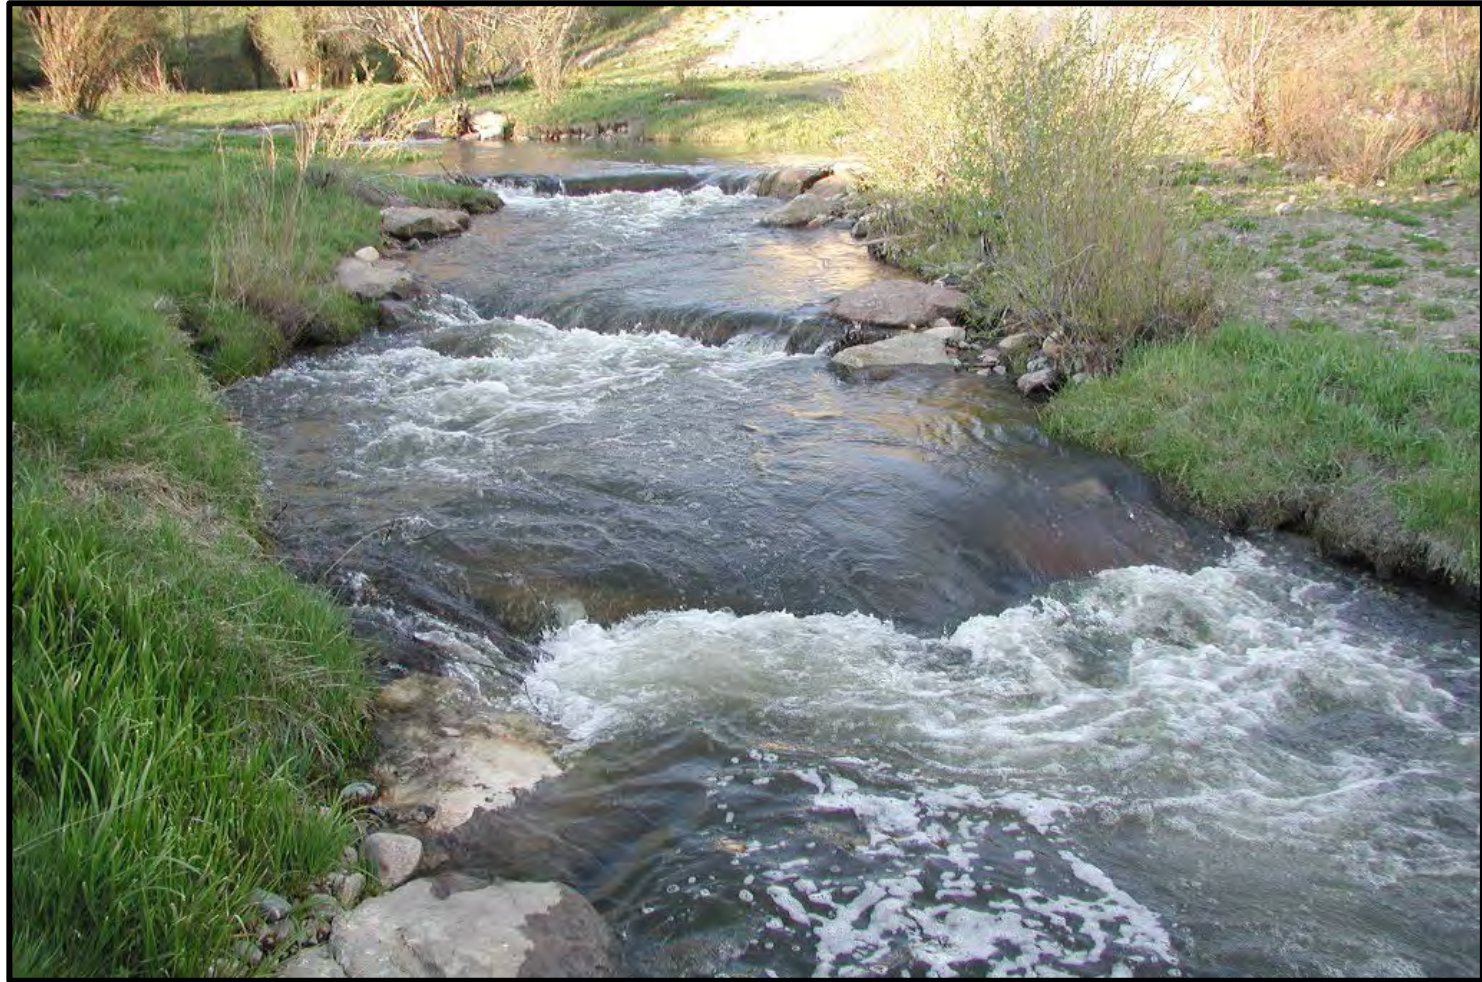
Rock Sill

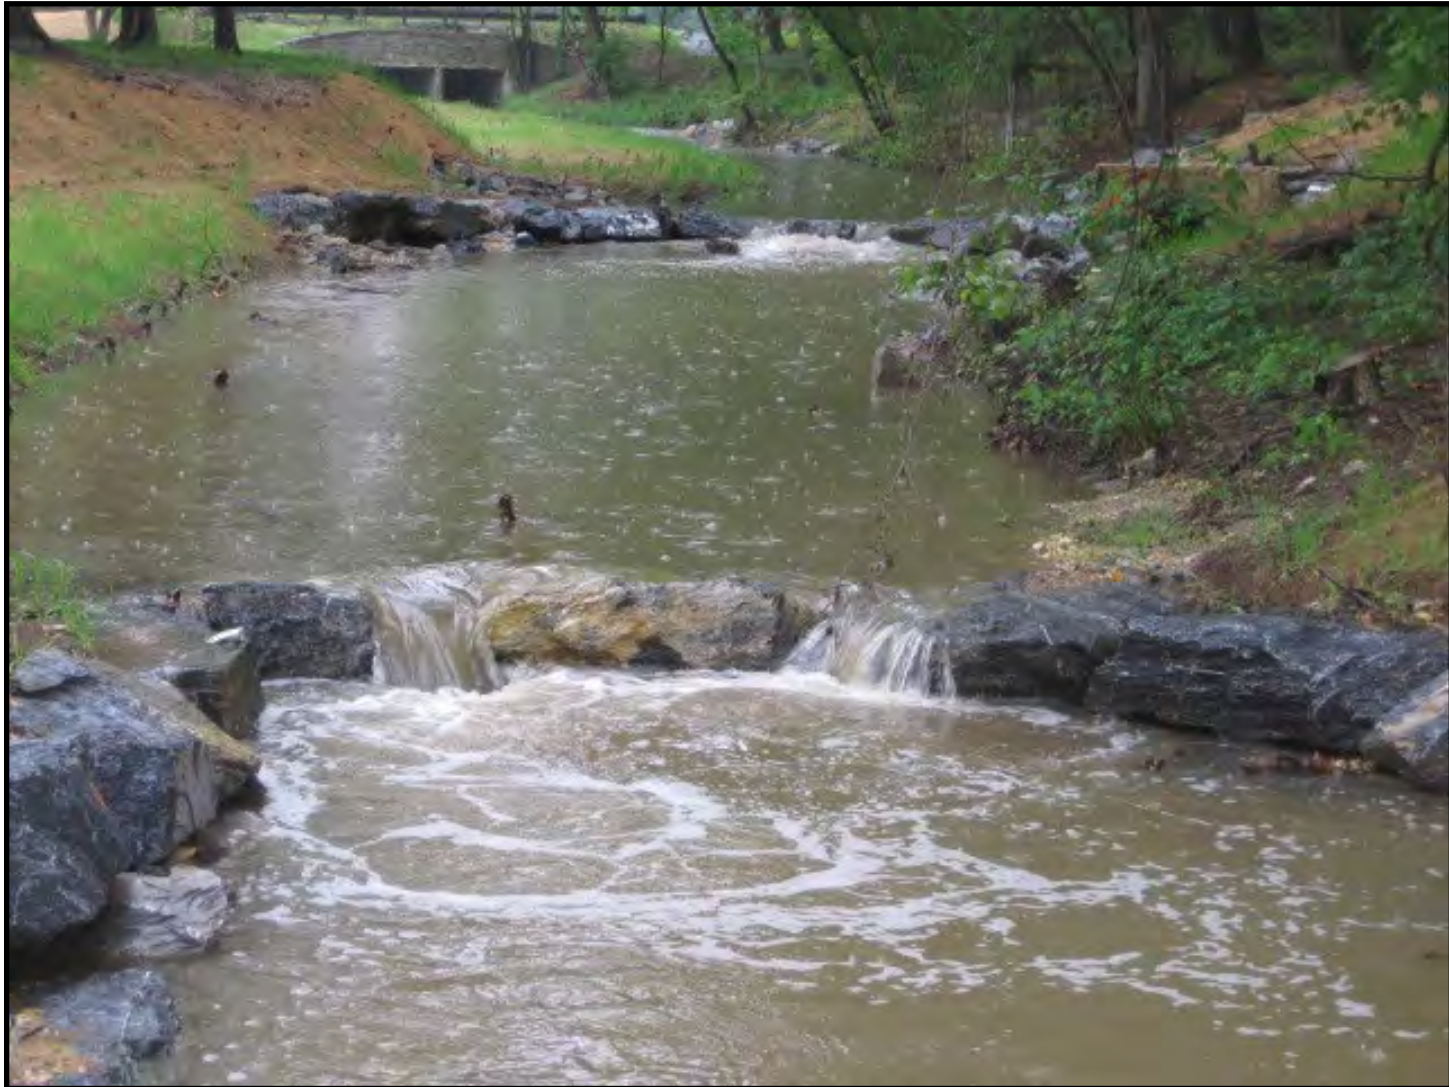
Cross Vane

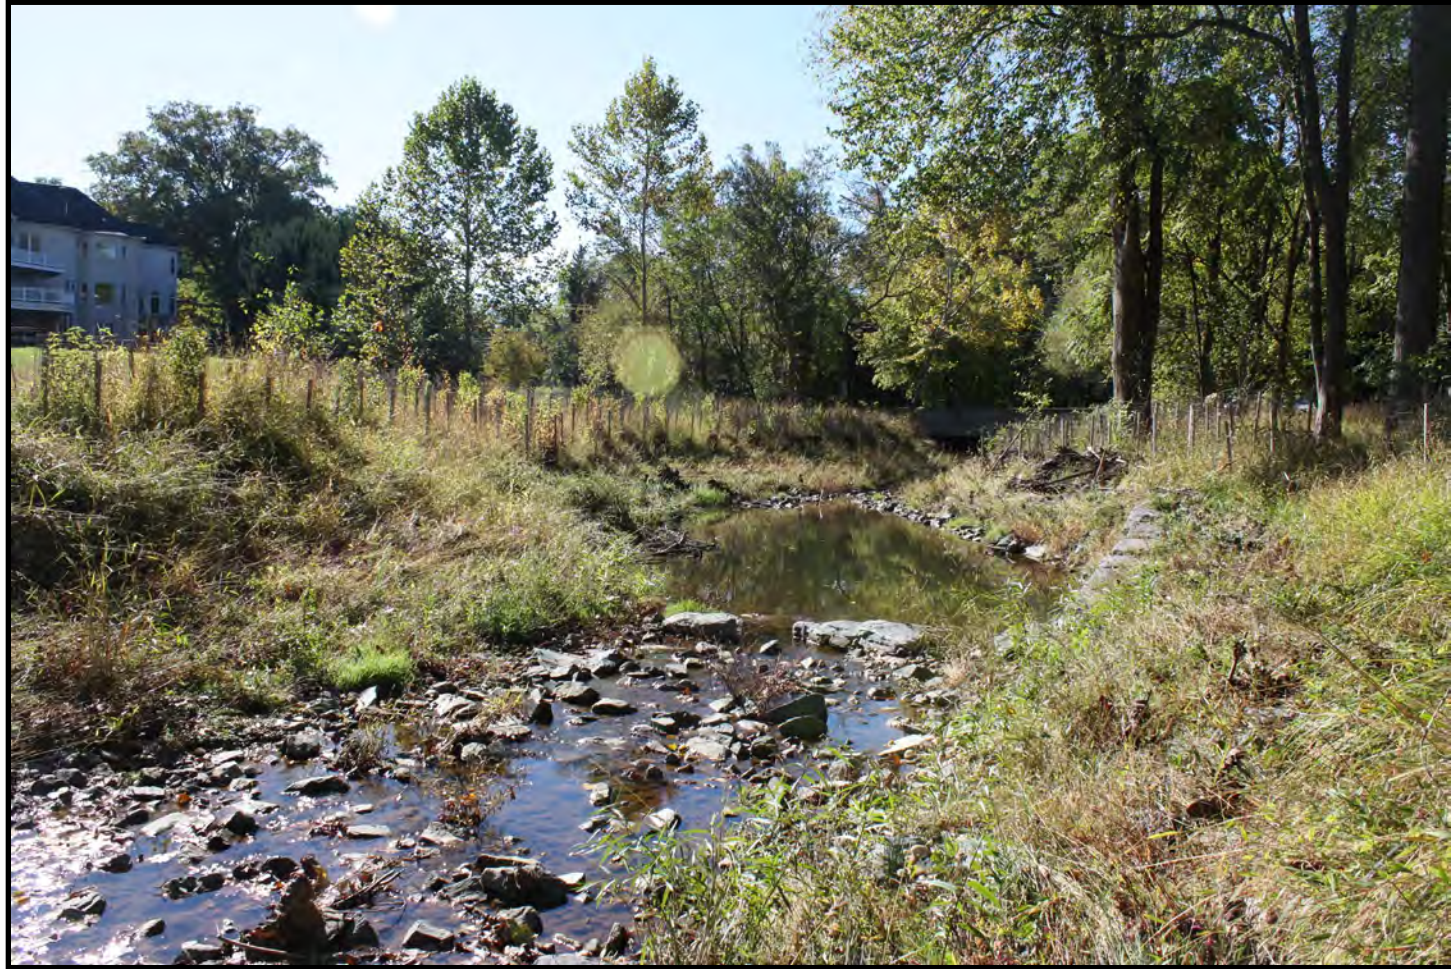
Cross Vane & Riffle

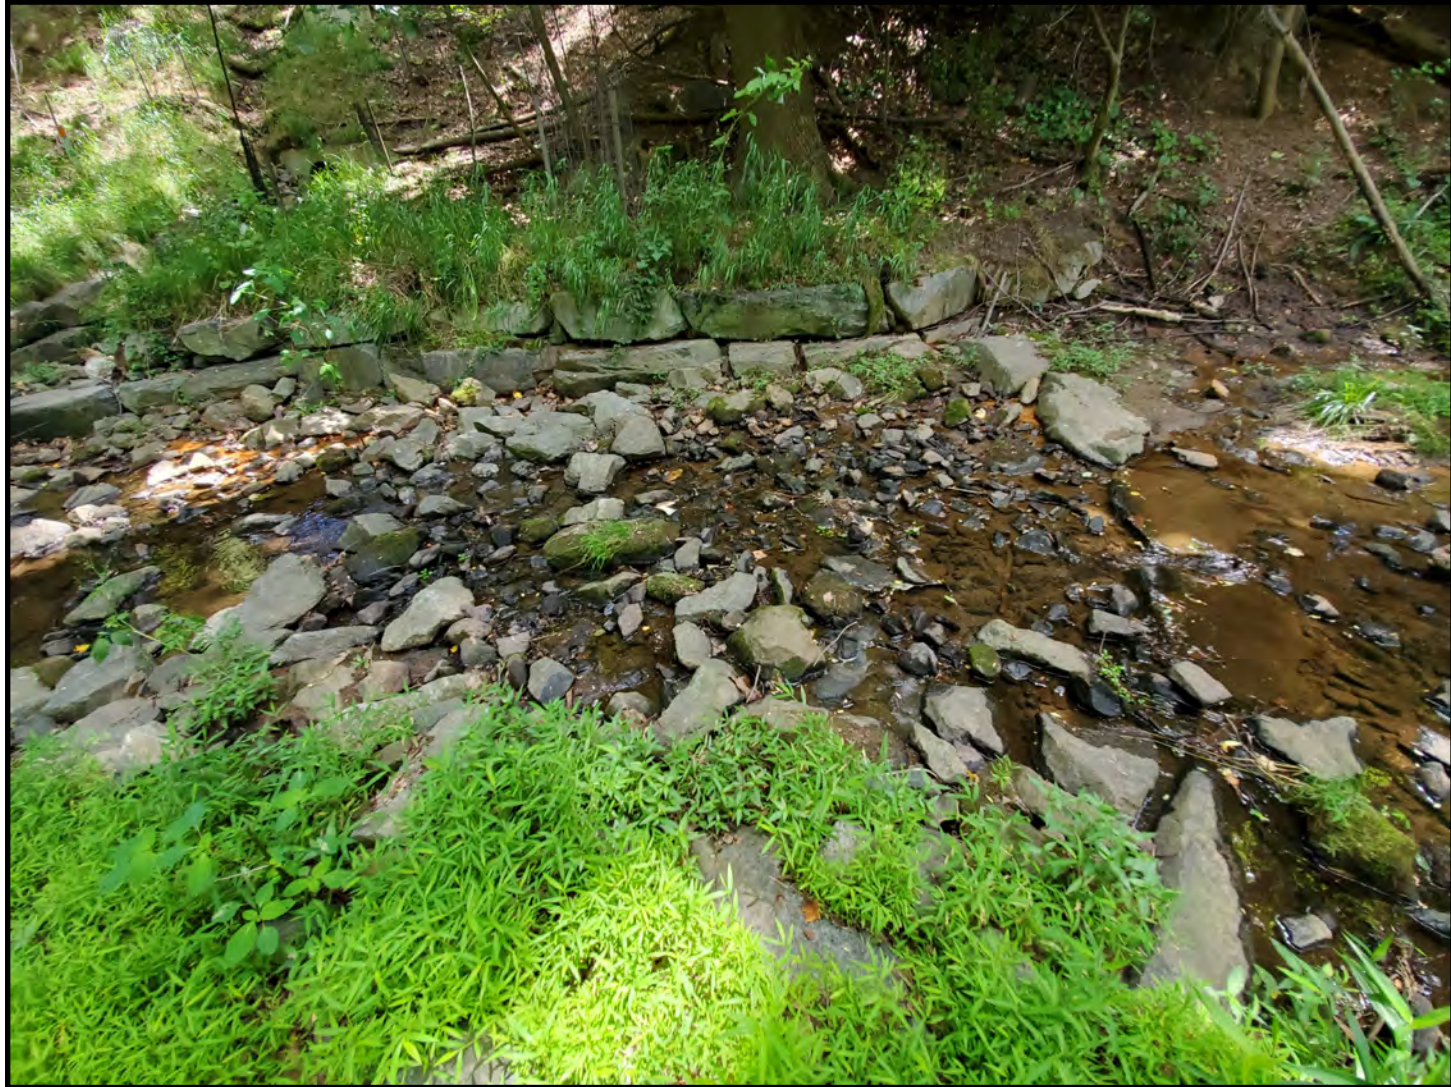
Rock Toe

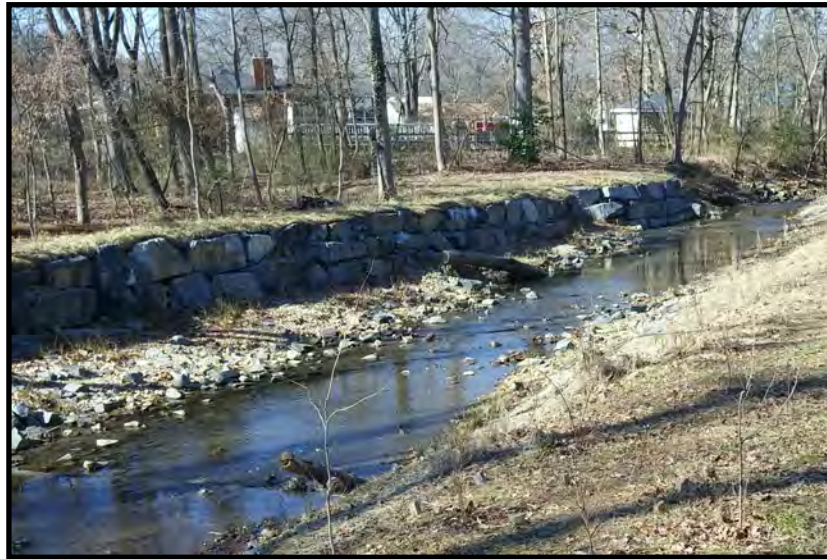
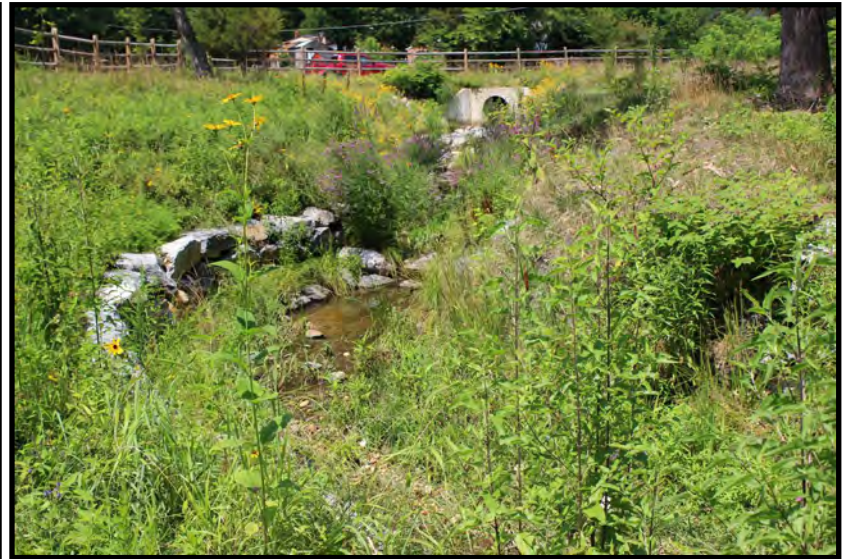
Imbricated RipRap Wall

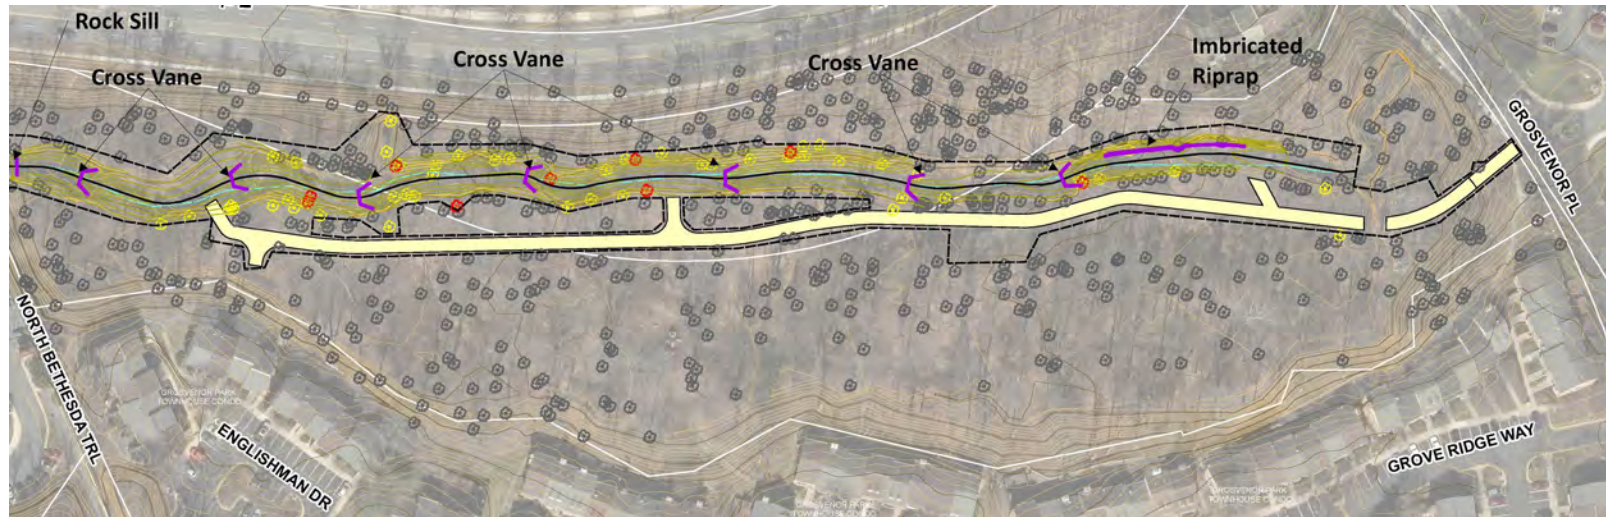
Tree Impacts (Grosvenor Park Area)

GL-08 TREES TO BE REMOVED (Diameter >= 24")	
COMMON NAME	CONDITION
30" Tuliptree	Fair, undermined
25.5" American Sycamore	Fair, undermined
24.5" Green Ash	Hazard Tree - Poor, emerald ash borer, dying/ possibly dead
28" American Beech	Dead, fallen, cut-up
25.5" Northern Red Oak	Fair, undermined, dead limbs
24" Tuliptree	Fair, leaning, few dead limbs
24" White Oak	Good, slightly undermined
28" American Beech	Poor, undermined, leaning
24" Northern Red Oak	Fair, reduced canopy, dead limbs, leaning

Additional Bankside Trees (Yellow) To Be Removed – majority eroded at roots

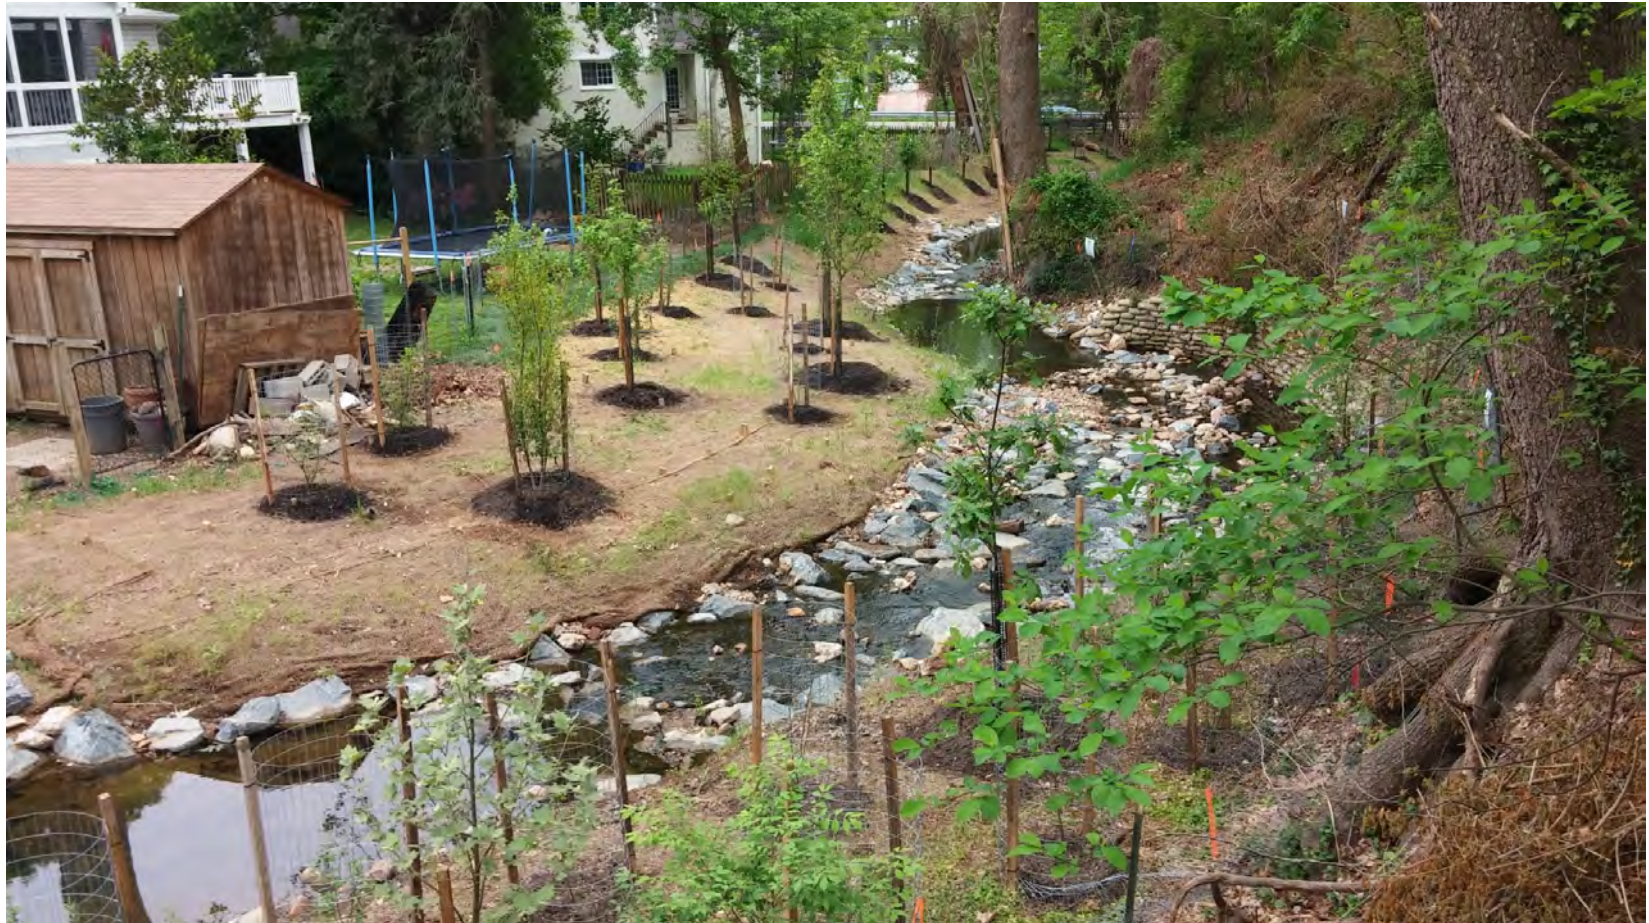
Streamside/ Riparian Planting

- Streamside Planting: Steeper slopes right against the stream banks
- Riparian Planting: Flatter slopes further away from the stream (larger overstory trees/ shrubs)
