Grosvenor Stream Restoration

Virtual Public Meeting

June 14, 2021

Tuckerman Station/ Gables, South of
Tuckerman Ln & Grosvenor Park Areas

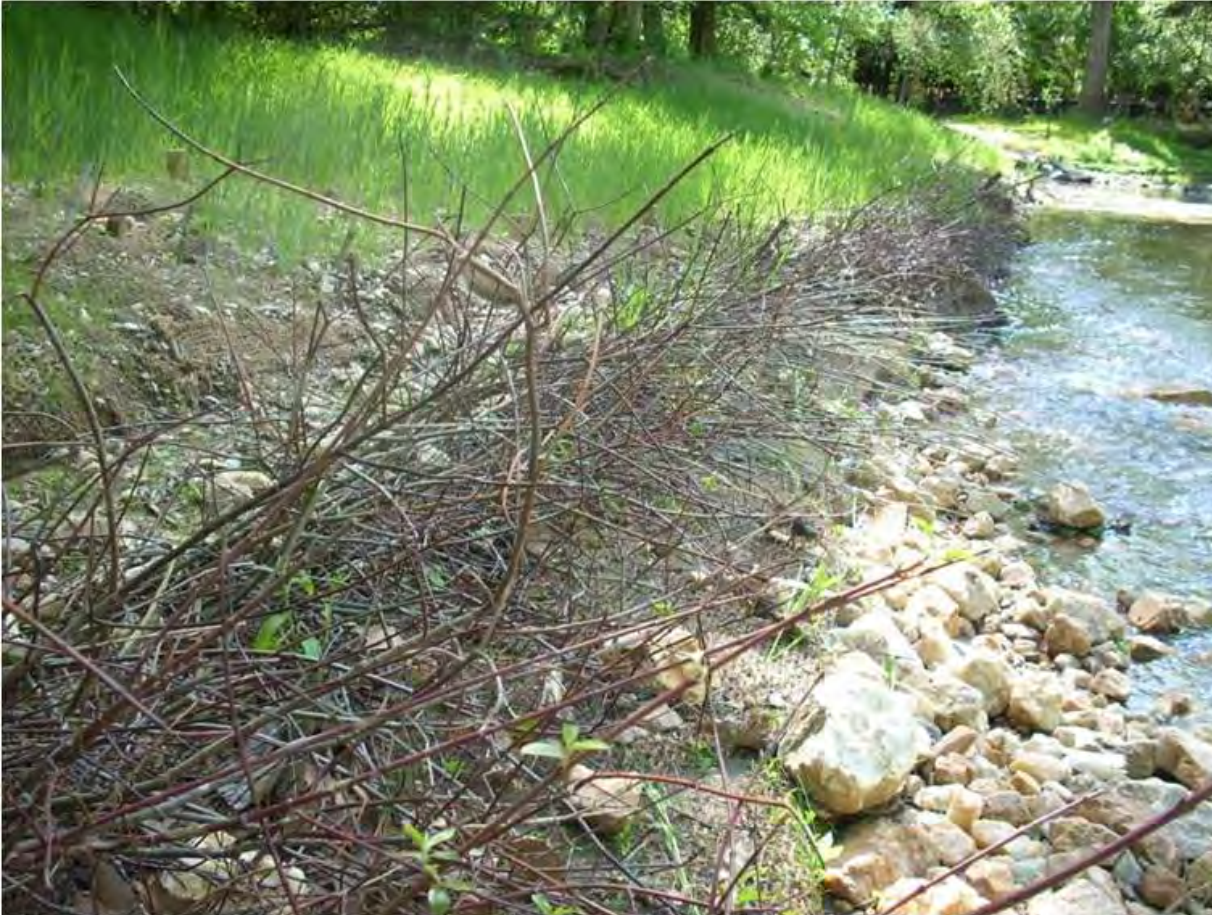
Live Stake Planting

- Live Stake Planting: These plants are placed along the toe of the new stream edge and will remain wet from base-flow.
