Watershed Restoration Program and Purpose of the Batchellors Run & Woodlawn Stream Restoration Projects

Jennifer St. John, Watershed Planner
Paul Bogle, Engineer

Batchellors Run - 95% Design

Woodlawn - 95% Design

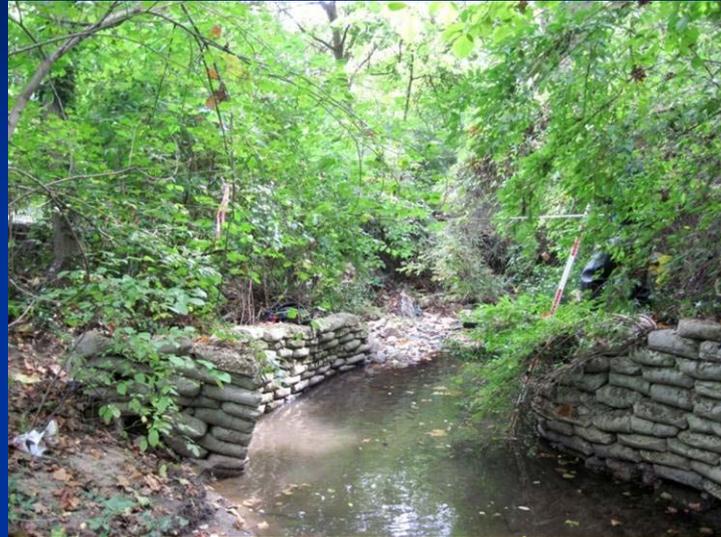
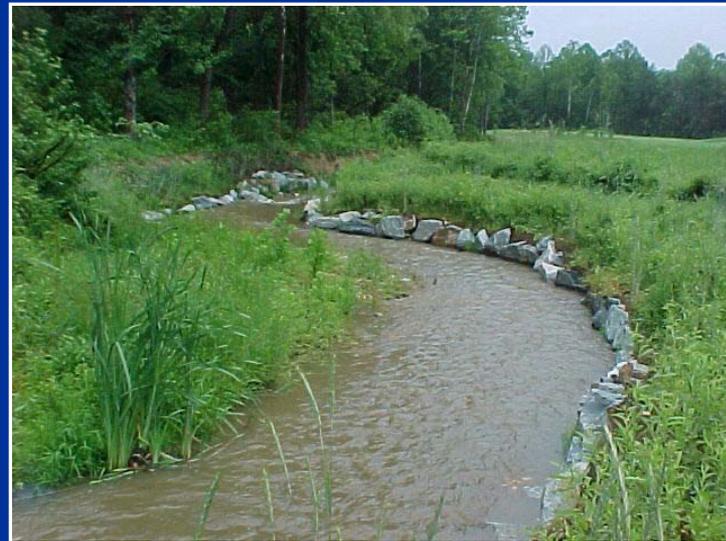
- Channel Constrictions

Existing

Proposed

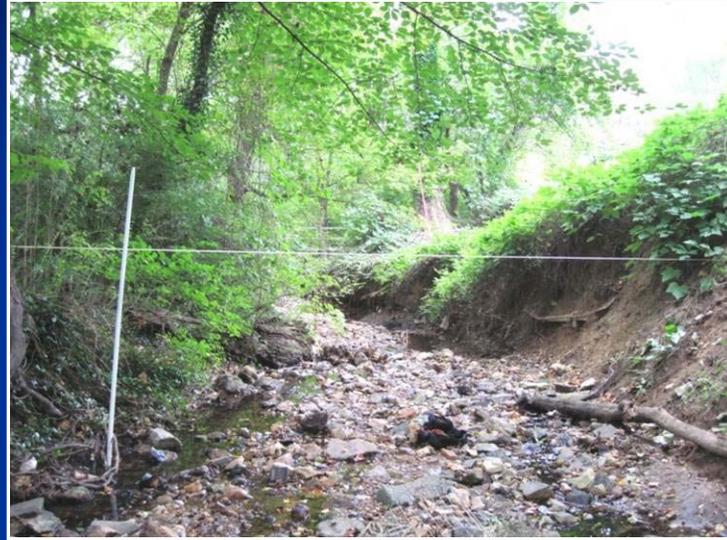
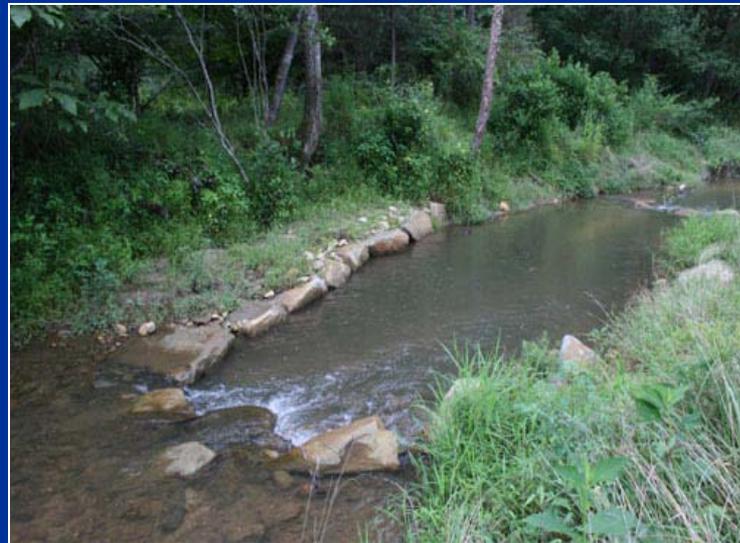
- Channel Constrictions
- Grade Control

Existing

Proposed

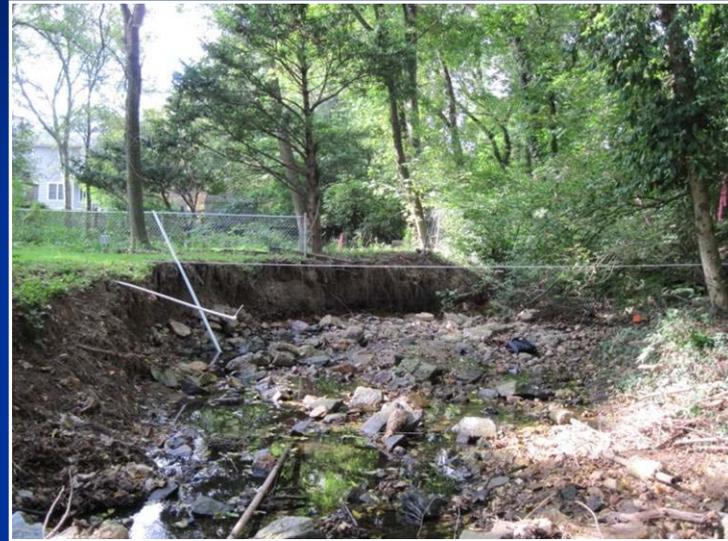
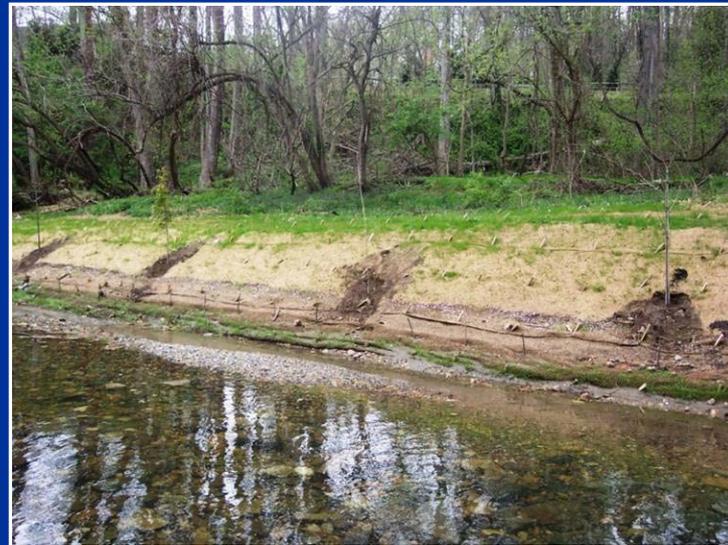
- Channel Constrictions
- Grade Control
- Eroded streambanks & inadequate stream buffers

Existing

Proposed

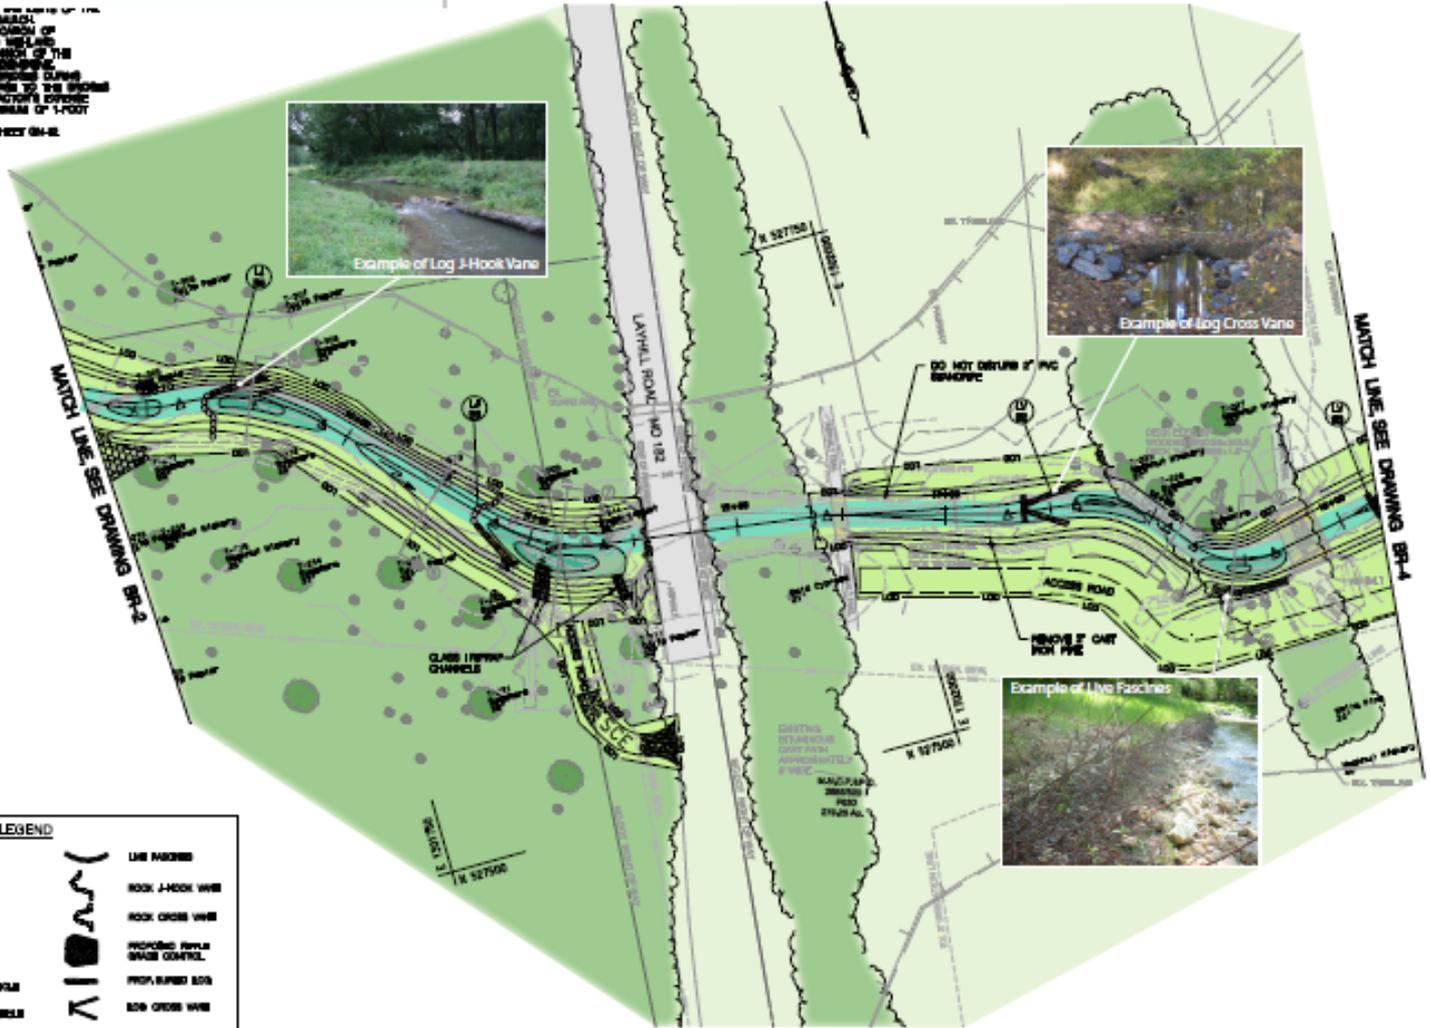
2

Batchellors Run - 95% Design

- Notes on Construction: Refer to the notes on sheet BR-1.
1. ACCESS ROAD NEAR TO PLACE BR-1.
 2. ALL POWER REPLACEMENT OR RELOCATION OF BR-1 SHALL BE COORDINATED WITH THE SOIL CONSERVATION SERVICE.
 3. ALL CONSTRUCTION SHALL PROTECT BR-1 DURING CONSTRUCTION ACTIVITIES DUE TO THE BR-1 SHALL BE REMOVED AT THE CONTRACTOR'S EXPENSE.
 4. THE FASCINES SHALL BE A MINIMUM OF 1-FOOT AND THE CHANNEL SHALL BE 1-FOOT.
 5. FOR RAINY CHANNEL, SEE SHEET BR-2.

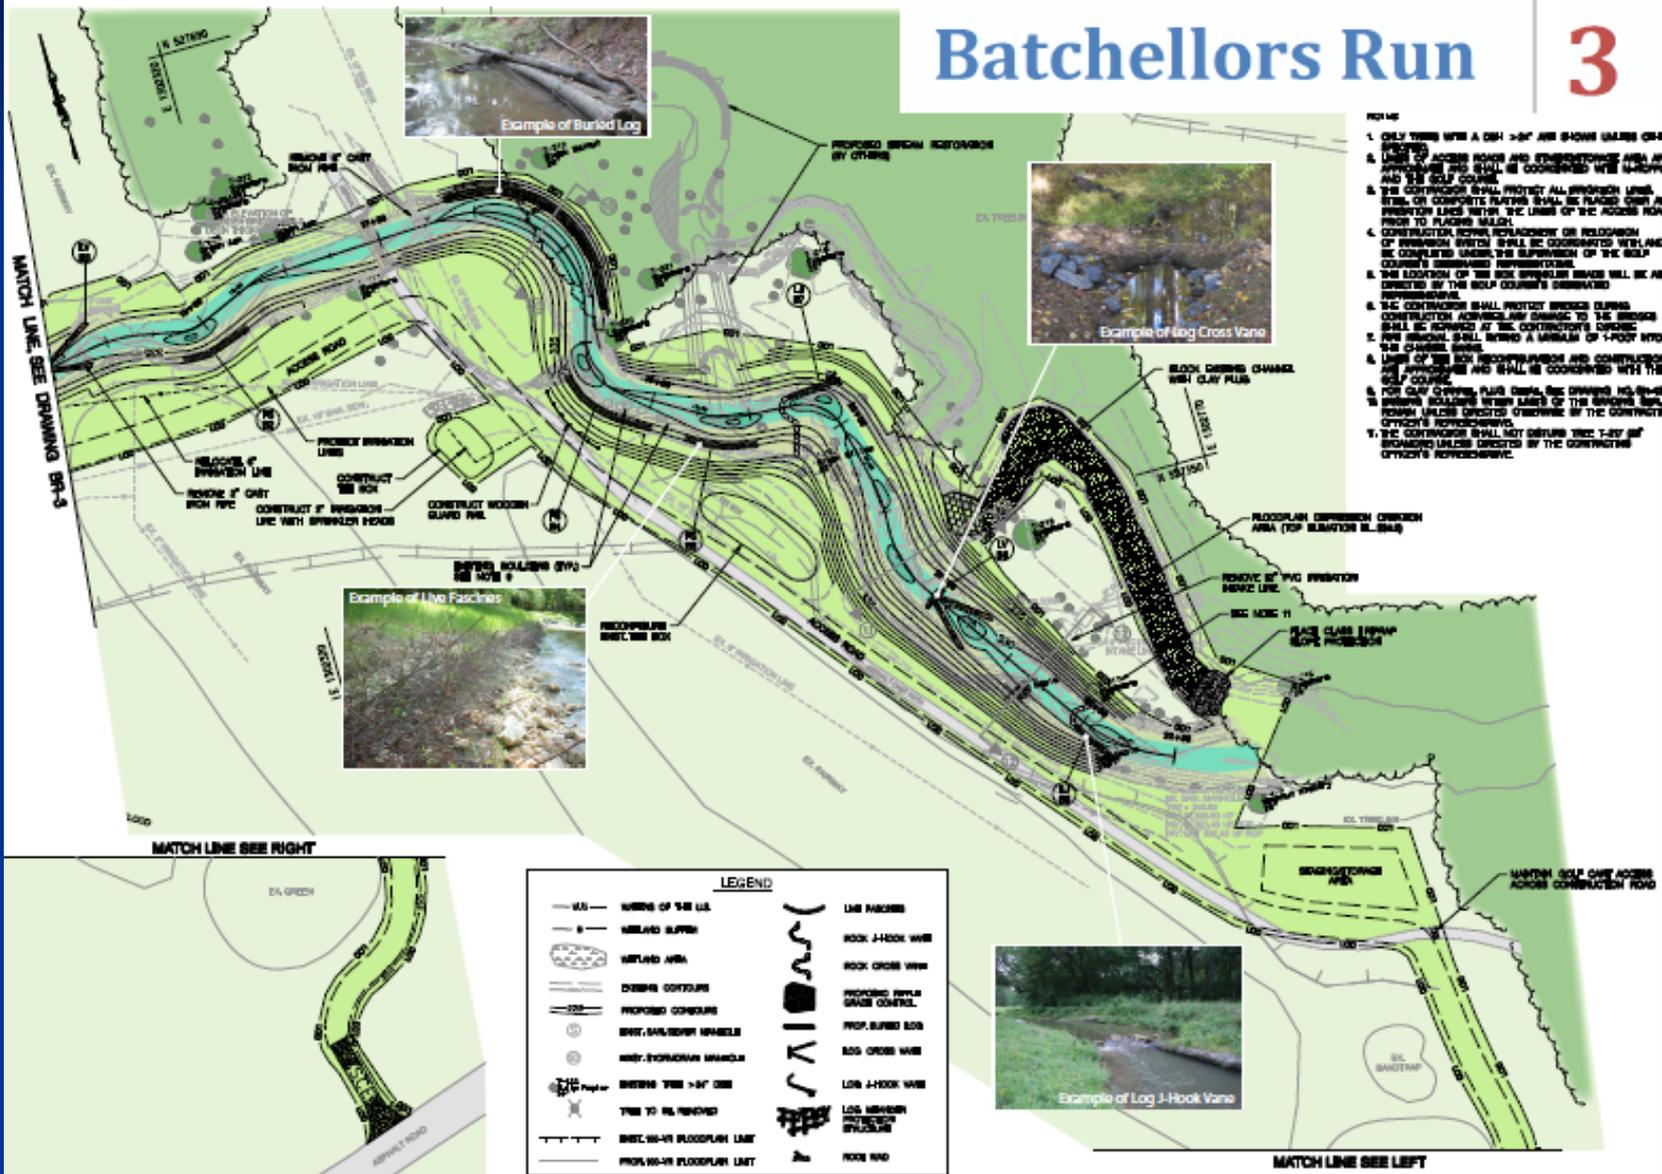
Batchellors Run 3

Batchellors Run - 95% Design

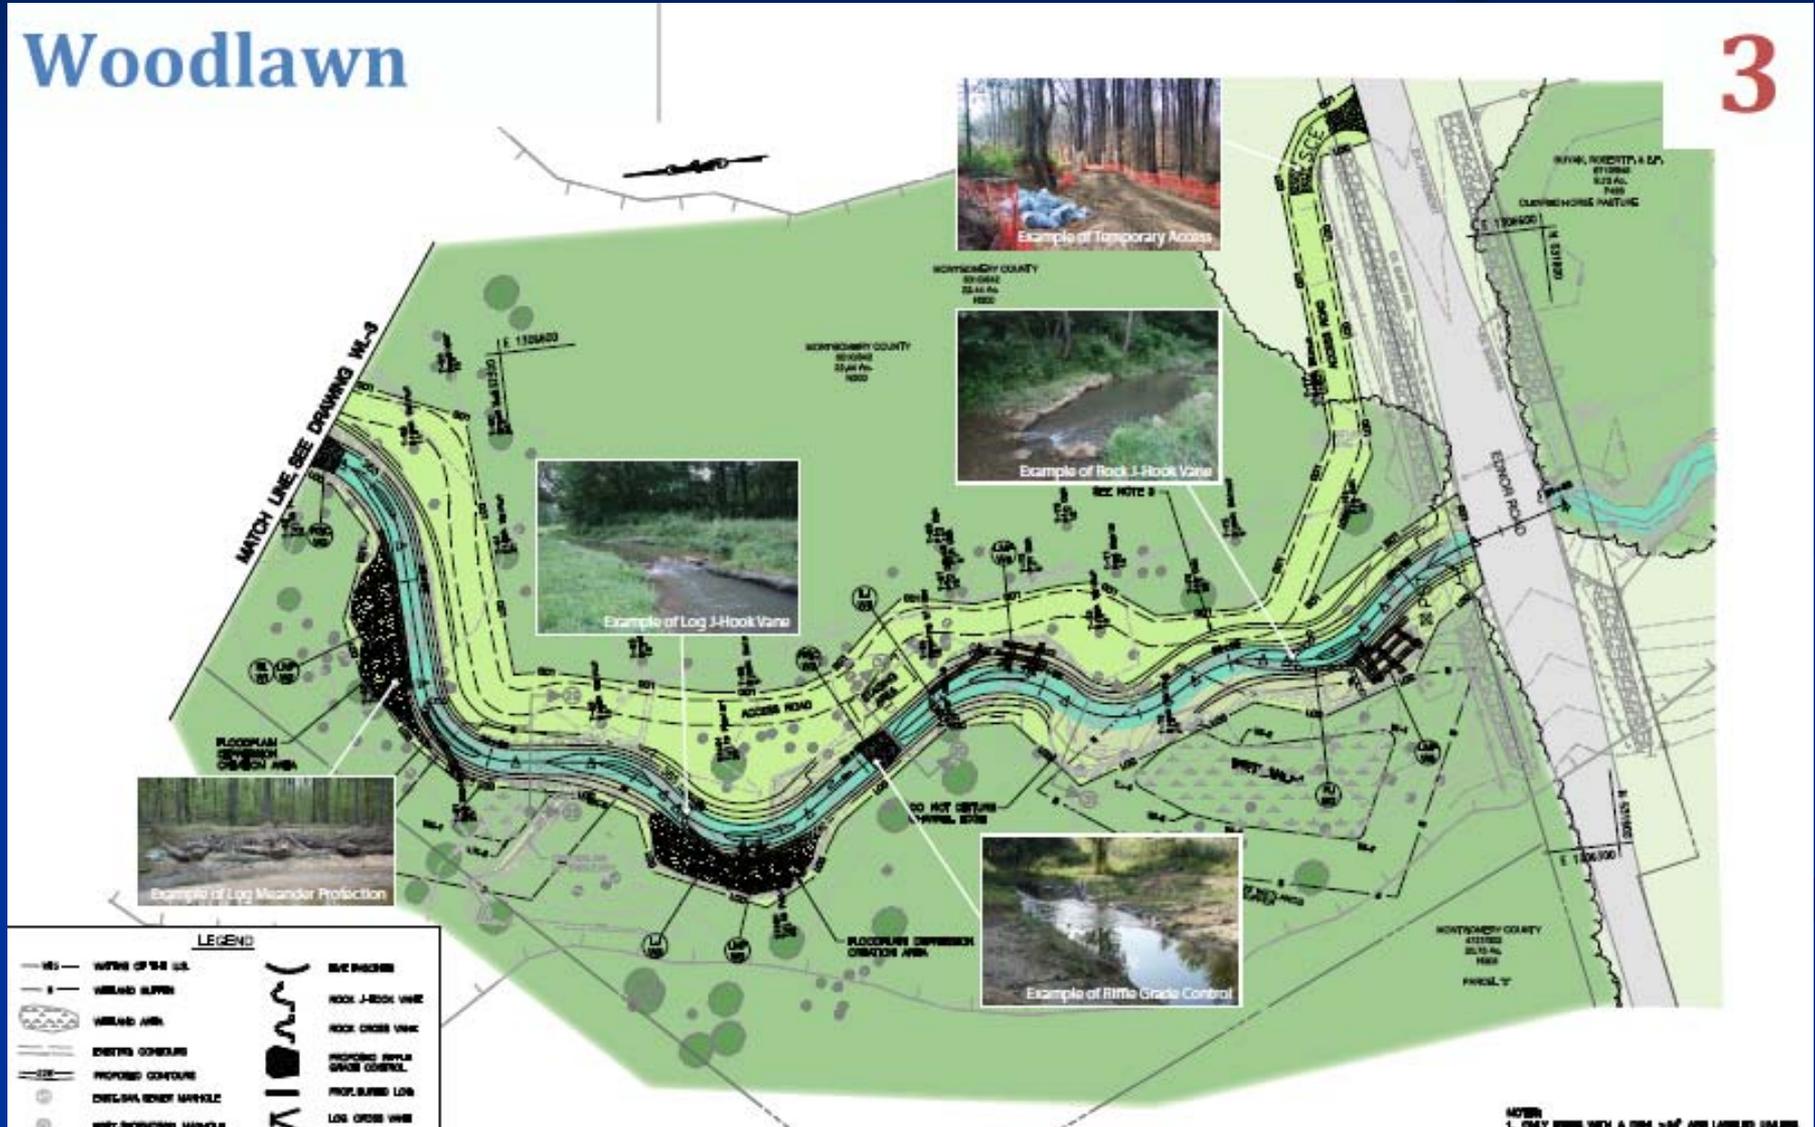
3

Woodlawn - 95% Design

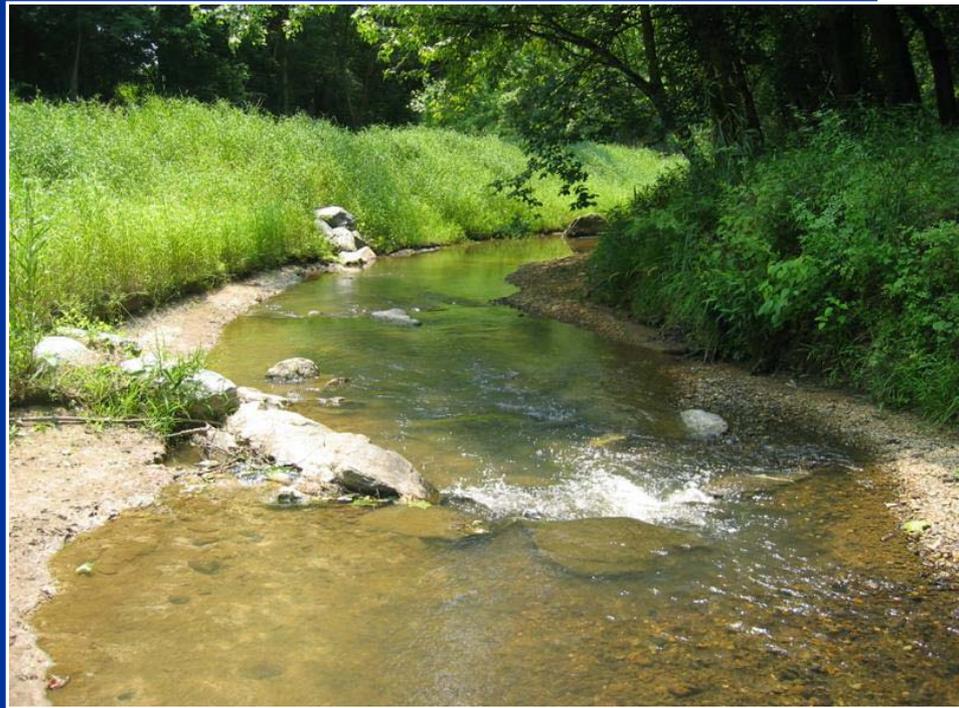
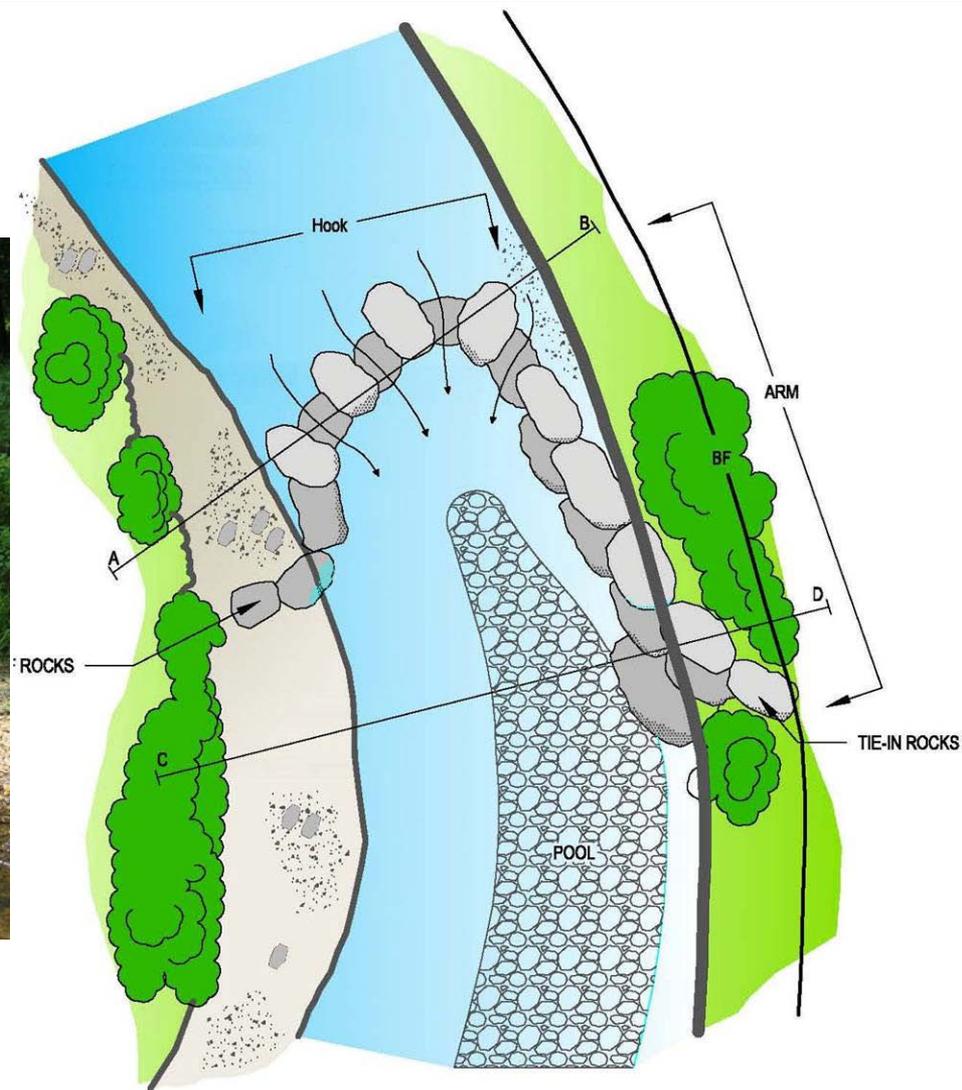
■ Boulder J-hook

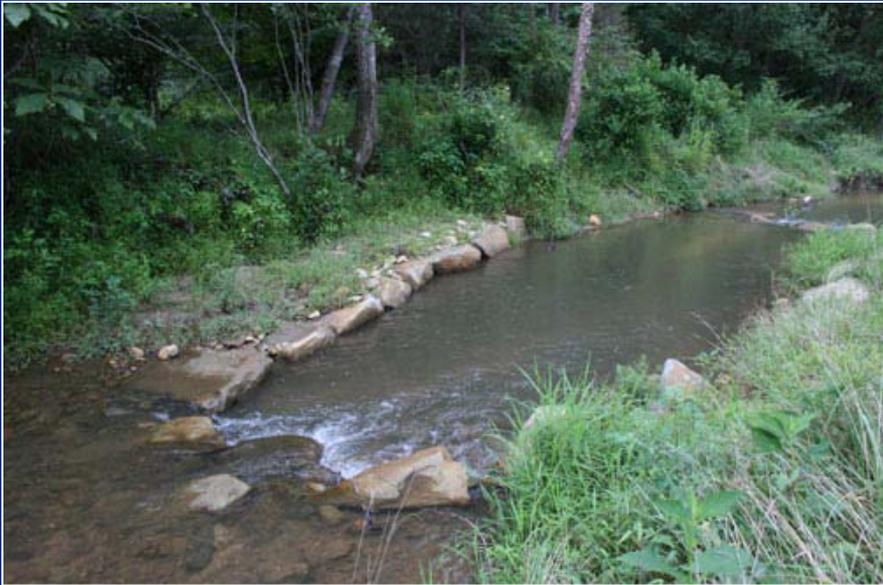
Boulder J-Hook

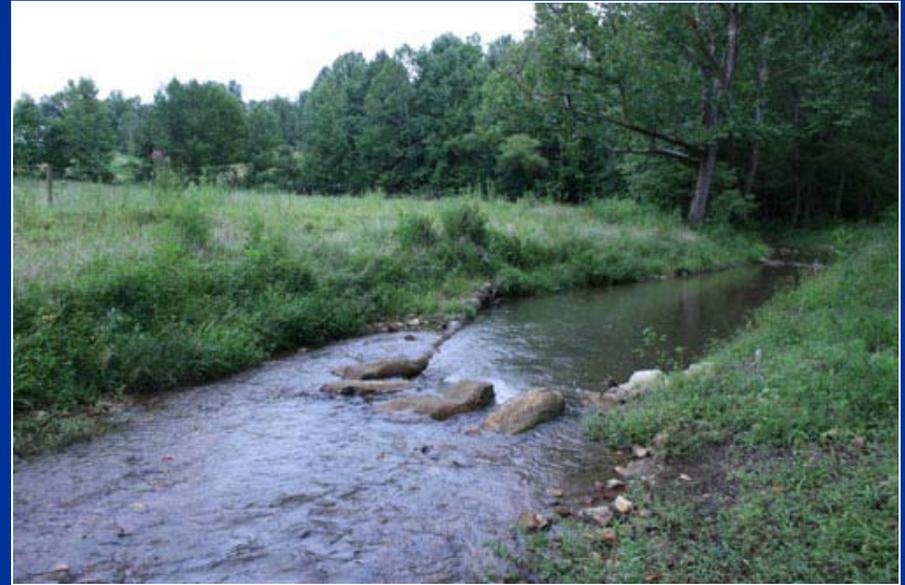
Log Boulder J-Hook

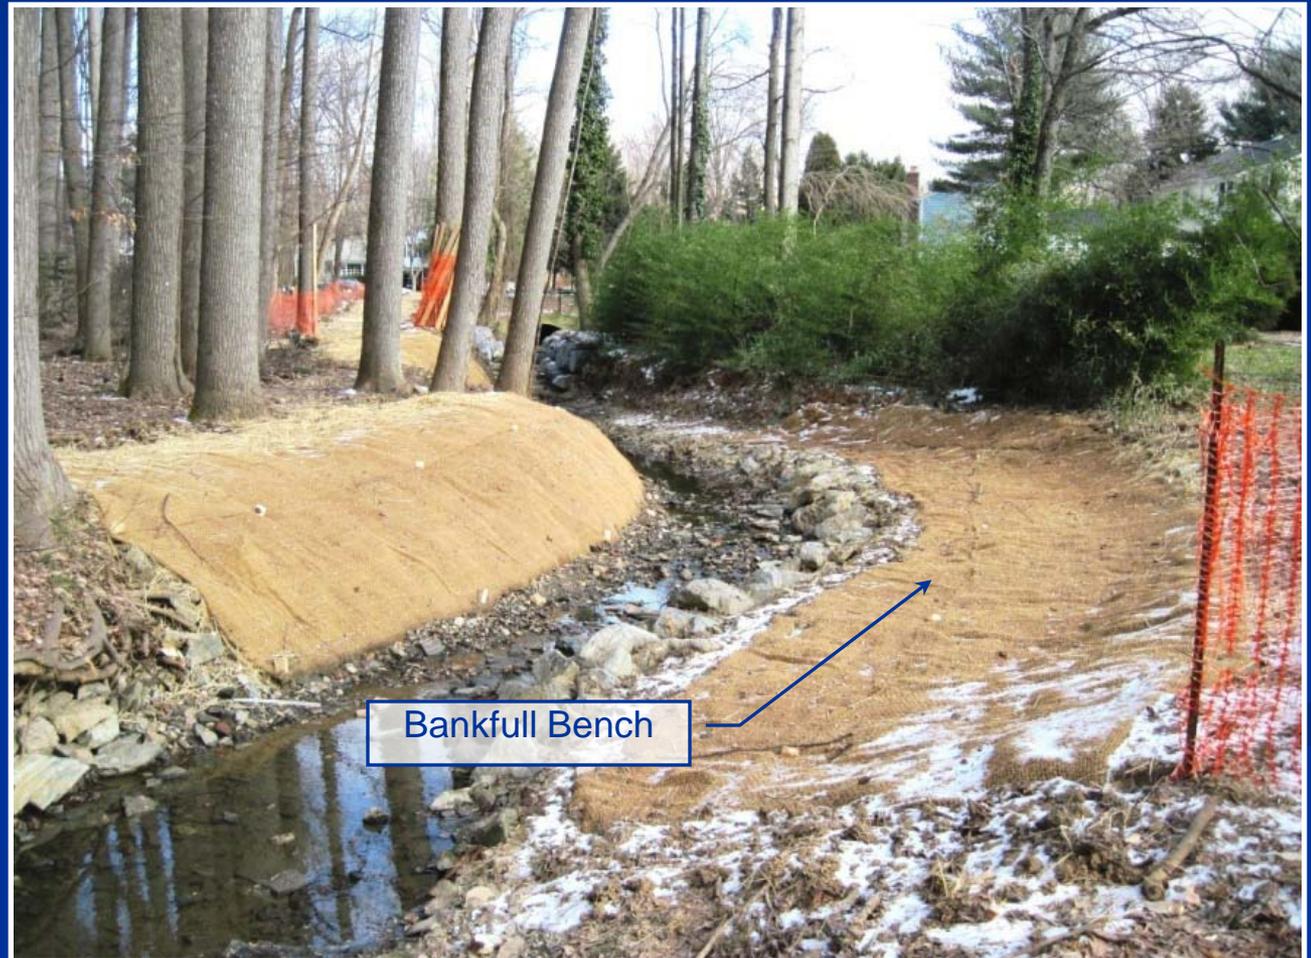
■ Bankfull Bench

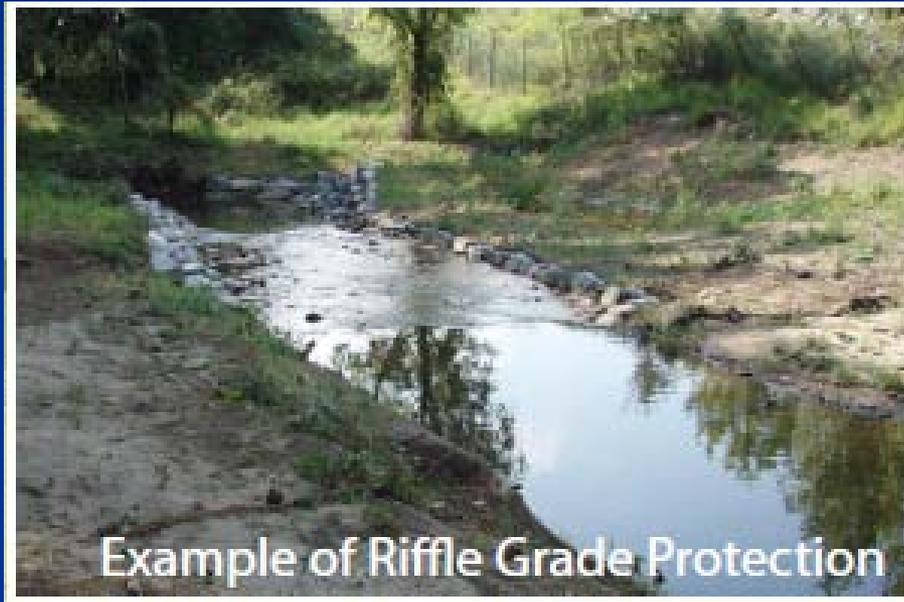
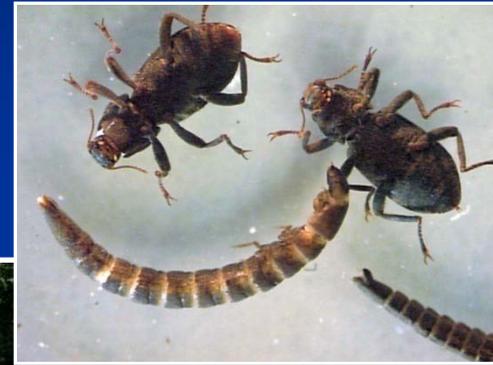
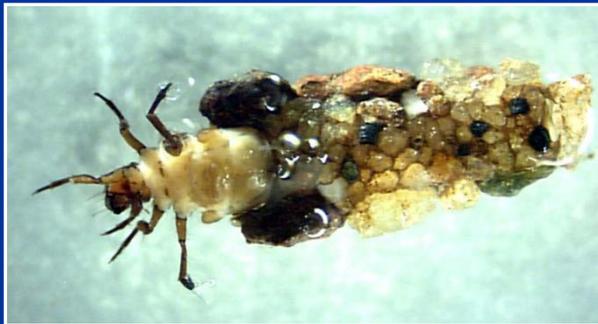
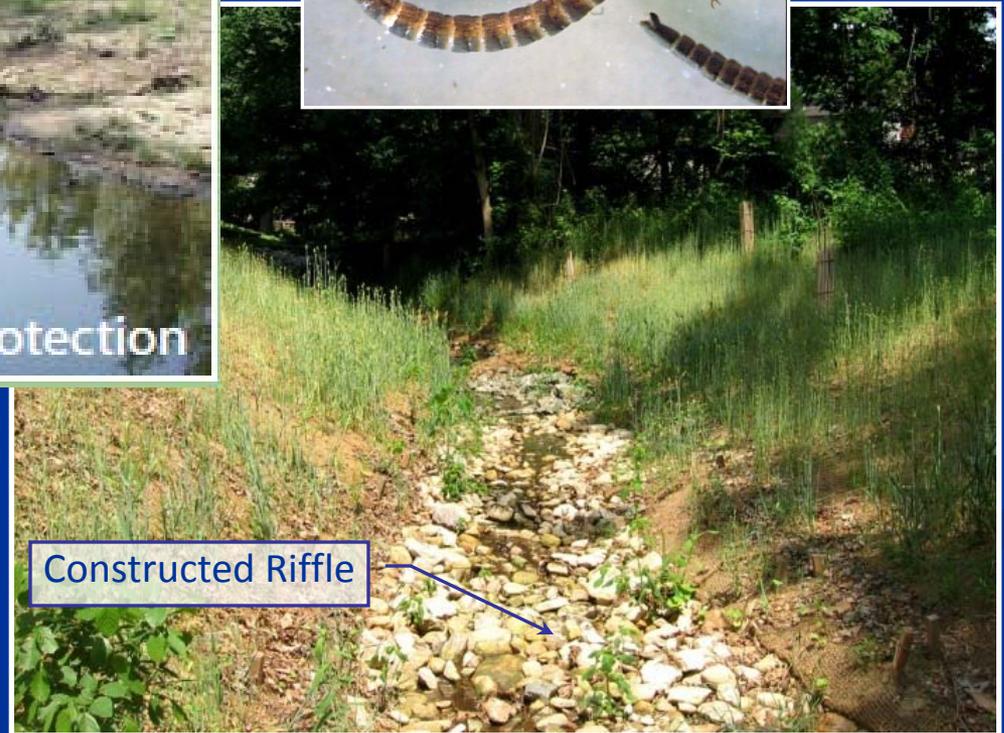
■ Constructed Riffle

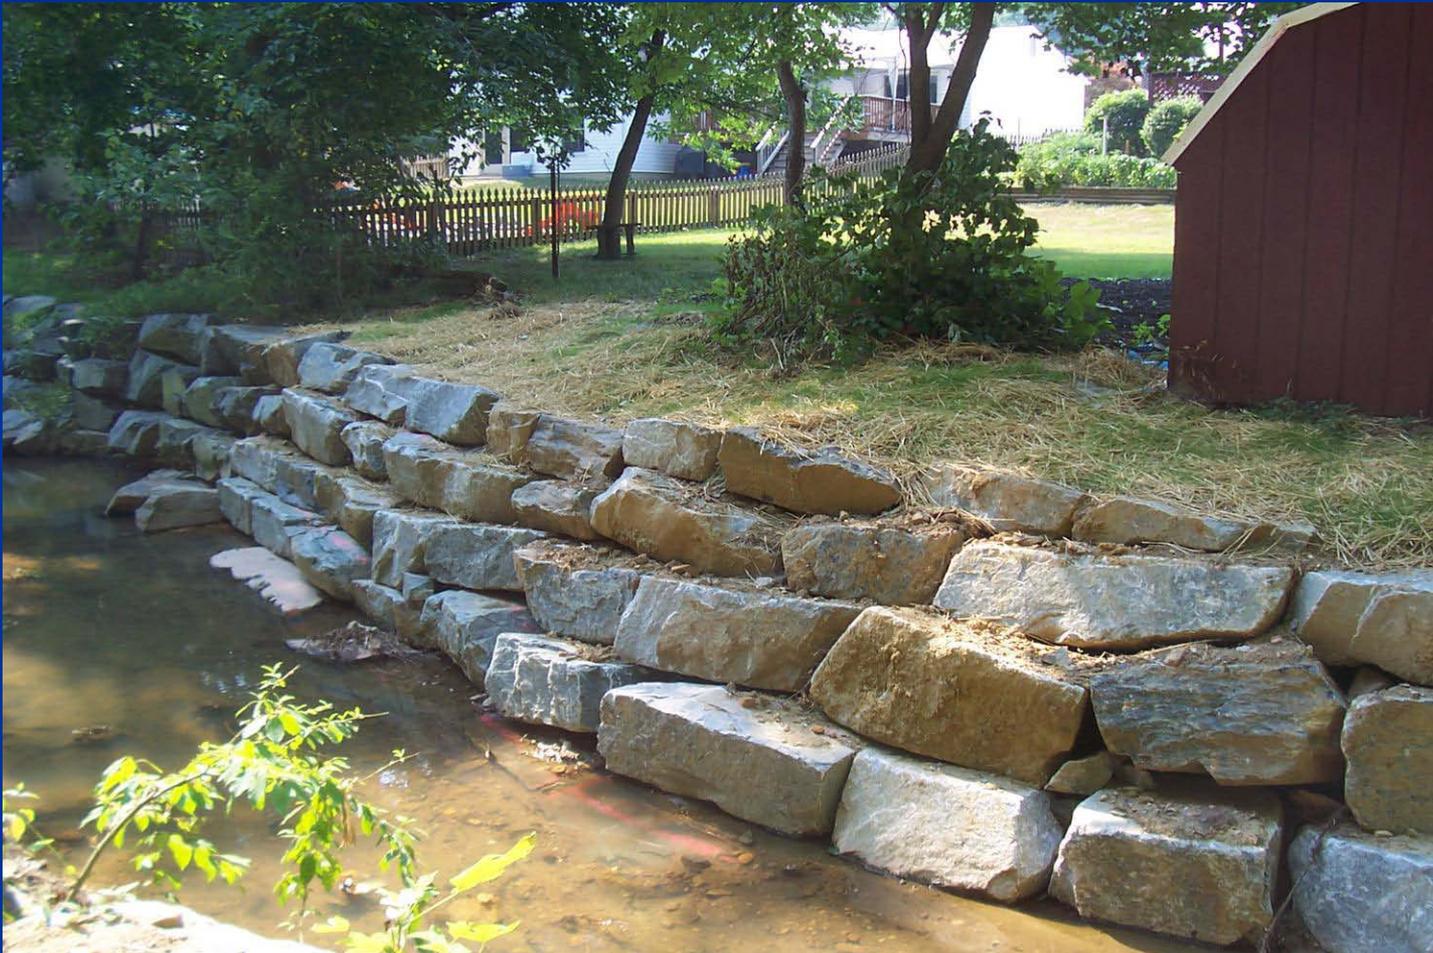
- Imbricated Rock Wall

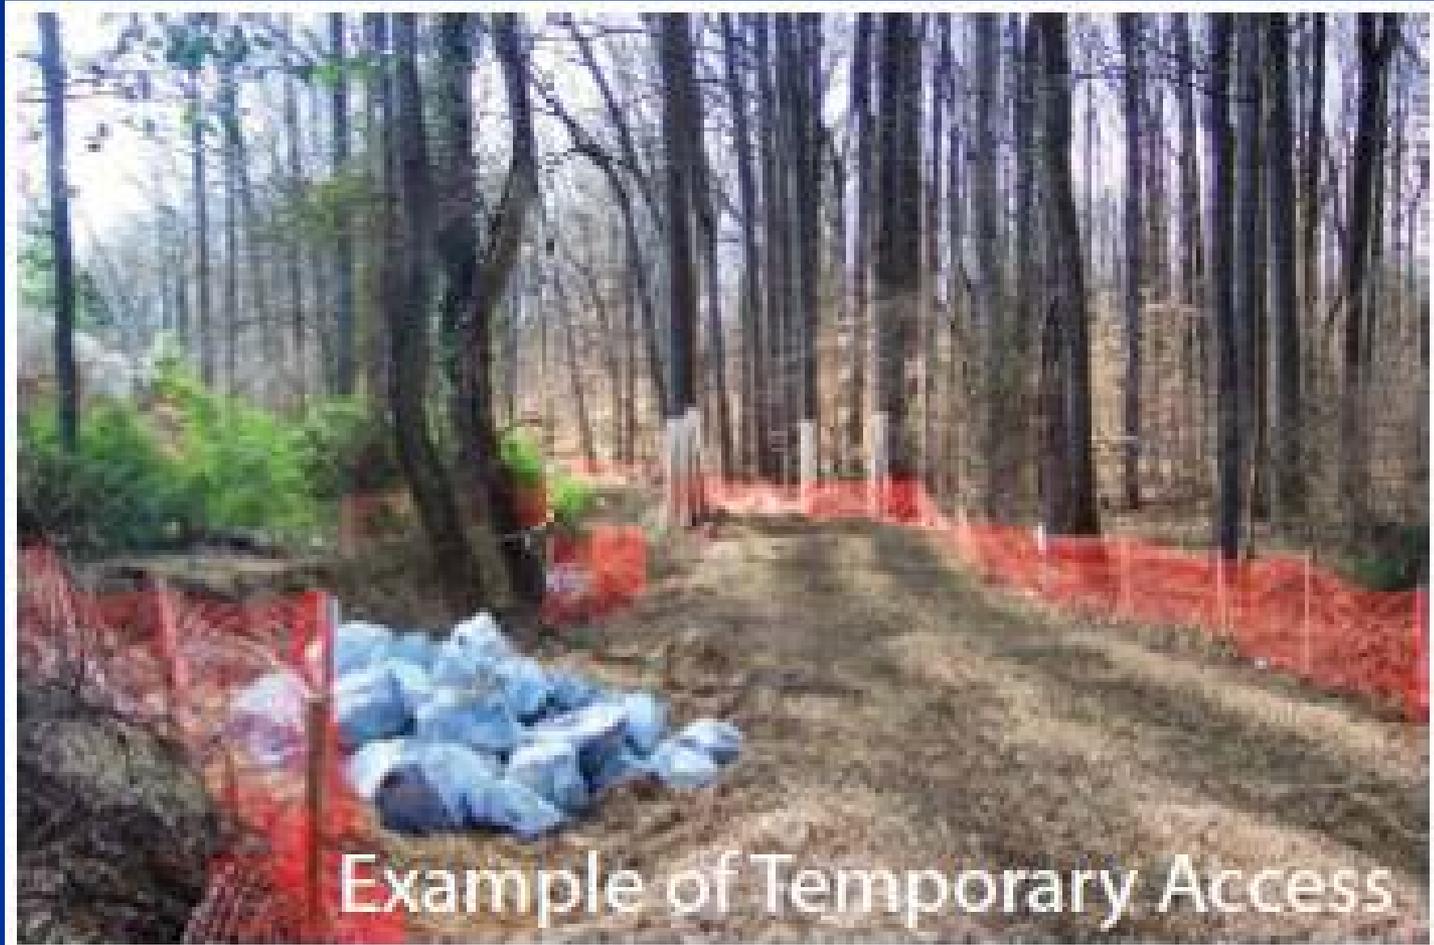
- Temporary Construction Access

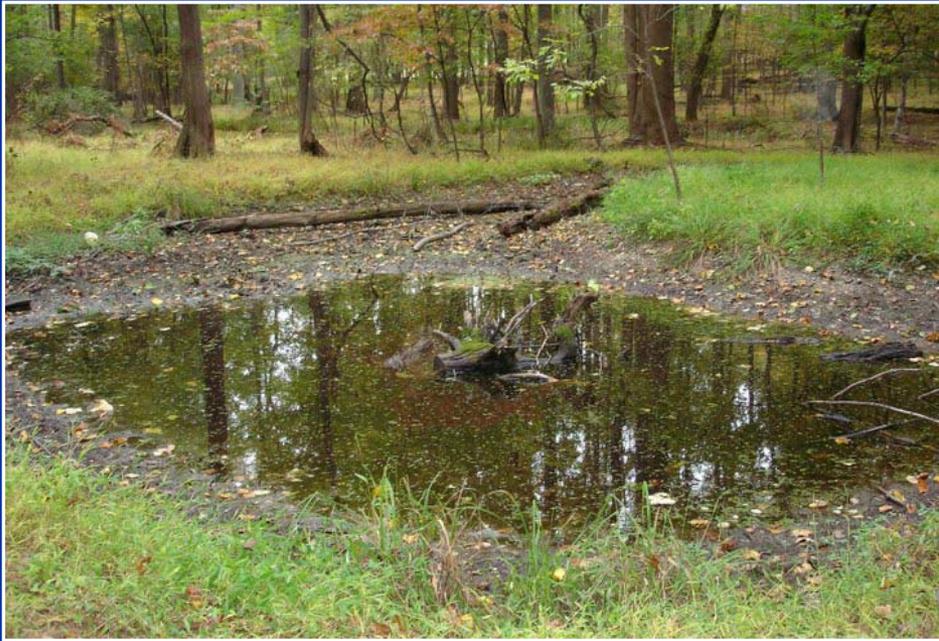
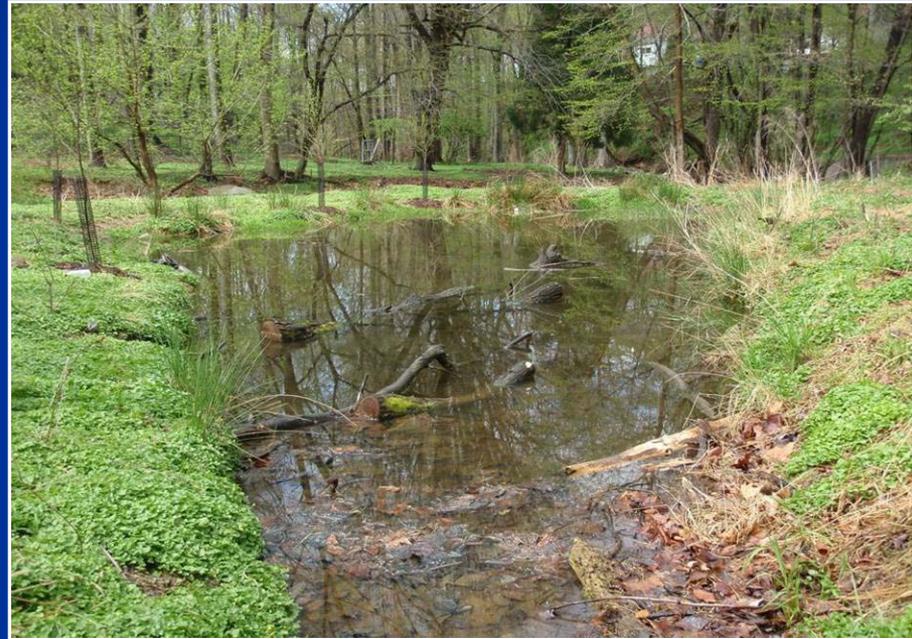
■ Wetland Creation

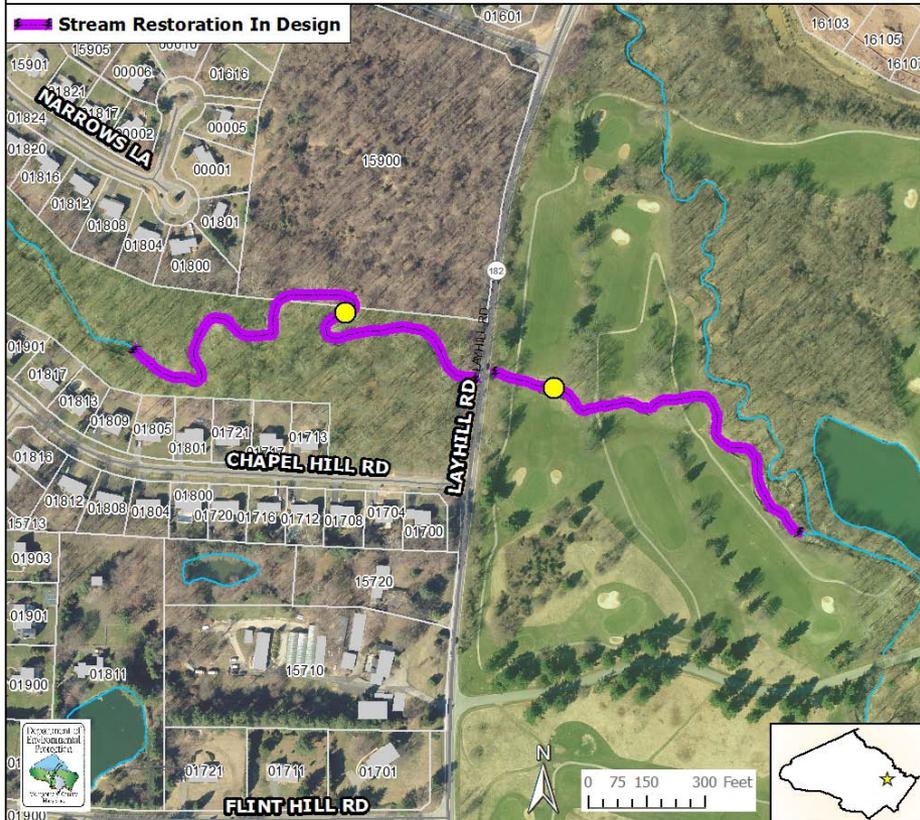
Batchellors Run Stream Restoration Monitoring Sites

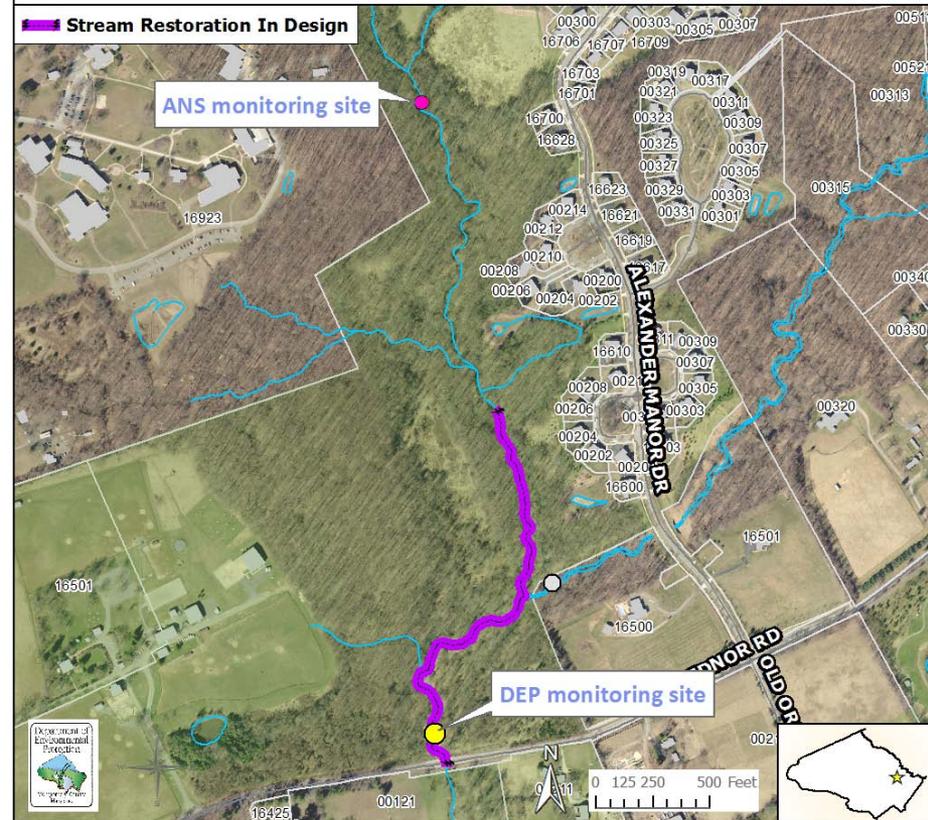
Woodlawn Stream Restoration Monitoring
