Watershed Restoration Factsheet:

University Towers/Northwood Presbyterian Church Stormwater Retrofit Project

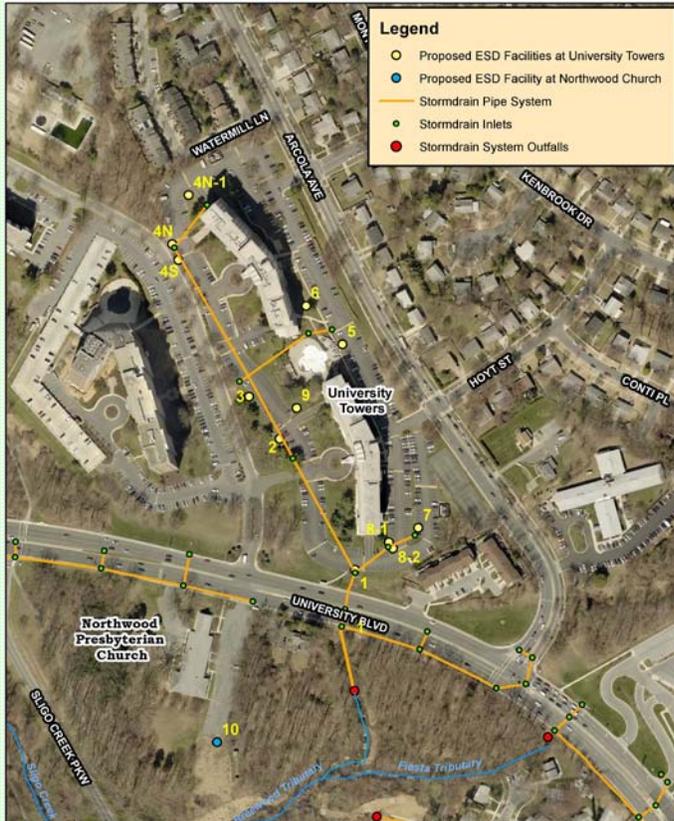
Locations of stormwater retrofit projects at University Towers and Northwood Presbyterian Church

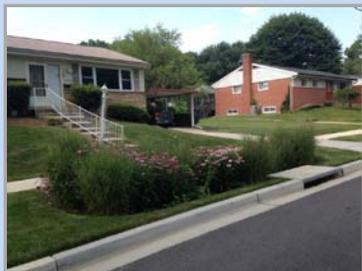
Example of a bioretention facility

Stormwater that flows into bioretention facilities, raingardens and tree boxes

soaks down through the planting media and into layers of sand and gravel. It's during this process that much of the pollutants are removed. Some pollutants, such as bacteria, oils & greases are broken down by microbes in the soil, while others, such as metals, are retained in the mulch and soil media, which is periodically removed and replaced during routine maintenance.

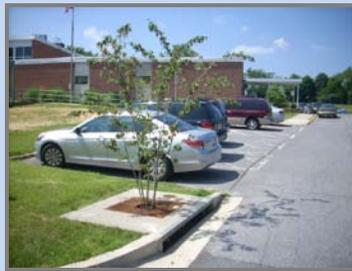
Example of a tree box

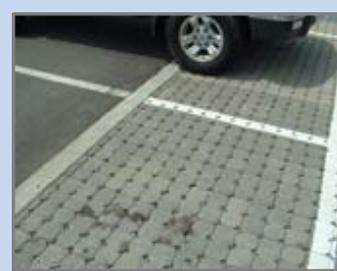
Example of permeable pavers

Additionally, permeable pavers will be installed at several locations throughout the parking lot to avoid loss of parking spaces. Permeable pavers allow water to pass through gaps between the pavers to a gravel bed where it is held until it either drains out an underdrain or soaks into underlying soils.
