# Paint Branch

## 3.14 Gum Springs Farm Stormwater Pond

### 3.14.1 Introduction

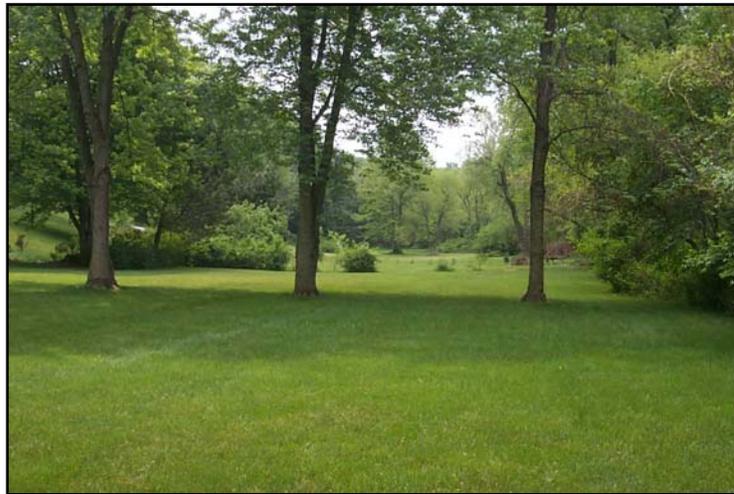
*Figure 3.14.1 – Pre-restoration View of the Gum Springs Farm Stormwater Pond Buffer and Pond Area (2001)*

The project is located south of Sturtevant Road, in the Lower Gum Springs Subwatershed, in an area that was previously a mowed field with some trees (**Figure 3.14.1**). The Lower Gum Springs Tributary was in need of stormwater quantity control due to the large uncontrolled area located upstream of the project site. Additionally, a limited stream buffer was observed along the Gum Springs Tributary that did not provide shade and bank stability for the stream.

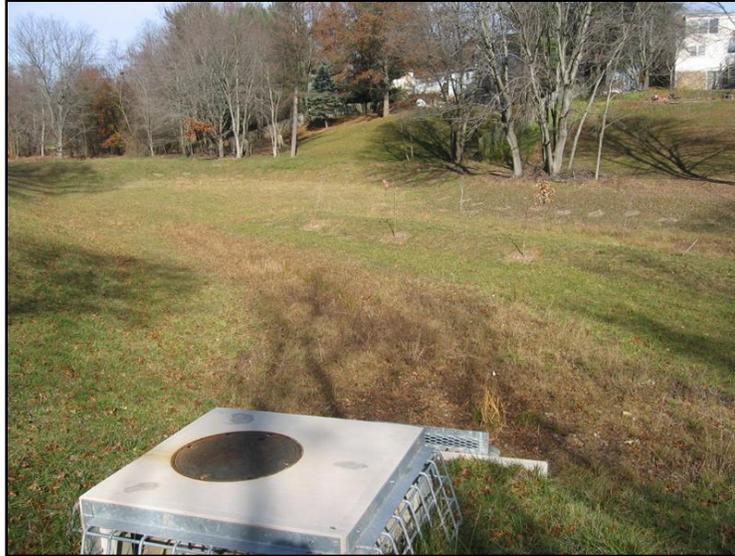
**Figure 3.14.2 – Gum Springs Farm Stormwater Pond in 2009**

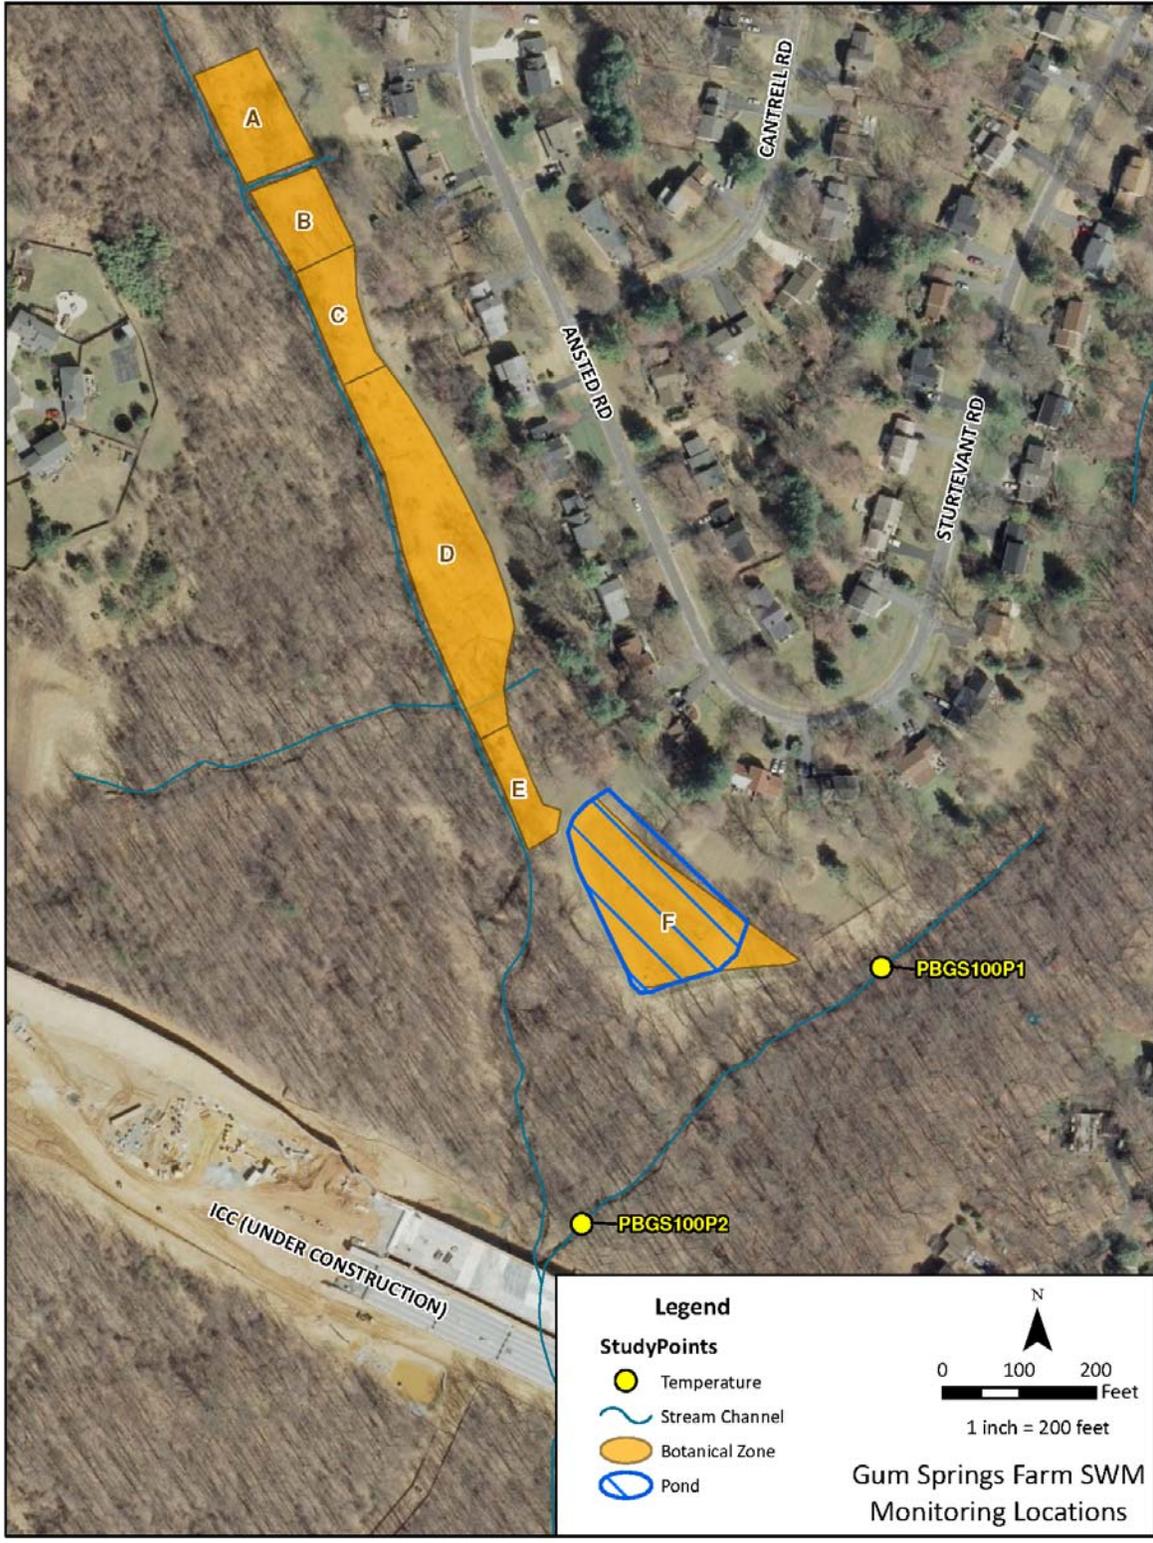
**Figure 3.14.4 – Map of 2009 Monitoring Locations for Gum Springs Farm Stormwater Management Project**

The basic sampling design for the temperature monitoring task was pre-restoration (before) and post-restoration (after) monitoring, located upstream and downstream of the project. Additionally, the riparian zone was monitored post-restoration only, after the plantings were installed and had time to establish. Data were collected at three sites in the vicinity of this restoration project, PBGS100P1, PBGS100P2, and PBGS100 (Zones A-F) (*Figure 3.14.4*).

Sites PBGS100P1, located upstream of the stormwater pond, and PBGS100P2, located downstream of the stormwater pond outfall (*Figure 3.14.4*), were established to monitor the temperature effects of the restoration (*Table. 3.14.1*). At these sites, temperature loggers were deployed to determine if the pond affected the stream temperature regime observed during pre-restoration monitoring. Crews also monitored the riparian plantings at PBGS100 (Zones A-F) to evaluate the overall success of the reforestation. A map showing the stormwater pond and monitoring locations is provided in *Figure 3.14.4*. All data collected in 2004 are considered pre-restoration data and data from 2009 are considered post-restoration. These data are presented in the results section below. For more information on how this monitoring is performed and used to measure stream health in the County, see the Methods (*Section 2*).

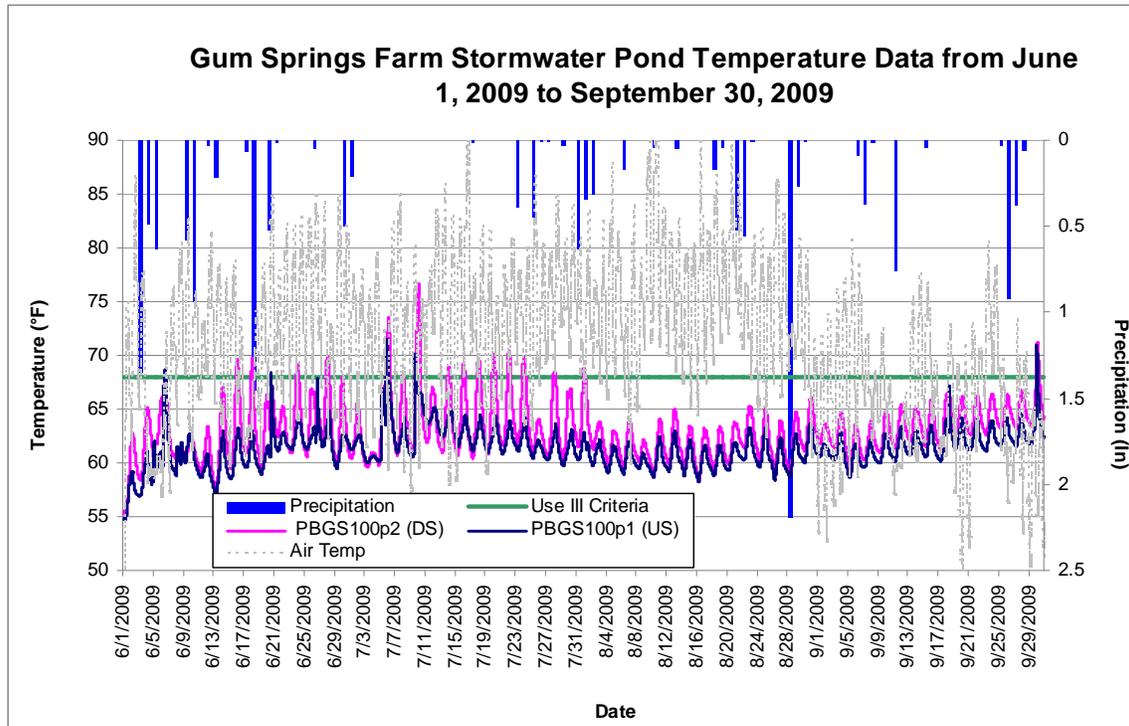
In 2009, after the pond was created, stream temperatures were also monitored upstream (PBGS100P1) and downstream (PBGS100P2) of the pond. **Figure 3.14.5** shows stream temperatures up and downstream of the Gum Springs Farm Stormwater Pond as well as air temperature and daily rainfall from June 1 to September 30, 2009. Rainfall data were obtained from the Weather Underground KMDSILVE11 weather station located in Calverton, MD, approximately three miles from the Gum Springs Farm Stormwater Pond. **Table 3.14.5** shows the minimum, maximum, and average temperature at each site, and the differences between these values up and downstream of the pond. It also shows the percentage of readings that exceeded the Use III temperature standard.

**Figure 3.14.5 – Stream Temperature Upstream and Downstream of the Gum Springs Farm Stormwater Pond in 2009**

In 2009, the minimum temperature below the pond was 7.2°F lower than it was above the pond. The maximum and average temperatures were higher below the pond than above, with temperature differences of 10.5°F and 1.6°F, respectively. Additionally, 11 percent of the readings exceeded the Use III standard below the pond and only 1 percent exceeded the 68°F standard above the pond.

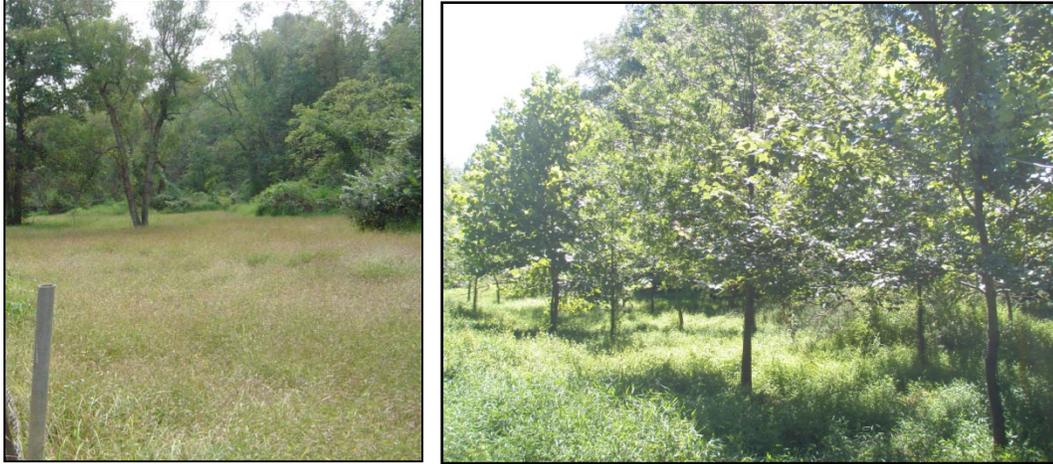
The Gum Springs Farm restoration project appears to have met the goal of reforesting the riparian zone of the Gum Springs Tributary. Many areas that were sparsely vegetated prior to construction have been planted as part of this restoration project and the riparian zone is considerably improved (**Figure 3.14.6**). Some of the plantings have died, including the majority of the shrub and tree plantings in the stormwater pond area (Zone F) (**Figure 3.14.7**). Only seven percent of the trees and shrubs planted in the vicinity of the stormwater pond (Zone F) survived. Riparian tree plantings were much more successful; between 38 to 63 percent of these plantings survived, with an overall average of 51 percent (Zones A-E). The planted trees that were most successful site-wide were swamp white oak, red maple, white oak, and northern red oak. Additionally, the caliper sizes of the individuals observed in 2009 were larger than those that were planted in 2006/2007. The increase in size of the planted individuals is a measure of successful growth and a sign that these trees are well established. The species that grew the most were river birch, American sycamore, and northern red oak.

***Figure 3.14.6 – Gum Springs Farm Botanical Reforestation area in 2005 versus 2009 (dominated by American sycamore and Japanese stiltgrass)***

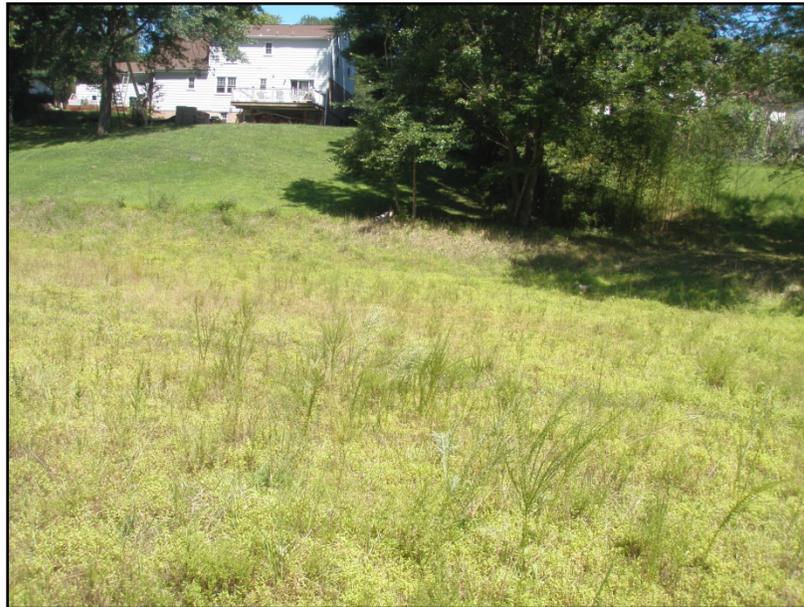
***Figure 3.14.7 – Gum Springs Farm Stormwater Pond in 2009***
