Rock Creek

Lower Rock Creek

3.19 Joseph's Branch 3B - Wheaton High School & Spruell Drive Stream Restoration

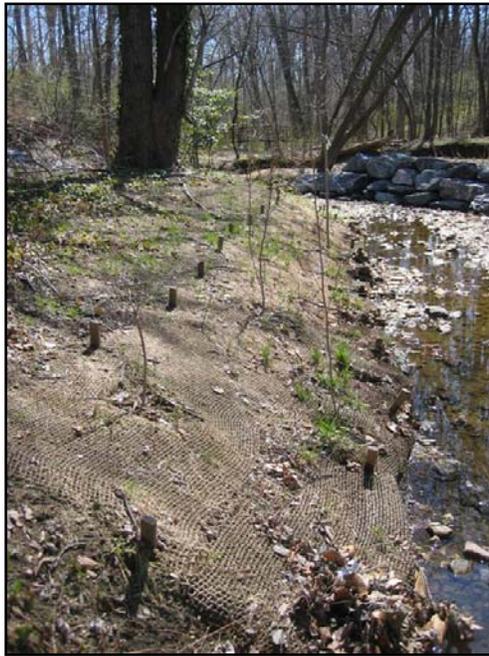
Figure 3.19.1 – Wheaton High School Restoration Site Showing Plantings and Streambank Stabilization (2008)

The Wheaton High School stream restoration project originates upstream of Randolph Road and continues 670 linear feet upstream on the upper reach of Joseph's Branch (*Figure 3.19.6*). The construction for this project was completed in December, 2006 and reforestation was completed in April 2007. Restoration associated with this project included the construction of in-stream structures to control erosive stream flows and to improve stream habitat and reforestation of the stream buffer. *Figure 3.19.1* shows an example of the Wheaton High School restoration project.

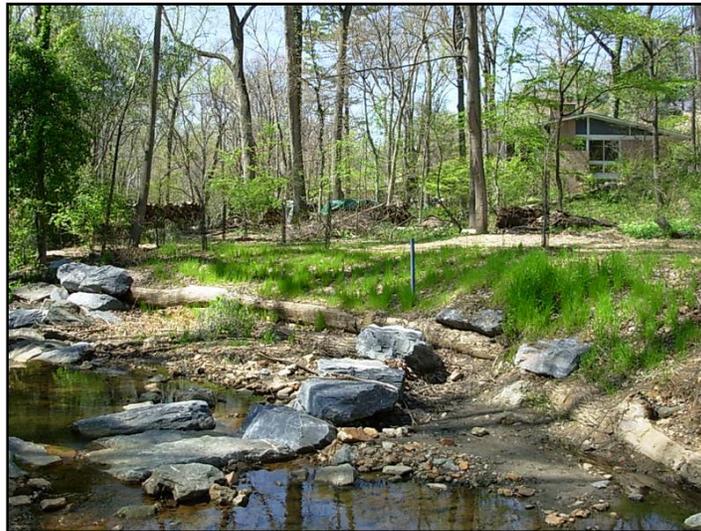
Figure 3.19.2 – Spruell Drive Restoration Site Showing Cross Veins and Logs Providing Streambank Protection (2007)

The Spruell Drive stream restoration begins at the pedestrian trail crossing located behind the Rock Creek Palisades Apartments to the west of Connecticut Avenue and continues downstream to the mainstem of Joseph's Branch (*Figure 3.19.7*). The construction for this project was completed in December 2006 and reforestation was completed in April 2007. Restoration included stabilizing the stream and planting native vegetation to enhance the riparian zone. *Figure 3.19.2* shows an example of the restoration associated with the project.

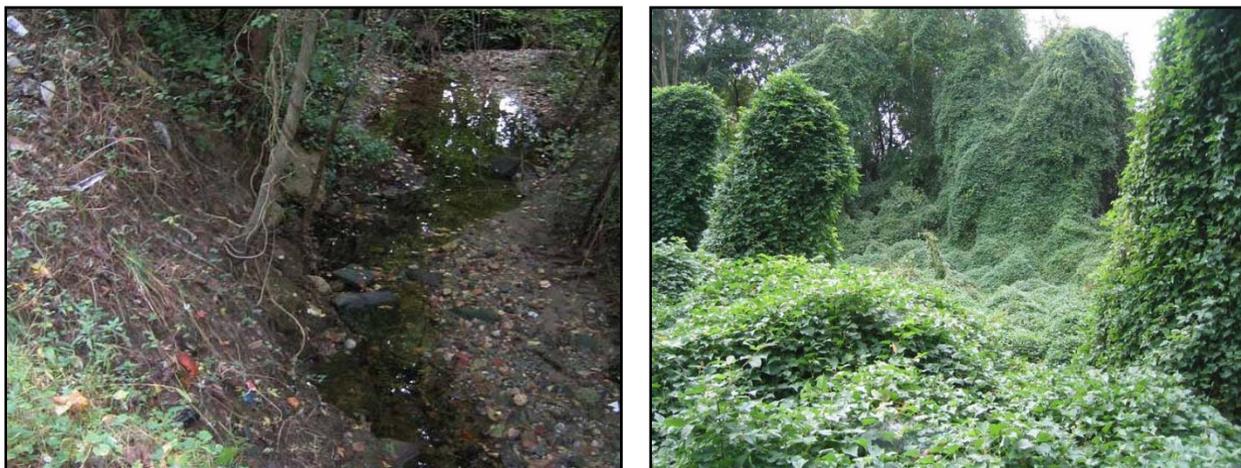
Over time, the stream channel down-cut and over-widened, limiting the stream’s access to the original floodplain. The down-cutting and over-widening exposed sewer manholes, threatened buried sewer lines, and destroyed habitat necessary for diverse aquatic life. Large amounts of sediment from eroded banks and road grit accumulated in the stream, further degrading stream habitat conditions (*Figures 3.19.4 and 3.19.5*).

Figure 3.19.4– Pre-Restoration Conditions at the Wheaton High School Site (2005)

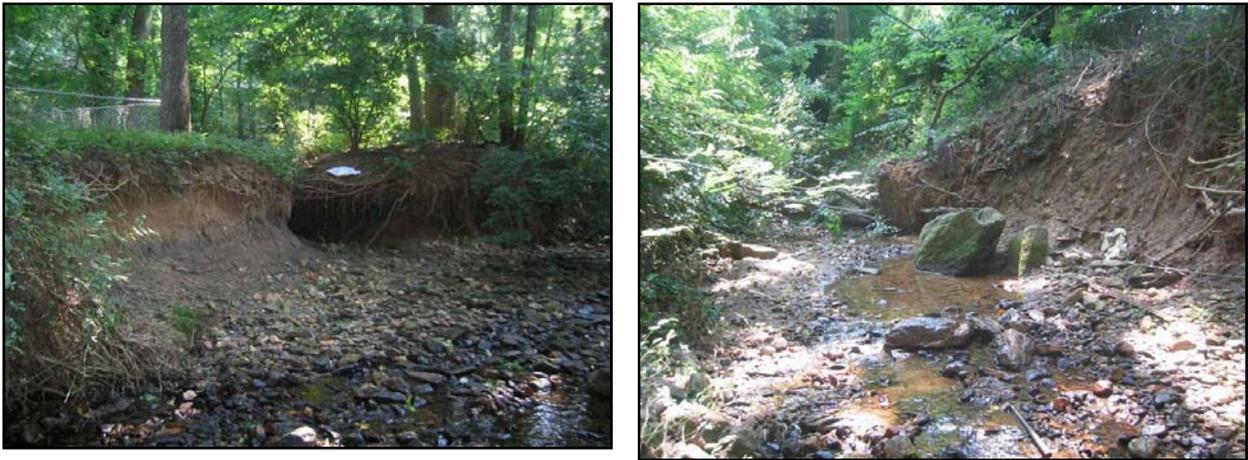
Figure 3.19.5 – Pre-Restoration Conditions at the Spruell Drive Site (2005)

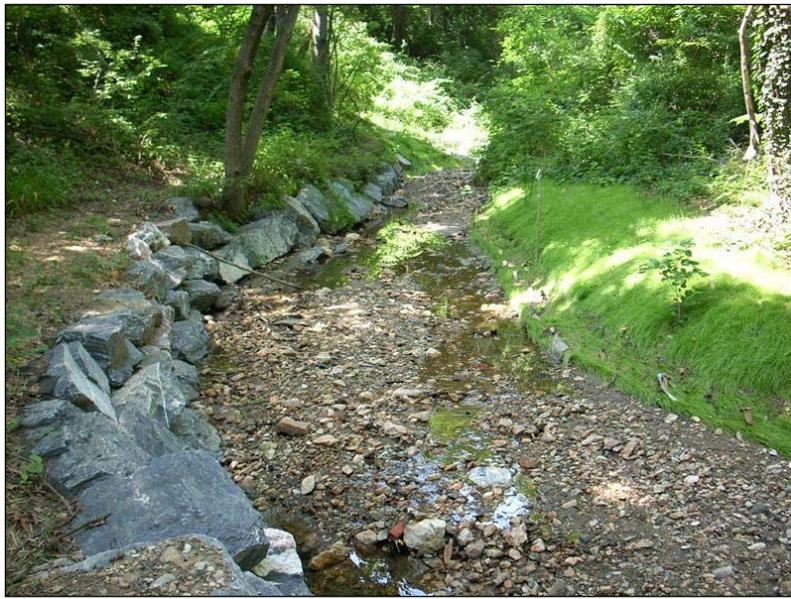
Figure 3.19.6 – Post-Restoration at Wheaton High School project (2007)

The Joseph's Branch Projects used restoration techniques and reforestation to help stabilize stream banks and enhance riparian habitat. Newly built in-stream structures included rock and log vanes that direct water away from unstable stream banks and form downstream scour pools, providing good habitat for fish. Rock cross vanes were also installed and function as grade control structures, slowing the erosive process of stream down-cutting. In-stream root wad revetments were installed to help stabilize streambanks, while creating scour holes to provide cover for fish. Boulder rock was installed at the toe of the streambank slope, stabilizing the area of the stream channel subject to the greatest erosive energy, or "shear" stress. The slopes above the reinforced toe were graded back to create new floodplain terraces and planted with native trees and shrubs to further stabilize the streambanks. The project attempted to save undercut streambank trees with supportive "rock packing." More seriously damaged trees were flush cut, allowing the root systems to remain in the bank for stabilization. Other efforts to enhance the riparian habitat and buffer included creating a shallow vernal pool at the upper end of the project, and planting more than 1,400 native plants and trees. **Figure 3.19.6 and 3.19.7** show examples of the restoration completed at the Wheaton High School and Spruell Drive restoration sites.

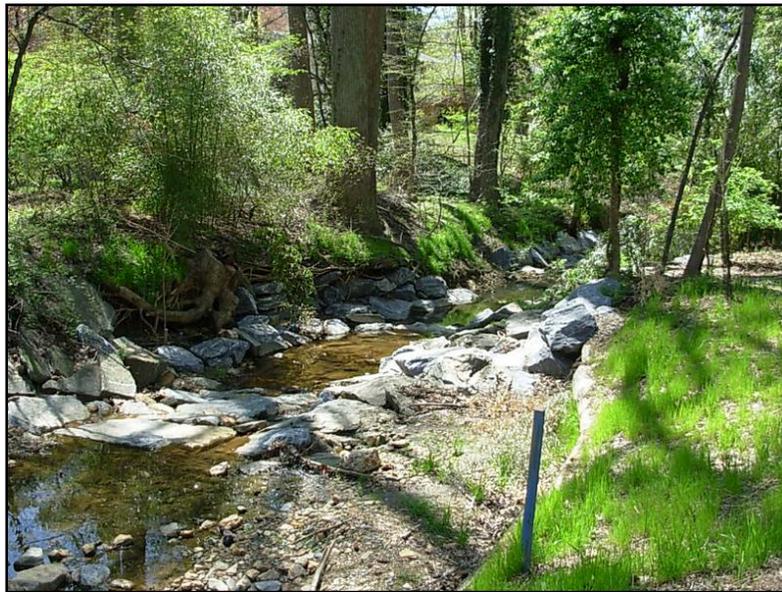
Figure 3.19.7 – Post-Restoration at Spruell Drive project (2007)

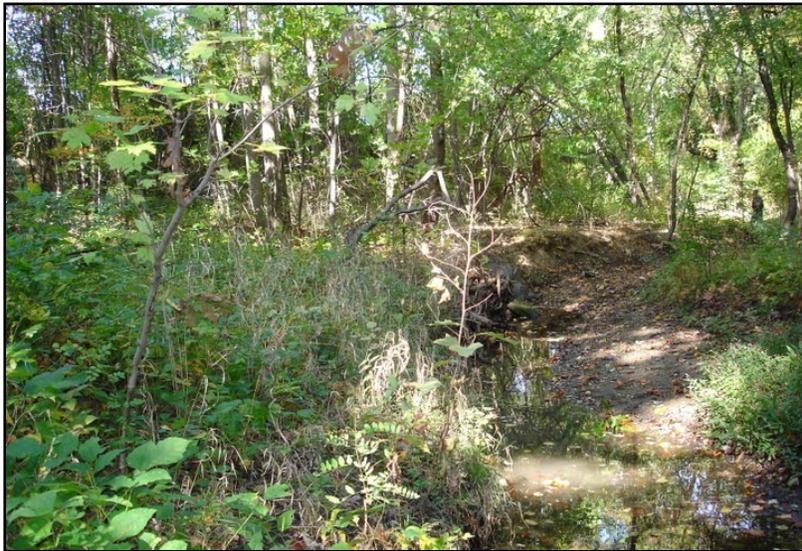
Planted tree and shrub species observed in 2009 included *Platanus occidentalis* (American sycamore), *Acer rubrum* (red maple), *Quercus palustris* (pin oak), *Viburnum prunifolium* (blackhaw), *Lindera benzoin* (northern spicebush), *Hamamelis virginiana* (American witchhazel) and *Aronia arbutifolia* (red chokeberry). Twenty-six live individuals were encountered in 2009 and five individuals were considered dead, including two American sycamore, two American witchhazel, and one unknown tree. Eighty-four percent the plantings were found alive in 2009. None of the trees were considered healthy, but all of the shrubs were healthy. Tip dieback was evident on all three of the tree species. Deer rubbing was also observed, but only on the maples. Planted trees generally ranged from 0.5 to 1.5 inch caliper and shrubs ranged from 3.5 to 5.5 feet tall. Red maples were the largest of the planted trees, ranging from 1 to 1.5 inch caliper. These trees were likely one inch caliper when planted in 2006 so several of them appeared to have grown. With the exception of the dead American witchhazel, all planted shrubs appeared healthy.

Figure 3.19.10 – Site LRJB101, Wheaton High School Project, Picturing Red Maple and American Sycamore Plantings

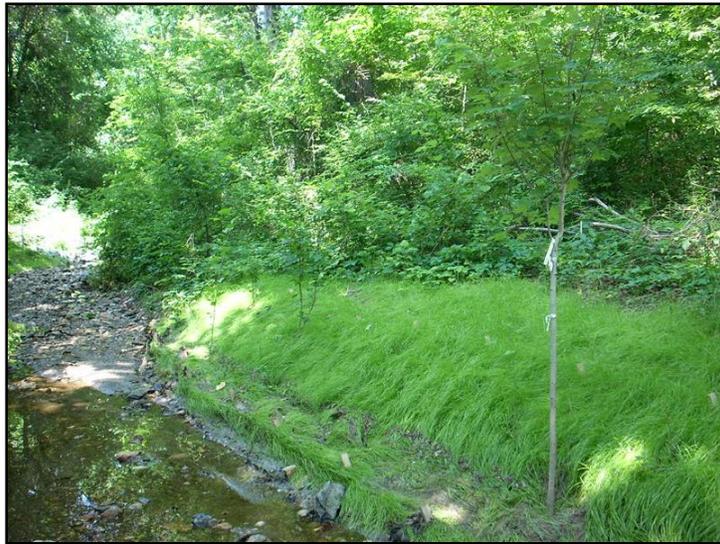
Three species of trees were planted for this project including American sycamore, red maple, and *Asimina triloba* (pawpaw). Twenty additional trees were planted in 2007, but it is unknown what species were planted. Eighty-eight percent of the trees at this site survived to 2009. One inch caliper American sycamore and red maples were planted in 2007 and planted pawpaws were one to two gallon or approximately 0.25-0.5 inch caliper. In 2009, many of the plantings were larger than the size of the individuals that were planted, with American sycamore growing the most (1.25-3 inch), red maple having the lowest growth differential (0.75-1.5 inch), and pawpaw individuals showing some growth (0.25 to 1.0 inch). **Figure 3.19.9** shows a few of the plantings in 2007.

Figure 3.19.11 – Site LRJB102, Spruell Drive Project, Picturing American Sycamore Plantings and a Stabilized Streambank (2007)

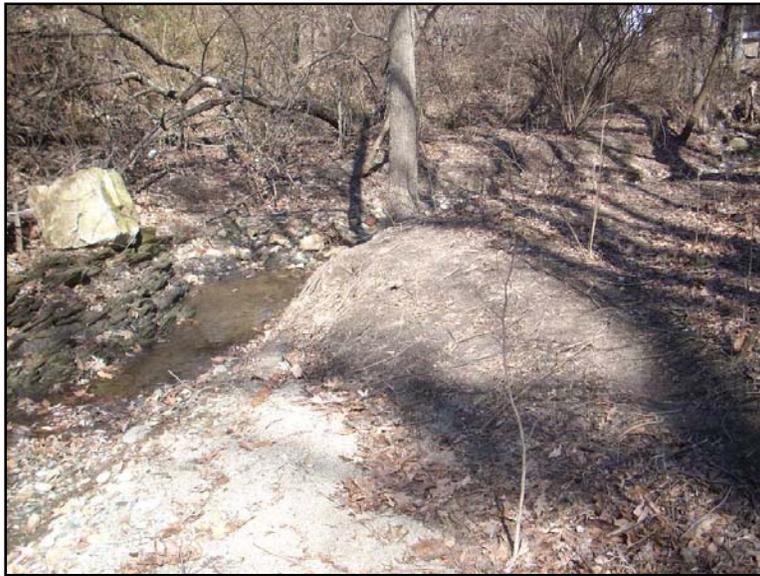
The current year’s monitoring effort indicated reforestation at the Wheaton High School project (site LRJB101) has been partially successful. The site had an 84 percent survival rate from the time the plantings were installed in 2007. However, all of the trees were either rubbed by deer or experiencing tip dieback and were not considered healthy. Also, trees do not appear to have grown substantially since being planted; only red maples were larger than one inch caliper. Several shrubs that were planted at this site were observed and were healthier than the trees, but many invasive plants and vines were present around the plantings. Deer and invasive species may be a problem at this site in the future. **Figure 3.19.12** below shows an area of riparian planting for the Wheaton High School restoration project.

Figure 3.19.12 - Site LRJB101, Wheaton High School Project, Picturing Small Riparian Plantings

To date, the Joseph's Branch 3B – Wheaton High School and Spruell Drive stream restoration projects were partially successful at improving the riparian vegetative buffer. Both projects had greater than 80 percent of the plantings survive since planting, however, all of the plantings at the Wheaton High School project were in poor health, likely due to deer activity or from the general stress of being planted. The Spruell Drive project was more successful, with a little more than half of the surviving plantings considered healthy. Re-caging or fencing the existing plantings may help allow the plants to establish and grow to a healthier size. Since the transplanting process is often stressful, additional time for these plantings to thrive may be necessary. These plantings had only been installed for two to three years when they were monitored in 2009. Botanical monitoring in 2011 and 2013 will determine if the riparian reforestation was successful at these sites or additional plantings with more aggressive deer protections are necessary.

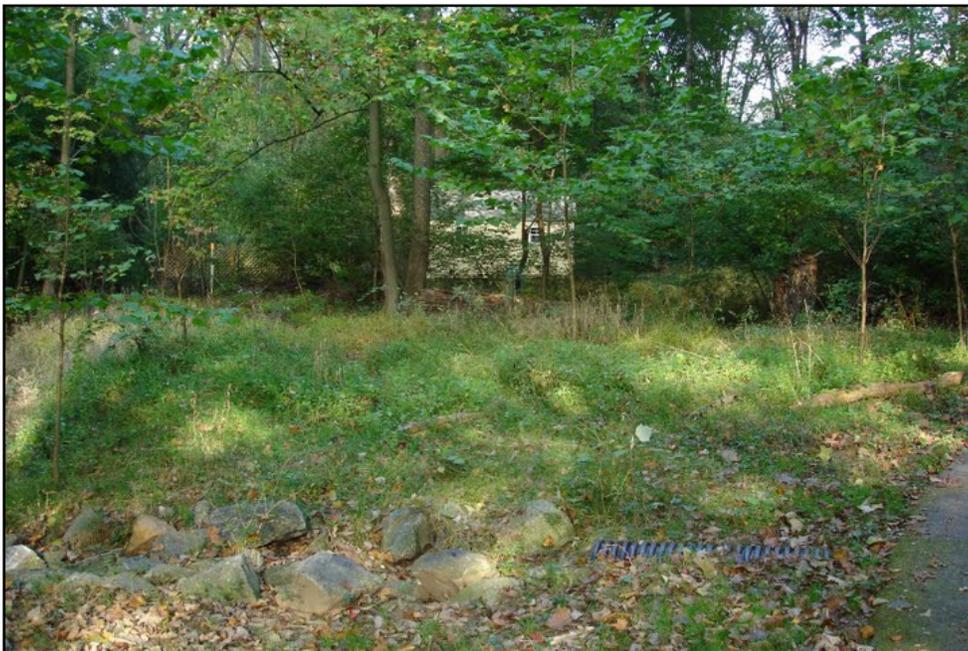
Overall, the reforestation at the Spruell Drive project (LRJB102) was more successful than it was at Wheaton High School (LRJB101). Eighty-eight percent of larger trees and 60 percent of the tubelings were observed in 2009. The condition of woody material was also better at this site; 52 percent of stems were considered healthy. The poorer health of plantings at LRJB101 may be due to deer activity that was apparent in the 2009 survey. Browsing and rubbing by deer was not as prevalent at LRJB102, but was affecting many of the plantings. Invasive plants, though present, did not appear to be causing significant damage to the planted trees and shrubs (***Figure 3.19.13***).

Figure 3.19.13 - Site LRJB102, Spruell Drive Project (2009), Picturing Small American Sycamore Plantings and Well Established Herbaceous Layer
