## 3.12 Sherwood Forest I Stream Restoration

### 3.12.1 Introduction

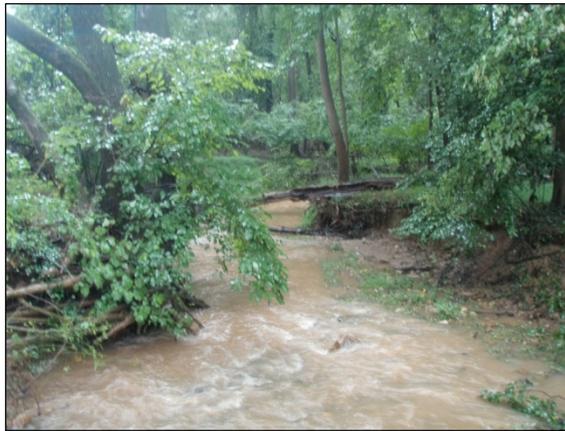
*Figure 3.12.2 – Sherwood Forest Tributary Picturing Storm Flow*

Much of the Northwest Branch Watershed was developed prior to regulations requiring stormwater management control, and the watershed contains a high percentage of impervious surfaces. Uncontrolled stormwater runoff from highly impervious areas creates erosive, high velocity or "flashy" flows (*Figure 3.12.2*) that cause damage to receiving streams. The Sherwood Forest tributary is characterized by eroded stream banks, unstable sand and gravel channel materials, bar formation (especially around present or former debris jams), low flow conditions, minimal access to floodplain and interaction with wetlands, and a general lack of in-stream cover for fish (*Figures 3.12.3 and 4*). While the Sherwood Forest I site does not currently exhibit serious degradation, there are opportunities, through careful repair and enhancement of habitat, to maintain and improve stream stability that would otherwise continue to deteriorate.

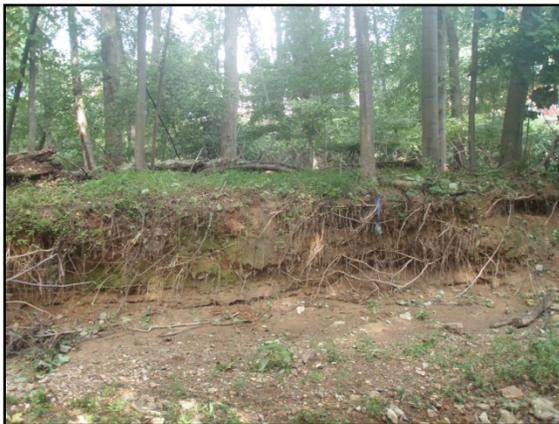
*Figure 3.12.3 – Sherwood Forest Tributary Picturing Eroded Streambank*

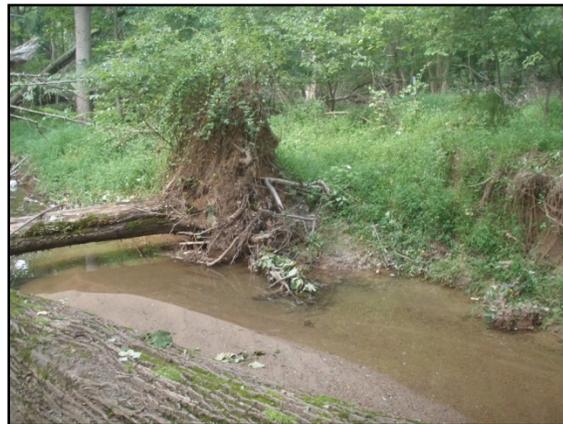
*Figure 3.12.4 – Sherwood Forest Tributary Picturing Eroded Streambank, Low Flow Conditions, and Unstable Sand*

3.12.6). Stone toe protection with plantings will help provide stream bank stability and shade for in-stream habitat. In-stream structures will include log and rock vanes that will direct water away from unstable stream banks, form downstream scour pools, and provide habitat for fish. Other planned stream habitat features include rock wing deflectors and riffle grade controls. Trees will be planted, and vernal pool wetlands (*Figure 3.12.4*) and floodplain access will be created to enhance the riparian zone alongside the stream.

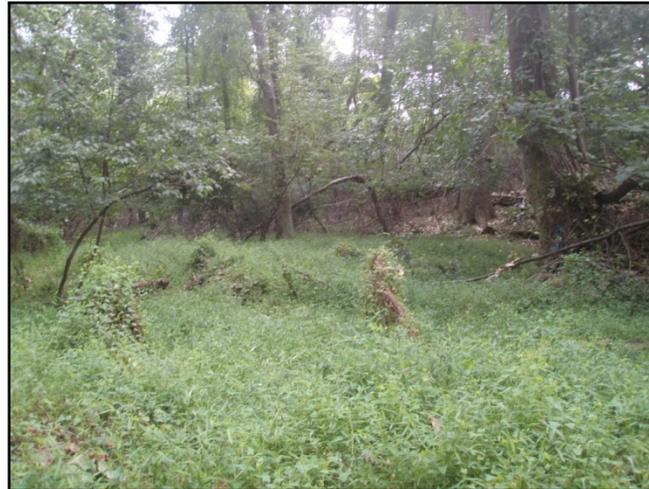
*Figure 3.12.5 –Proposed Wetland Creation Area Alongside the Sherwood Forest Tributary*

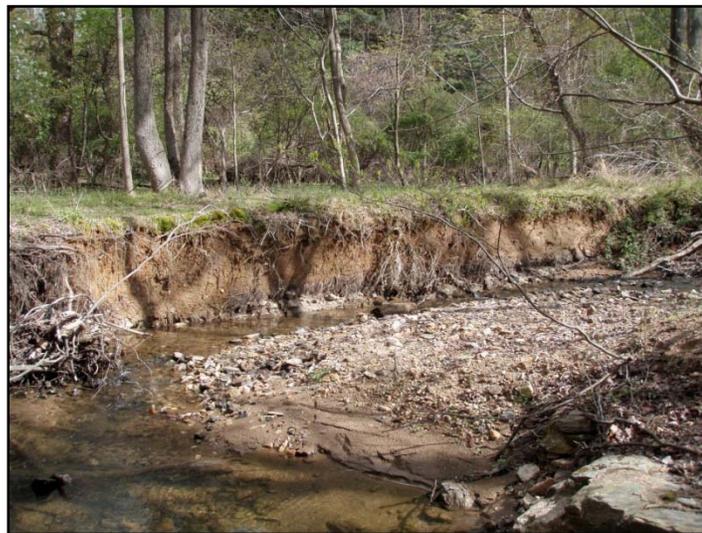
*Figure 3.12.14 – Site NWSF201 Picturing Bank Erosion (2009)*

Aquatic habitat was evaluated at NWSF201 in the spring and summer of 2004, 2006, and 2009 and was rated as Good, Good/Fair, or Fair (**Figure 3.12.12**). In-stream cover for fish and epifaunal substrates for benthic macroinvertebrates were generally considered suboptimal. Moderate sedimentation was documented at this site and embeddedness was also estimated as moderate (>50 percent). Bank stability on both banks was rated as moderately stable to unstable (**Figure 3.12.13**). Very little riparian vegetation was present at this site on the left bank due to the stream's proximity to maintained lawns (**Figure 3.12.14**).

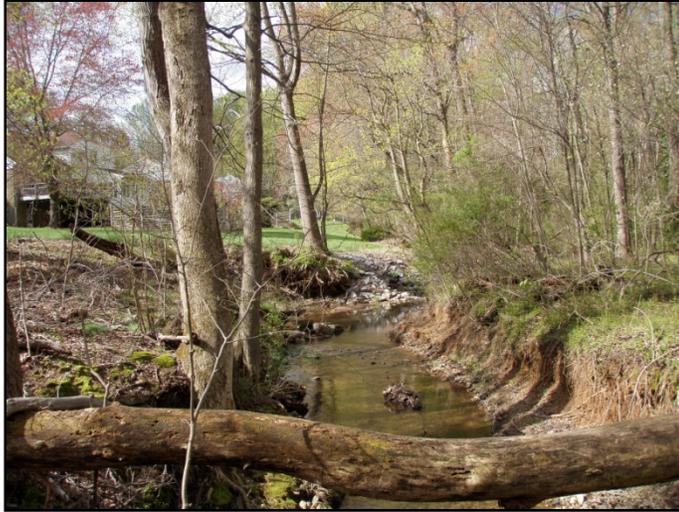
**Figure 3.12.15 – Site NWSF201 Picturing Limited Riparian Buffer (2009)**
