3.13 Woodlawn Stream Restoration

3.13.1 Introduction

Table 3.13.1 below presents the restoration goals, monitoring performed to characterize pre-restoration conditions, and when and where monitoring has occurred or is planned to occur following restoration. This is a pre-restoration monitoring report and summarizes the pre-restoration conditions within the Woodlawn Stream Restoration project area.

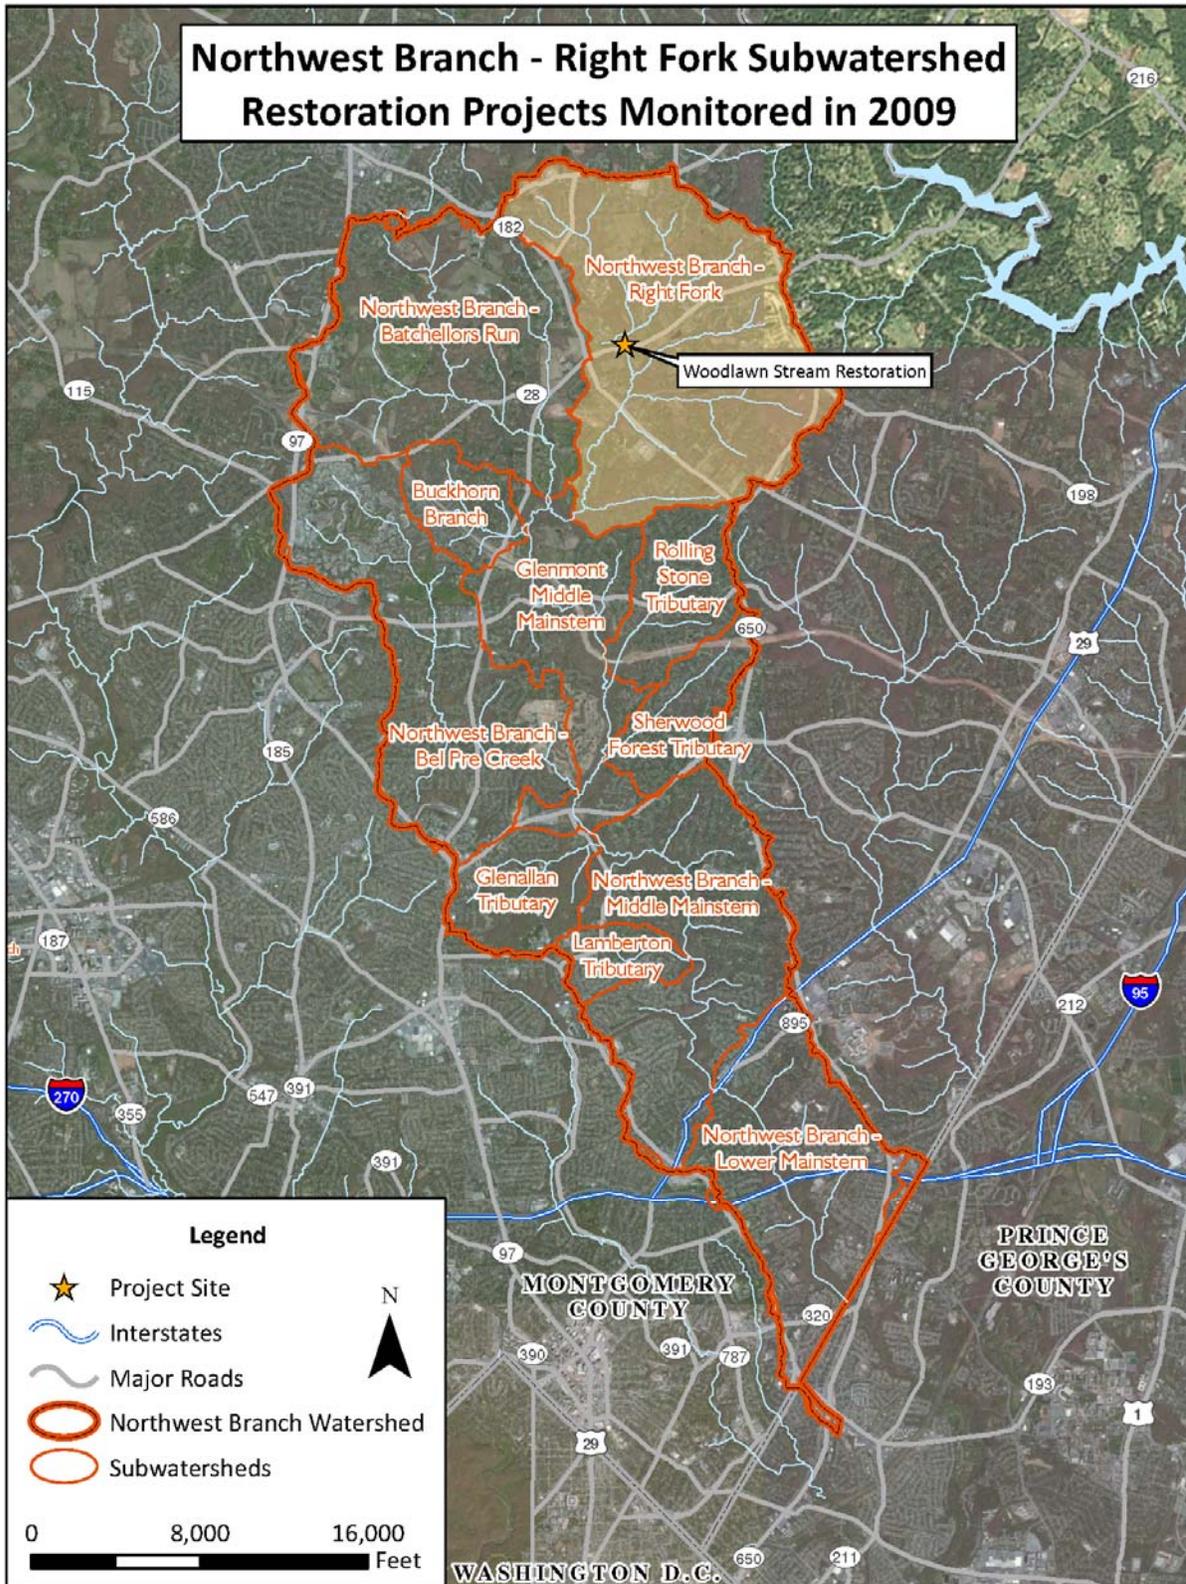
Figure 3.13.1 – Northwest Branch Right Fork Restoration Projects Monitored in 2009, Including Woodlawn Stream Restoration

The Right Fork of the Northwest Branch, (Woodlawn tributary), along with several other stream reaches, was identified as a priority for restoration in the Northwest Branch Watershed Feasibility Study (July 2000). The Montgomery County Department of Environmental Protection, in collaboration with the M-NCPPC and the USACE completed three stream restoration projects for Upper Northwest Branch Package 1 in 2011, which included Batchellors Run East, Upper Northwest Branch, and Bryants Nursery Run. Upper Northwest Branch Package 2 projects include Sherwood Forest I, Batchellors Run I & II, and Woodlawn stream restorations, which are planned to be completed from fall of 2012 to the summer of 2013 (**Figure 3.13.1**).

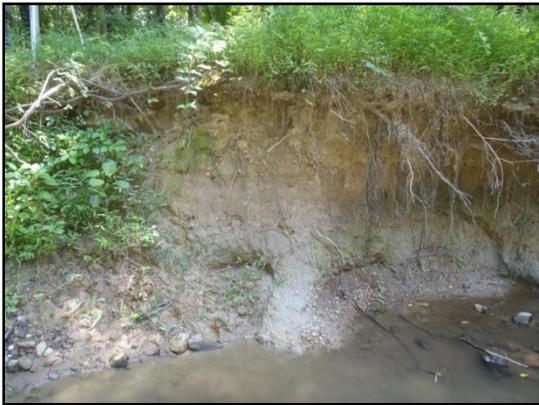
The Woodlawn tributary is characterized by eroded stream banks, aggraded channel materials, side channel bar formation (especially around present or former debris jams), low flow conditions, minimal access to its floodplain, and limited interaction with wetlands, and a general lack of in-stream cover for fish (*Figures 3.13.2 – 3.13.4*). The site is generally well forested with adequate canopy cover.

Figure 3.13.2 – Severe Streambank Erosion Prior to Restoration

Entrance to the site for construction is anticipated from Ednor Road and Alexander Manor Drive. Restoration activities are planned for approximately 2,000 feet of stream north of the Ednor Road crossing. Stone toe protection with plantings will help provide stream bank stability and shade for in-stream habitat. In-stream structures will include log and rock vanes that will direct water away from unstable stream banks, form downstream scour pools, and provide habitat for fish. Other planned stream habitat features include rock wing deflectors and riffle grade controls. Trees will be planted, and vernal pool wetlands and floodplain access will be created to enhance the riparian zone alongside the stream.

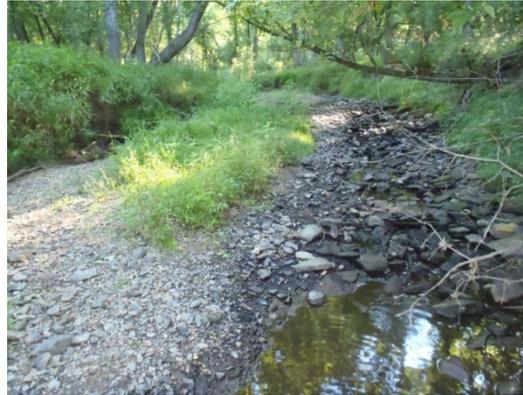
Figure 3.13.3 – Example of Overwidened and Low Flow Conditions in Woodlawn Tributary

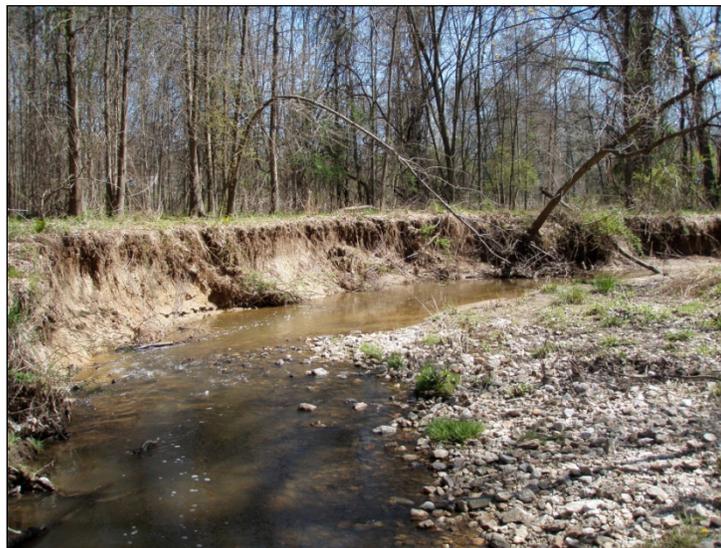
Figure 13.3.4 – Proposed Woodlawn Stream Restoration site, Picturing Erosion and Lack of In-stream Cover for Fish

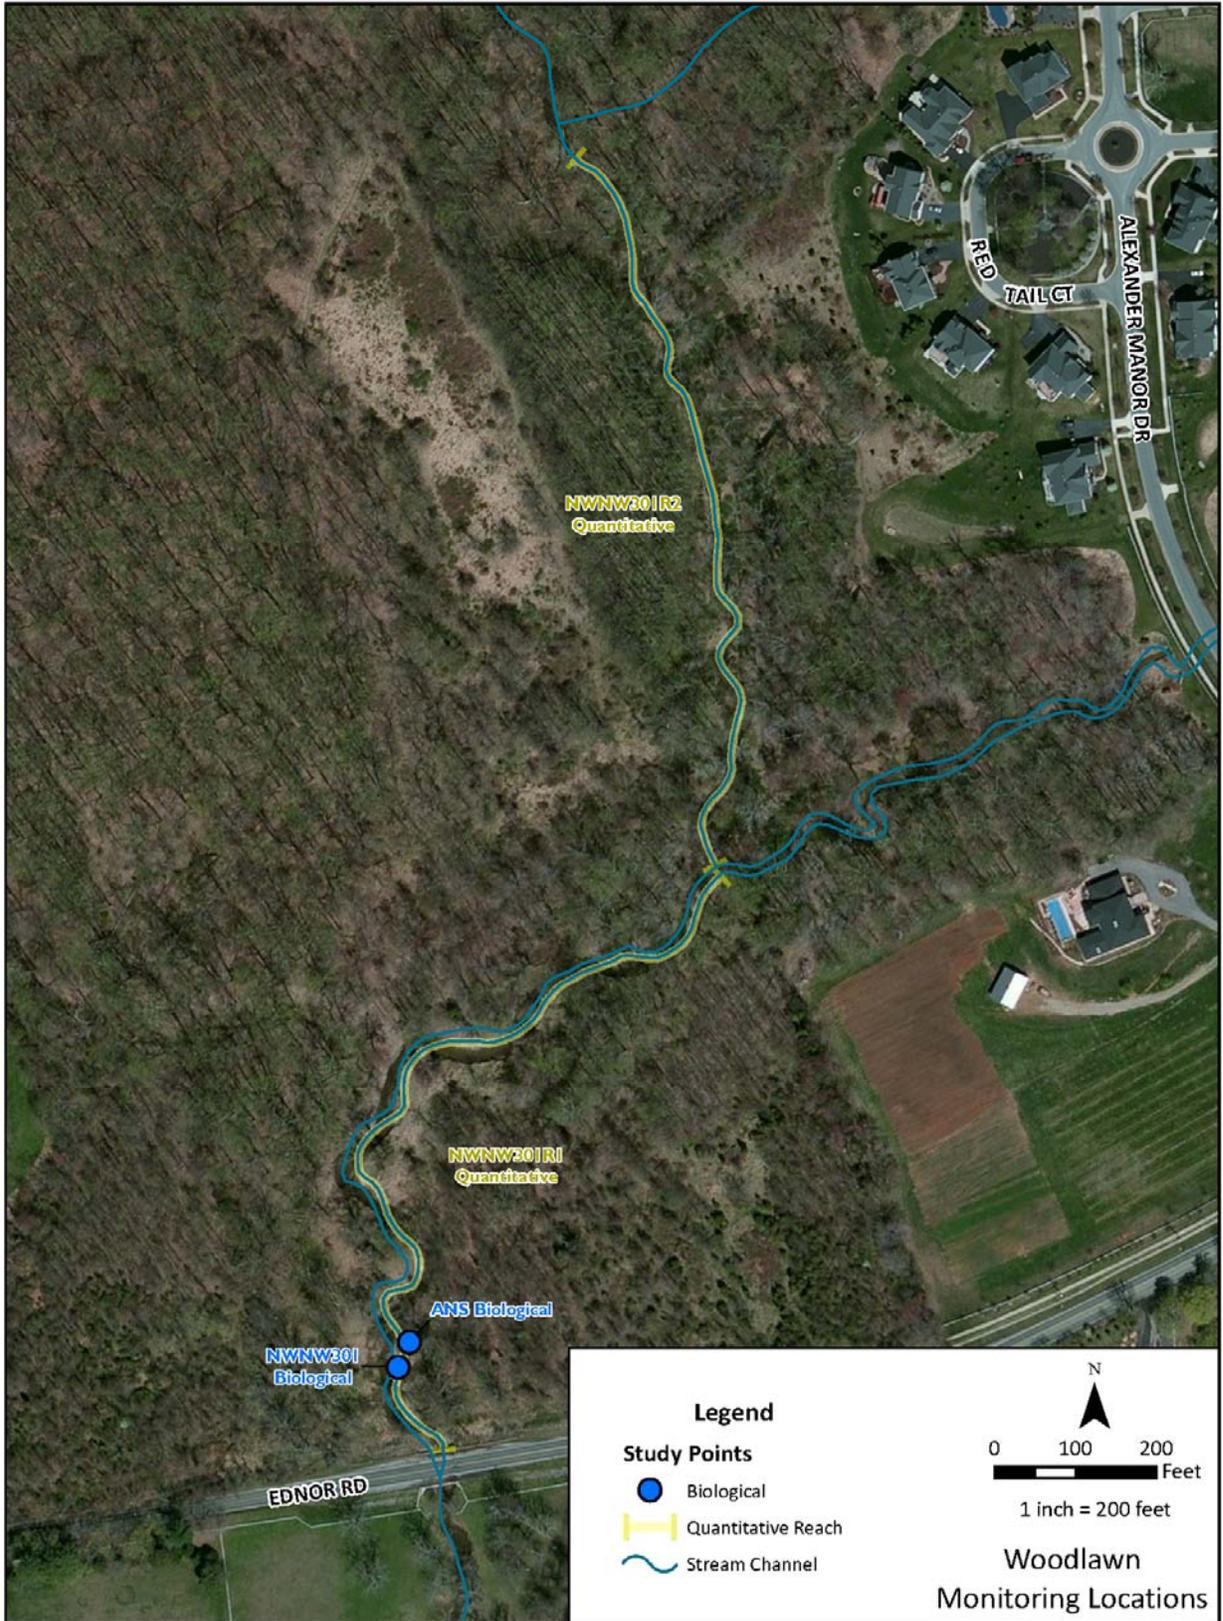
Figure 3.13.5 – Map of 2009 Monitoring Locations at the Woodlawn Restoration Site. The Quantitative Reaches Correspond with the Extent of Proposed Stream Restoration

The basic sampling design for the Woodlawn Stream Restoration project is pre-restoration (before) and post-restoration (after) monitoring. The County monitored the biological communities (benthic macroinvertebrates and fish), performed rapid habitat assessments (RHAB), and took in-situ water chemistry measurements at one biological monitoring site (NWNW301) to evaluate the aquatic habitat conditions and water quality during the pre-restoration period. The County also performed a quantitative survey for the entire project length, but this work was postponed until 2011 due to missing benchmarks. Post-restoration wetland and botanical surveys are planned once the wetlands are created and trees are planted. If the project is completed as planned in the summer of 2013, all data collected prior to 2013 will be considered pre-restoration data and all subsequent data will be considered post-restoration. Pre-restoration monitoring was performed in 2001, 2002, 2004, and 2009 at the NWNW301 site within the proposed project limits (*Figure 13.3.5*). Post-restoration monitoring is planned for at least years one, three, and five after restoration.

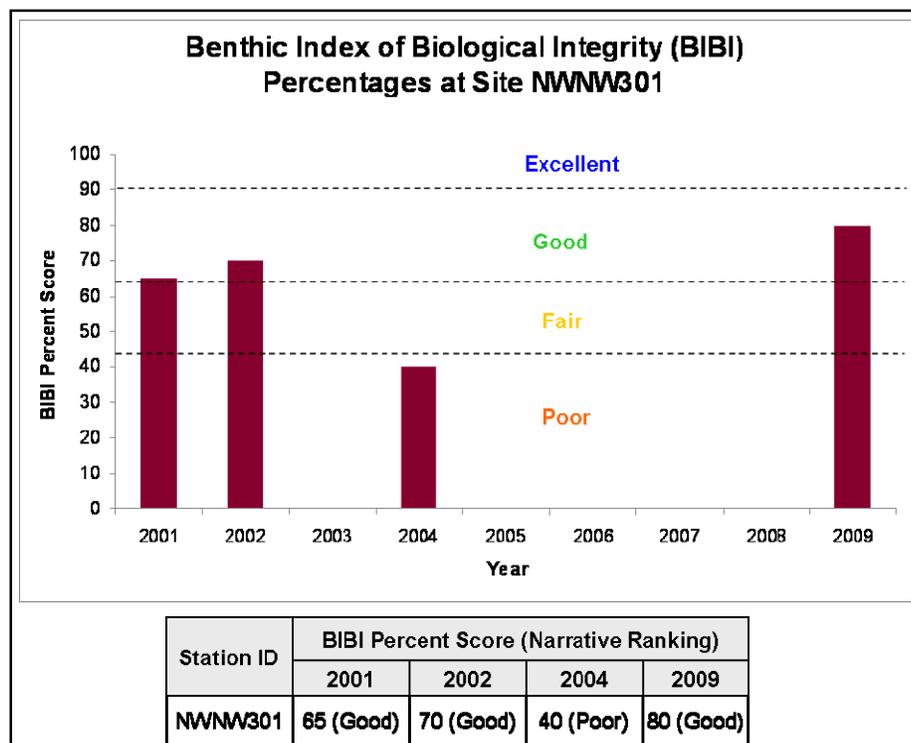
Pre-restoration benthic macroinvertebrate assessments were conducted at site NWNW301 in 2001, 2002, 2004, and 2009. This site was rated by the Benthic Index of Biological Integrity (BIBI) as Good in 2001, 2002, and 2009, and Poor in 2004 (**Figure 3.13.6**). In all years, the benthic community was dominated by Chironomidae (midges), however, in 2001, 2002, and 2009, the community was more diverse and had other more sensitive taxa and specialized feeders as sub-dominants. The decline in BIBI score in 2004 was generally due to an increase in the proportion of dominant taxa, a decline in the number of Ephemeroptera (mayfly), Plecoptera (stonefly), and Trichoptera (caddisfly) taxa, collectively referred to as EPT, and a decrease in the proportion of EPT individuals. Field data sheets completed in 2009 for this task are included in *Appendix D*.

Figure 3.13.6 – Pre - Restoration Benthic Index of Biological Integrity (BIBI) Percentages at NWNW301

The pre-restoration benthic macroinvertebrate community at NWNW301 was consistently rated as Good in all years, except in 2002 when it was rated as Poor. In all years, the community was dominated by midges but was more diverse in the higher scoring years. Individuals tolerant to stressors were most abundant at NWNW301; however, sensitive individuals were also present at this site, comprising 22 percent of the community prior to restoration. The fish community was rated by the FIBI as Fair in all years, except in 2009 when it improved to the Good range. Blacknose dace, a tolerant fish species, was consistently the most dominant fish species collected at this site. Omnivores were the most dominant fish functional feeding group, but invertivores and insectivores, feeding groups that are considered as specialists, made up 20 percent of the community. No fish considered sensitive to disturbance were collected at this site. Aquatic habitat was generally rated as Good at NWNW301, but was rated as Excellent in spring of 2002 and Fair in the spring of 2004. However, scores generally declined overtime, with habitats for benthic macroinvertebrates and fish showing the clearest declines in the later years. Streambanks at this site were moderately unstable to unstable and sediment deposition was moderate. All in-situ water chemistry readings were in compliance with COMAR standards for this Use IV stream.

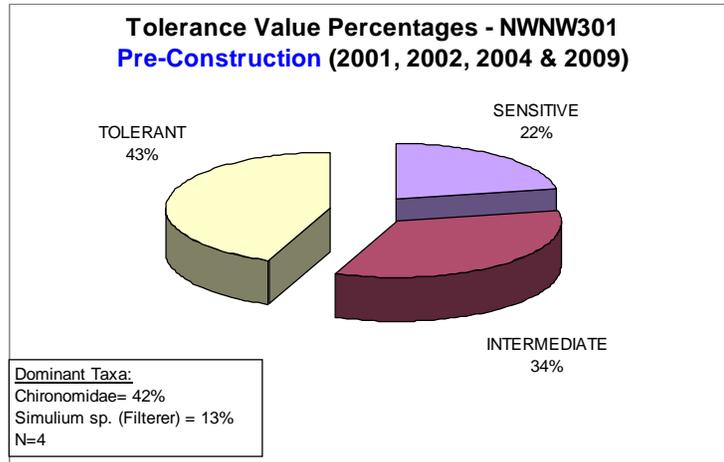
Midges dominated the benthic macroinvertebrate community at NWNW301 during the pre-restoration period (**Figure 3.13.7**). Midges are considered tolerant to urbanization. A genus of black fly larva (*Simulium sp.*) was second most dominant, and is considered intermediate in sensitivity. Tolerant individuals were dominant (43 percent) at NWNW301 prior to restoration, individuals intermediate to sensitivity were second most dominant (34 percent), and sensitive individuals were least abundant (22 percent).

Figure 3.13.7 – Benthic Macroinvertebrate Tolerance Composition and Dominance at NWNW301

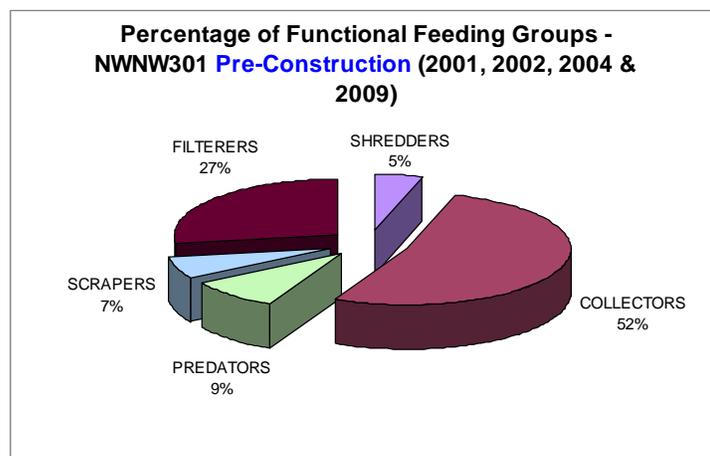
Collectors and filterers were the most dominant feeding groups at NWNW301 comprising 77 percent of the community (**Figure 3.13.8**). These two groups are considered generalist feeders and can inhabit more degraded streams. More specialized feeders, including scrapers and shredders, comprised a total of 12 percent of the community in the pre-restoration period.

Figure 3.13.8 – Benthic Macroinvertebrate Functional Feeding Group Composition at NWNW301

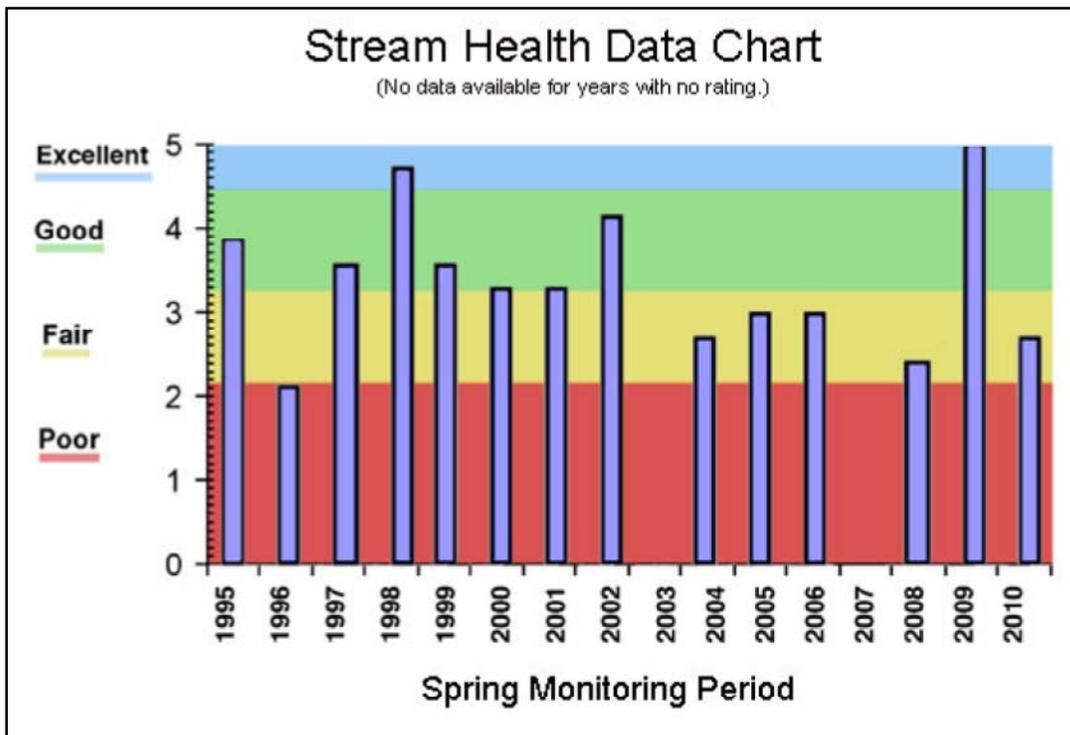
Benthic macroinvertebrates were sampled by ANS volunteers nearby the County site, NWNW301, pre-restoration from 1995 to 2010. Despite differences in collection and identification procedures, ANS data is used in a similar way to MCDEP to represent stream conditions. Reported conditions range from Poor to Excellent, with an average score of Good (3.3) and most consistently reported as Good/Fair (Figure 3.13.X). The scores appear to be more consistently Good prior to 2003, and are reported more consistently as Fair after 2003, (with the exception of 2009 where the score was excellent). Coincidentally, the neighborhood just upstream of the site, along Alexander Manor Drive, was built 2001-2002.

Figure 3.13.9 – Audubon Naturalist Society (ANS) Benthic Macroinvertebrate Community Health Ratings, Pre-Restoration 1995-2010. Results were retrieved from ANS website at <http://www.audubonnaturalist.org/index.php/nature-programs/water-quality-monitoring>.

The Audubon Naturalist Society (ANS) also has monitored for benthic macroinvertebrates from 1995-2012 at the same site (NWNW301) as well as another site approximately 1,000 feet upstream from the proposed restoration limits. ANS uses slightly different sampling methodology from DEP, and only identifies benthic macroinvertebrates in the field to the family level (DEP identifies to genus). Even though ANS data cannot be directly compared to DEP data, the data is similarly converted into stream condition scores and are included in this report for reference (*Figure 3.13.9*).

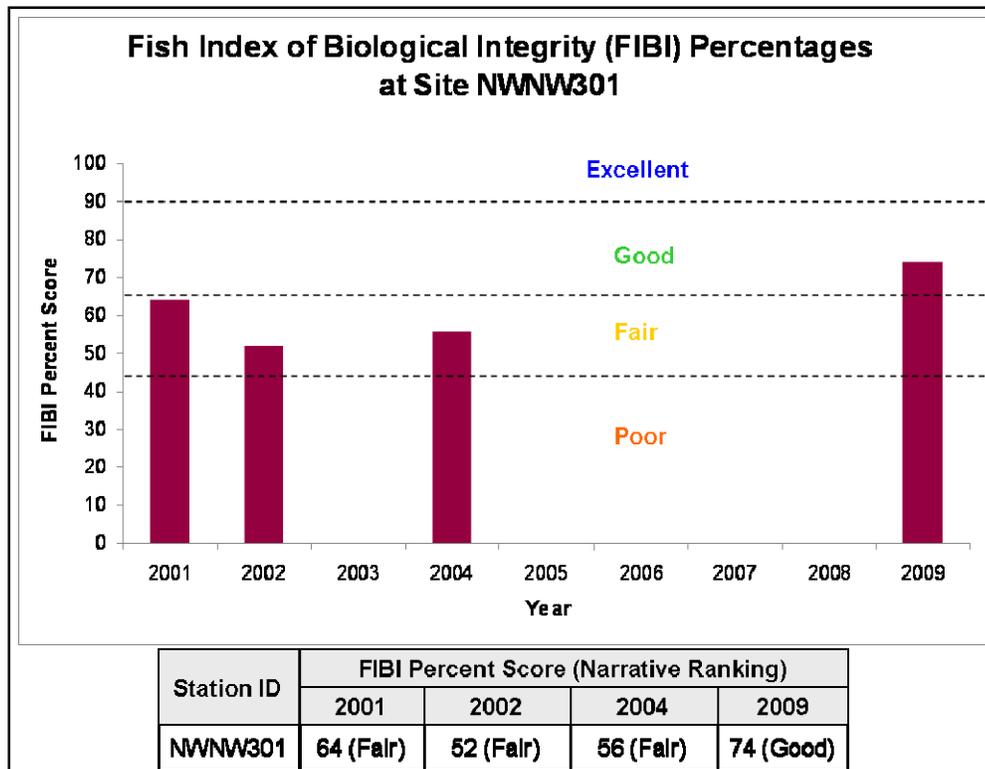
Pre-restoration benthic macroinvertebrate assessments were conducted at site NWNW301 in 2001, 2002, 2004, and 2009. This site was rated by the Fish Index of Biological Integrity (FIBI) as Fair in 2001, 2002, and 2004, and Good in 2009 (**Figure 3.13.10**). In all years, the total number of fish species and number of minnow species were in the high range and the number of intolerant fish species metric was in the low range. The increase in FIBI over time was generally due to a decline in the proportion of tolerant individuals and an increase in the total number of individuals. Field data sheets from the 2009 fish monitoring are included in **Appendix D**.

Figure 3.13.10 – Pre - Restoration Fish Index of Biological Integrity (FIBI) Percentages at NWNW301

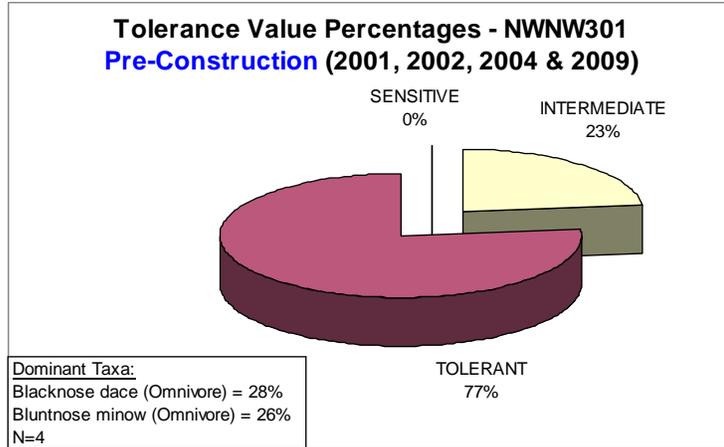
In all years, the fish community was dominated by *Rhinichthys atratulus* (blacknose dace). Blacknose dace are considered tolerant to degraded stream conditions (**Figure 3.13.11**). Tolerant species were consistently dominant at this site, comprising 77 percent of the community. Several other species tolerant to degraded stream conditions were collected at this site including, *Pimephales notatus* (bluntnose minnow), which was the second most dominant fish species, *Catostomus commersoni* (white sucker), *Notropis procne* (swallowtail shiner), and *Etheostoma olmstedti* (tessellated darter). Species intermediate in sensitivity made up 23 percent of the fish community, with the most abundant species including, *Etheostoma flabellare* (fantail dater), *Clinostomus funduloides* (rosyside dace), and *Notropis buccatus* (silverjaw minnow). Species considered sensitive to stream degradation were not collected at this site.

Figure 3.13.11 – Fish Tolerance Composition and Species Dominance at NWNW301 Prior to Restoration

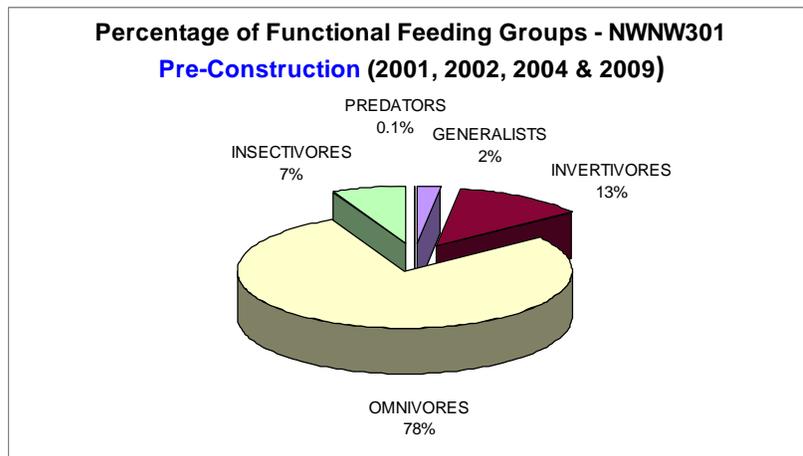
Omnivores were the most dominant feeding group (78 percent) present at NWNW301 and were represented by several species of minnows including blacknose dace, bluntnose minnow, *Rhinichthys cataractae* (longnose dace), and *Notropis buccatus* (silverjaw minnow) (**Figure 3.13.12**). Invertivores were second most dominant (13 percent) and were represented by *Etheostoma olmstedti* (tessellated darter), rosyside dace, and a few other less dominant species, including several species of *Lepomis* sp. (sunfish). Insectivores were the third most dominant (7 percent) feeding group, solely represented by fantail darter.

Figure 3.13.12 – Fish Functional Feeding Group Composition at NWNW301 Prior to Restoration

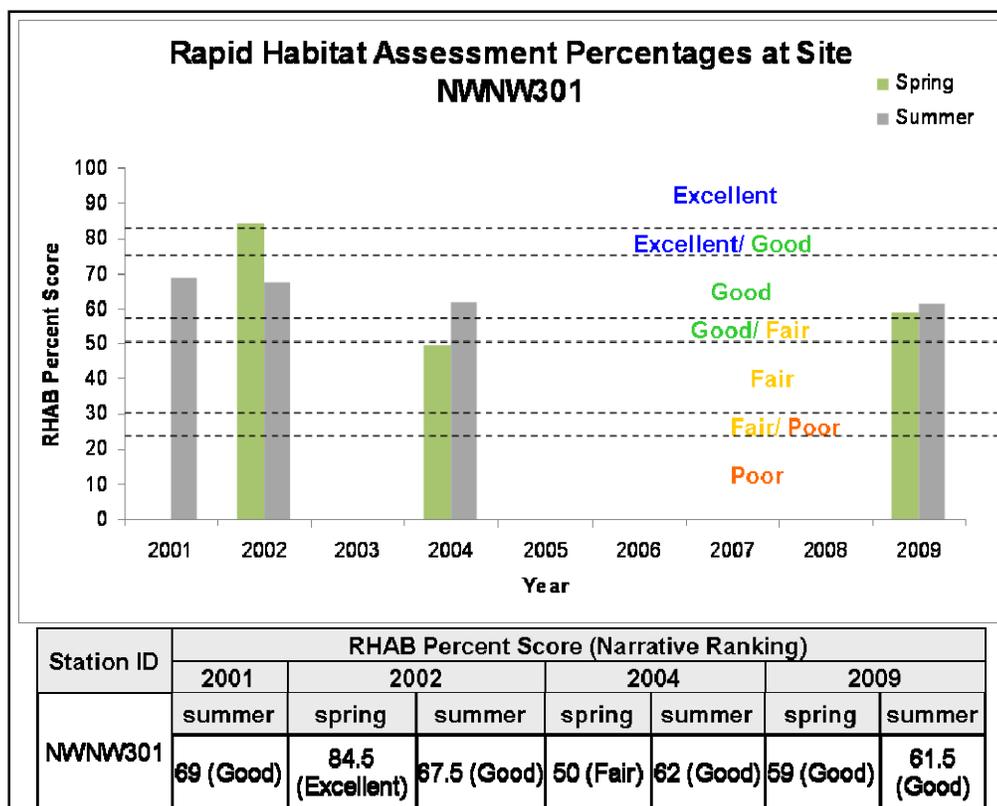
Aquatic habitat was evaluated at NWNW301 in the summer of 2001 and the spring and summer of 2002, 2004, and 2009. With the exception of the assessments done in the spring of 2002 and 2004, which were rated as Excellent and Fair, respectively, RHAB scores were otherwise consistently rated as Good (**Figure 3.13.13**). Instream habitat for fish and epifaunal substrates for benthic macroinvertebrates were rated higher in 2001 and 2002, with ratings in the

suboptimal/optimal categories. In 2004 and 2009, these individual metrics were rated as marginal/suboptimal. Moderate sediment deposition was observed in all years. Streambanks at this site were assessed as being moderately unstable to unstable, but the riparian zone was generally unimpaired by human activities.

Figure 3.13.13 – Rapid Habitat Assessment (RHAB) Percentages at NWNW301
