Lake Whetstone Dredging Project and Sediment Testing

Public Meeting December 13, 2011

Montgomery County
Department of Environmental Protection

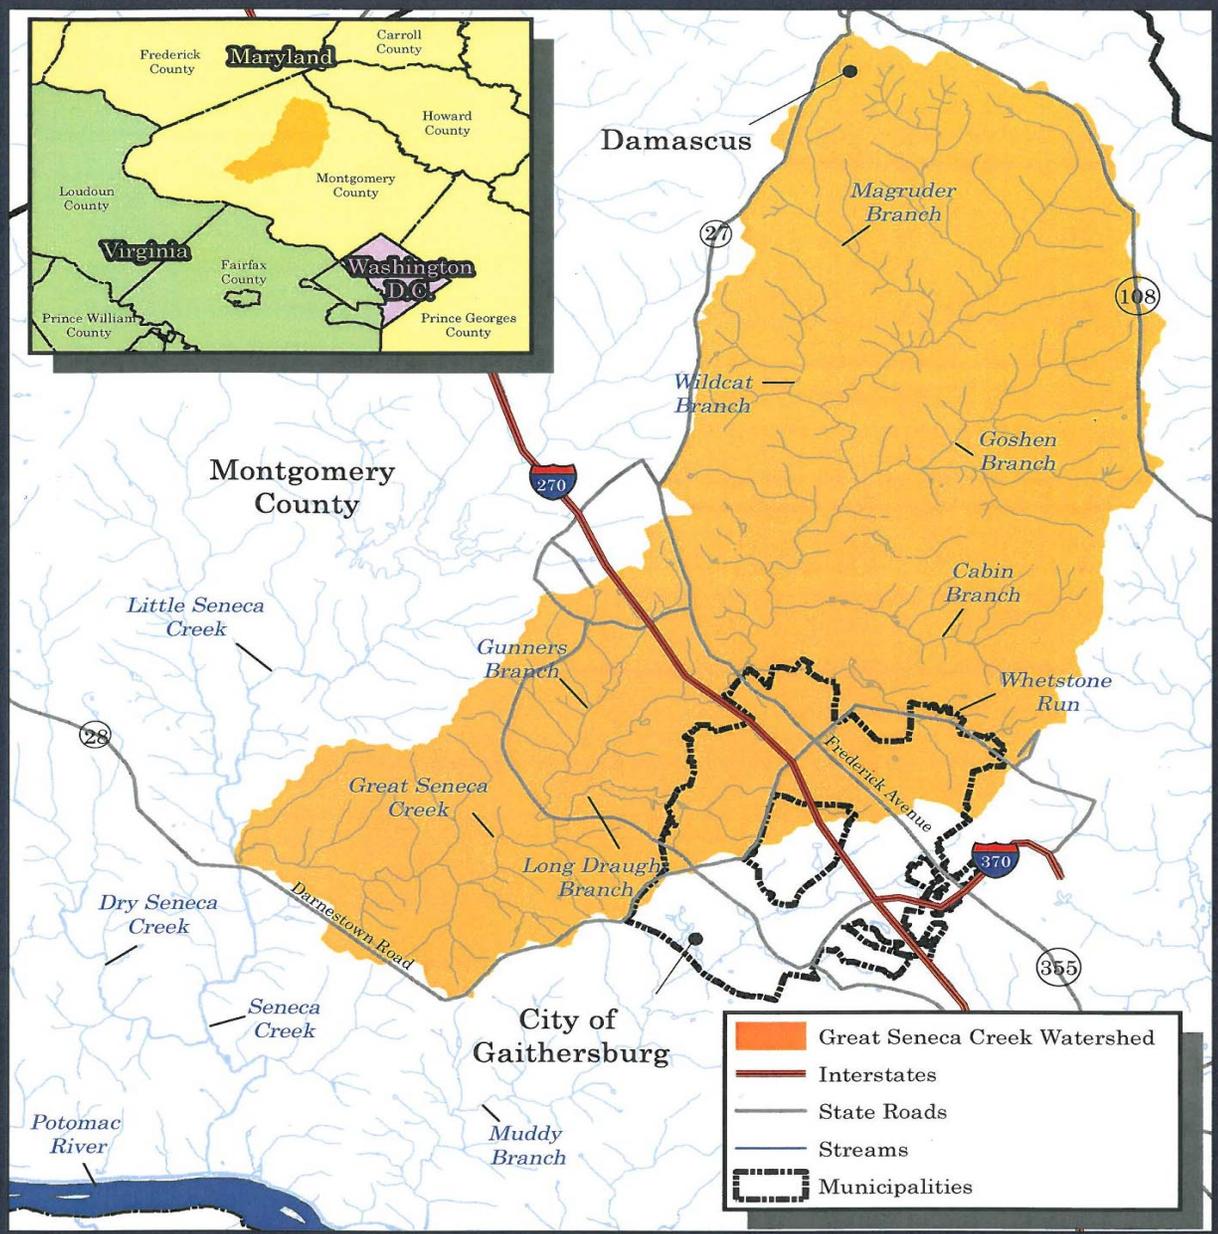
Figure 1.1
Study Area-
Great Seneca Creek Watershed

Great Seneca Creek Watershed

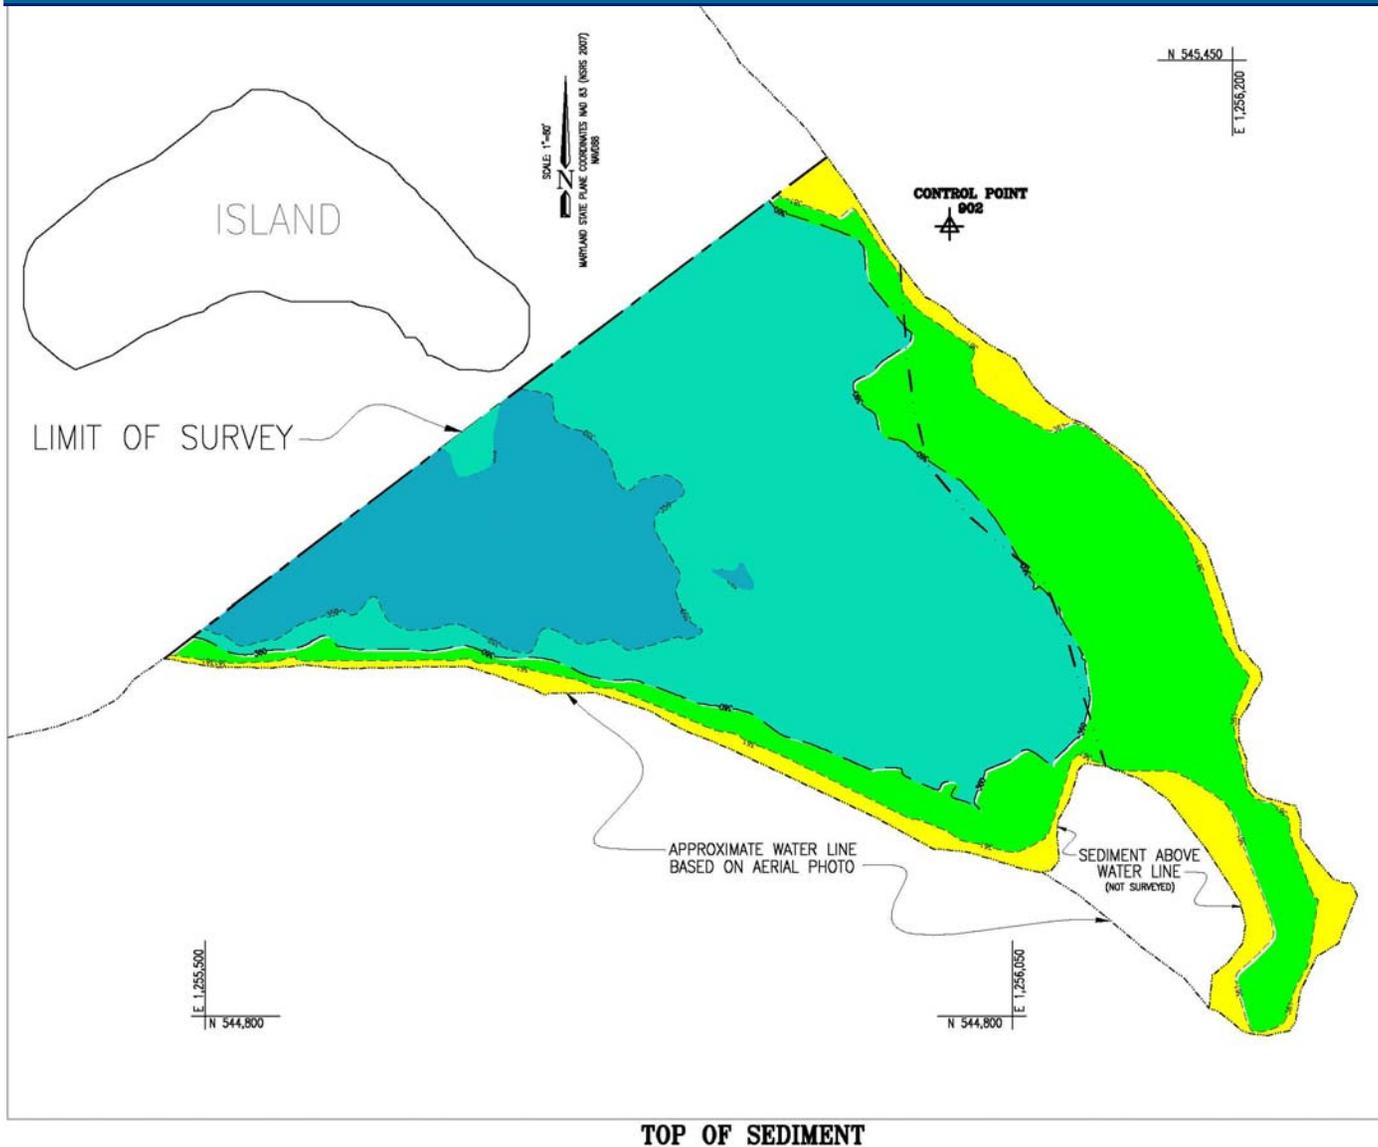
Bathymetric Survey:

- Bathymetric survey performed to evaluate the sediment levels
- Survey of forebay/inflow from Whetstone Run
- Approximately 4 acres
- Results:
 - No more than 10,500 C.Y.
 - 4% total lake volume

WATER SURFACE (WSEL) = 361.64

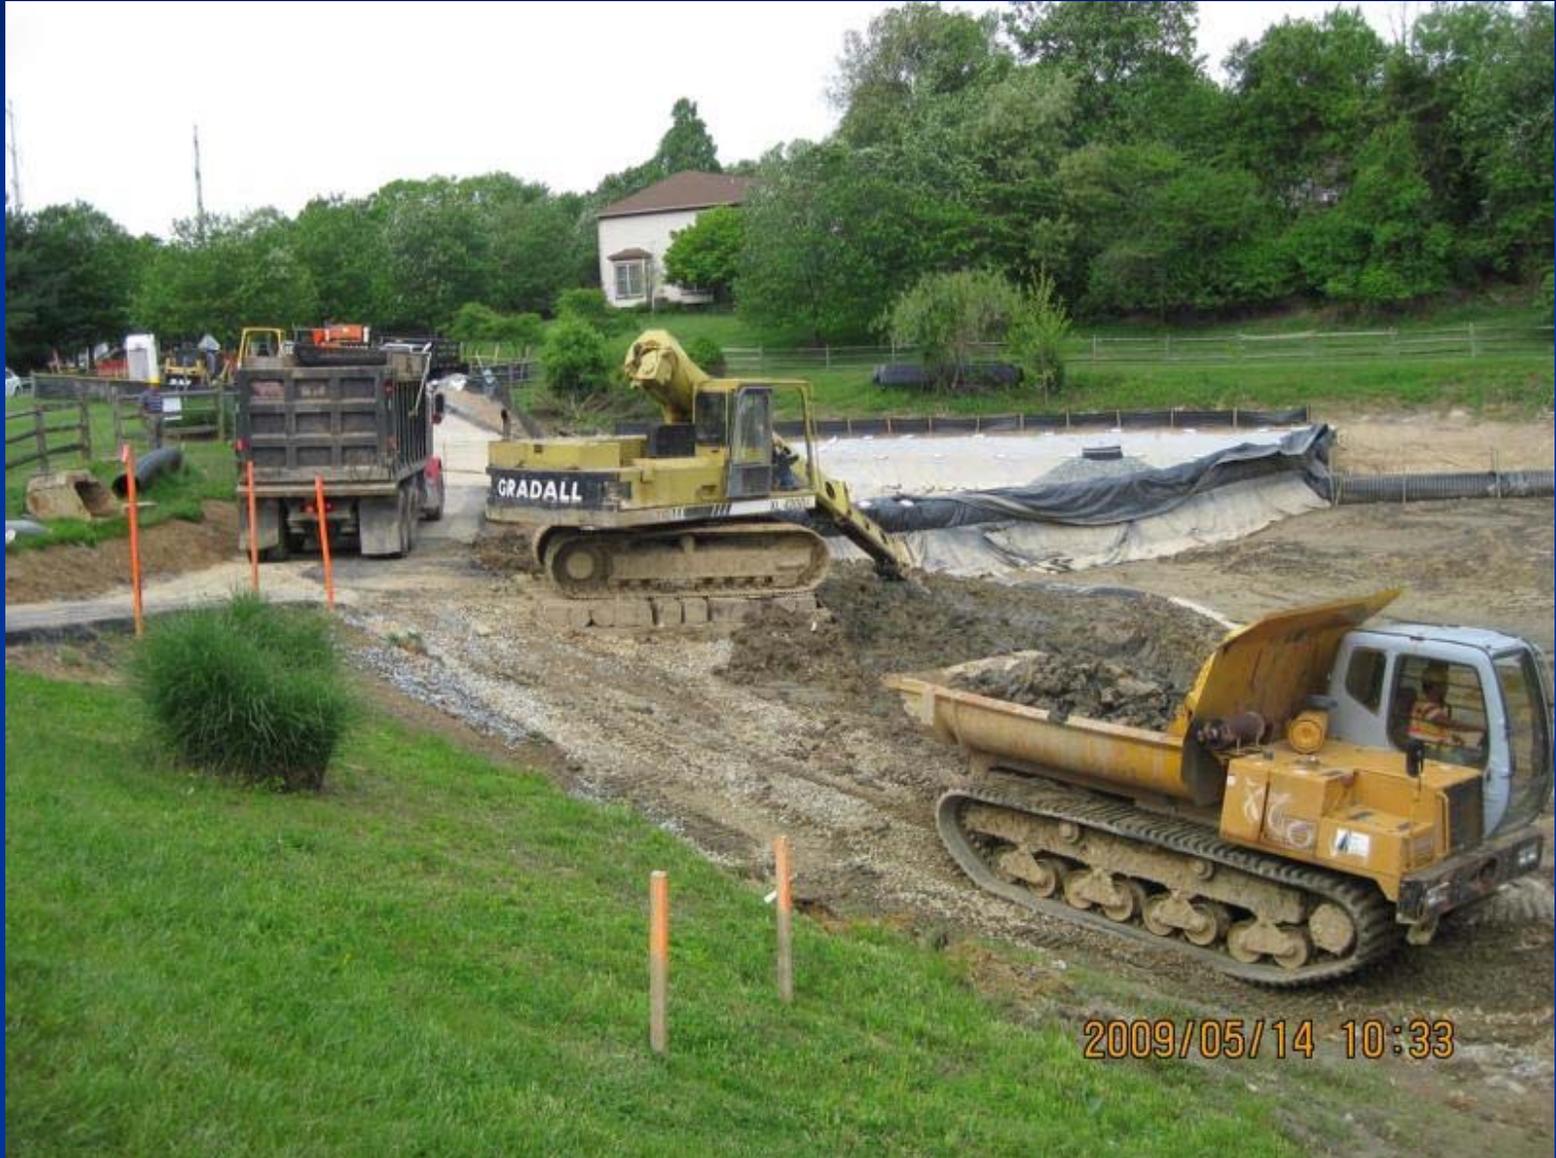
Mechanical Dredging:

- Mechanical Dredging
 - divert stream
 - Isolate dredging area with a berm or dike
 - Dewater dredging area
 - Use hydraulic excavator or clam shell to remove sediments.
 - Stock pile to dry out sediment
- Boat dock parking lot for staging
- Access lake from foot path

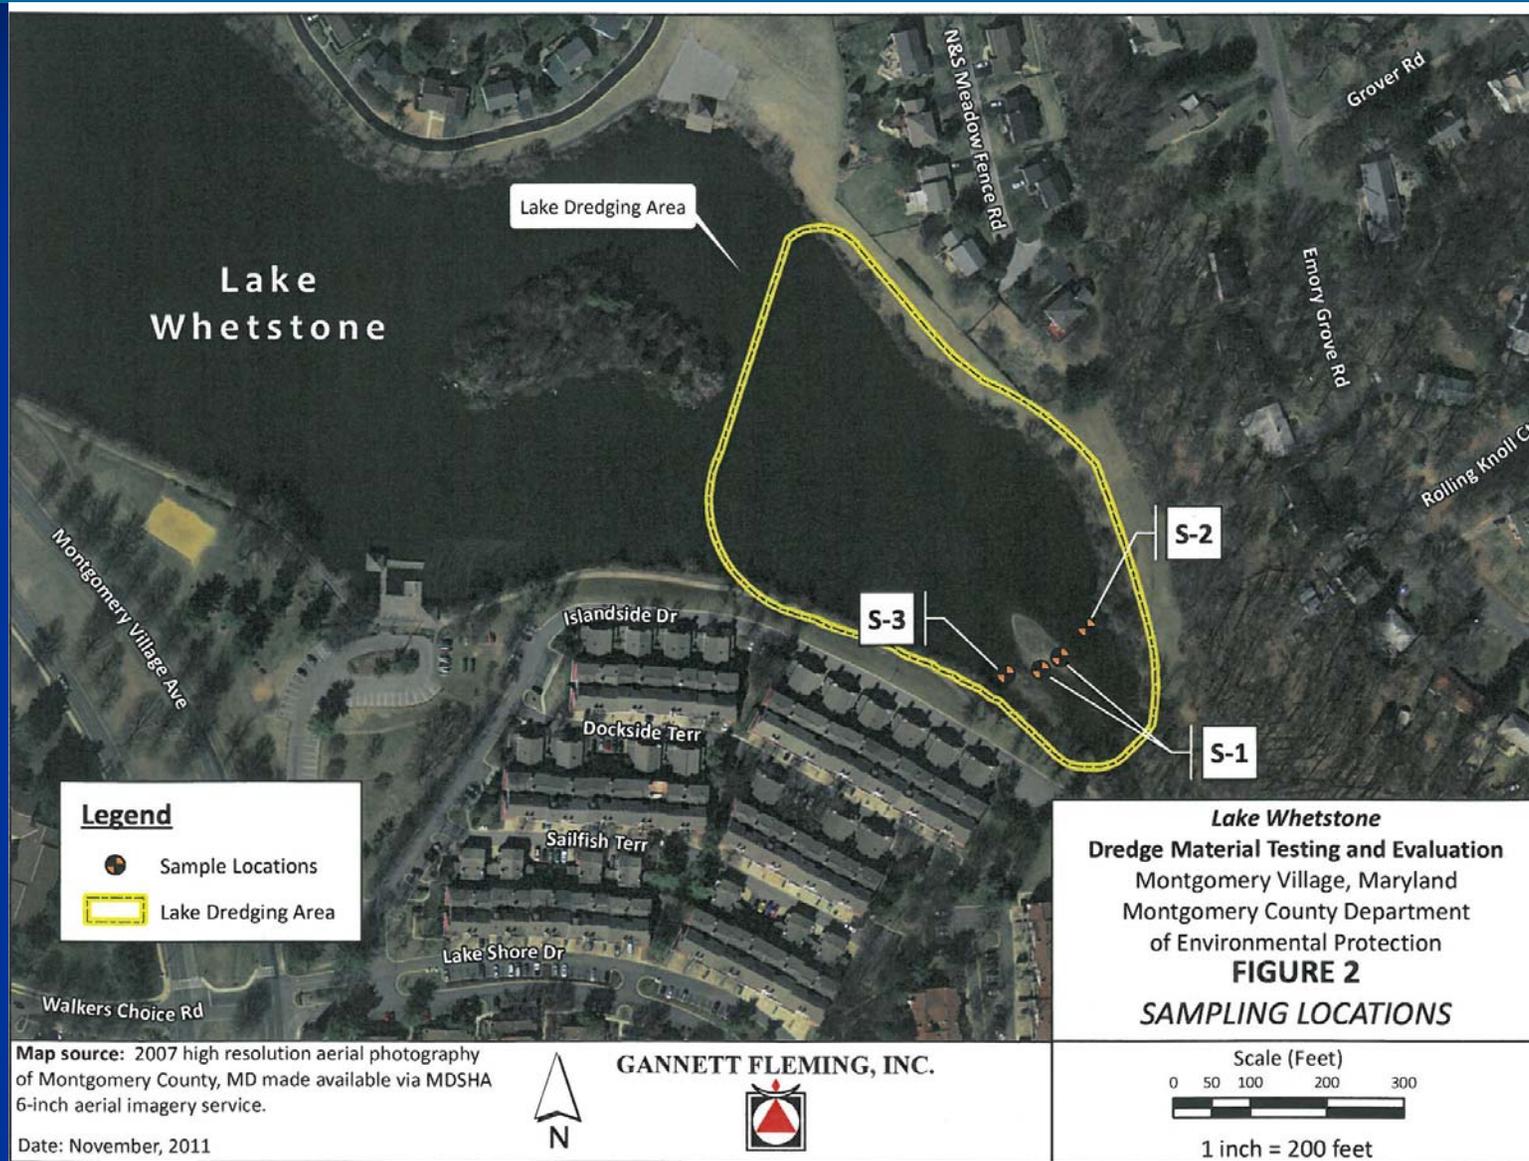
Sampling Locations S1 to S3

- Three (3) samples taken from lake.
- One (1) background sample from ball field
at Apple Ridge Road & Montgomery Village
Ave.

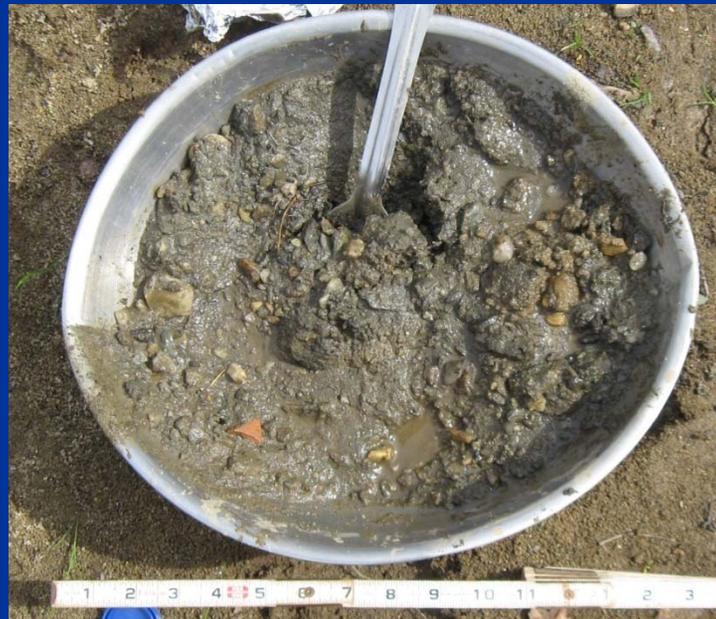
- Samples results vary from poorly graded sand with gravel to sandy silt.

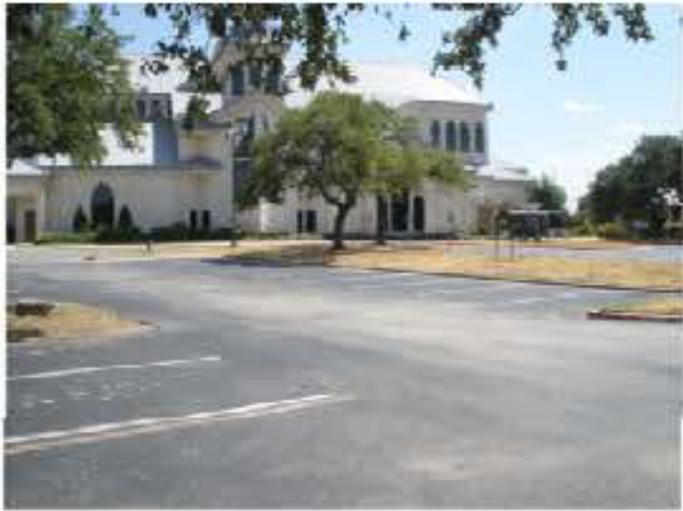
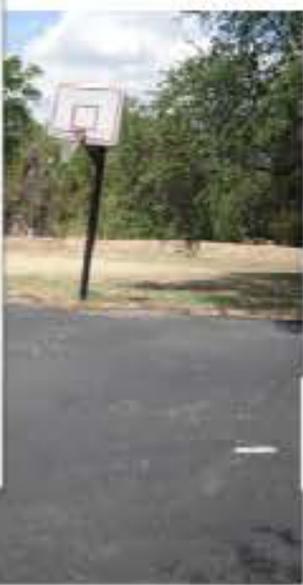
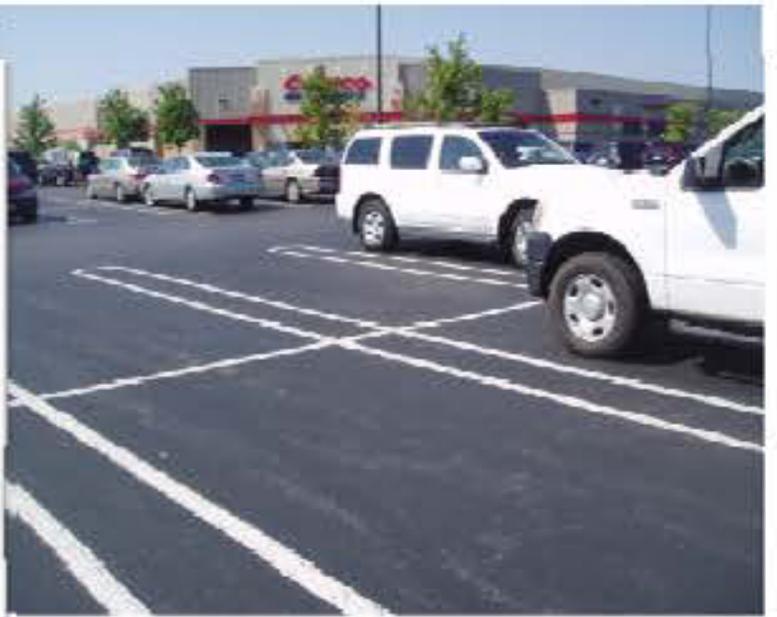
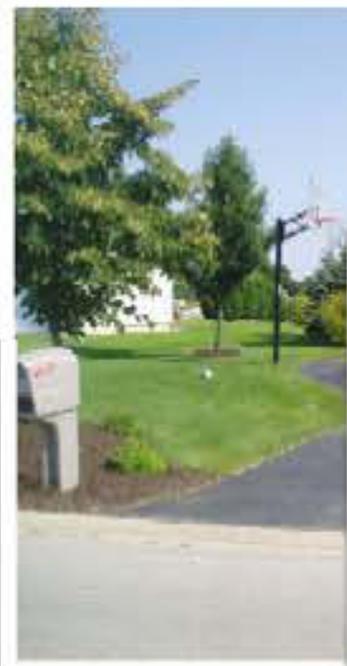
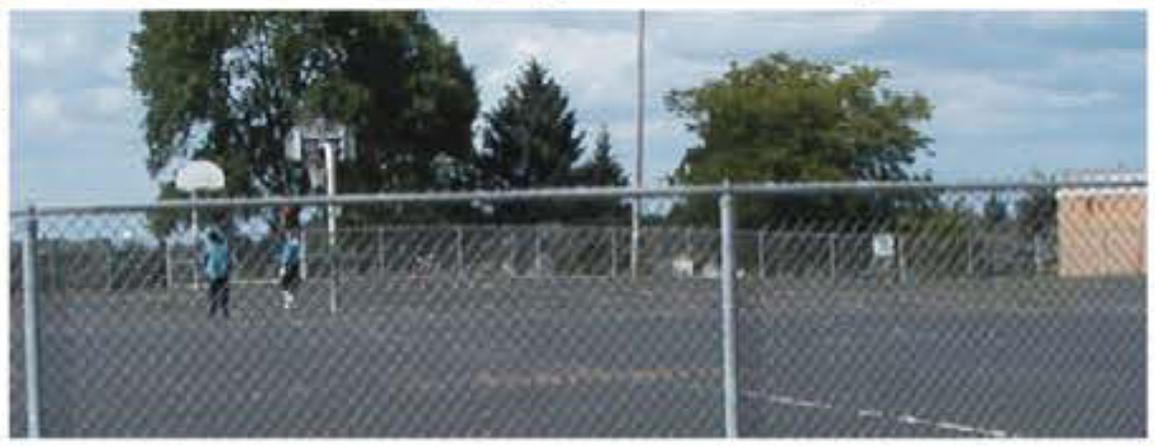
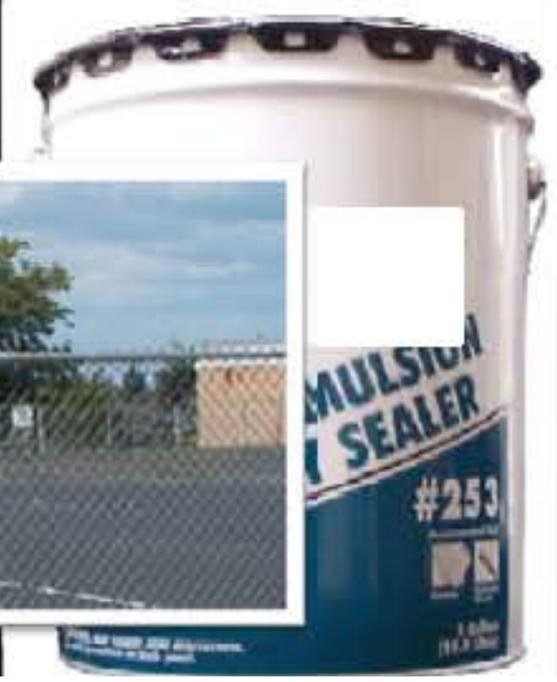
What could be the source?
1,500 mg/kg in creek sediment

• Fresh asphalt	1.5	Pavement
• Weathered asphalt	3	Sealcoat
• Fresh motor oil	4	
• Brake particles	16	Asphalt-based
• Road dust	24	50
• Tire-wear particles	86	
• Diesel engine emissions	102	Coal-tar-based
• Gasoline engine emissions	370	100,000
• Used motor oil	440

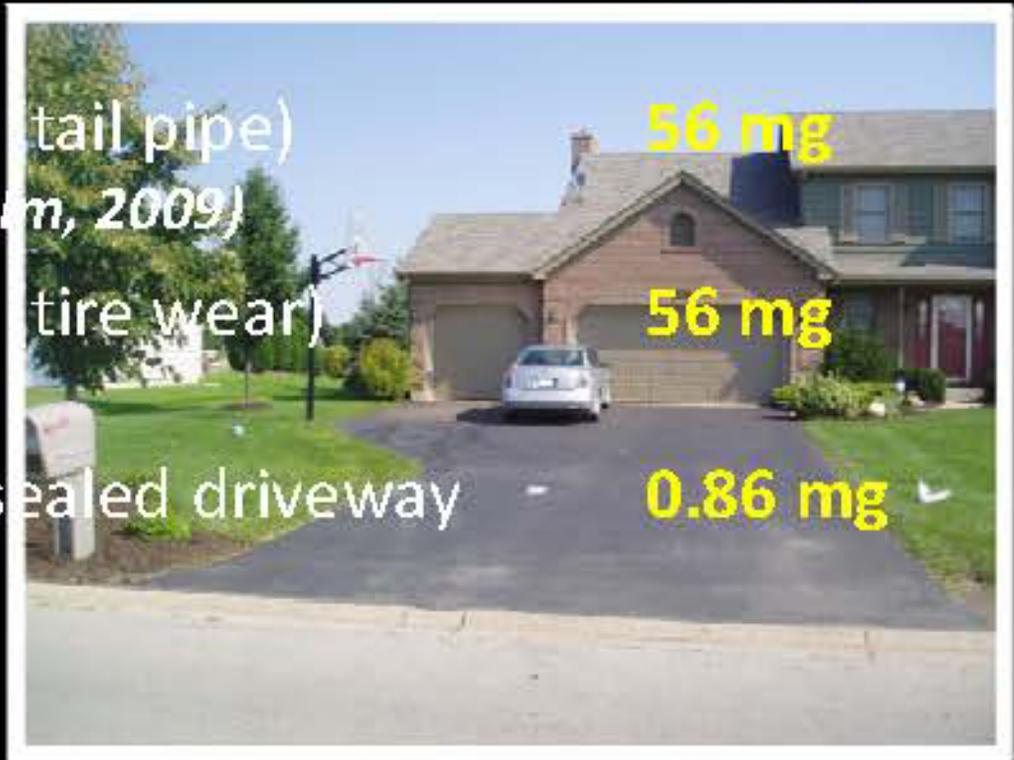
How do some sources compare? Milligrams of PAH in:

- One storm on a CT sealed driveway **56 mg**
(Mahler et al., 2005)
- One storm on a CT sealed driveway **174 mg**
(Watts et al., 2011)
- Driving 12,000 miles (tail pipe) **56 mg**
(Bergvall and Westerholm, 2009)
- Driving 23,000 miles (tire wear) **56 mg**
(Aatmeeyata, 2010)
- One storm on an unsealed driveway **0.86 mg**
(Mahler et al., 2005)
