# Annual Report for FY11 NPDES Municipal Separate Storm Sewer System Permit

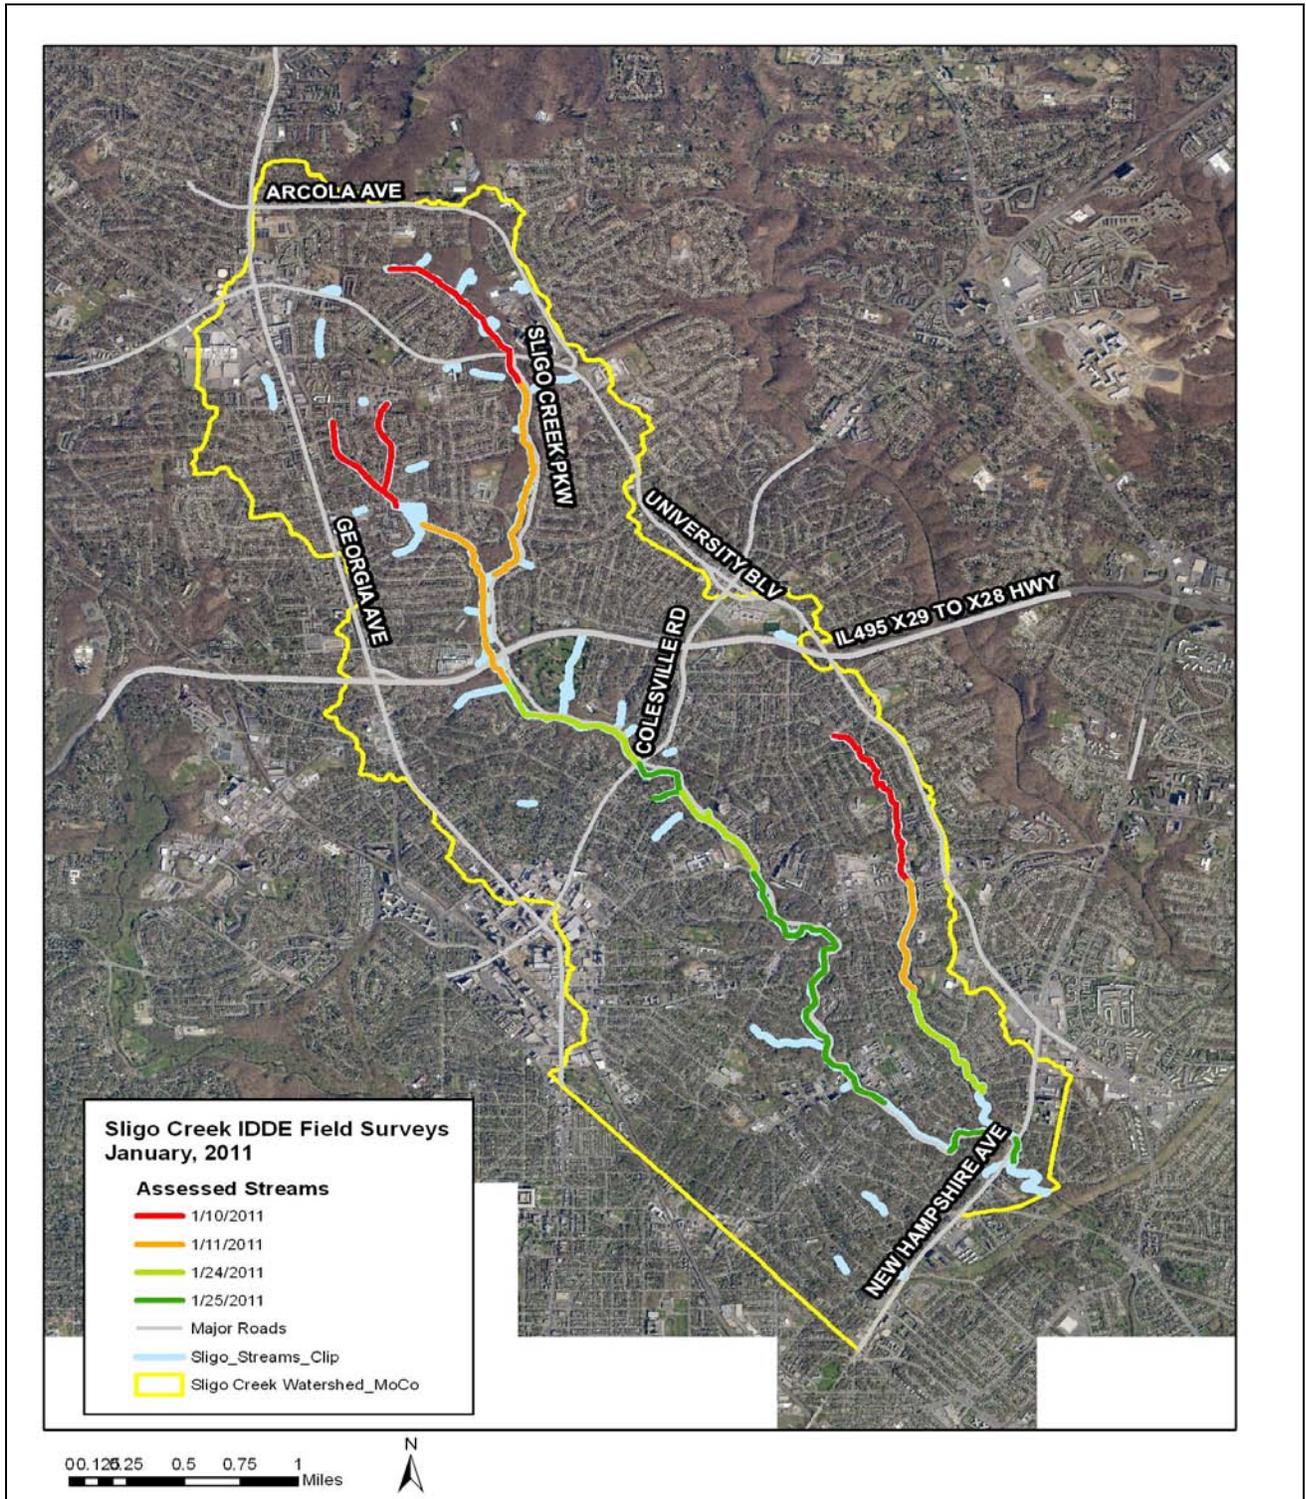
Figure III-E1. Map of Sligo Creek IDDE Field Surveys

In January 2011, the team assessed 213 outfalls in 10 miles of Sligo Creek watershed, the majority of the outfalls in the watershed. A map of the stream reaches walked for the outfall surveys is shown in Figure III-E1. The complete field findings can be found in the electronic (CD) attachment, Appendix E, *Field Findings, Pollution Detection & Elimination in Sligo Creek, Montgomery County, MD.*, Center for Watershed Protection, July 13, 2011.

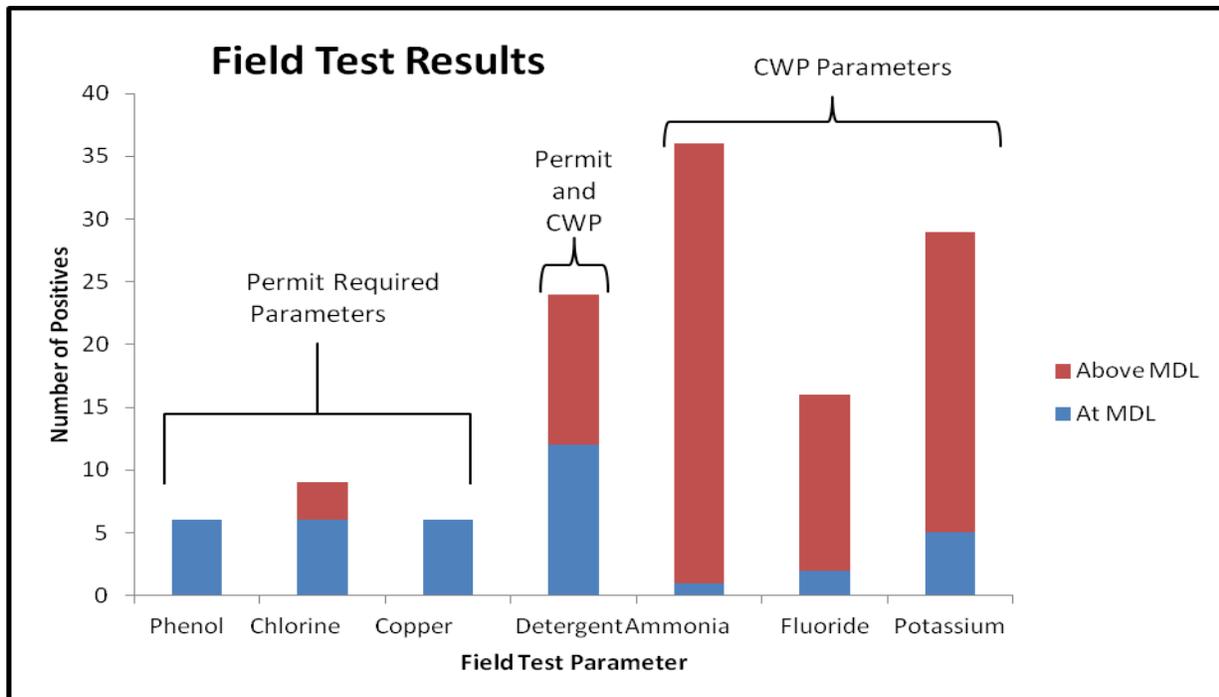
**Figure III-E2. Comparison of Field Test Positives by Parameter during the CWP/DEP IDDE Investigation in Sligo Creek**

Results of dry weather discharge outfall screening using CWP parameters found 45 suspected illicit discharges. The Permit required parameters yielded 29 potentially illicit discharges, with the majority of the positive results due to the presence of detergents (23), which is also a CWP parameter. Excluding positive detergent results, the Permit required parameter field tests (i.e. using only copper, chlorine, and phenols) yielded only 8 chlorine positive discharges, 6 of which were also positive for phenol and copper. At all outfalls with discharges that were positive for one or more Permit required parameters, there was also detection of one or more CWP parameters (Figure III-E2). Most of the Permit-required parameters, if present, were measured at the method detection level of .01 mg/l while concentrations detected for the CWP parameters were consistently above method detection limits. This indicates greater sensitivity for detecting illicit discharges using the CWP parameters and methods rather than the Permit-required parameters and methods.

The DEP recommends that future IDDE investigations use an amended list of required test parameters. Testing for the Permit required field parameters copper, chlorine and phenol in the past have not historically added information useful in characterizing and isolating illicit discharges. Adding the additional field test parameters ammonia, potassium and fluoride, however, can help distinguish between groundwater and major types of discharges such as industrial wastewater, sewage, wash water (laundry discharge) and tap water, providing useful information that may aid the difficult task of identifying sources of illicit discharges.

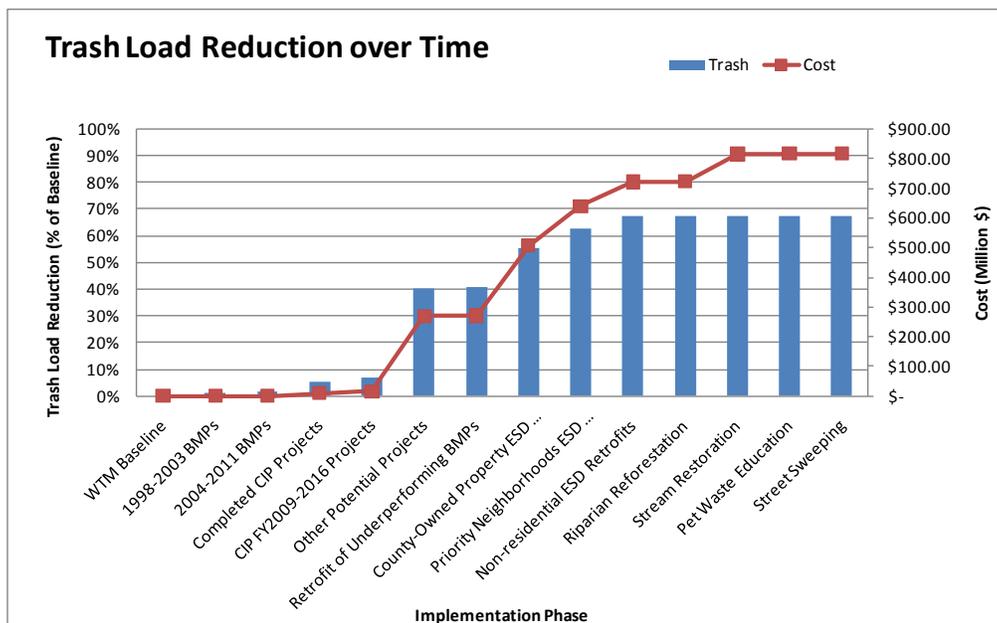
**Figure III-E3. Trash Load Reductions over Time**

The Strategy includes trash reduction strategies and work plans to meet the Potomac Trash Free treaty goals and the MS4 WLAs for the 2010 Anacostia Trash TMDL. The Strategy also provides a workplan for outreach and education that includes specific performance goals to increase residential and commercial recycling rates, improve trash management, and reduce littering. The Strategy showed that the trash load to the Anacostia River could be reduced by 68% using the same structural and non-structural BMP restoration strategies outlined for the bacteria, nutrient, and sediment load reductions. Figure III-E3 shows the trash load reductions over time associated with BMP implementation. Note that stream restoration, riparian reforestation, Pet Waste Education, and streetsweeping will have little effect on trash levels, However, these practices are recommended for implementation in order to meet WLAs for other pollutants.

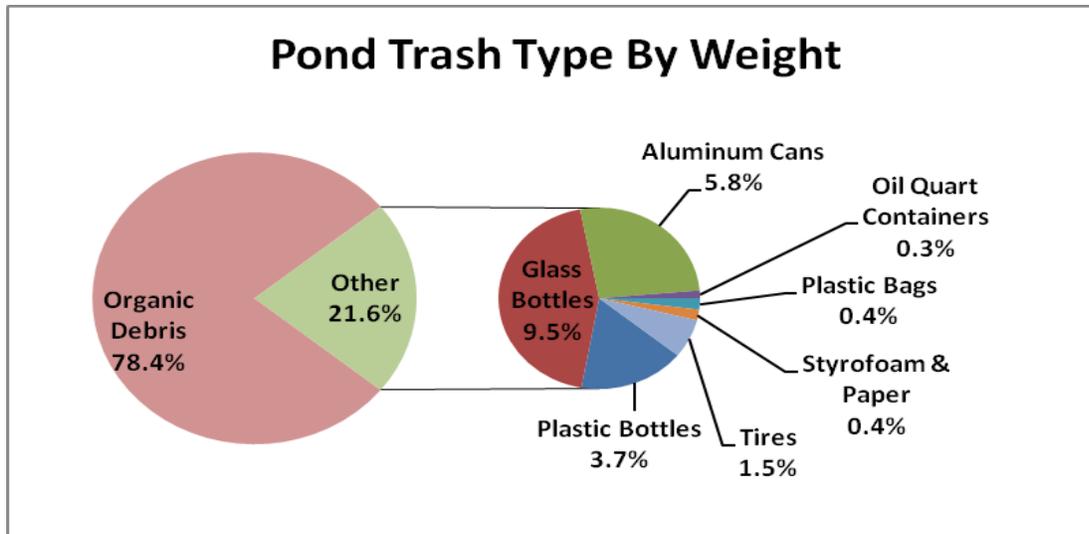
*Figure III-E5. Pond Trash Type By Weight*

As shown in Figure III-E5, by weight most of the material removed was organic debris (e.g. leaves, twigs, and branches). In the 'other' category, recyclable materials (aluminum, glass and plastic bottles, plastic containers) comprised the bulk found. These materials could easily have been removed from the waste stream through the County's recycling program. Future trash source control efforts will need to focus on additional ways to keep these recyclables from entering waterways.

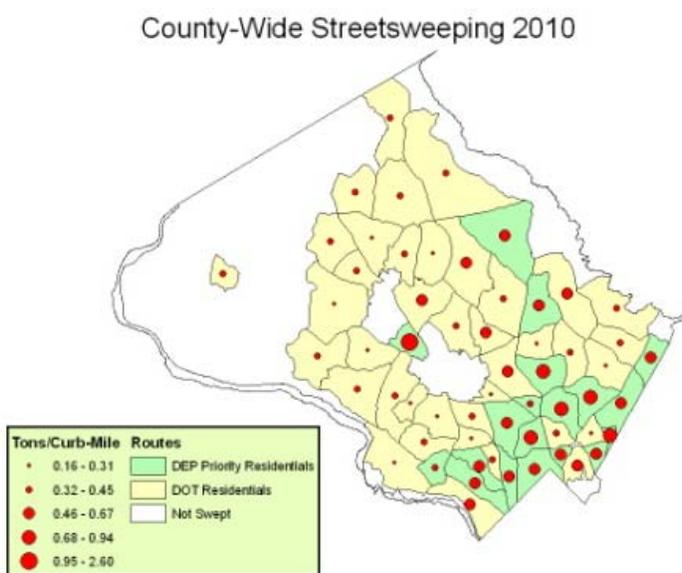
**Figure III-E6. Countywide Street Sweeping**

The County sweeps the 56 residential routes shown in Figure III-E6 at least once per year. On most roads, sweeping begins each year early in spring to pick up sand left over from winter storm applications. In 2003, DEP agreed to fund 19 of the 56 County routes as priority residential routes. In selecting the priority routes, DEP evaluated the average tons per curb mile collected during annual street sweeping activities, the likeliness of inadequate or no stormwater management based on age of development, and MDE identification of water quality impairment from sediment. These routes also tend to coincide with areas in the County of the highest annual average daily traffic as shown in Figure III-E7.

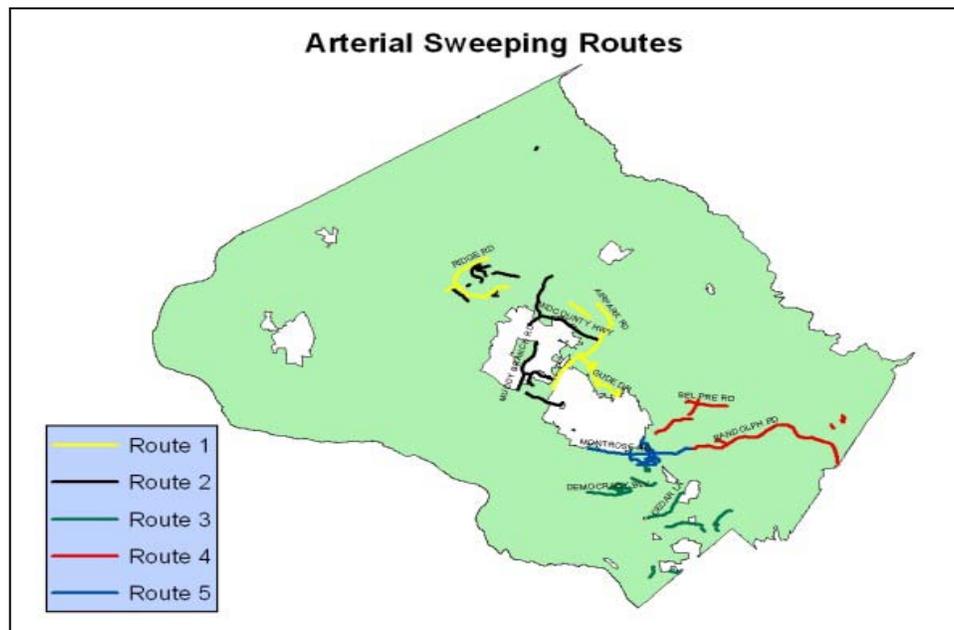
*Figure III-E8. Montgomery County Arterial Street Sweeping Routes*

The County also sweeps a third category of roads; arterial routes, shown in Figure III-E8, which are larger roads with more commercial activity, traffic, and based on visual observations, trash. These routes are swept at night when traffic volumes are low, and sweeping is only done on segments of the roads without residential housing because of noise considerations. There are no cars parked on these roads at night which facilitates operations.

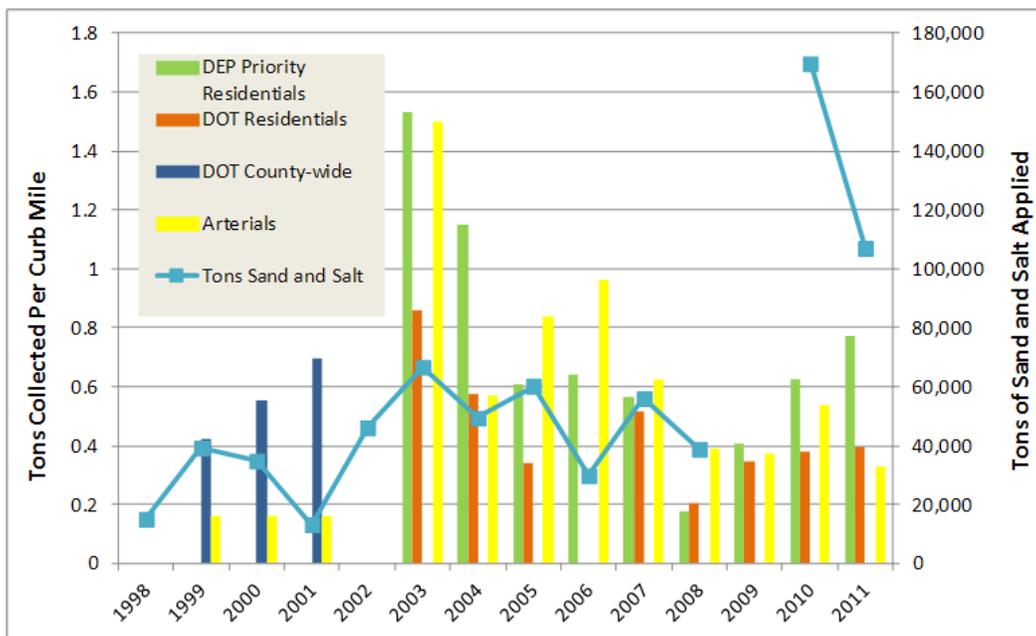
**Figure III-E9. Tons of Street Sweeping Material Collected by Montgomery County 1998-2011**

The arterial routes sweeping cost is much lower than for residential routes, and combined with the average higher materials removed per curb mile, arterial route sweeping is more cost effective than residential route sweeping to prevent roadway dirt and debris from entering the storm drains and receiving streams.

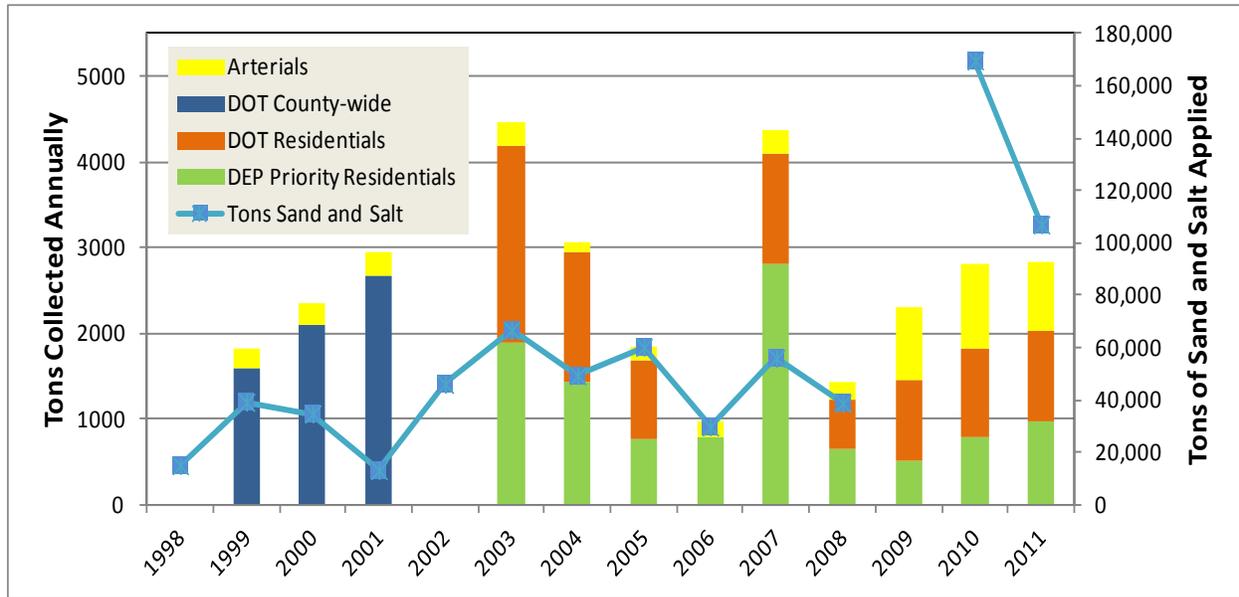
**Figure III-E11. Tons of Material Applied During Winter Activities and Collected by Street Sweeping 1998-2011**

In 2009, DEP decided to sweep the arterial routes multiple times and decrease the sweeping frequency of the priority residential routes, leading to a modest decrease in total miles swept since the peak year of 2007, as shown in Figure III-E10. Total miles swept still remain higher than any year before 2007 and costs have decreased greatly. The amount of material collected per year has remained well above what was collected in 2008, as shown in Figure III-E11.

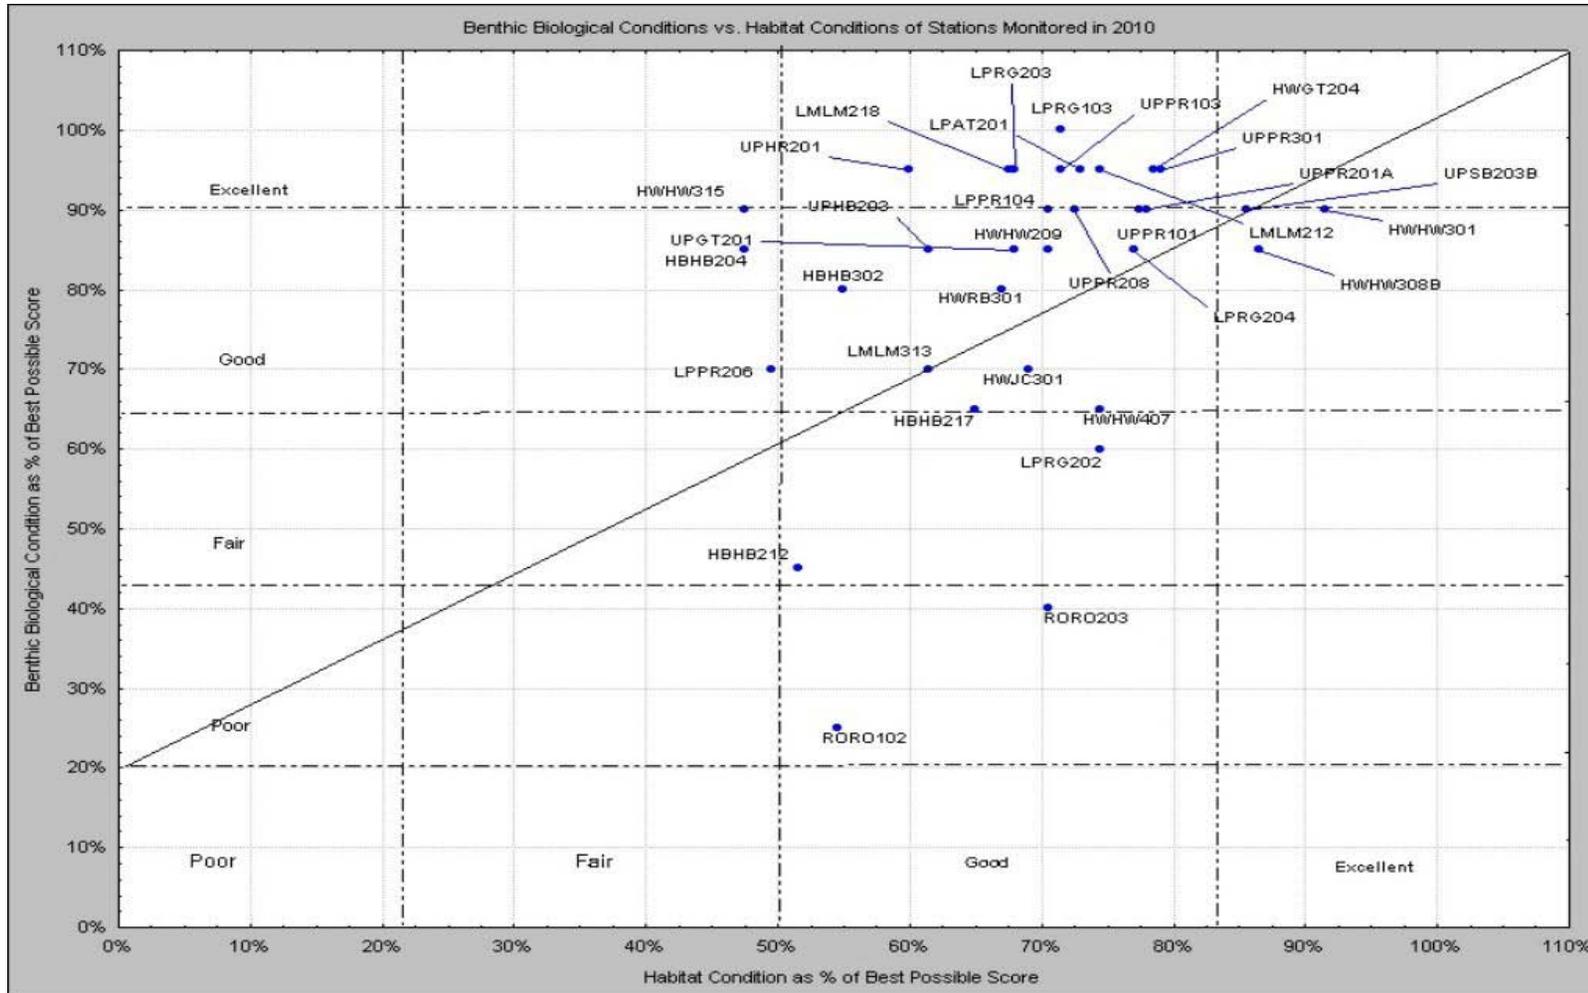
**Figure III-F1. Comparison of Benthic Biological Conditions with Habitat Conditions of sites monitored in 2010**

Of the 32 stations, two were found to be biologically impaired due to degraded habitat. These were stations RORO102 and HBHB217. One station, LPRG202, was impaired due to factors other than habitat. Of these three stations, only station (RORO102) had a drainage area larger than 300 acres and was sampled for both biological communities. These three stream reaches will undergo additional evaluation when the DEP conducts restoration assessments in these subwatersheds.

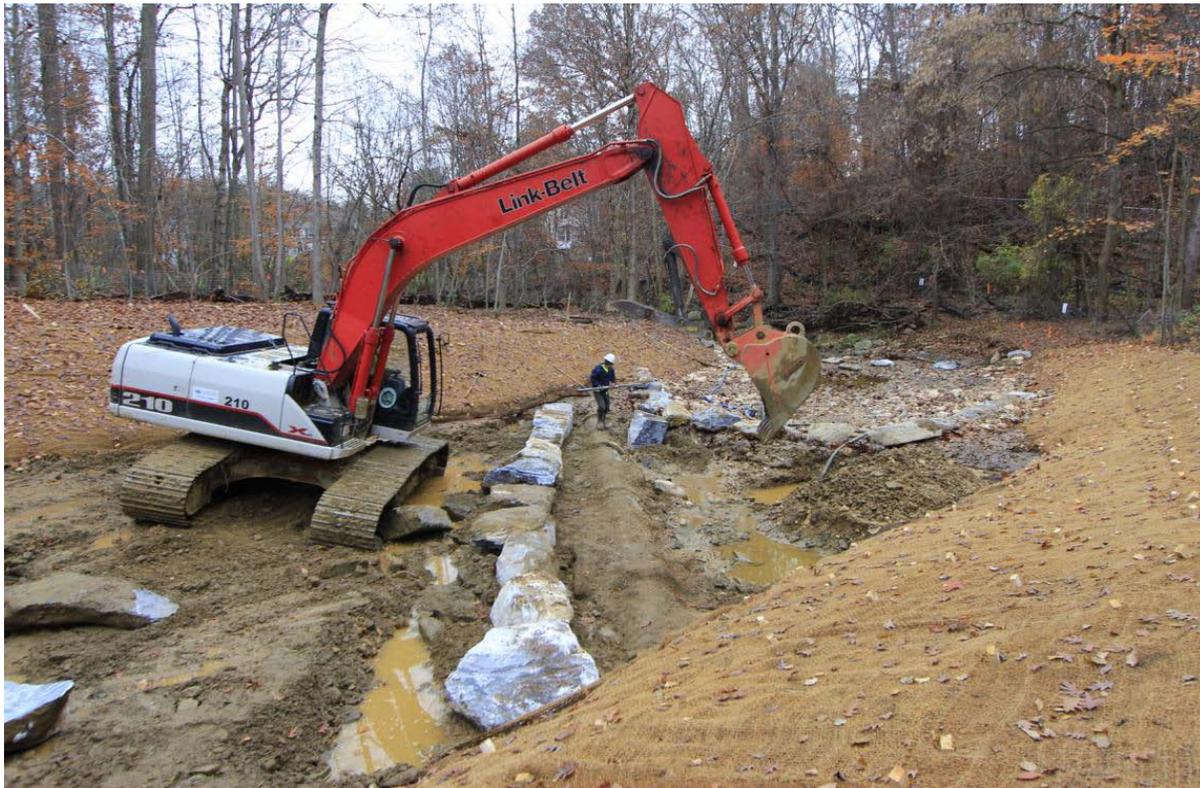
*Figure II-G2. Lower Booze Creek Stream Restoration Project Under Construction*

Figure III-G.2 below shows the FY11 stream restoration project under construction in Lower Booze Creek of the Cabin John Watershed.

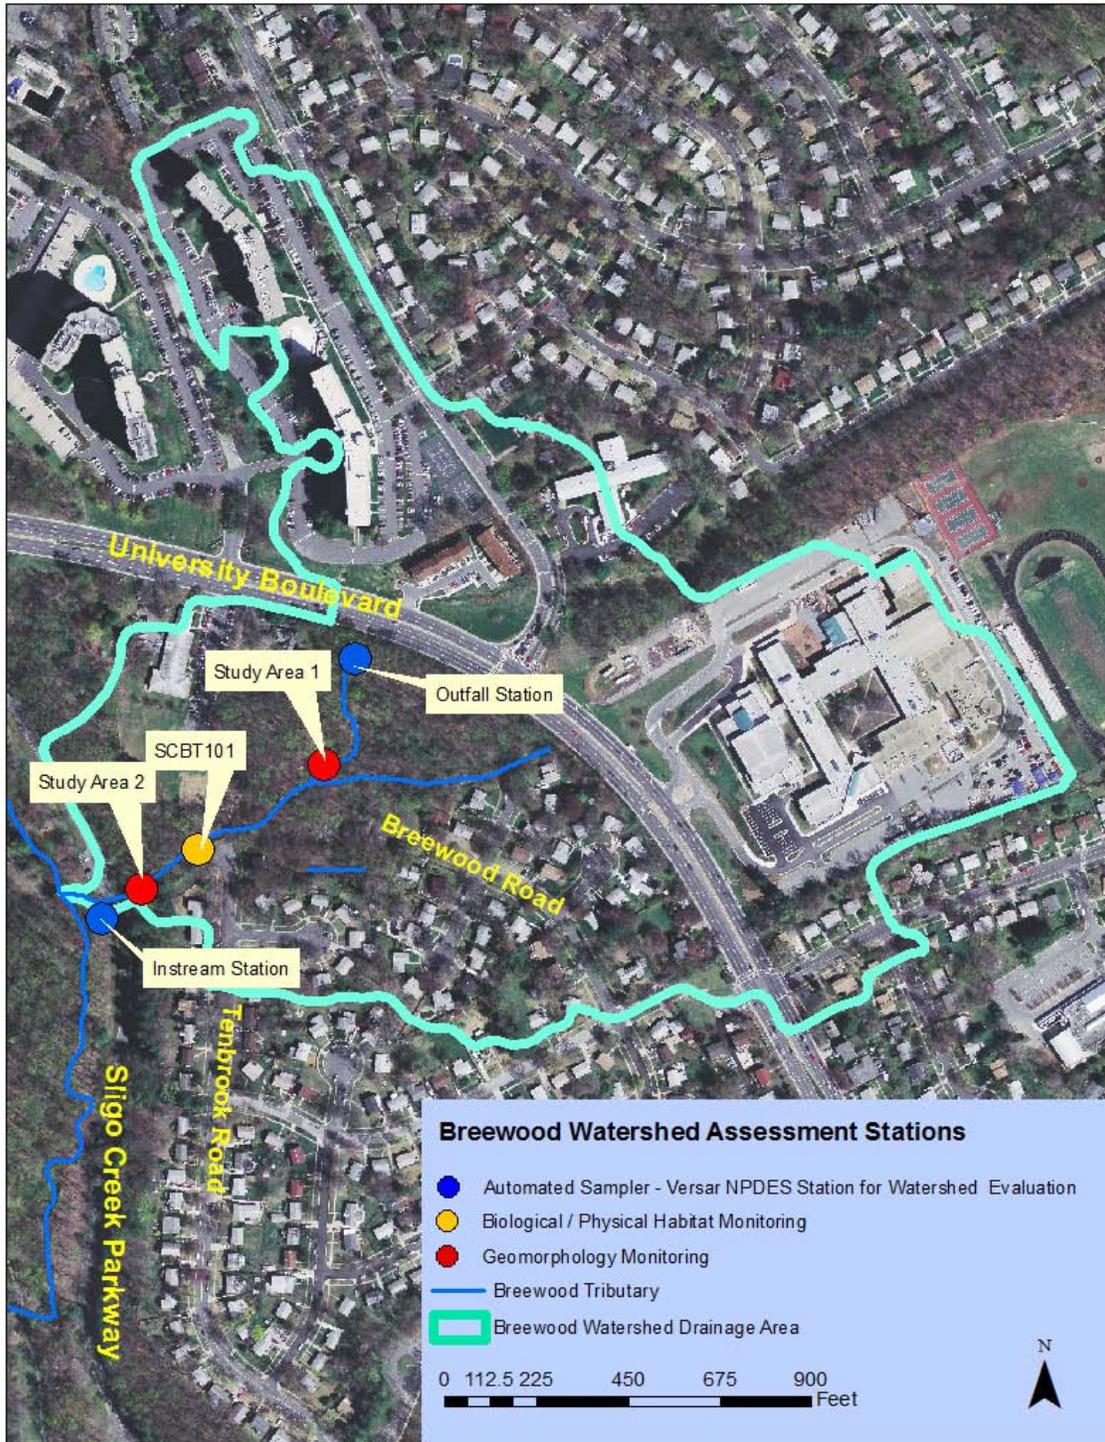
*Figure III-H2. Locations of Stream Chemistry, Biological, Physical Habitat and Geomorphology Monitoring Stations, Breewood Tributary of Sligo Creek.*

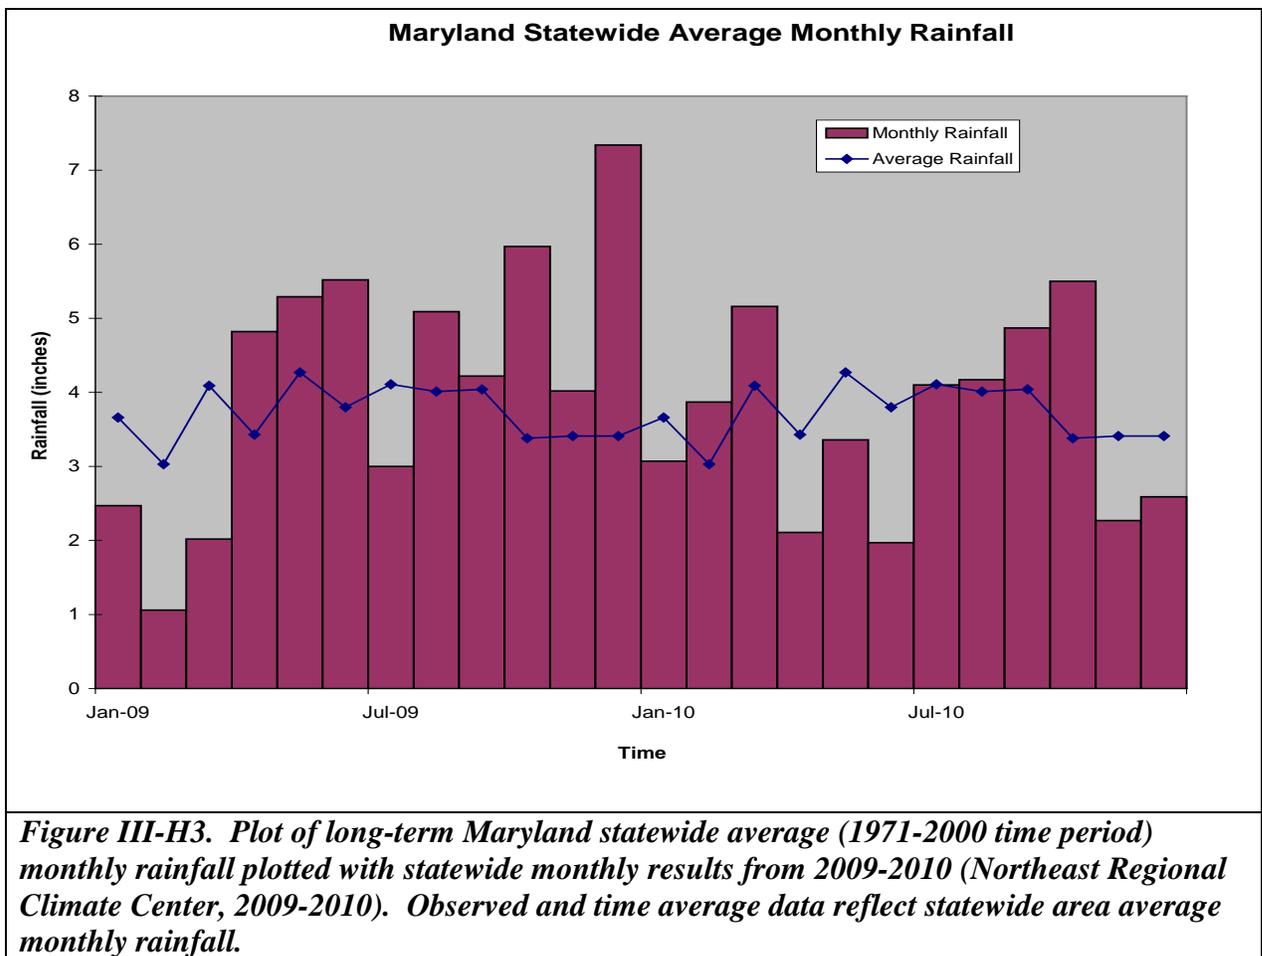
**Figure III-H3. Plot of long-term Maryland statewide average (1971-2000 time period) monthly rainfall plotted with statewide monthly results from 2009-2010 (Northeast Regional Climate Center, 2009-2010). Observed and time average data reflect statewide area average monthly rainfall.**

The region experienced 13.8% higher rainfall amounts during 2009 than in an average year. Conversely, in 2010, rainfall was 3.6% less than in an average year. The 2009 period also included much higher than normal amounts (115%) recorded in December. A plot of statewide average rainfall measured during 2009-2010 is shown in Figure III-H3.

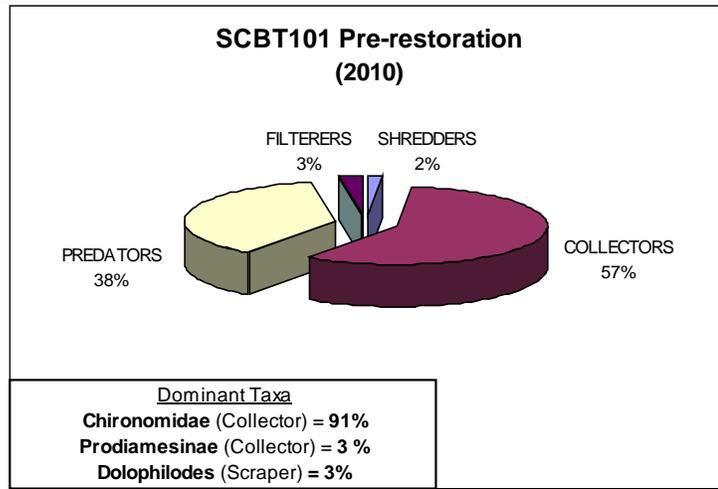
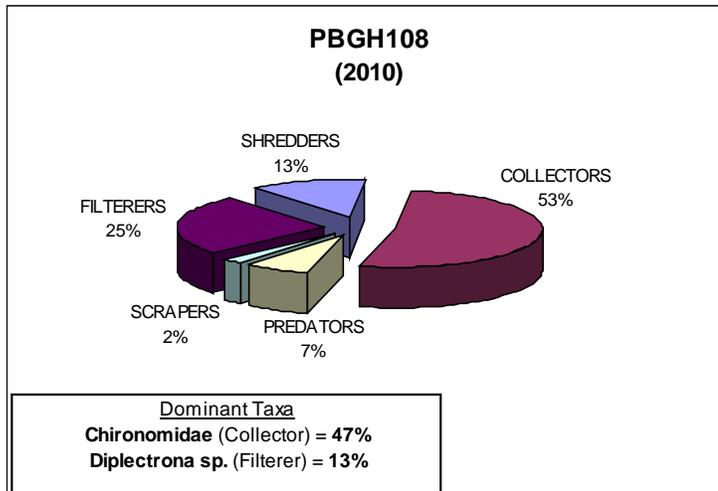
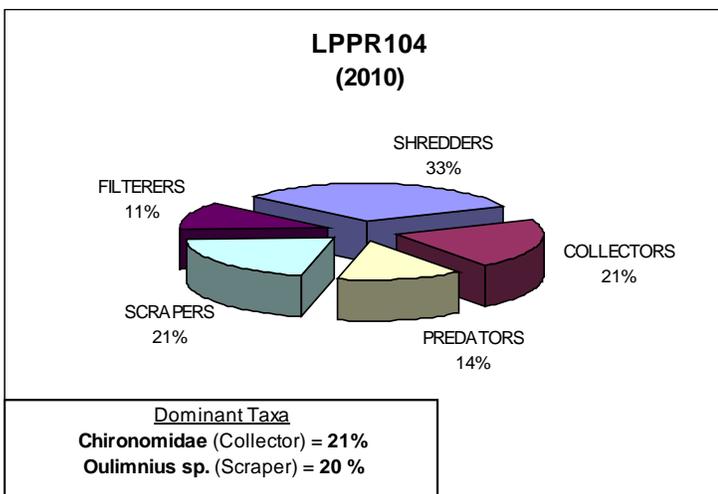
***Figure III-H4. Functional Feeding Group Comparison in the Breewood Tributary (SCBT101), Good Hope Tributary (PBGH108), and tributary to the Lower Patuxent (LPPR104.)***

Figure III-H4 shows the proportion of each FFG at SCBT101 and in two reference stream reaches, one in the Good Hope tributary to Paint Branch (PBGH108) and the other in a tributary to the Lower Patuxent River (LPPR104). The benthic community of the Good Hope tributary was rated 'Good' while that in the Lower Patuxent River tributary was rated 'Excellent'. Note that the relative percentage of taxa in the category 'collector' decreases and the percentages for 'filterers', 'shredders'; and 'scrapers' increases with increases in benthic community rating

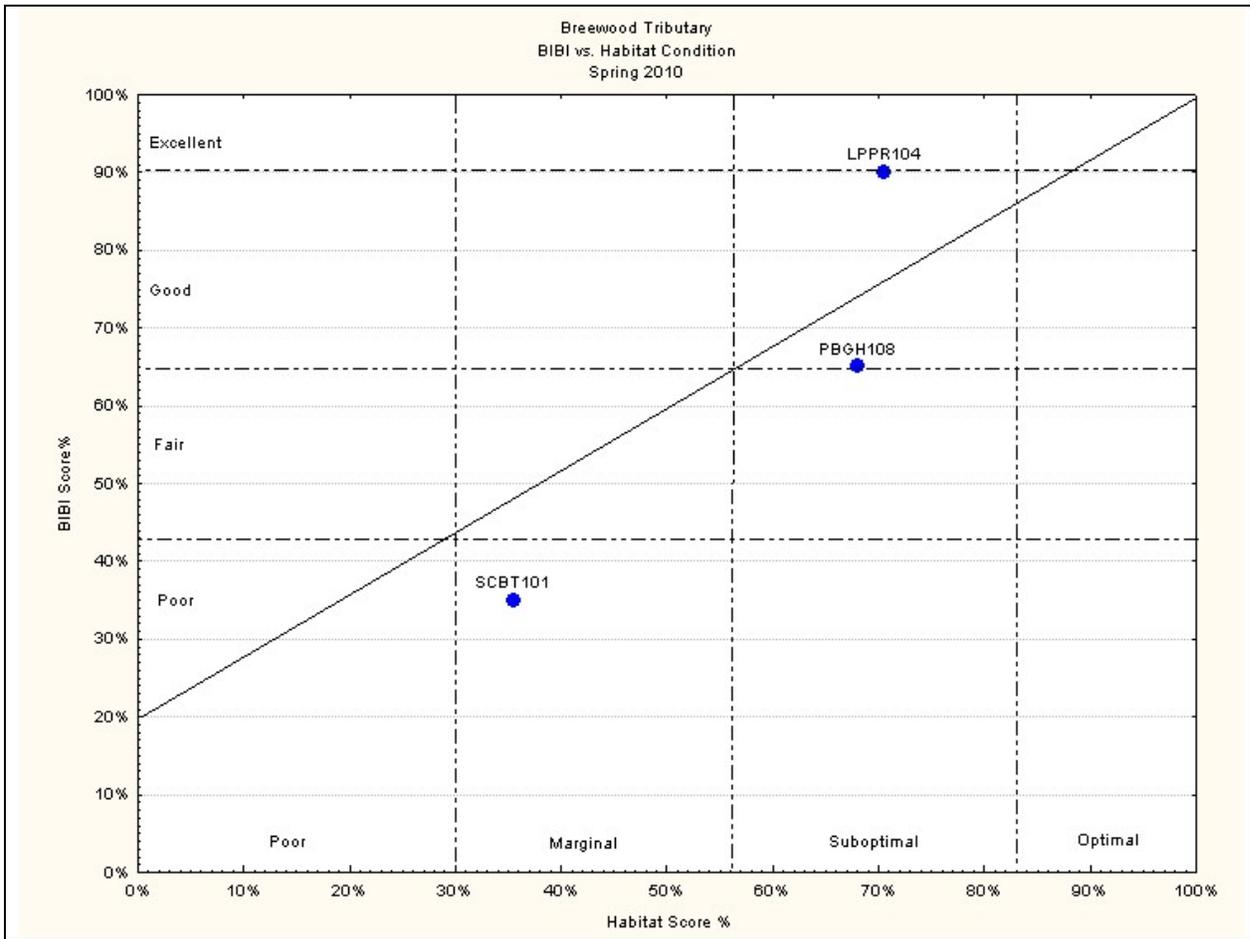
**Figure III-H5. BIBI at Breewood Tributary and Reference Streams vs. Habitat Condition, Spring 2010**

Figure III-H5 shows a comparison of the Breewood tributary BIBI and habitat conditions with those in the Paint Branch and Lower Patuxent streams in Spring 2010. While habitat conditions are similar at the Paint Branch (PBGH108) and Lower Patuxent (LPPR104) stations, the BIBI scores are much higher for the Lower Patuxent. The data is not shown but there are differences in specific habitat parameters between these two stations, with the PBGH108 station showing lower scores for embeddedness, sediment deposition, and bank stability than at LPPR104.

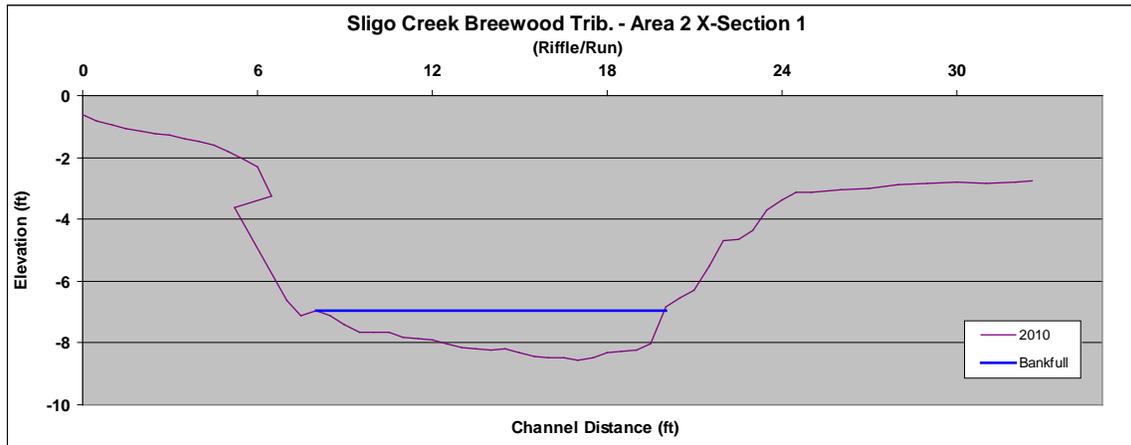
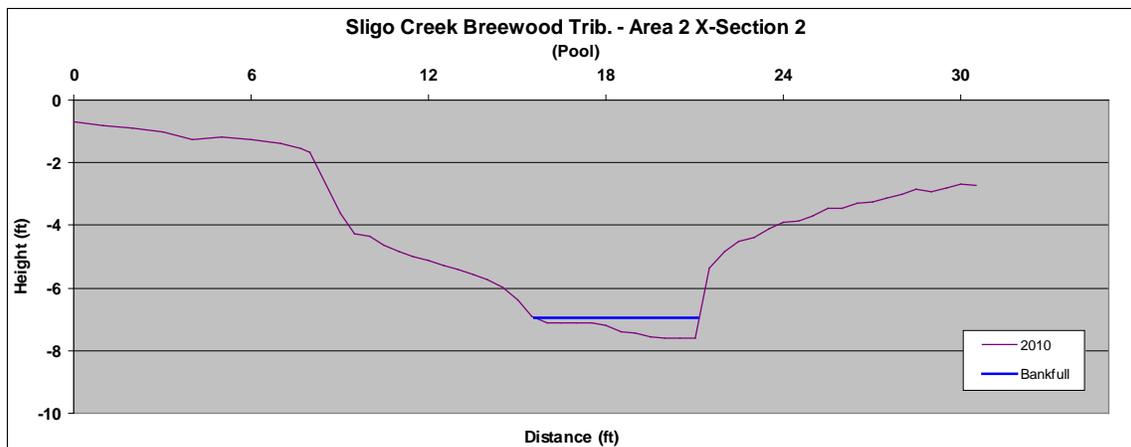
**Figure III-H6. Representative Cross Sections From Breewood Tributary, Study Area 2.**

Figure III-H6 provides Study Area 2 representative cross section views. The average particle size of the channel substrate below the bankfull channel height was 2.8mm, which is classified as very fine gravel. This area of the stream is predominated by riffles, which accounted for 81% of the reach surveyed. The results of the survey indicate a degraded channel with low sinuosity, and high erosion potential. Results for both stations will be reported in the FY12 Annual MS4 Report.

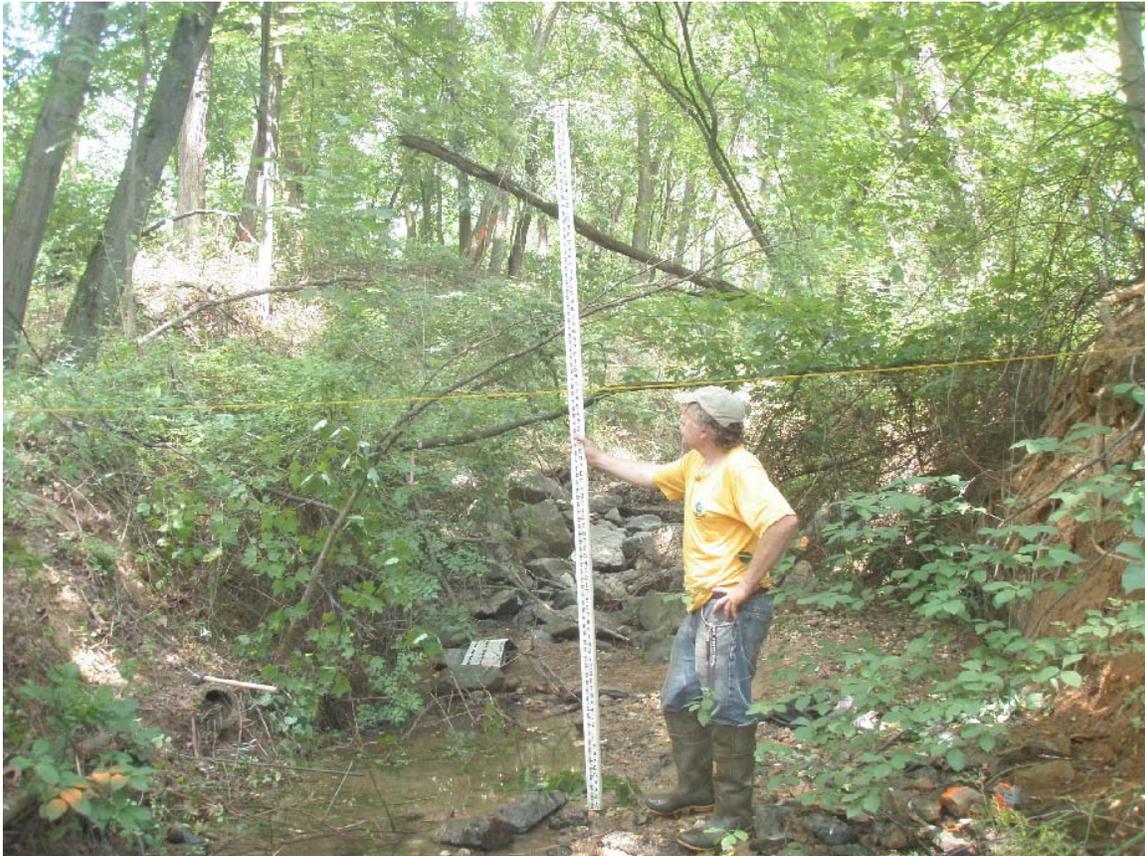
***Figure III-H7. Upstream View of Sligo Creek, Breewood Tributary, Study Area 2- Cross Section 1.***

Figure III-H7 provides a photograph of a representative cross-section with Study Area 2, demonstrating the severe down-cutting that has occurred in this part of the Breewood tributary.

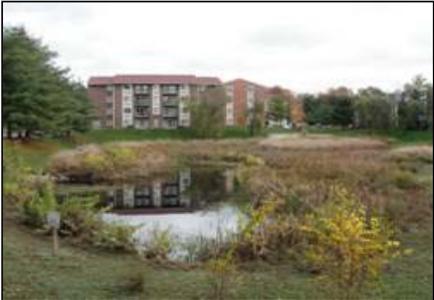
<p><b>Figure 2 - Peppertree Farm Stormwater Pond (2009)</b></p>

Avoid introduction of new thermal impacts	Partially successful – no thermal impacts were observed downstream of Matthew Henson I or Peppertree stormwater ponds but were observed downstream of Matthew Henson II.		
Reduce stream erosion and sedimentation	Unable to determine - monitoring delayed until 2011 due to missing survey monuments. Results will be available in 2011 reporting.		
Reduce erosive stream flows	Unable to determine - monitoring delayed until 2011 due to missing survey monuments. Results will be available in 2011 reporting.		
Create wetlands	Successful - open water, emergent and scrub shrub wetlands now exist in the restoration area that was previously open field		
Reforest riparian zone	Partially successful – trees have been planted and allowed to grow in the restoration area that was previously sparsely vegetated; however, many plantings have died and most planted areas have extensive invasive species present.

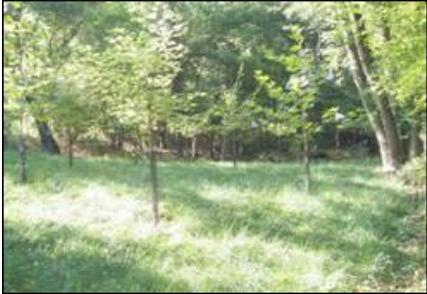
<p><b>Figure 3 - Reforestation in Turkey Branch</b></p>	
<b>Goal</b>	<b>Result</b>		
Improve aquatic habitat conditions	Partially successful – frequency of riffles improved at all sites; some sites had improved fish and benthic habitat and others had a decline.		
Improve water quality	Partially successful – increasing trend in the fish community, general declining trend in the benthic macroinvertebrate community.

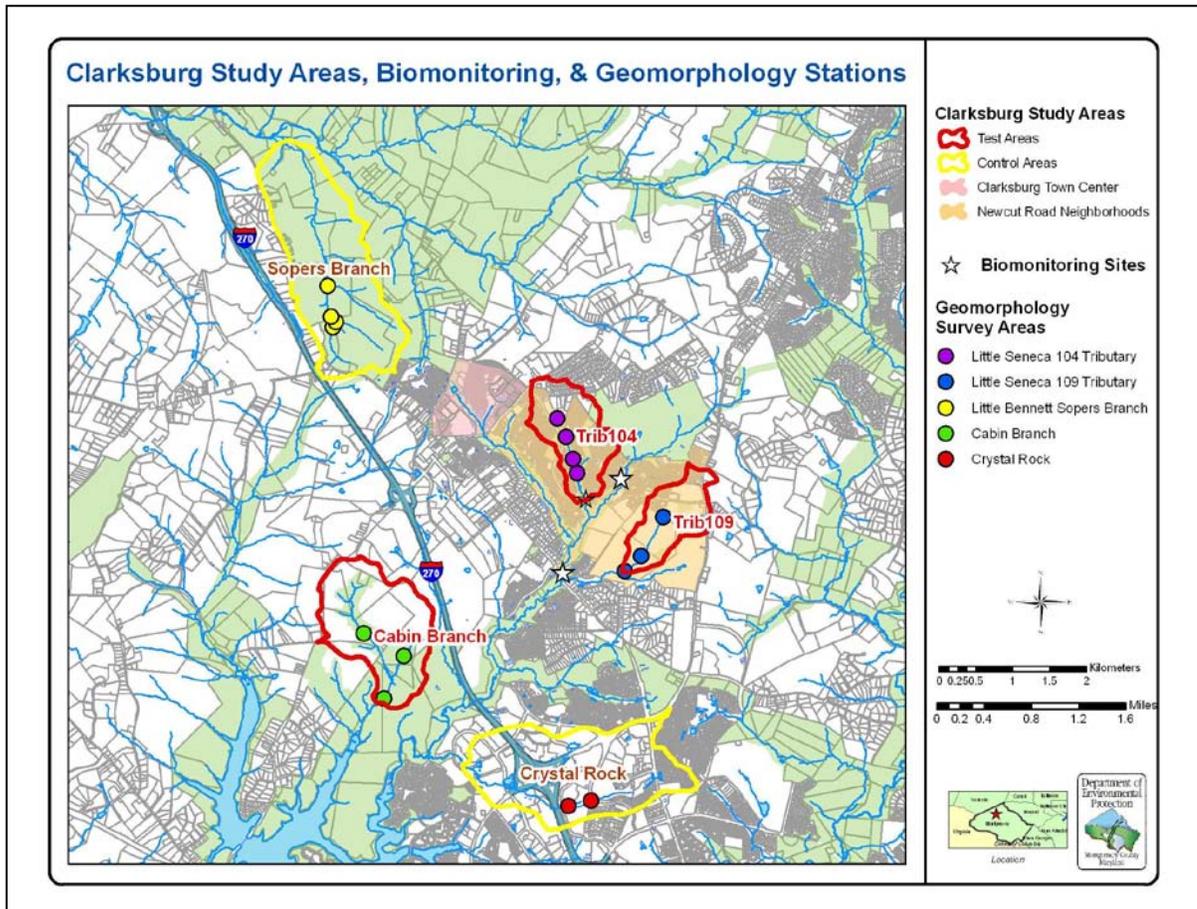
**Figure III-H10. Location of the Clarksburg Monitoring Partnership three test areas and two control areas. Also included are biological monitoring stations and geomorphic survey locations.**

The CMP is using a *Before, After, Control, Impact (BACI) design* or *paired catchment (watershed) design* (Farahmand et al. 2007) approach to assess the land use changes and the impacts to stream conditions, and has been monitoring since 2004. The CMP is also using Light Detection and Ranging (LiDAR) imagery to provide greater resolution in mapping landscape changes at this smaller drainage area scale than possible using traditional aerial photography.

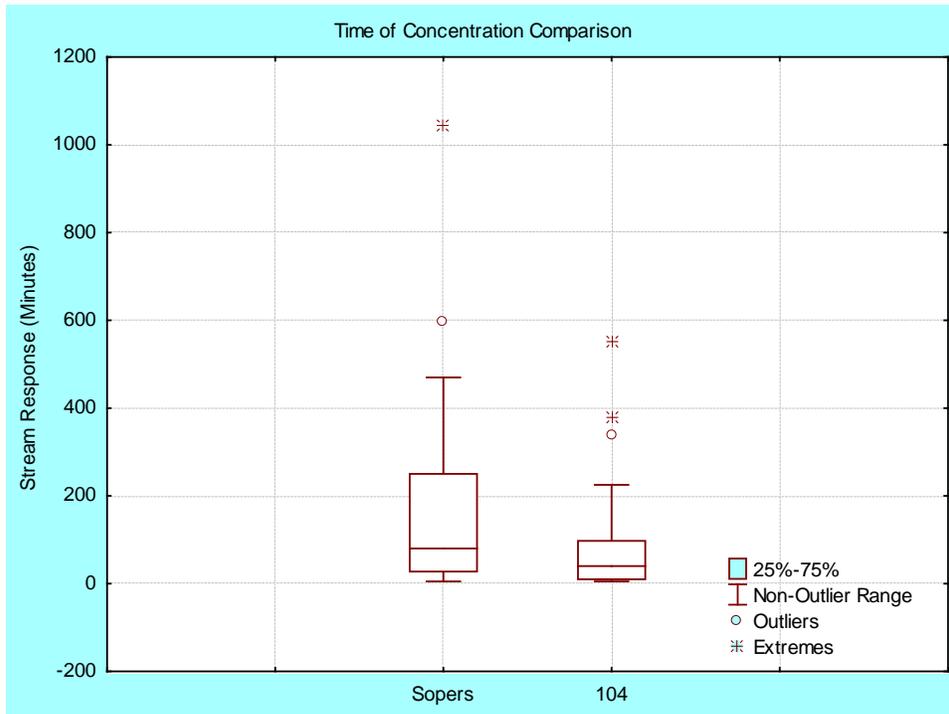
During three years of the construction period (October 1, 2007 thru September 30 2010), the TOC was evaluated at the Sopers Branch control area stream gage (LSLB101) and at the test area stream gage (LSLS104). On average, the test area tributary responded twice as fast as the Sopers Branch control area for the same range of storms exceeding ½” of rainfall (see Figure III-H11).

**Figure III-H11. Comparison of Time of Concentration (TOC) at the Sopers Branch control area stream gage and at the test area (LSLS104) stream gage for rainfall greater than 1/2" in 24 hours.**
