# Annual Report for FY11 NPDES Municipal Separate Storm Sewer System Permit

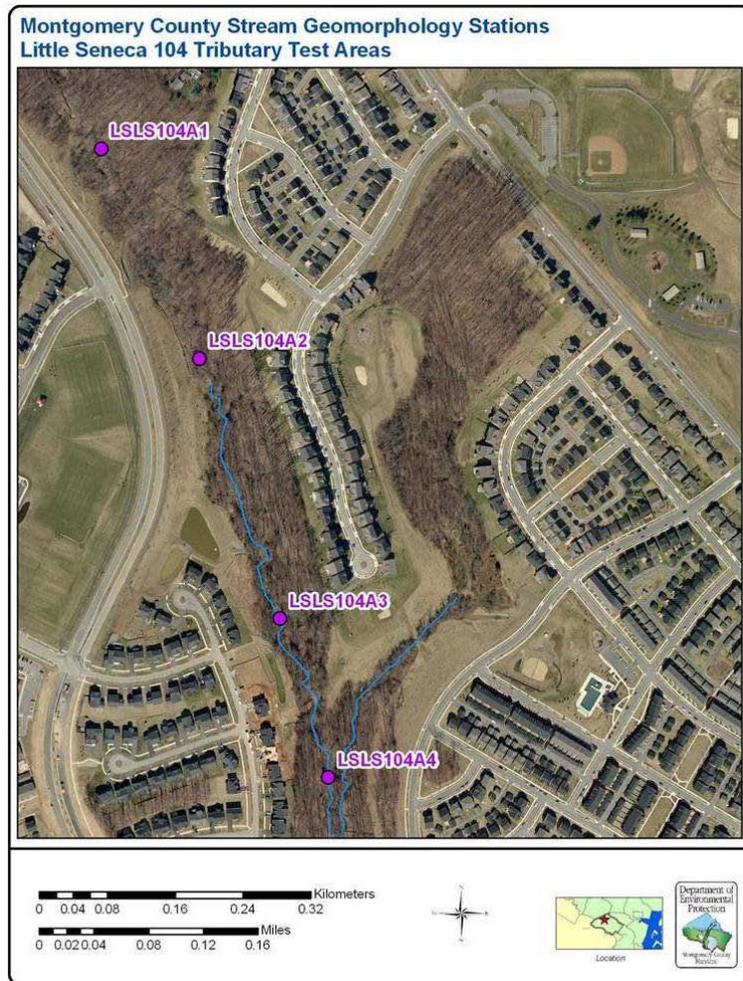
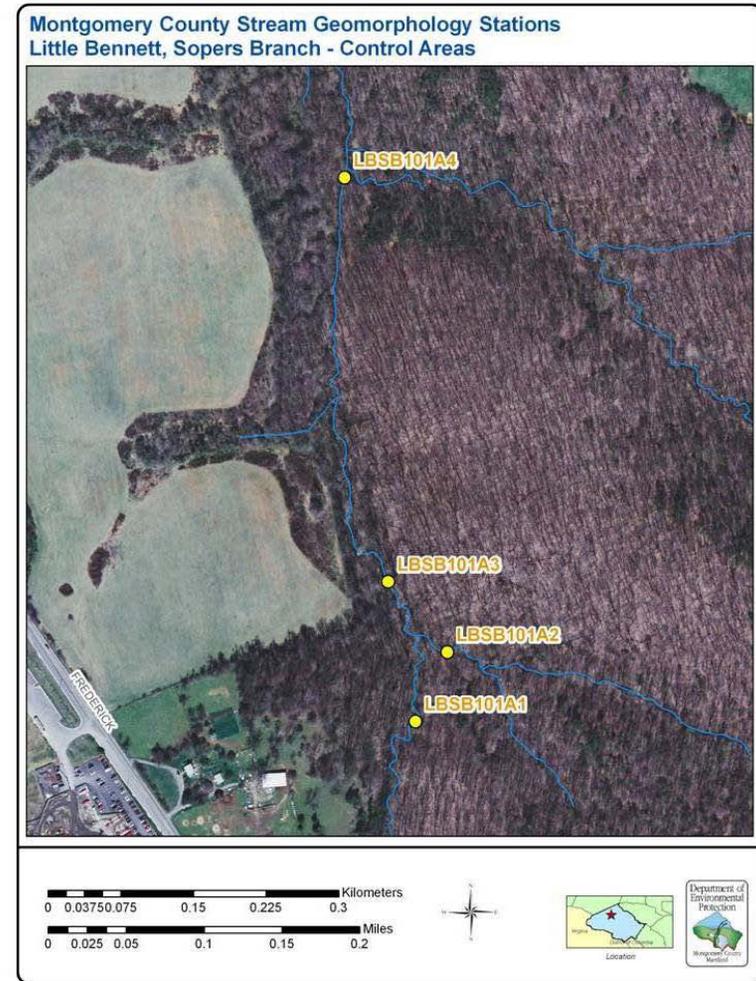
Figure III-H12. Geomorphology Survey Locations: Newcut Road Neighborhood Tributary to Little Seneca Creek Test Area (A), Sopers Branch Control Area (B)

Surveys were established within similar habitat sections of each study stream. At that time, the upstream habitat sections were steeply-graded, straight channels (low sinuosity index) consisting mostly of riffle habitat. More downstream sections were characterized by decreasing slopes, increasing sinuosity and pools become more prevalent. There are four channel cross-section locations in both study areas, labeled from 1-4, with location 4 representing the most downstream cross-section location. All cross sections used in this comparison were measured in riffle/run stream areas. Riffle/run areas serve as grade control for the stream and are areas that resist changes to cross-section features.

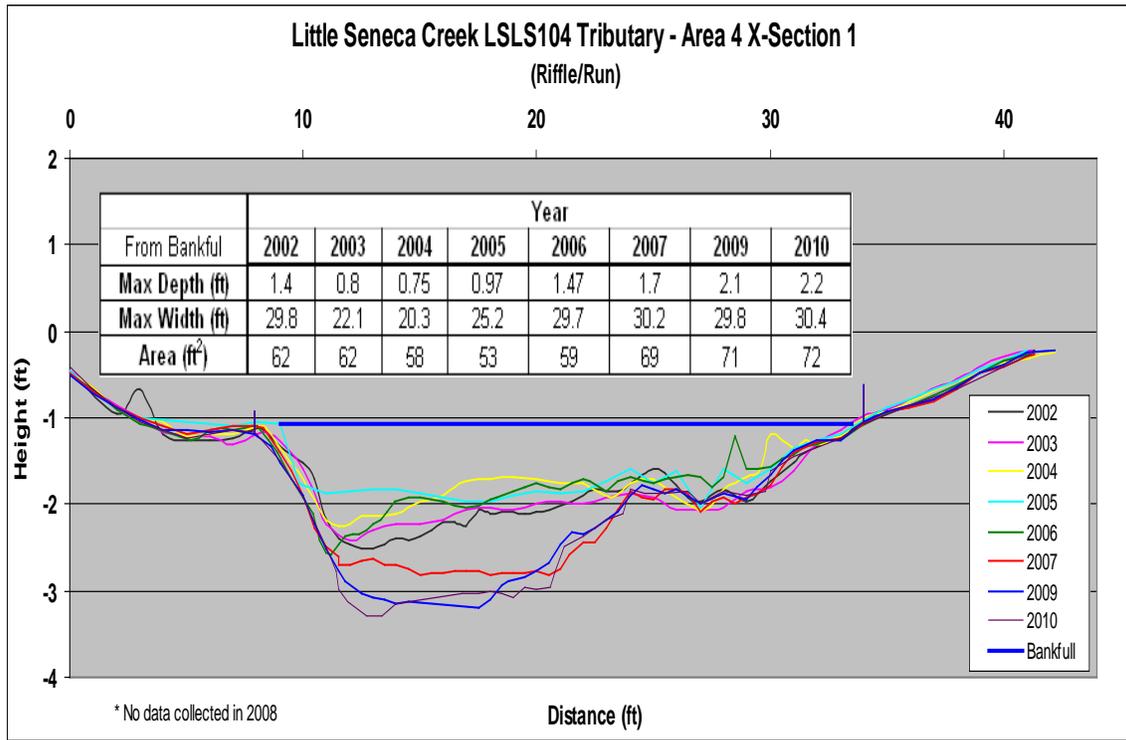
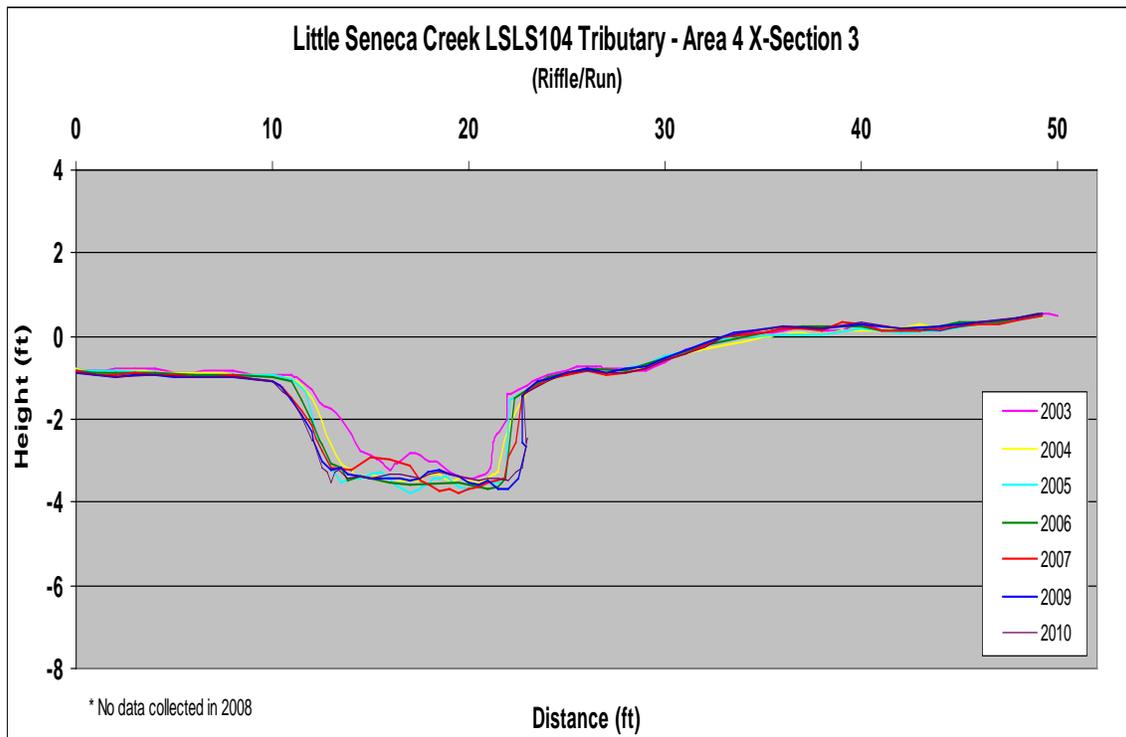
**Figure III-H13. Representative cross sections from the Newcut Road Neighborhood tributary to Little Seneca creek test area (LSLS104), cross section location 4 (most downstream location). Cross sections are both measured in Riffle/run features.**

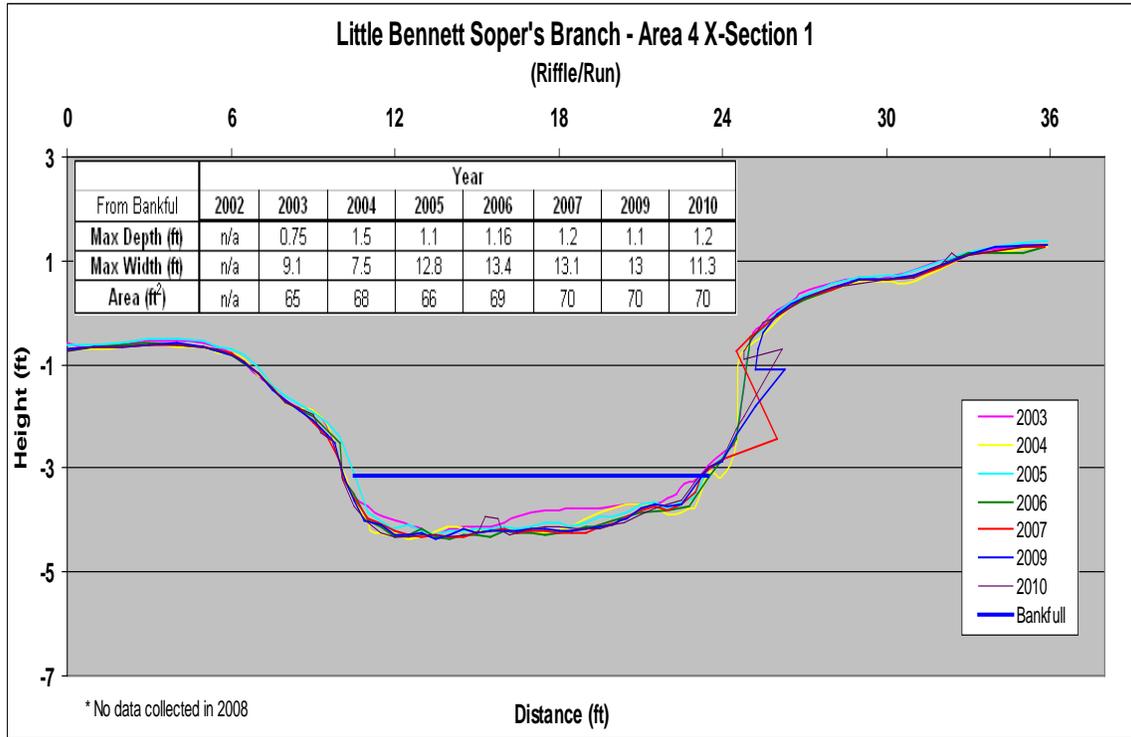
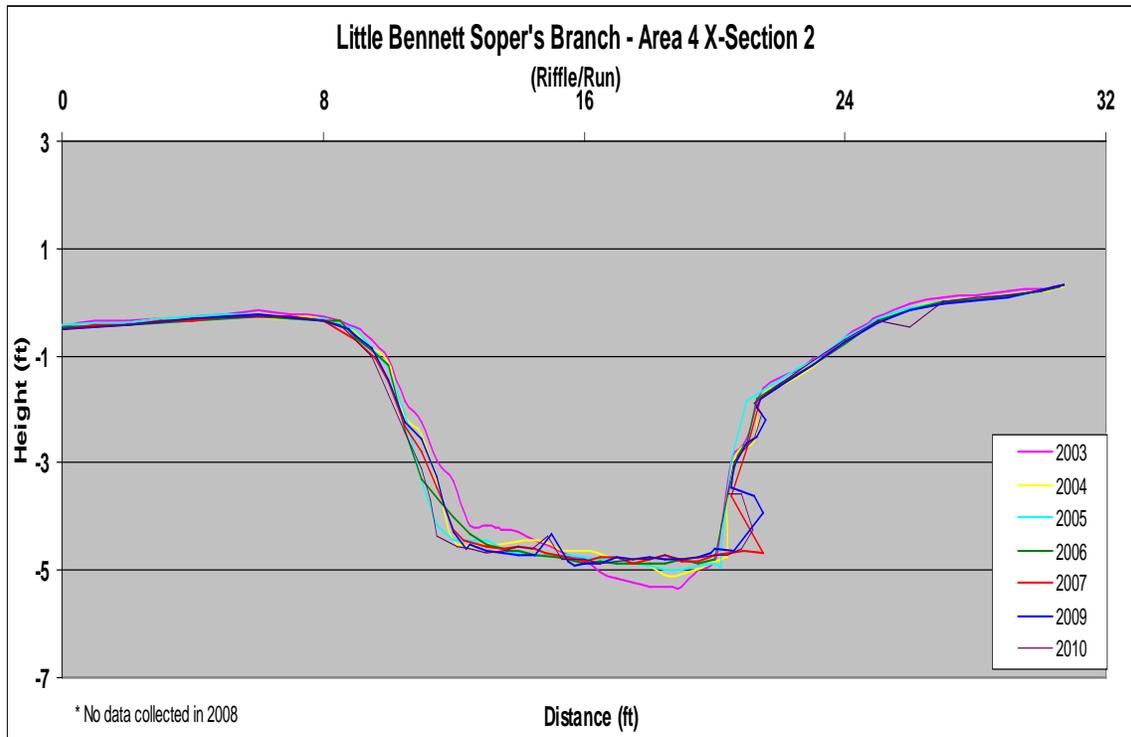
In contrast, representative sections from the Sopers Branch control area showed little yearly change (Figure III-H14).

**Figure III-H14. Representative cross sections from the Sopers Branch control area, cross section location 4 (most downstream location). Cross sections both measured in Riffle/run features.**

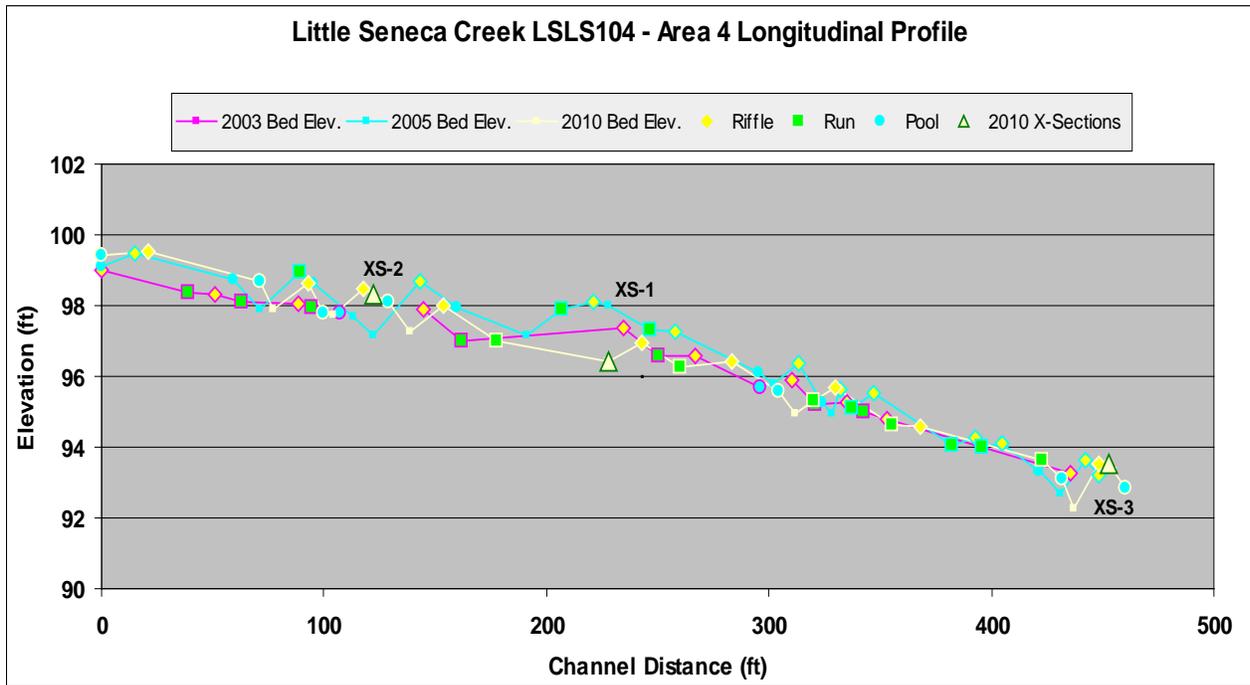
Results presented herein are preliminary as the ESC control devices have not all been converted to SWM structures and therefore post-construction monitoring is not completed. However, from the preliminary results, it appears that the construction phase of development has impacted the test area (LSLS104) tributary channel morphology due to channel straightening, down-cutting, and enlargement.

**Figure III-H15. Longitudinal profiles Newcut Road Neighborhood tributary to Little Seneca creek test area (LSLS104) cross section location 4 (most downstream location).**
