Annual Report for FY15 NPDES Municipal Separate Storm Sewer System Permit

Published by the Montgomery County Department of Environmental Protection
for the Maryland Department of the Environment

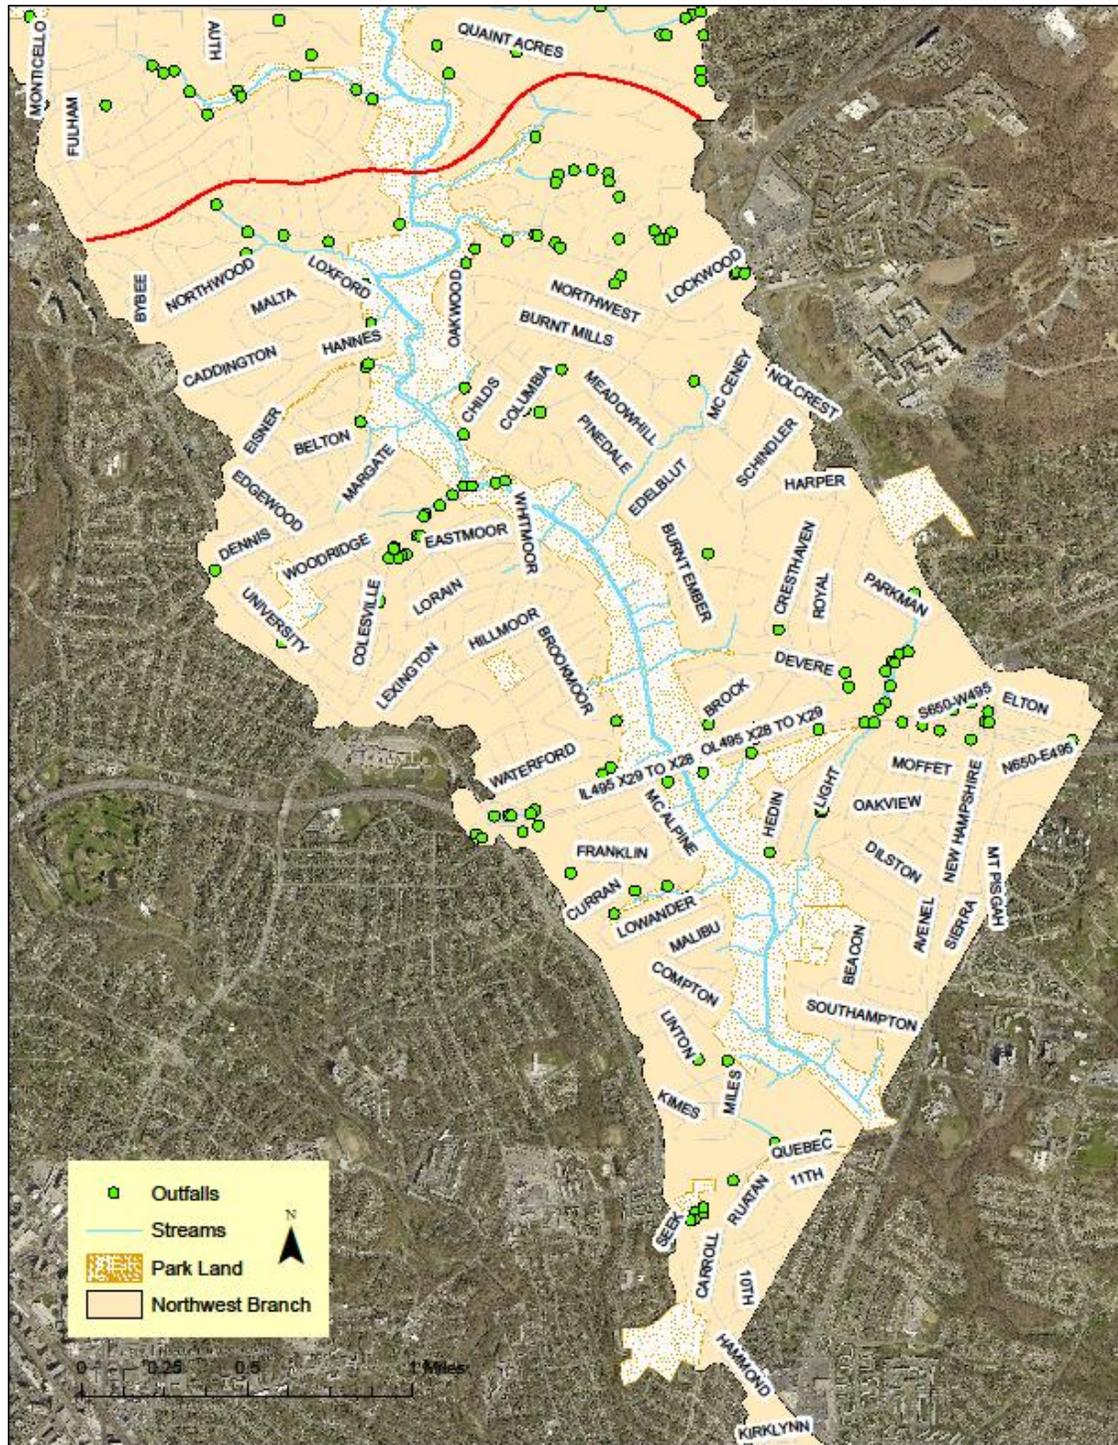
Figure III.E.2. FY15 Outfall Screening – Lower and Middle Mainstem Subwatersheds of the Northwest Branch of the Anacostia Watershed

For FY15 DEP will screen outfalls in the Middle Mainstem, Lamberton Tributary and Glenallen Tributary subwatersheds of the Northwest Branch of the Anacostia Watershed.

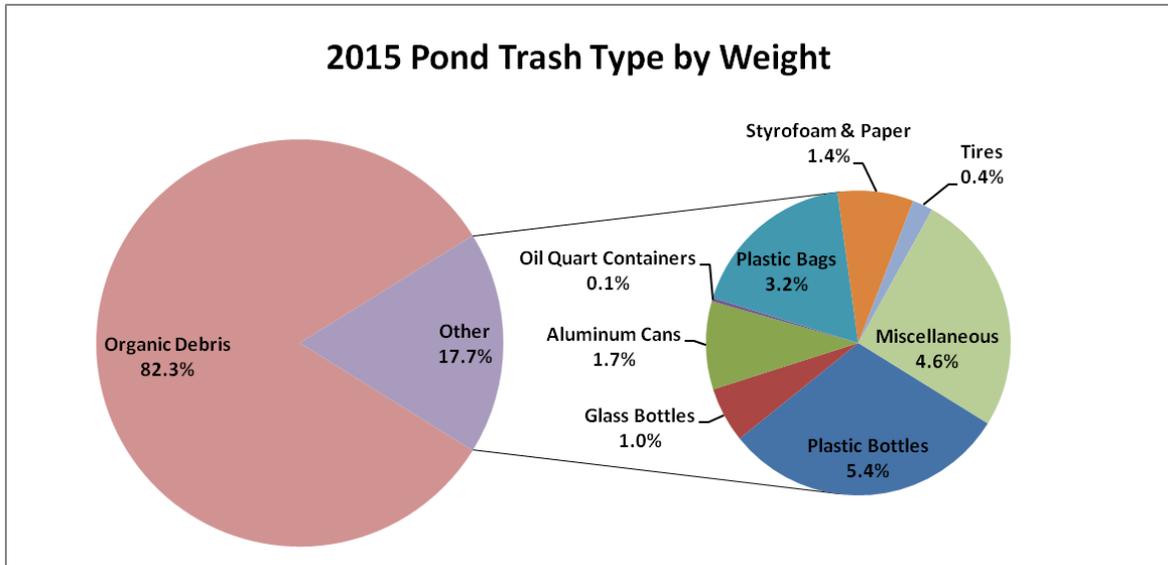
Figure III.E.4. Pond Trash Collected in FY15 by Type

In FY15, as shown in Table III.E.8 and Figure III.E.4, by weight 82.3% of the material collected was organic debris, collected on two dates in June from the Wheaton Pond. Of the inorganic material collected, 74.2 percent was plastic bottles, plastic bags or miscellaneous items (Figure III.E.5). Recyclable materials (aluminum, glass and plastic bottles, styrofoam and paper) comprised 54 percent of the inorganic materials found. These materials could easily have been removed from the waste stream through the County's recycling program. Over the past 5 years there has been a clear shift away from glass bottles and a corresponding increase in plastic bottles. In FY15 plastic bottles made up 30 percent by weight of the items collected at the ponds. More pounds of plastic bottles were collected than any of the other categories besides organic debris and miscellaneous trash. Future trash source control efforts will need to focus on additional ways to keep plastic bottles and the other recyclables from entering waterways.

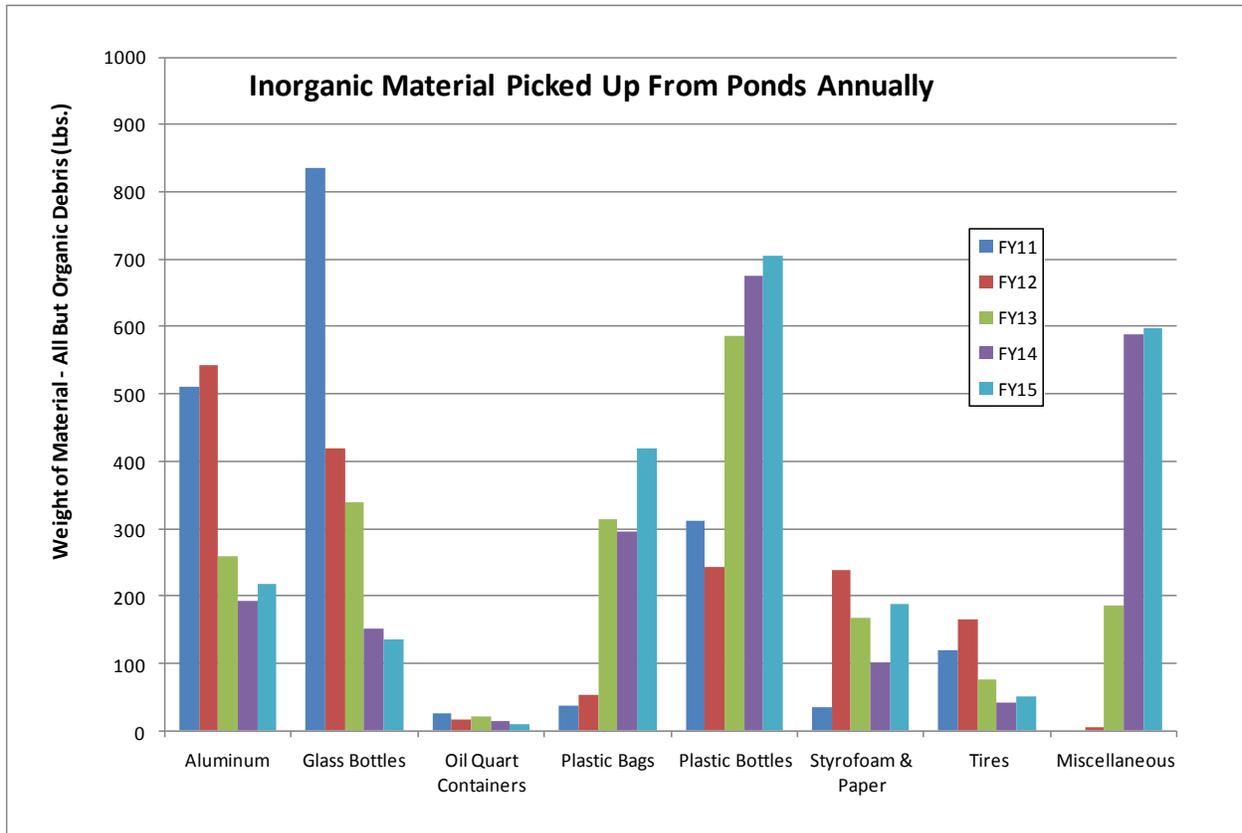
Figure III.E.5. Inorganic Material Removed from the SWM Ponds Annually

The Carryout Bag Tax which went into effect on January 1, 2012 (FY12) does not appear to be reducing the amount of bags collected at the ponds. As seen on Figure III.E.5, there were about 122 more pounds of plastic bags collected in FY15 than in FY14

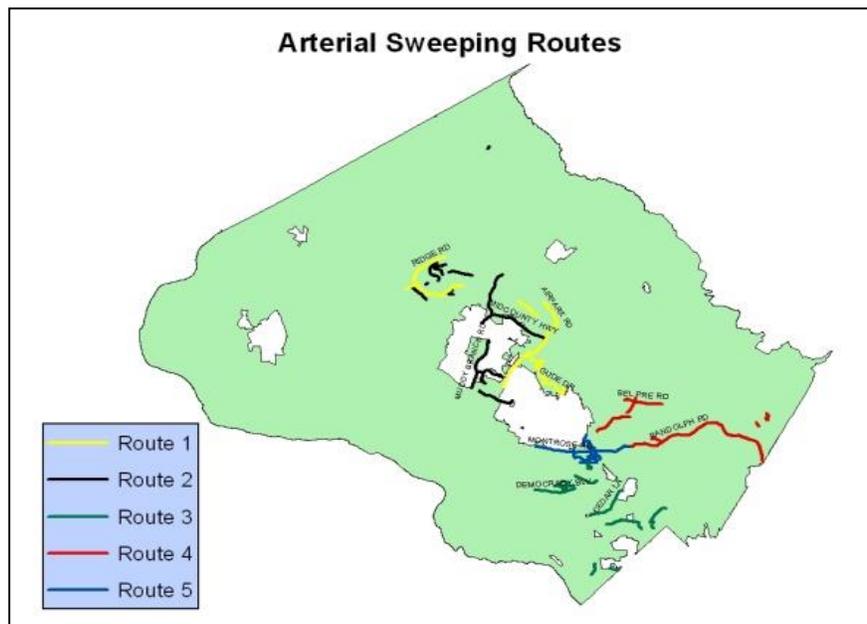
Figure III.E.8. Montgomery County Arterial Street Sweeping Routes

The DEP funded sweeping of 229 curb miles on arterial routes, shown on Figure III.E.8. The routes are swept at night when traffic volumes are low. Sweeping is only done on segments of the roads without residential housing because of noise considerations. In FY15, DEP swept the arterial routes 23 cycles.

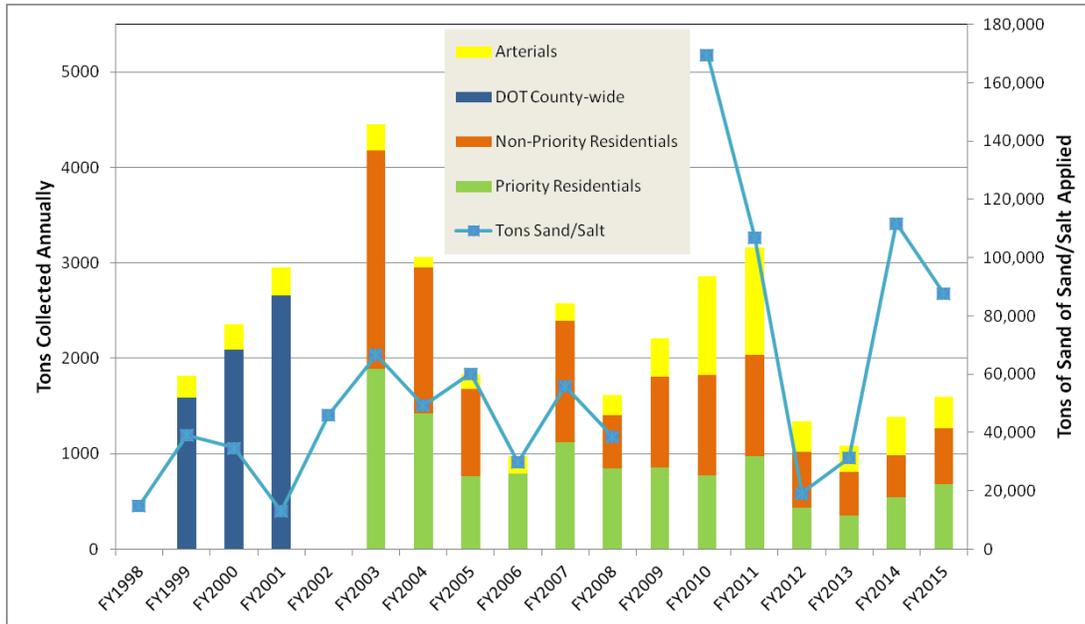
Figure III.E.9. Tons of Material Applied During Winter Activities and Collected by Street Sweeping 1998-2014

Figure III.E.9 shows tons of materials removed annually by street sweeping from 1999 to present. The tons of sand and salt applied were not reported for FY09 and FY10. In 2002, no County street sweeping was conducted due to lack of funding. The amount of material removed seems related to the amount of sand applied for de-icing, which is related to winter precipitation. More snow and ice increases the need for application of sand to the roads, which then becomes more available for collection during street sweeping. In 2012, DOT stopped mixing sand and salt as a routine practice. DOT now applies a salt brine solution before storms and granular salt to accumulated snow. Sand is still used as a spot treatment and during icy conditions, but the amounts of sand used have declined dramatically. In FY15, no sand was used with 87,900 tons of salt used during 28 mobilizations.

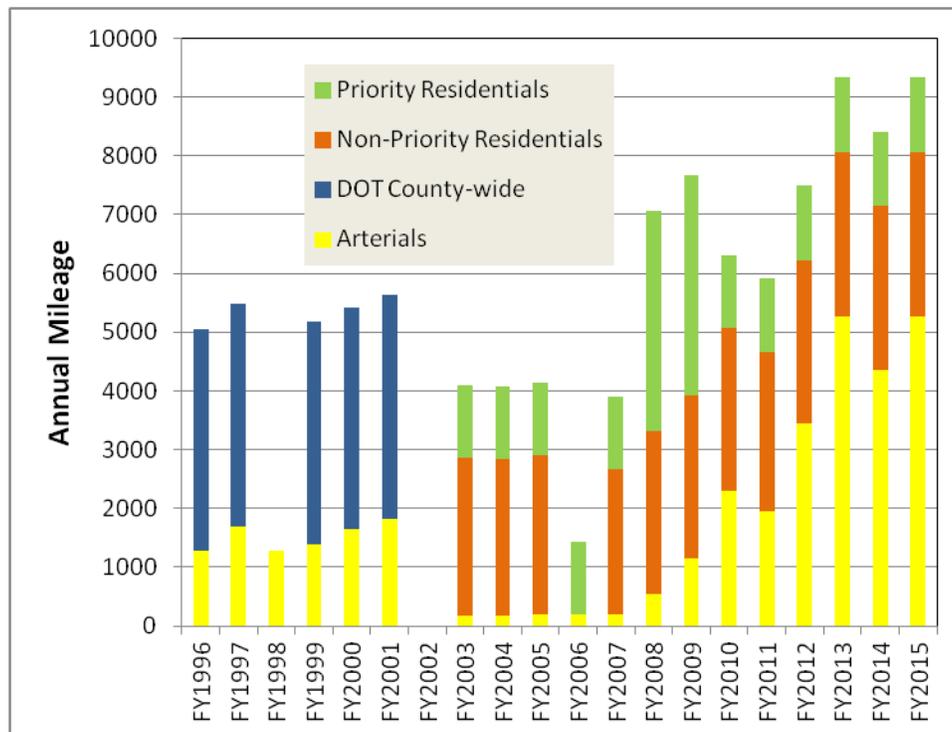
Figure III.E.10. Annual Montgomery County Street Sweeping Mileage 1996-2013

Figure III.E.10 below shows the mileage swept per year by route category. Overall average cost per mile remains low as the County continues to emphasize arterial sweeping. (Figure III.E.11).

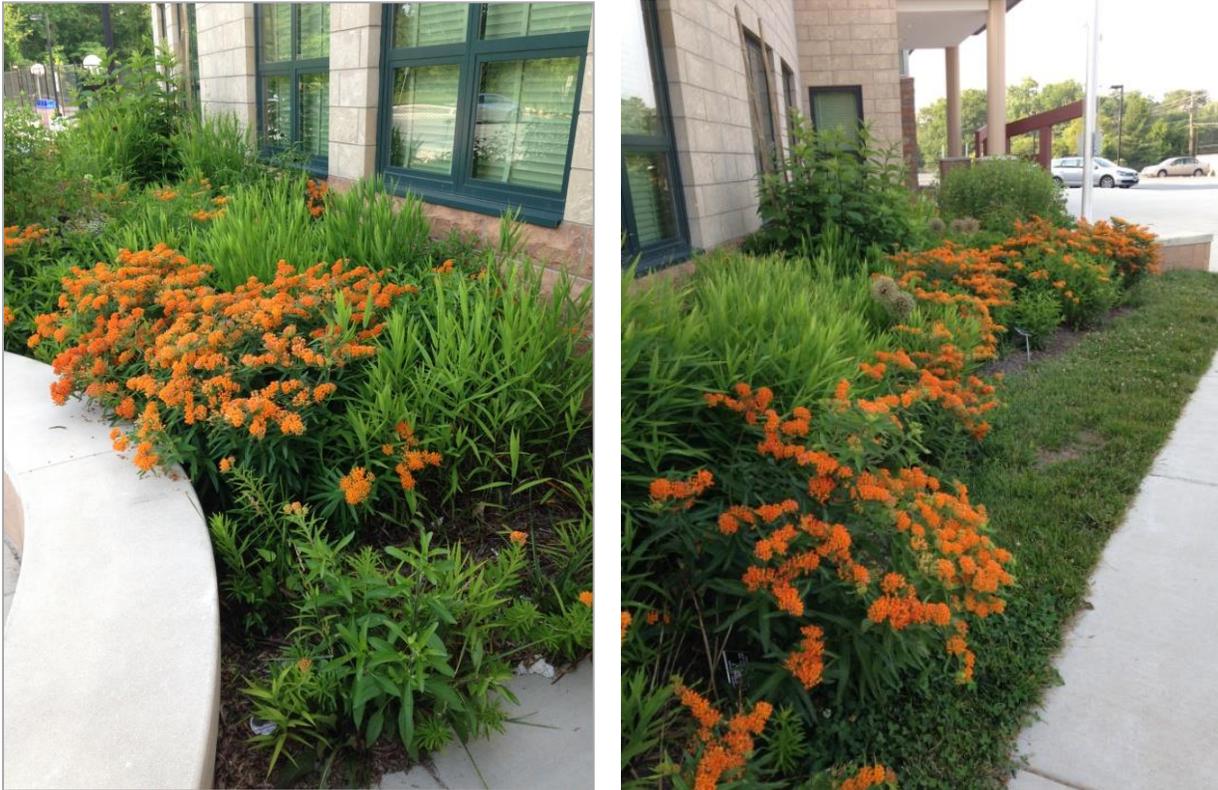
Figure III.E.23. RainScapes for Schools Conservation Landscape Garden Filtering Storm Water and providing Monarch Butterfly Habitat at the Seven Locks Elementary School

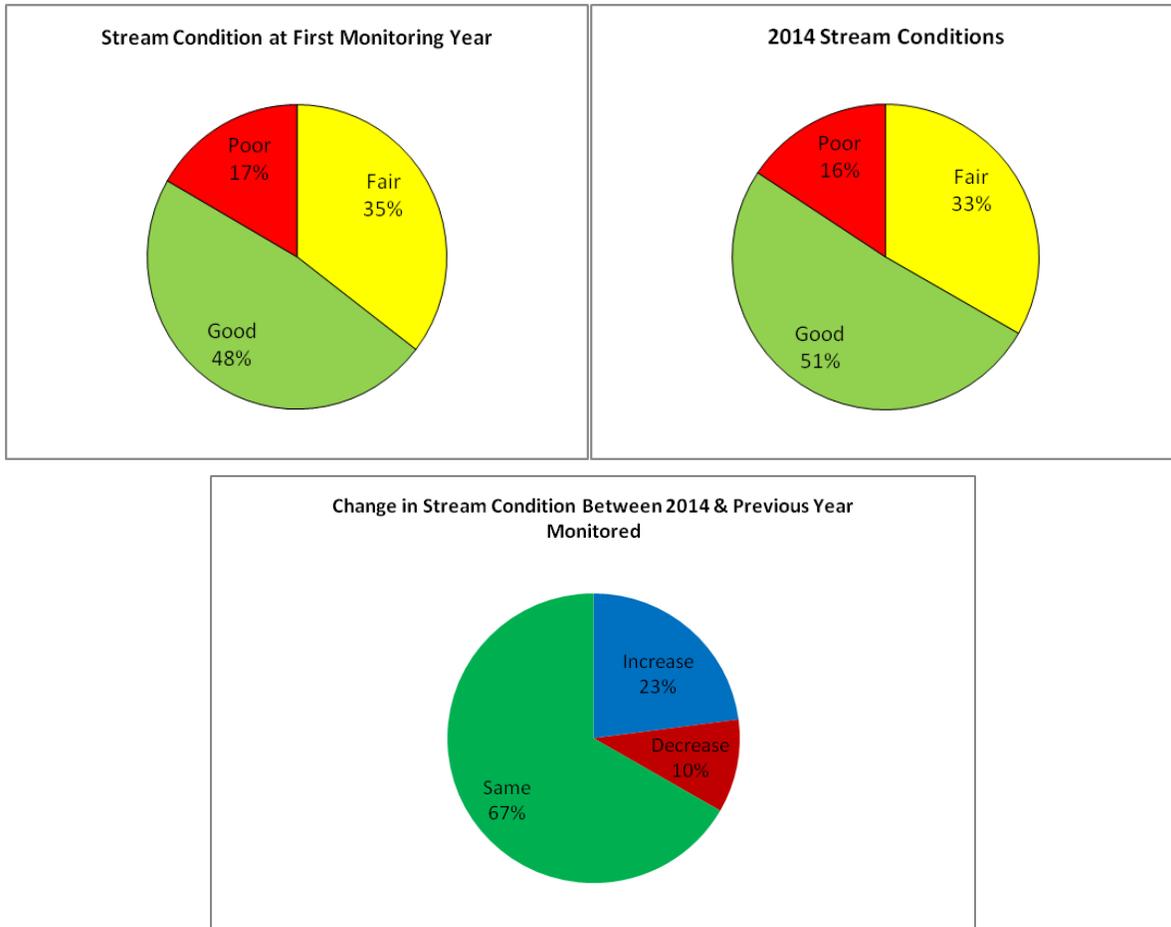
Restoration projects have been focused in urban, southern and eastern county watersheds of Little Falls and Cabin John. Most projects in Little Falls were completed prior to 2008 and impacts appear limited to date. Since 2002, the average stream conditions have been constant. Average stream conditions in Cabin John also continue to be constant. The restoration projects generally have been completed close to the 2014 monitoring cycle, allowing little time for recovery.

Figure IILF2. Overall Stream Condition Change Summary for Rock Run, Horsepen Branch, Little Falls, Little Monocacy, Dry Seneca, Broad Run, Potomac Direct, Cabin John, Little Seneca, Watts Branch, and Muddy Branch Watersheds, 2014

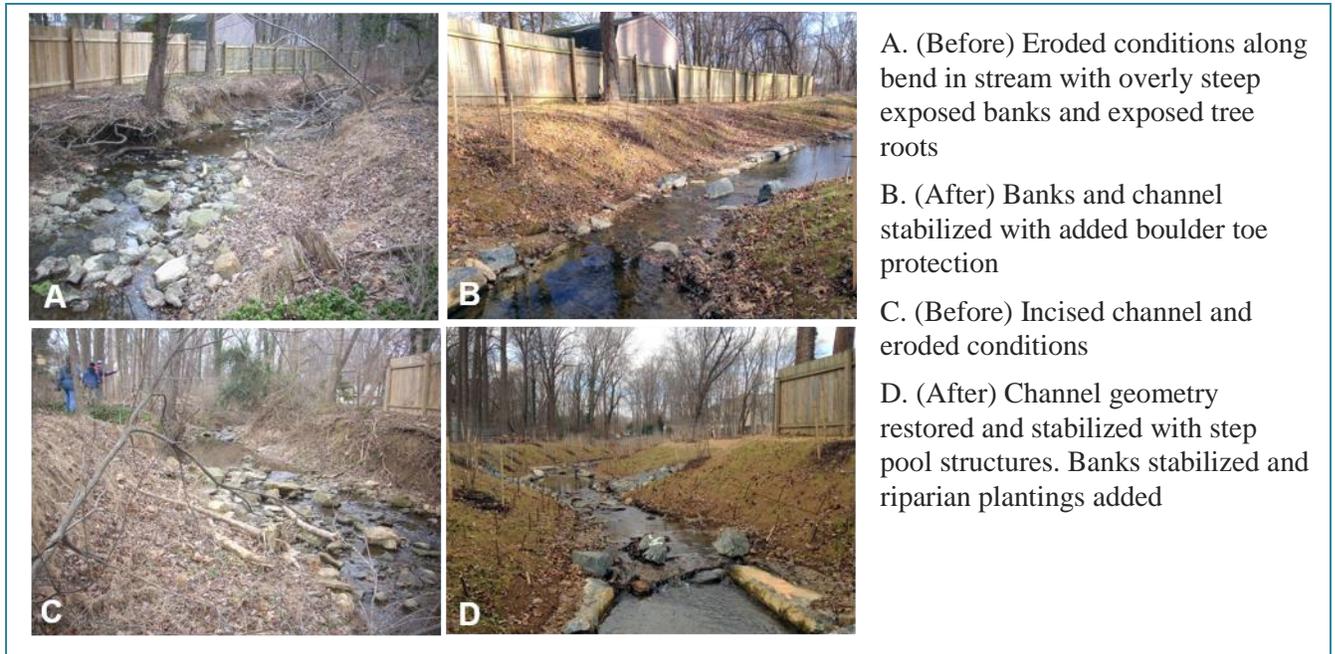
Figure III.G.3 Hollywood Branch Stream Restoration

Canon Road Green Streets improvement projects completed in surrounding neighborhoods will also contribute to the long-term success of the stream restoration.

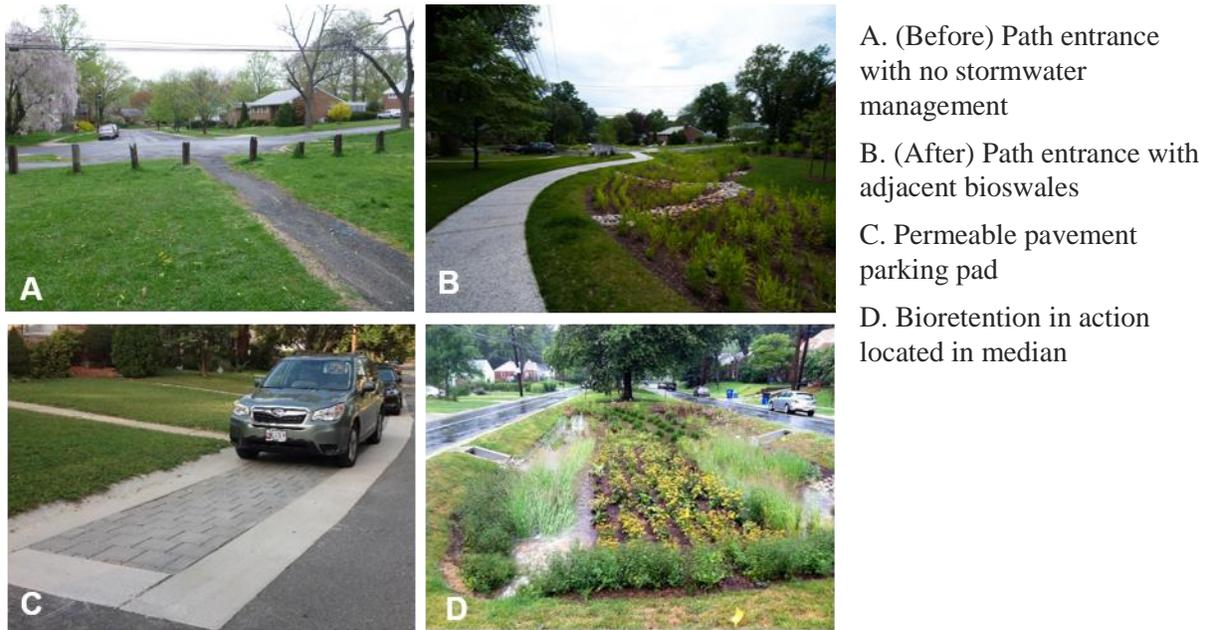
Figure III.G.4 Dennis Avenue Green Streets

Partnership with DOT facilitated right-of-way permitting and expedited project design and construction.

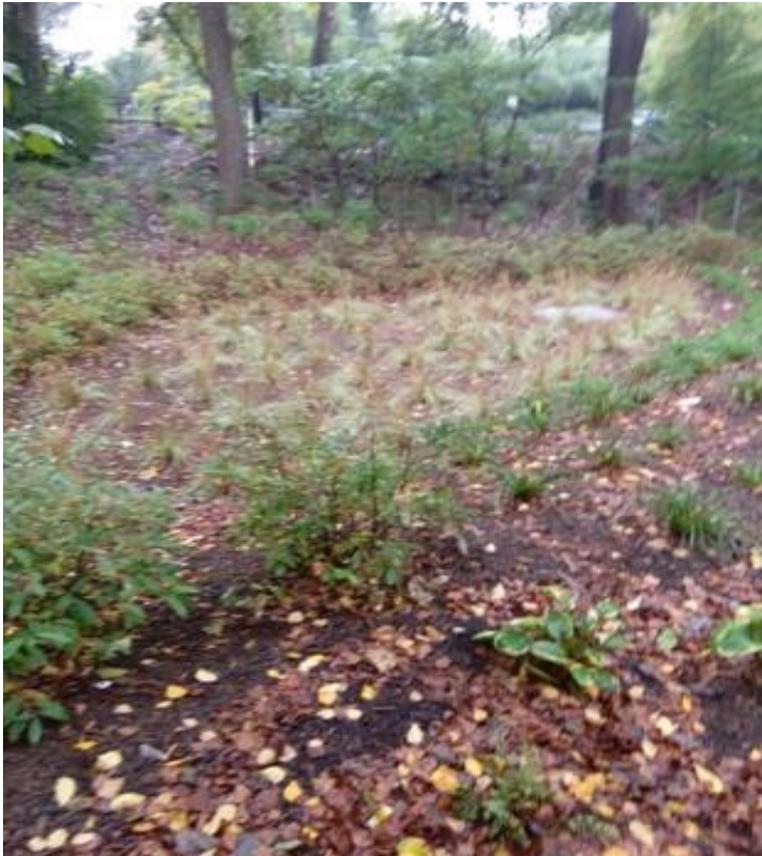
**Figure III.G.12. Rain garden
Installed by The Town of Chevy
Chase**

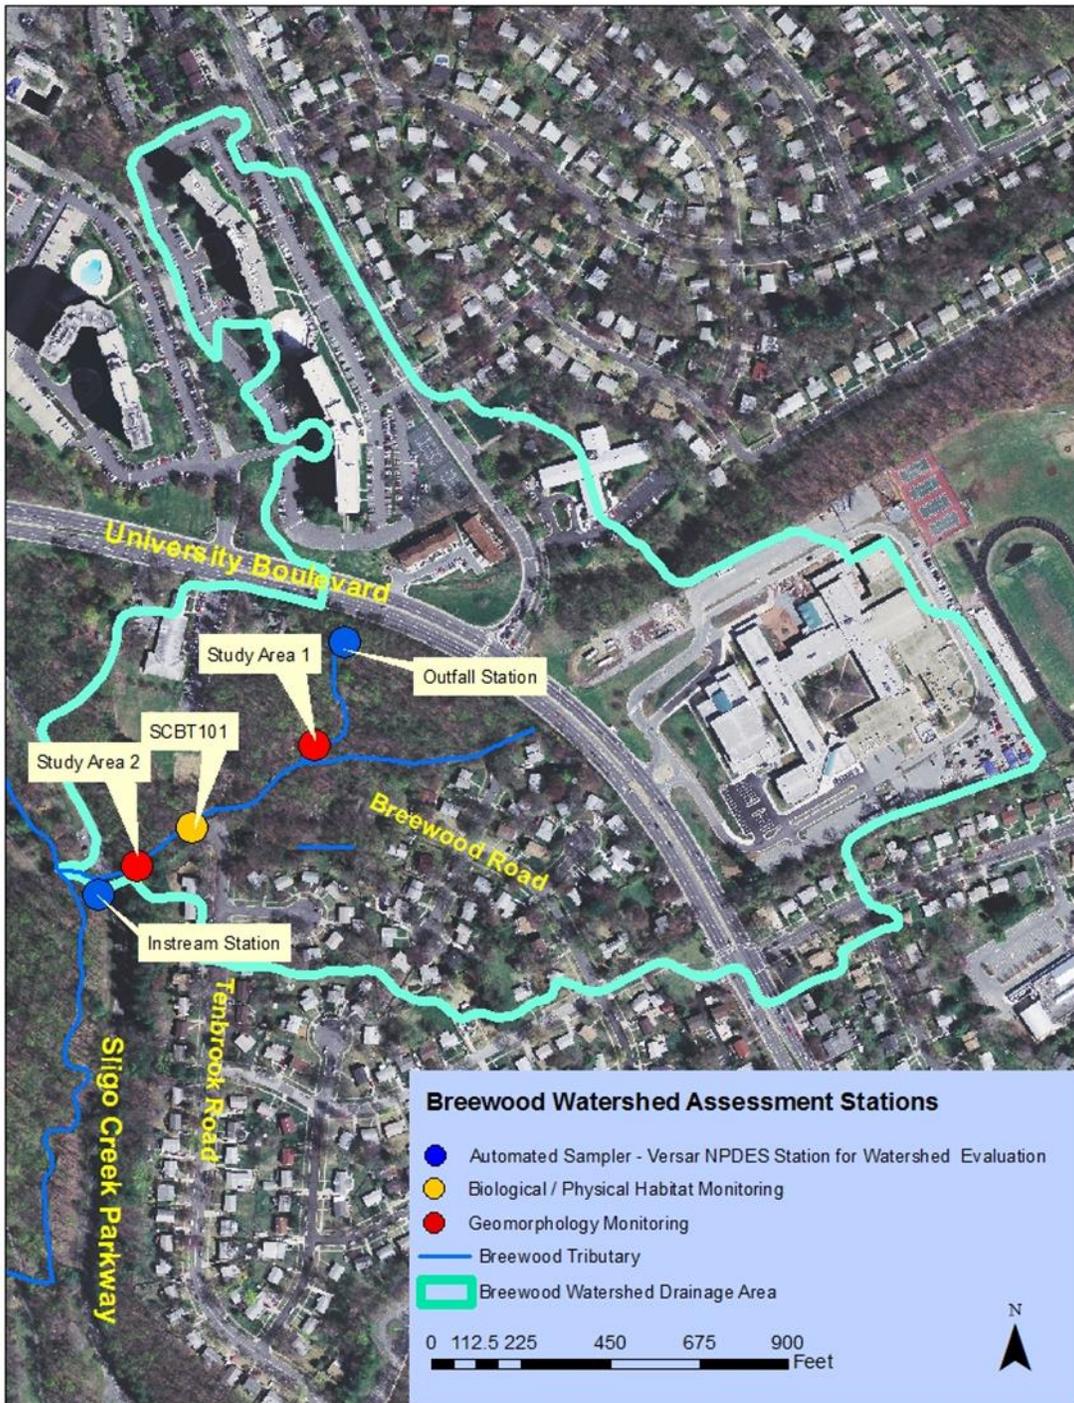
Figure III.H.2. Locations of Stream Chemistry, Biological, Physical Habitat and Geomorphology Monitoring Stations, Breewood Tributary of Sligo Creek

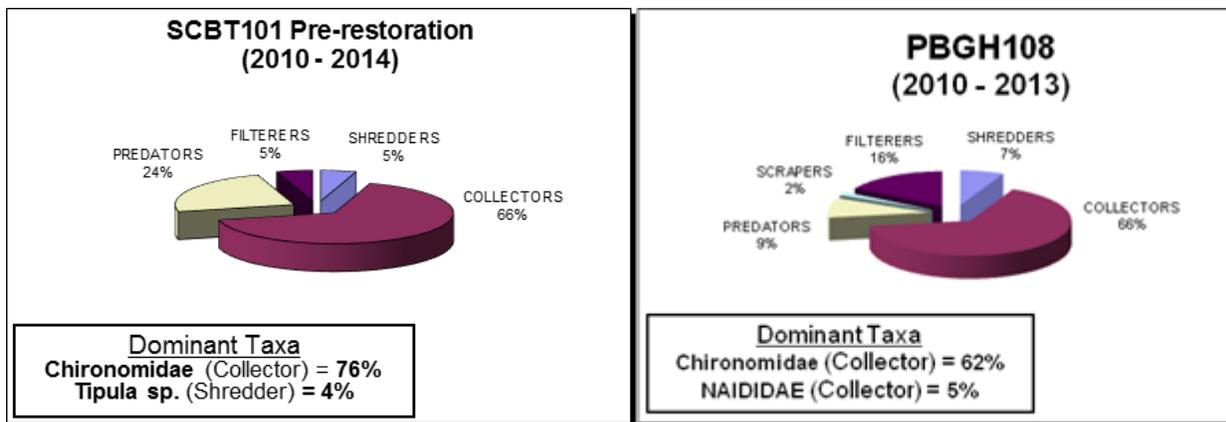
Figure III.H.4. Functional Feeding Group Comparison in the Breewood Tributary (SCBT101) and in the Good Hope Tributary (PBGH108)

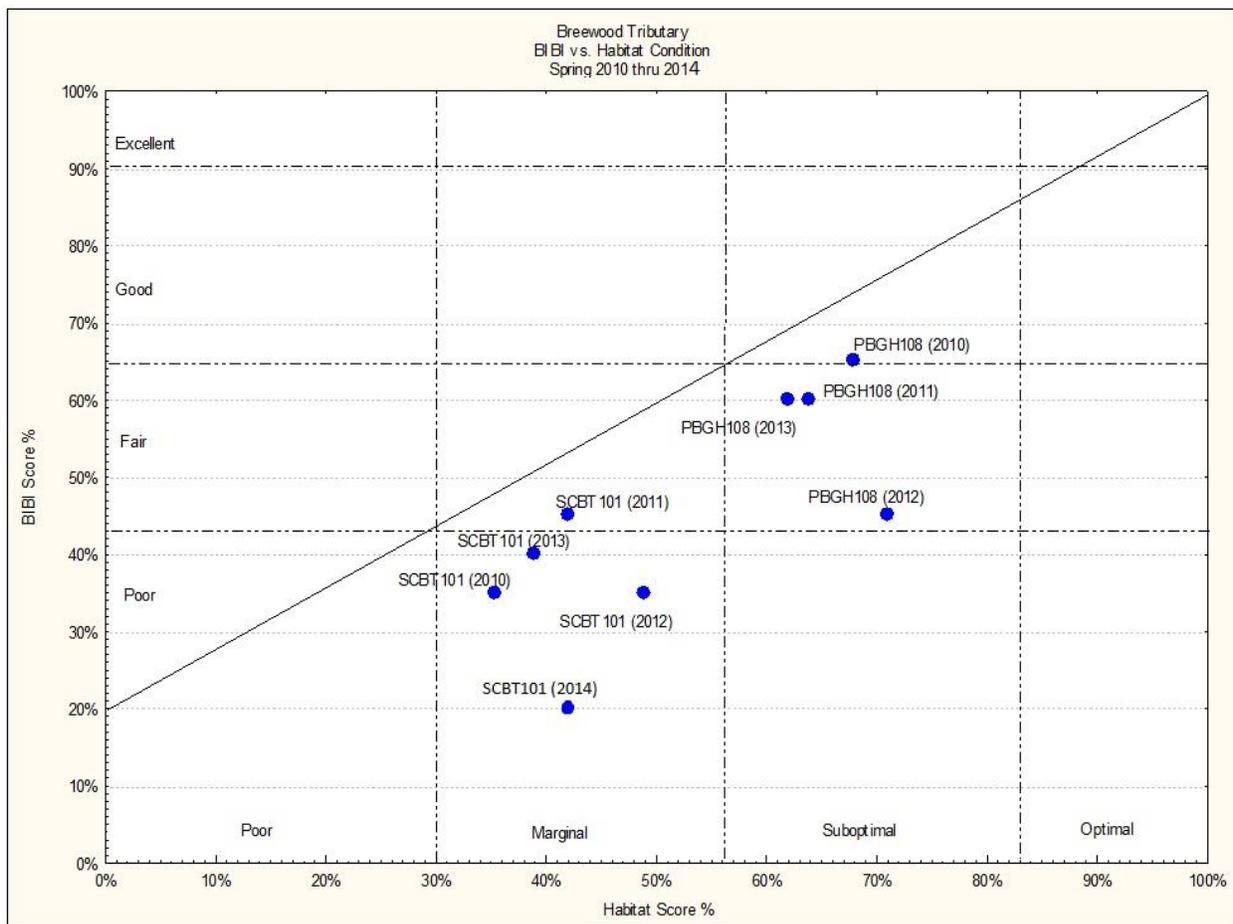
Figure III.H.5. BIBI vs. Habitat Condition at Breewood Tributary and Reference Stream, Spring 2010 thru Spring 2014

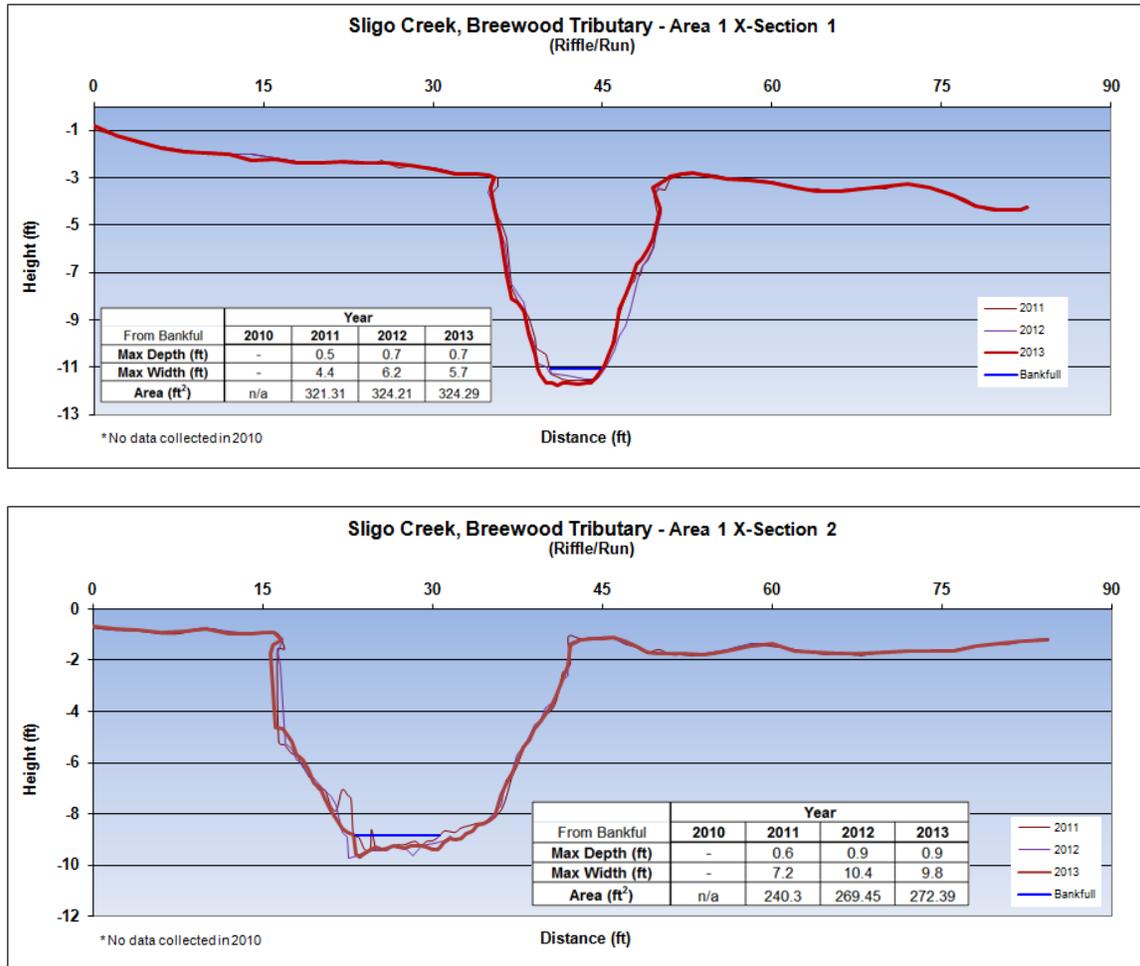
Figure III.H.6. Representative Cross Sections from Breewood Tributary, Study Area 1

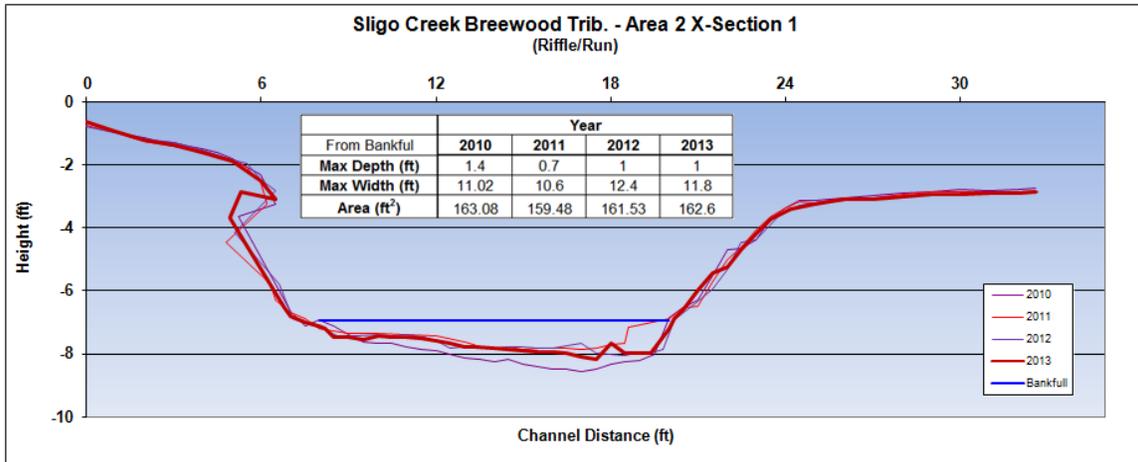
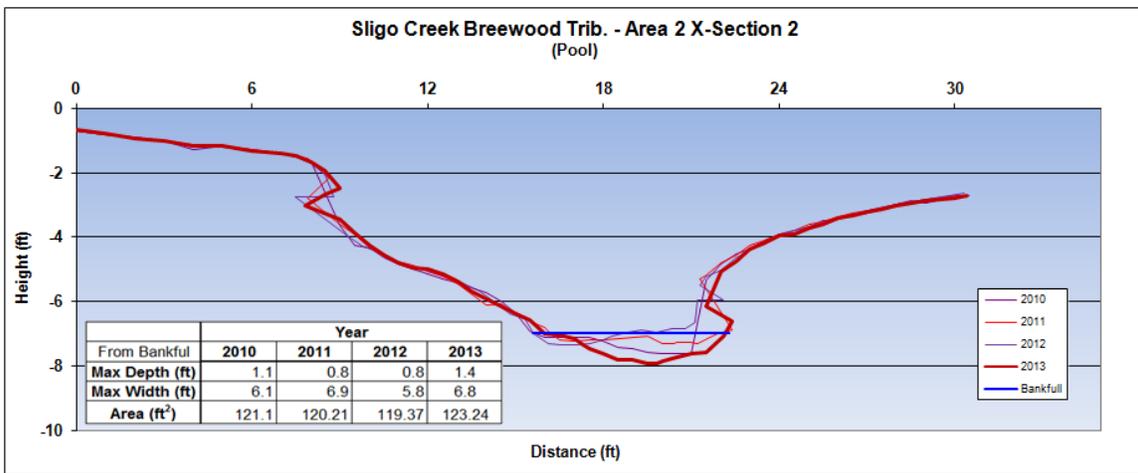
Figure III.H.7. Representative Cross Sections From Breewood Tributary, Study Area 2

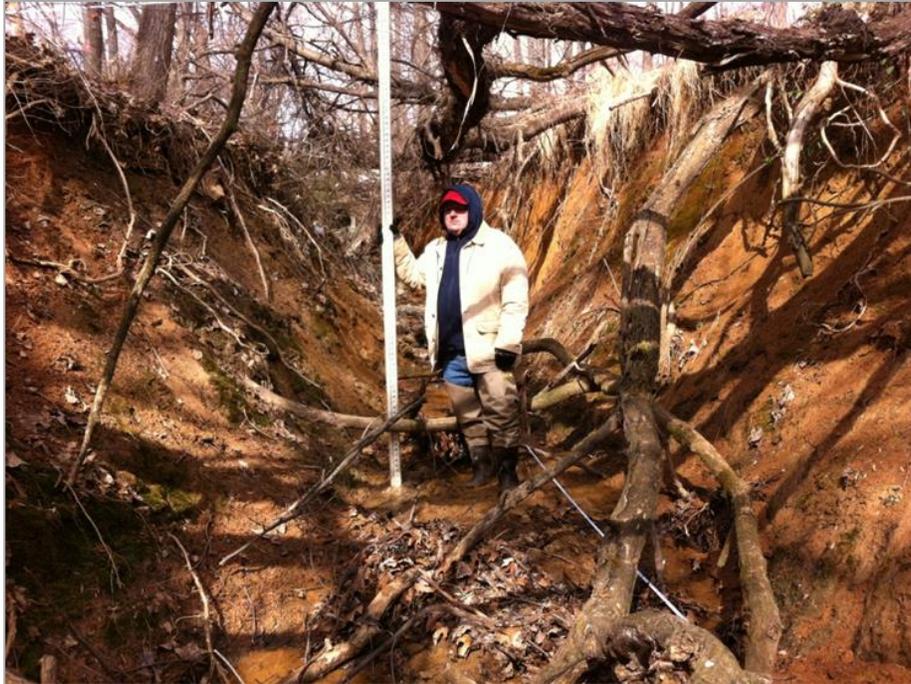
**Figure III.H.8. Upstream View of Sligo Creek,
Breewood Tributary, Study Area 1- Cross Section 1. Pre-Restoration**

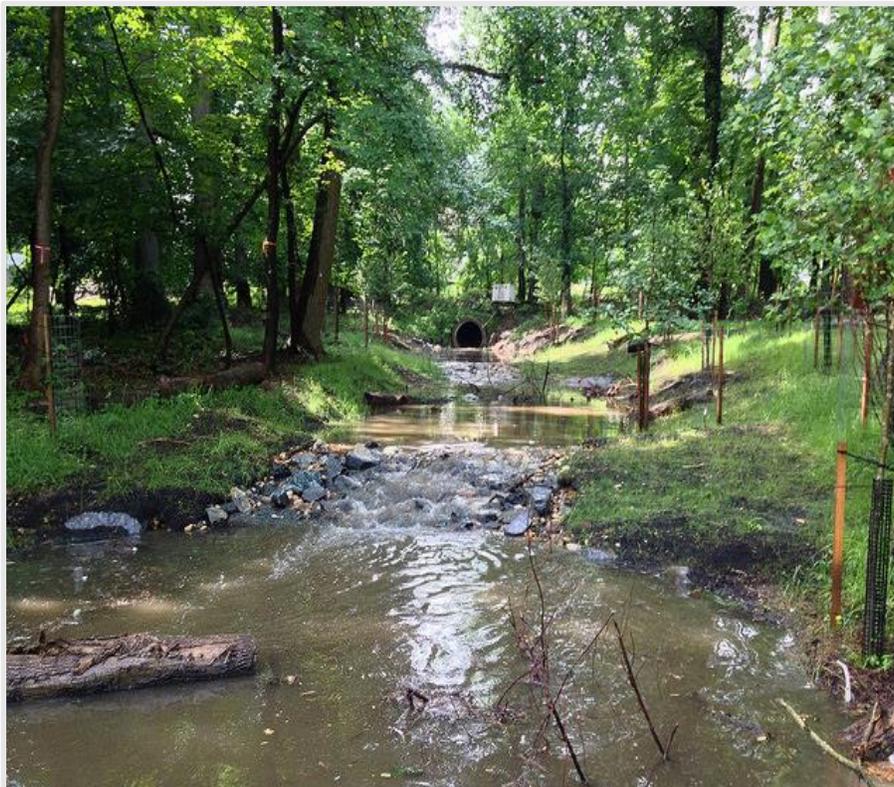
**Figure III.H.9 Breewood Tributary, Study Area 1- Cross Section 1. Post
Restoration**

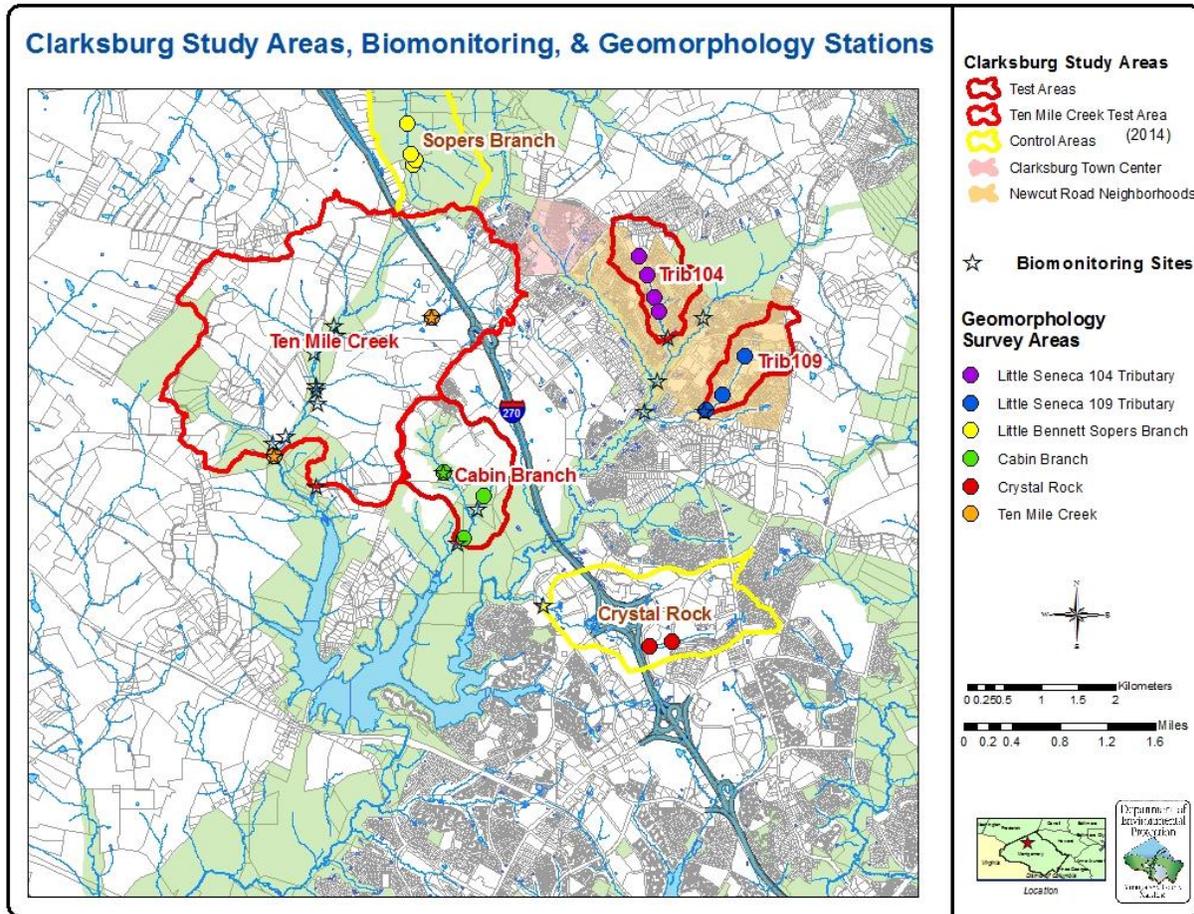
Figure III.H.10. Location of the Clarksburg Monitoring Partnership three test areas and two control areas. Also included are biological monitoring stations and geomorphic survey locations.

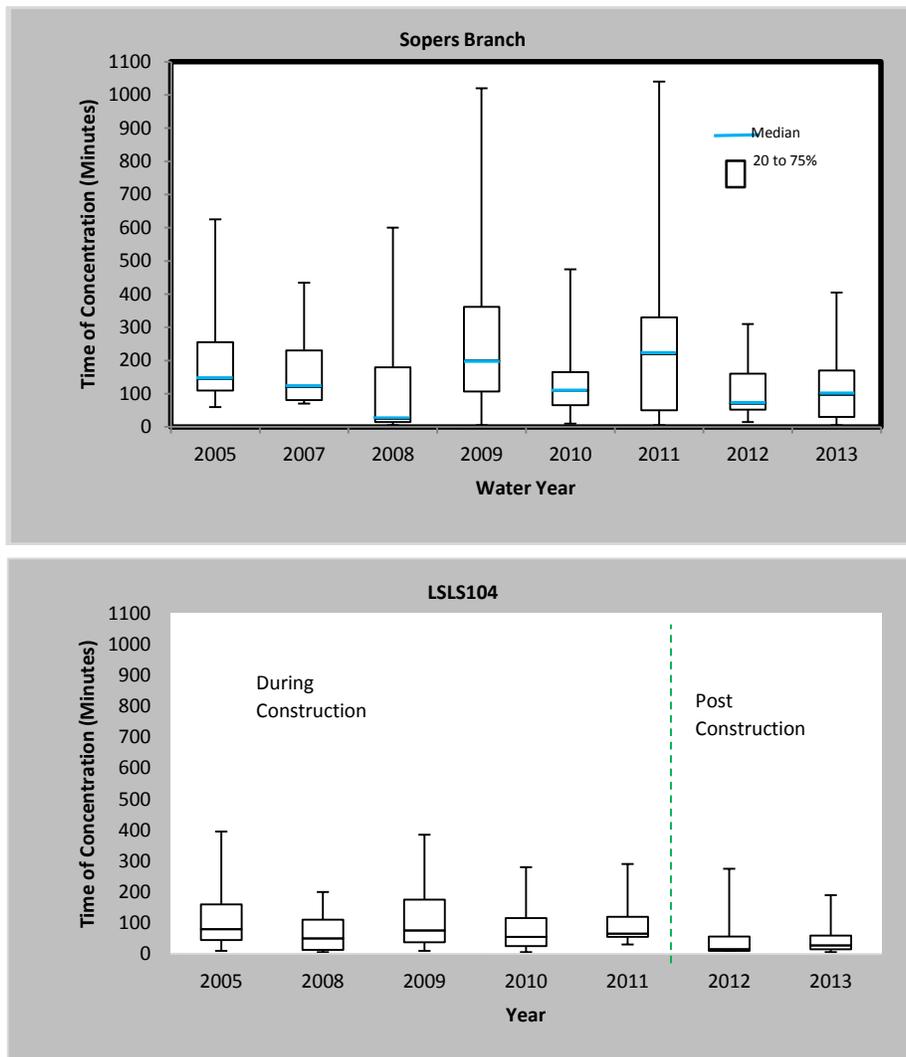
Figure III.H.10 Time of Concentration for Soper's Branch and Newcut Road Neighborhood Tributary 2005 to 2013

In 2014, the natural hydrology of the test area has been altered by the development process. On average, the overall amount of precipitation infiltrating into the ground or lost via evapotranspiration has declined in the test area while remaining fairly constant in the control area. The results indicate the stream channel at the test area may still be in a state of flux as the system responds to the conversion from S&EC to SWM structures. Post-construction monitoring has not yet been completed. DEP has observed changes in the test area channel morphology as evidenced by straightening, down-cutting, and enlargement of the channel

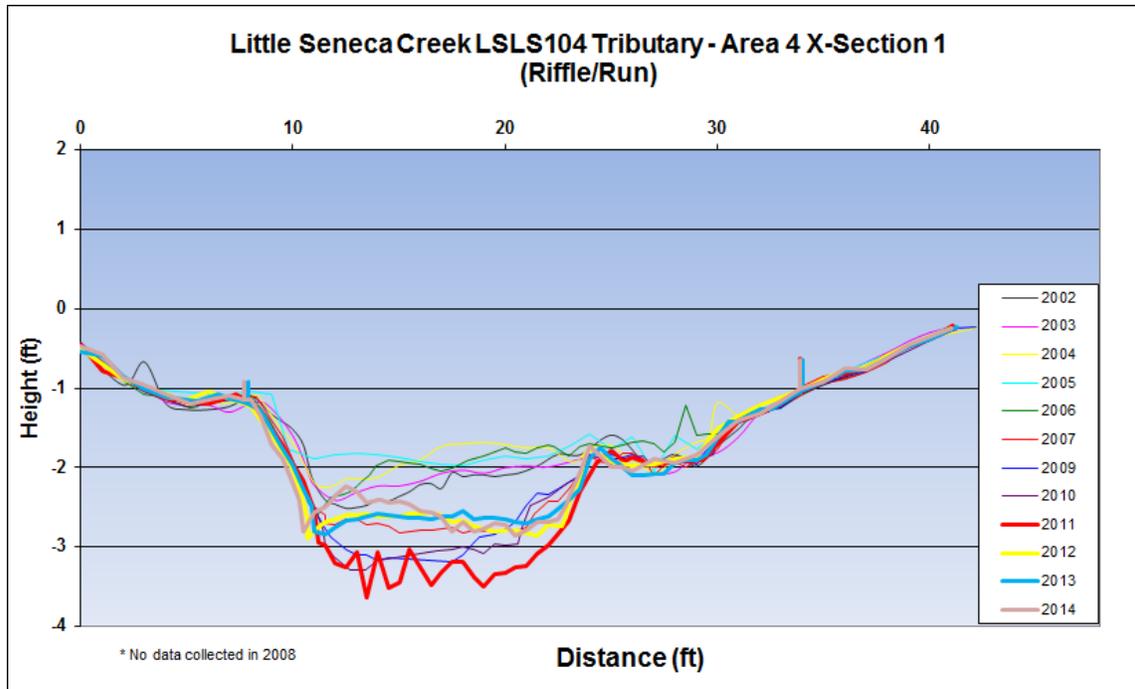
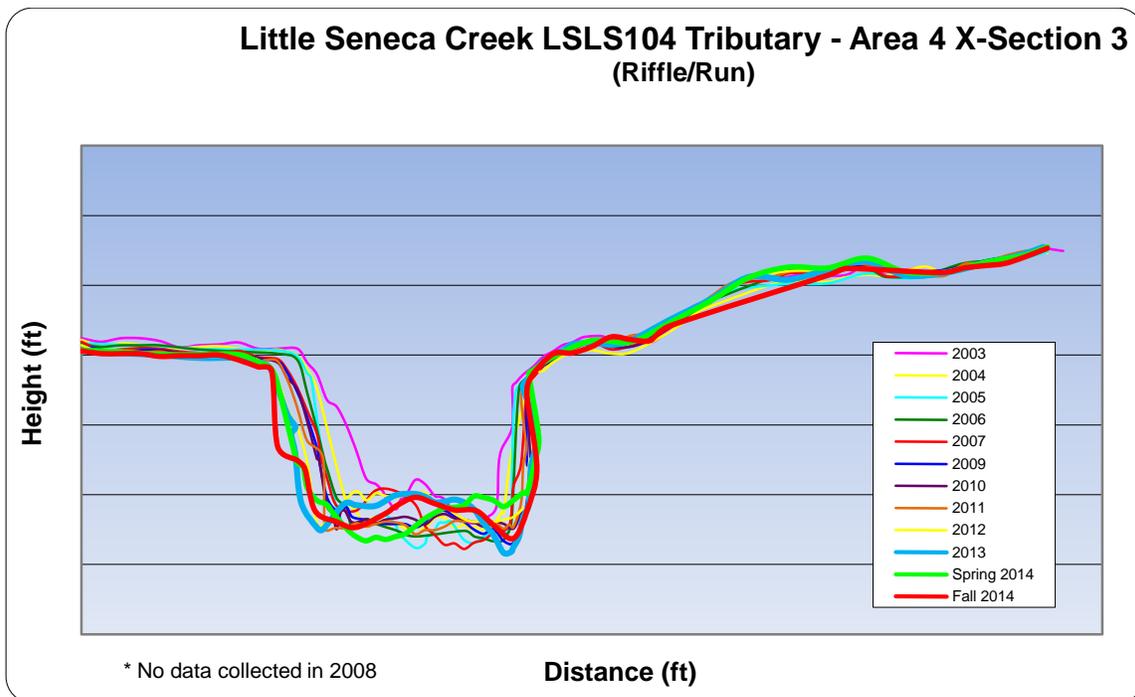
Figure III.H.13. Representative cross sections from the test area (LSLS104), cross section location 4 (most downstream location). Cross sections are both measured in riffle/run features.

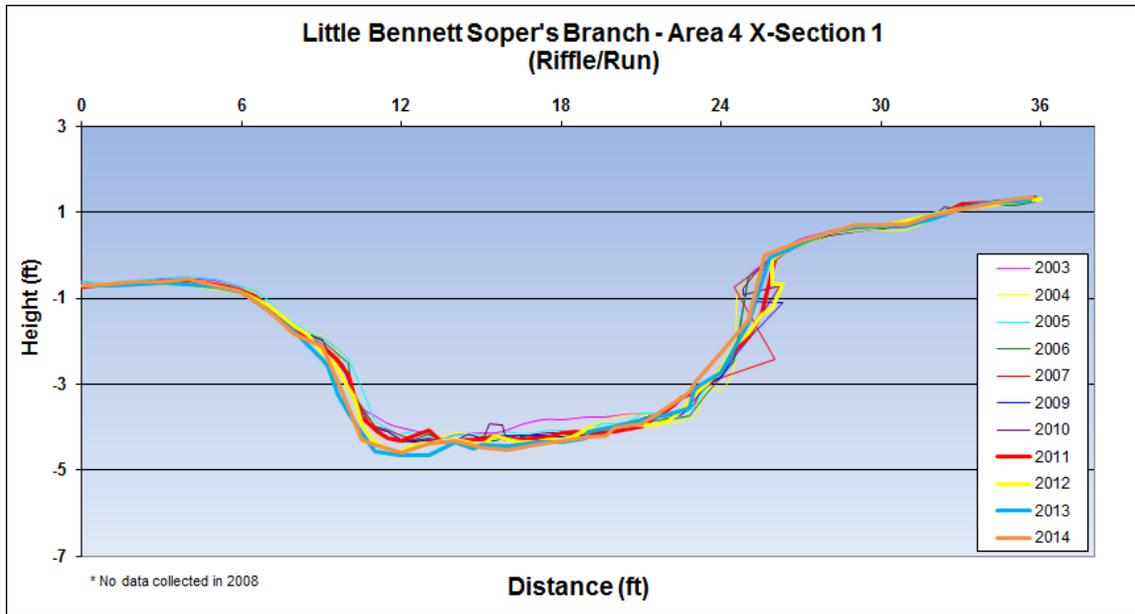
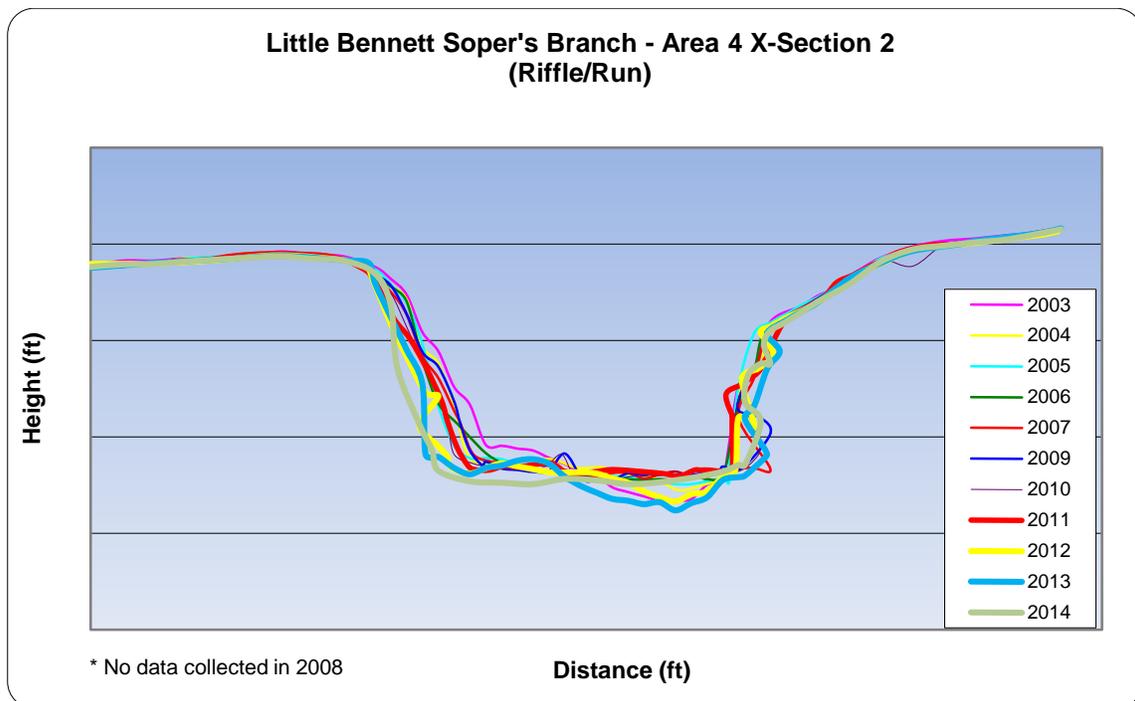
Figure III.H.14. Representative cross sections from the control area, cross section location 4 (most downstream location). Cross sections both measured in riffle/run features.
