Annual Report for FY15 NPDES Municipal Separate Storm Sewer System Permit

Published by the Montgomery County Department of Environmental Protection
for the Maryland Department of the Environment

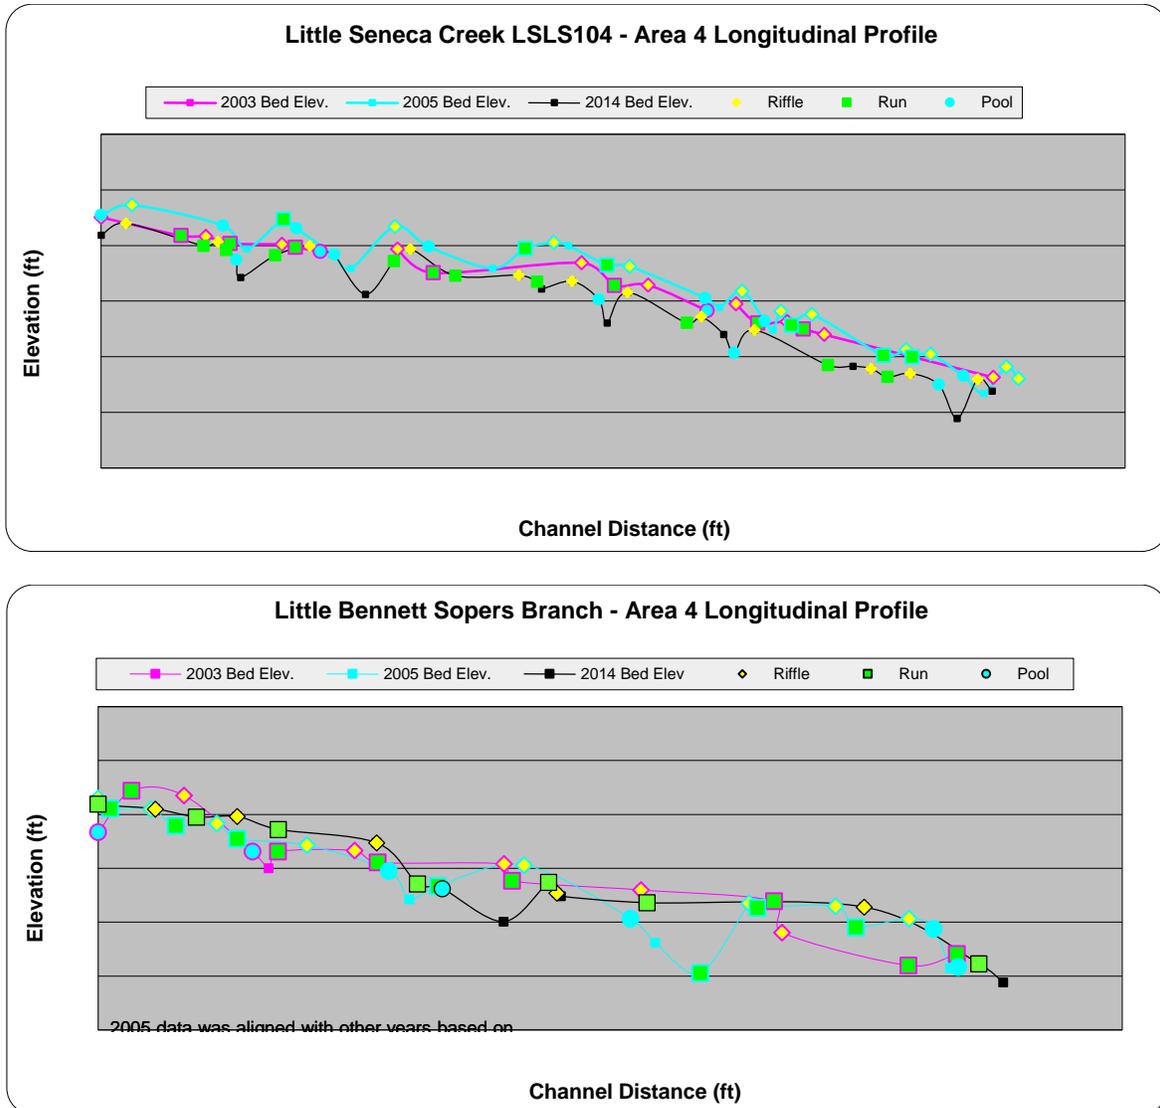
Figure III.H.15. Longitudinal Profiles Test Area (LSLS104) and Sopers Branch Control, Study Area Location 4 (Most Downstream Location).
