# Special Protection Area Program Annual Report 2010

Prepared by the Montgomery County Department of Environmental Protection in Cooperation With the Department of Permitting Services and the Maryland-National Capital Park and Planning Commission

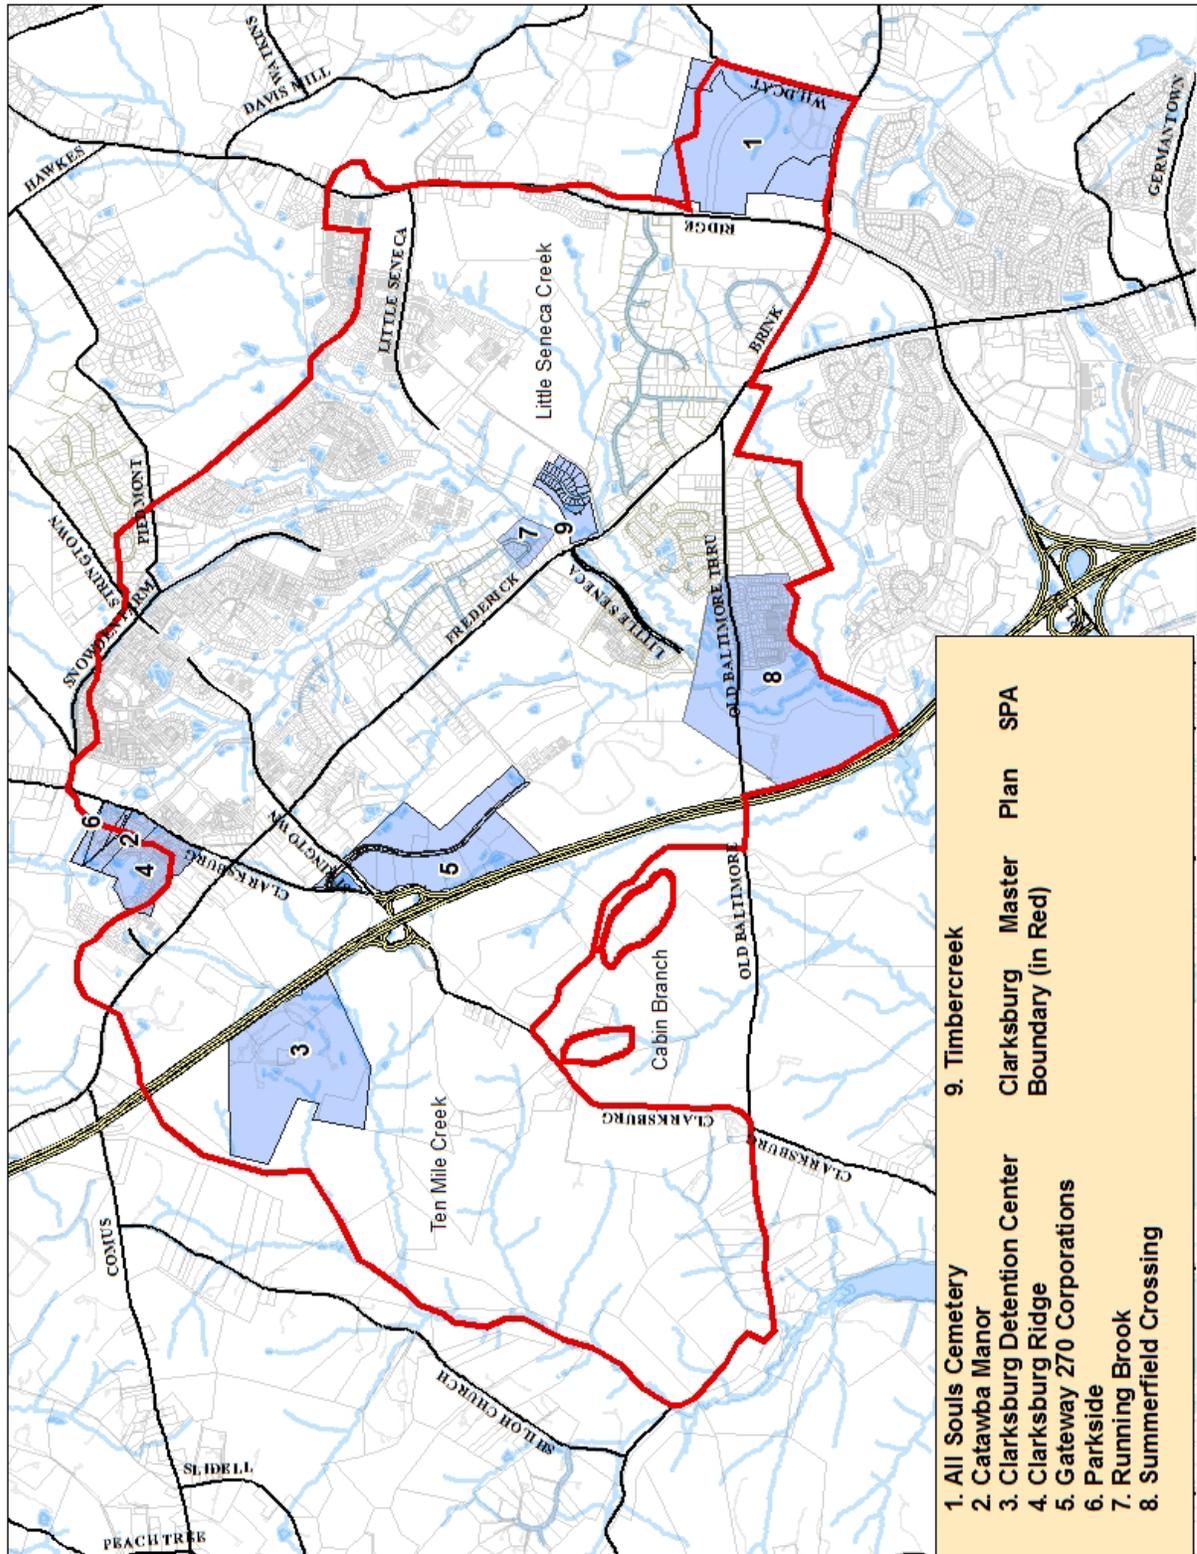
**Figure ES- 1. All Properties (in blue) within the Clarksburg SPA where Stormwater Management BMP's have been monitored as of 2010. For a detailed map of BMP monitoring status in the Clarksburg SPA refer to Figure 3.2.**

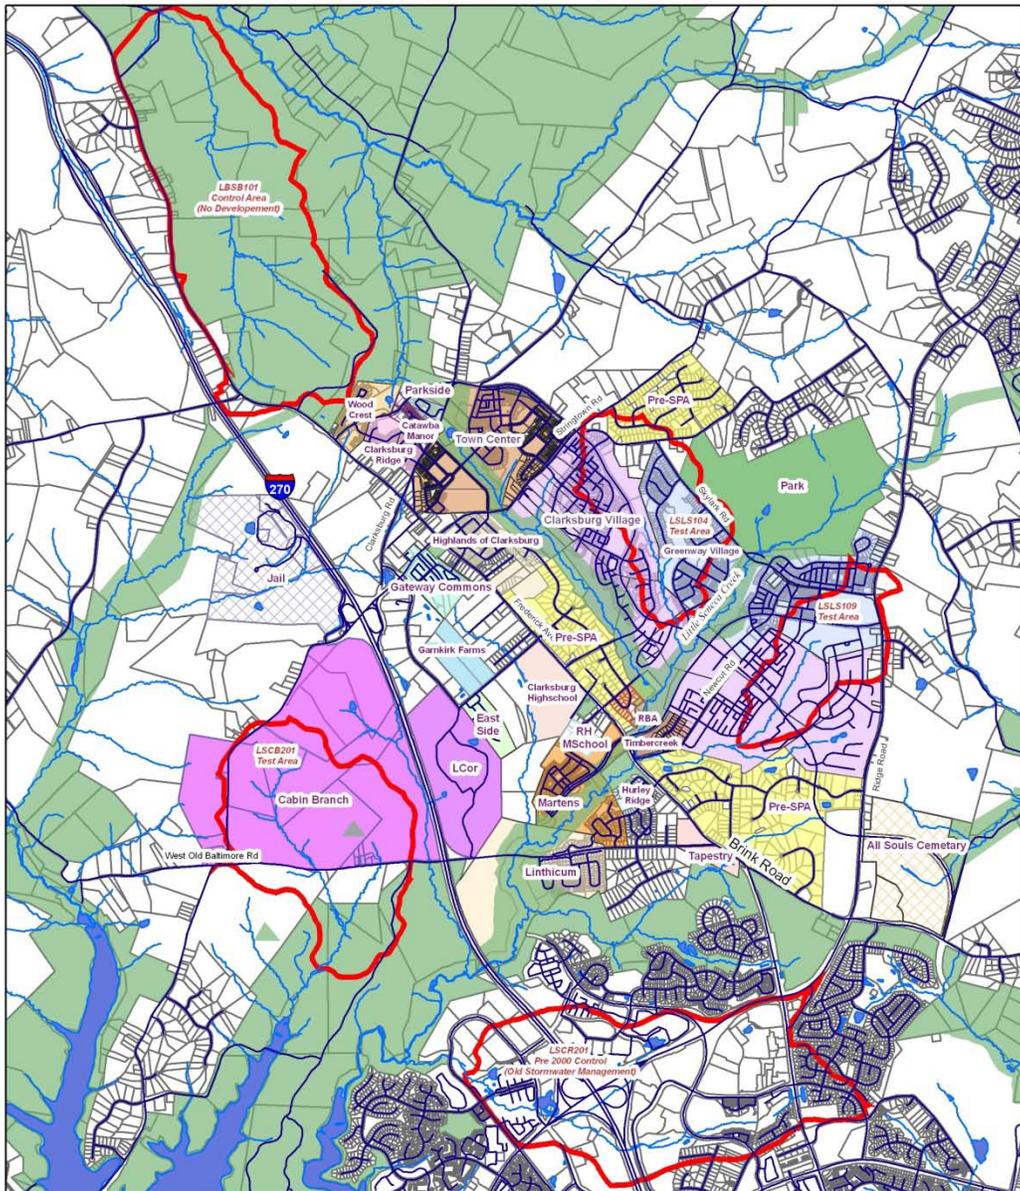
**Figure 1.2. Location of the Clarksburg Monitoring Partnership BACI Three Test Areas and Two Control Areas.**

The CMP is using a [Before, After, Control, Impact \(BACI\) design](#) approach (Fig. 1.2) to assess the land use changes and the impacts to stream conditions. Three test areas were selected: two in the Newcut Road Neighborhood and one in the Cabin Branch Neighborhood (Fig. 1.2). An undeveloped control area was established in Little Bennett Regional Park and a final developed control area was set up in Germantown (Fig. 1.2). All the test and control areas have United States Geological Survey (USGS) flow gages installed and are collecting continuous stream flow data over time. Two rain gages monitor area rainfall and document local rainfall intensities to correlate rainfall to stream flow. Light Detection and Ranging (LiDAR) imagery will assist in the mapping of landscape changes as a result of the terrain alterations in Clarksburg.

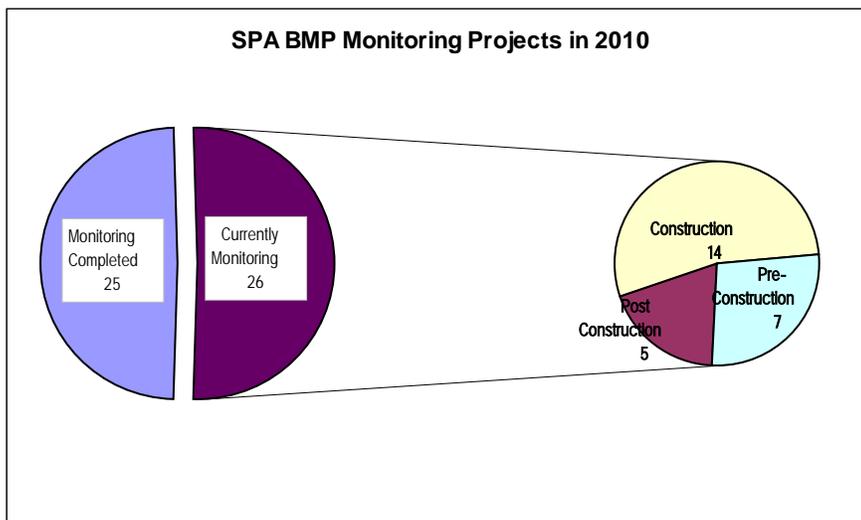
**Figure 3.1. SPA BMP Monitoring Project Completion Status in 2010.**

There are a total of 51 monitoring projects as of 2010. Status of the BMP monitoring projects being conducted in 2010 as part of the SPA program is shown in Figure 3.1. A list of parameters monitored per project is located in Technical Appendix 3.

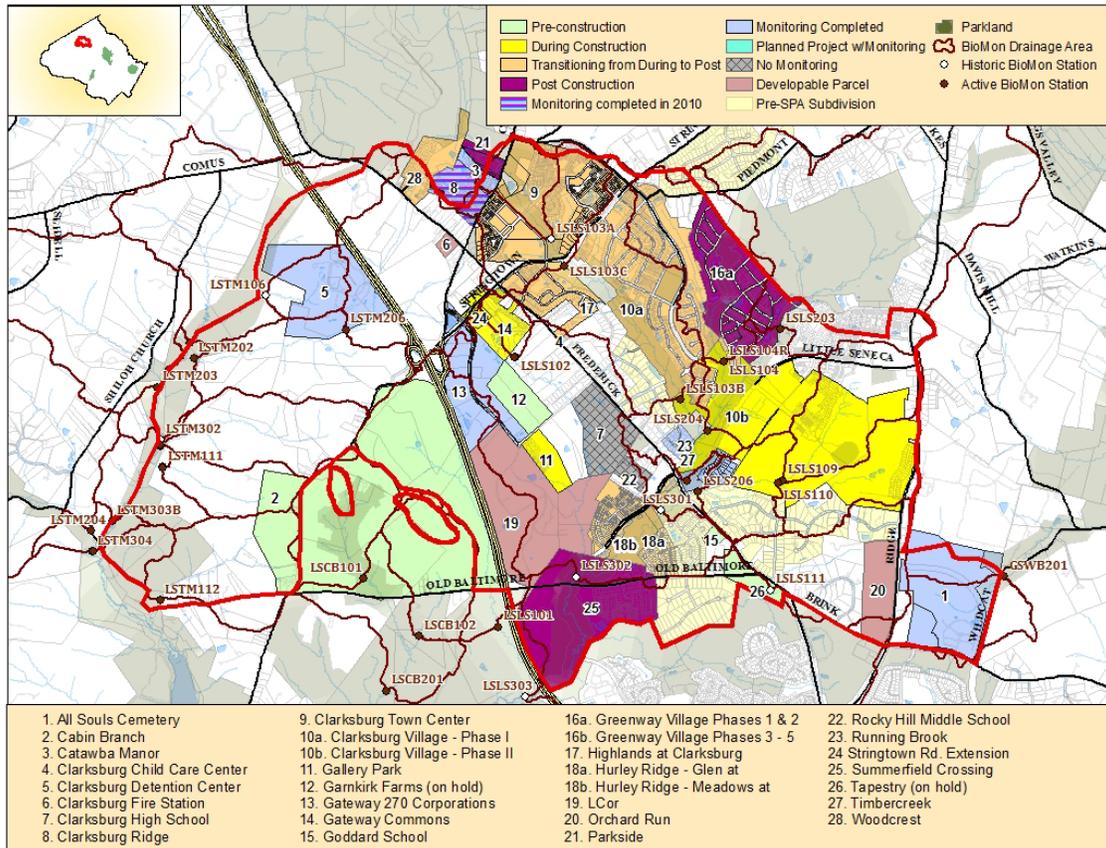
Figure 3.2. 2010 Status of Clarksburg SPA Monitoring Projects.

Much of the Clarksburg Special Protection Area still remains in the during construction monitoring phase but many properties have largely been stabilized, with some S&EC basins converted to SWM facilities (Fig. 3.2).

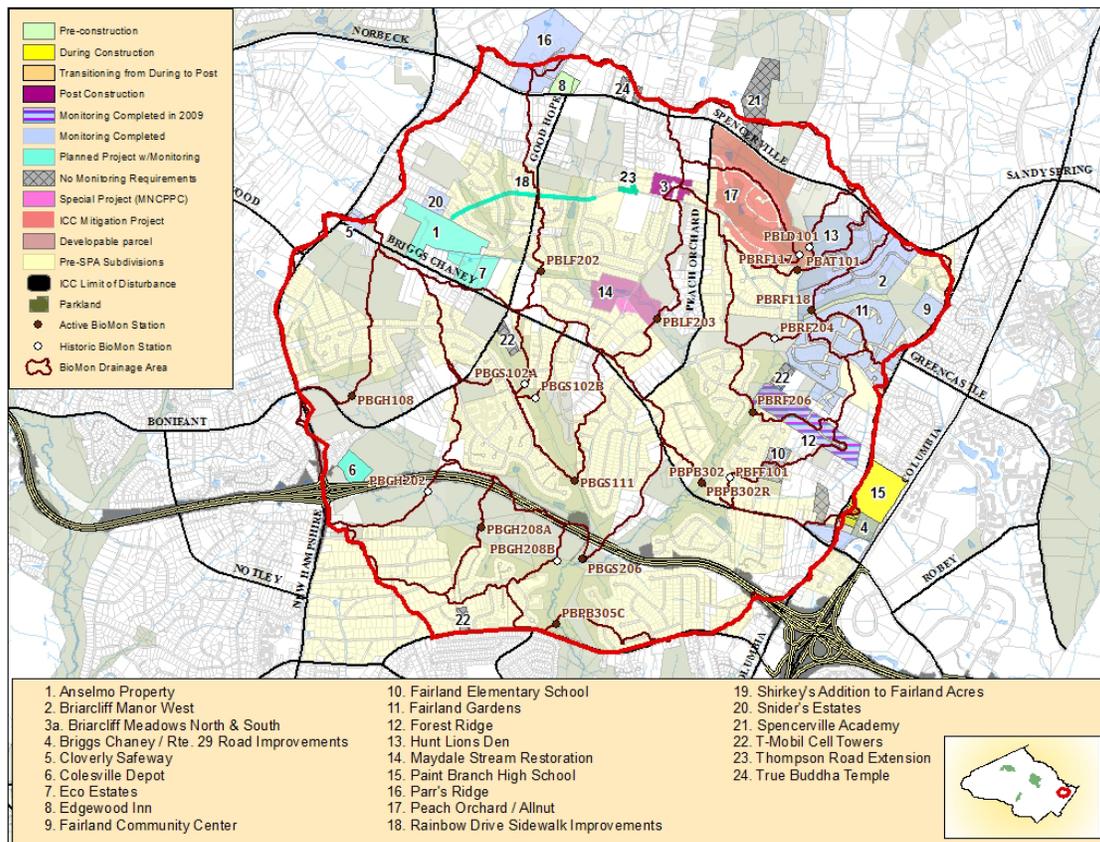
**Figure 3.3. 2010 Status of Upper Paint Branch SPA Monitoring Projects.**

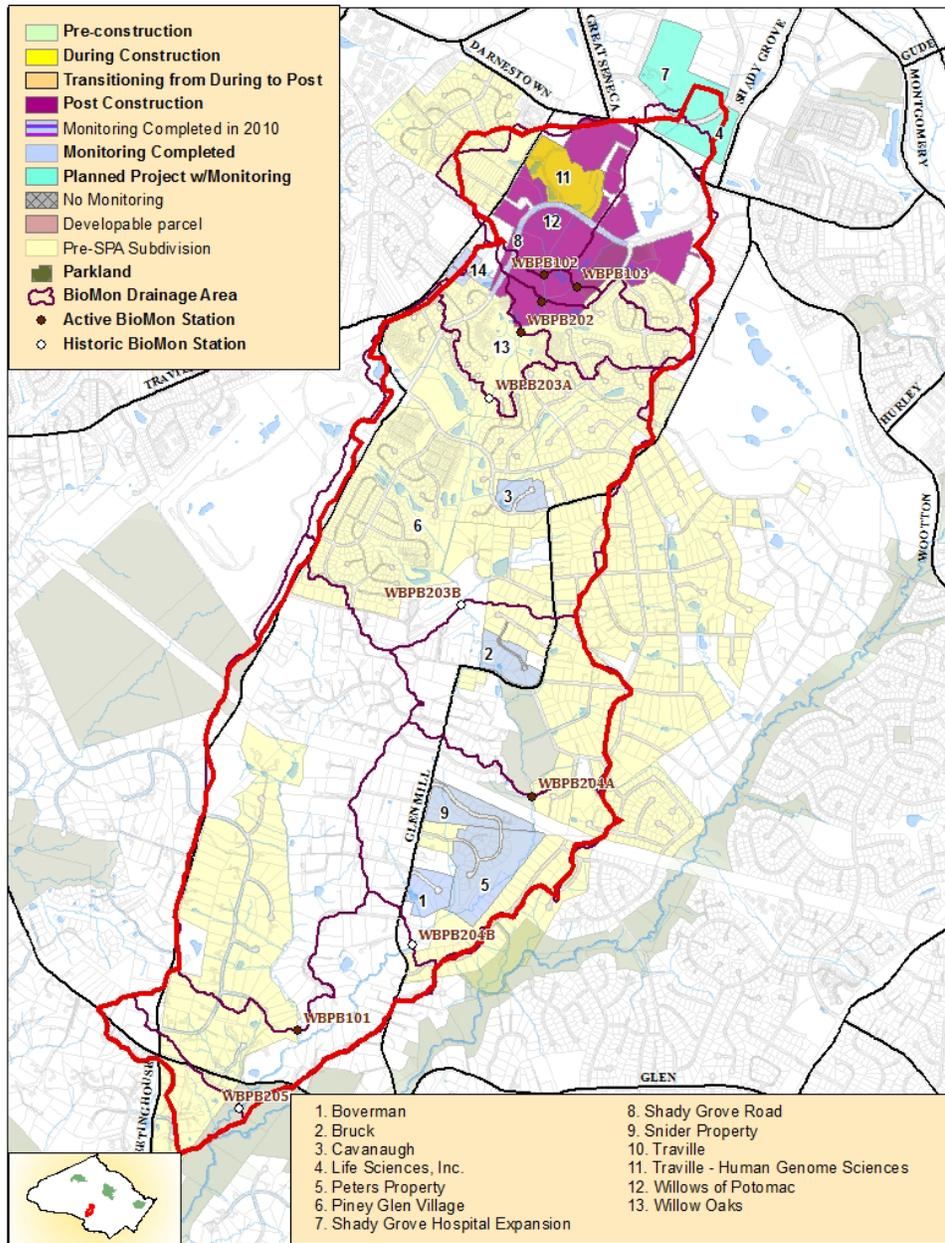
Figure 3.4. 2010 Status of Piney Branch SPA Monitoring Projects.

The only monitoring project still active in the Piney Branch SPA is Traville (Fig. 3.4). A post construction monitoring permit for the project was issued in April 2009. Post construction monitoring activities were initiated at one sand filter on Traville in September 2010, but no viable water chemistry samples were collected. The remainder of monitoring (water chemistry and groundwater recharge) is scheduled to be initiated in 2011. Samples will be analyzed for nitrate, nitrite, TKN (total Kjeldhal nitrogen), ortho-phosphate, total phosphorus, copper, cadmium, lead, and zinc.

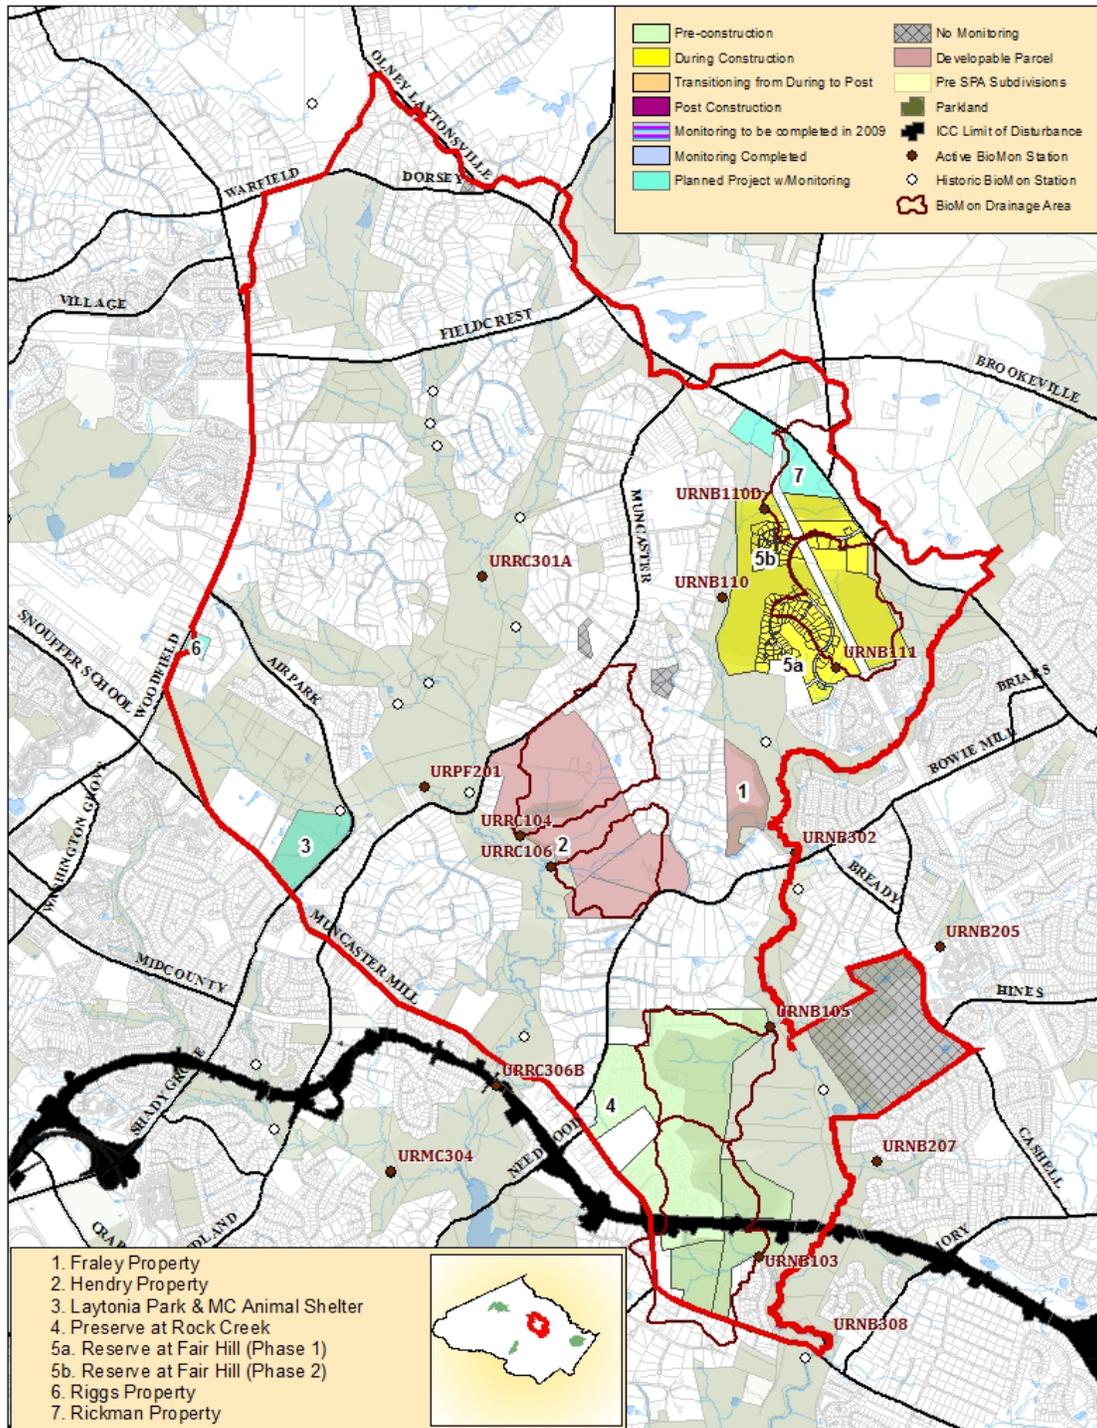
Figure 3.5. 2010 Status of Upper Rock Creek SPA Monitoring Projects.

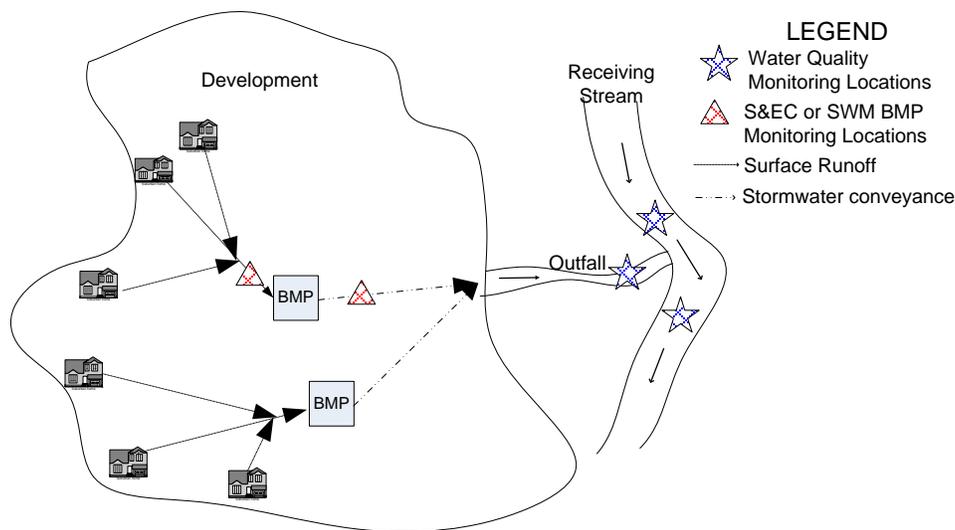
**Figure 3.6. Schema Representing SPA BMP Monitoring Locations.**

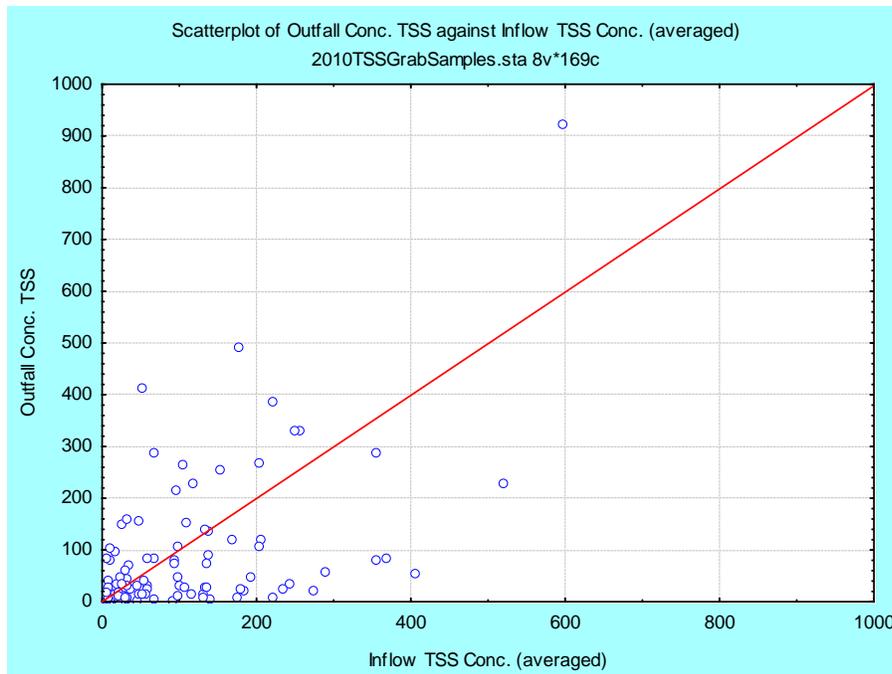
**Figure 3.7. Inlet and Outfall TSS Concentrations (Grab Sample Data) From Monitored Sediment and Erosion Control Structures. For Some Structures, Inlet TSS Concentrations Represent a Calculated Average Value for Multiple Inlets.**

S&EC structures receiving dirty, sediment-laden water (likely to occur during the early development periods involving cutting, filling, and grading) resulted in larger TSS concentration reductions than in samples with concentrations lower than 100 mg/L (which are often collected later in the construction process). For storm events where influent TSS concentrations were greater than or equal to 100 mg/L, the median TSS removal efficiency was 63.6 % (Fig. 3.8). At concentrations below 100 mg/L, the results were much more variable with a median removal efficiency of only 17.5% (Fig. 3.9). In some cases, water leaving the S&EC BMP contained higher concentrations of TSS than the entering water. The less polluted water (less than 100 mg/L) entering the S&EC structures could be the result of the sampling event taking place fairly late in the grading and site preparation process during the period where most of the cut and fill were completed. It may also be the result of soil compaction as final lot and road grades were completed to maintain the final surveyed grades. The higher outfall concentrations could be from the resuspension of fine clays and silts already in the control structure basin. As projects get closer to completion and less exposed earth is present on the site, there may be more sediment accumulated from prior storms being washed out of structures than is entering and settling in the trap.

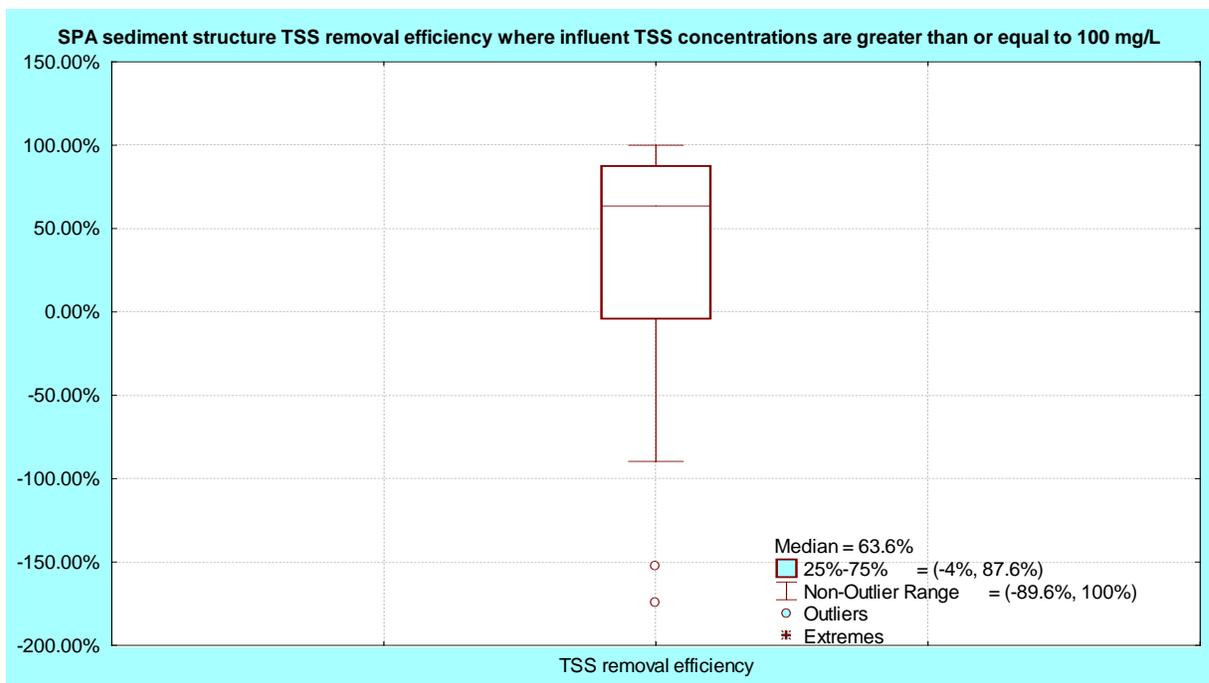
**Figure 3.8. Percent Difference of Inlet and Outlet TSS Concentrations From Grab Samples Where Influent TSS Values are Greater Than or Equal to 100 mg/L.**

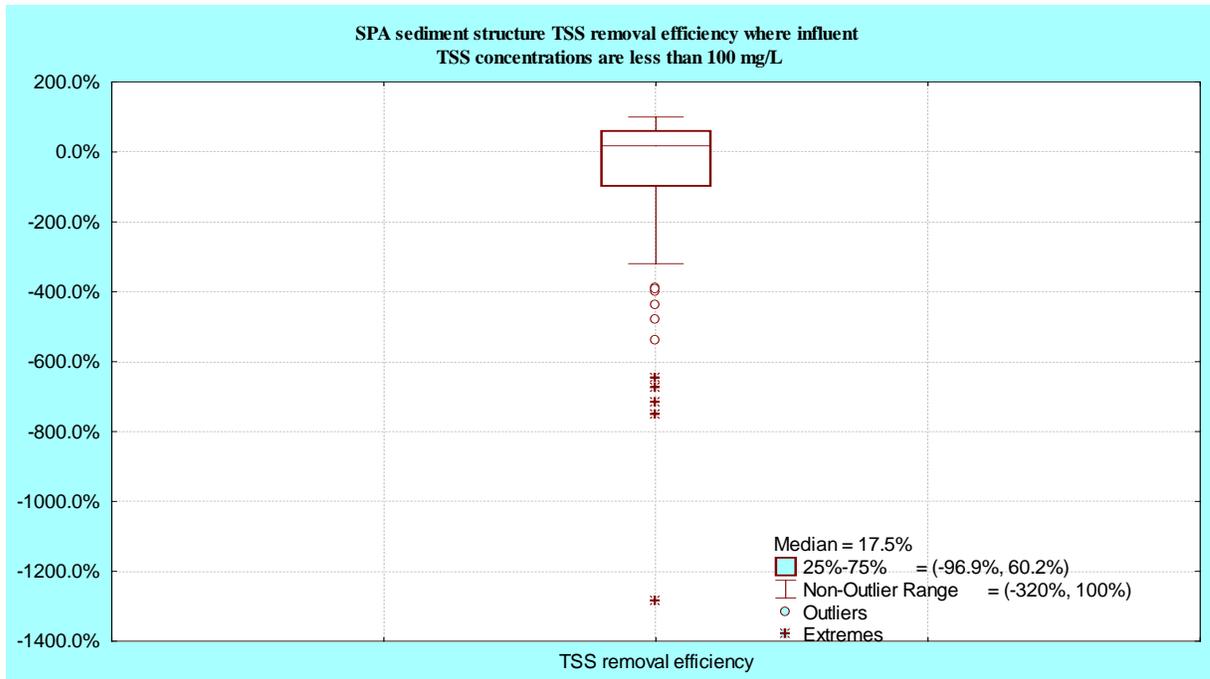
**Figure 3.9. Percent Difference of Inlet and Outlet TSS Concentrations from Grab Samples Where Influent TSS Values are Less Than 100 mg/L.**

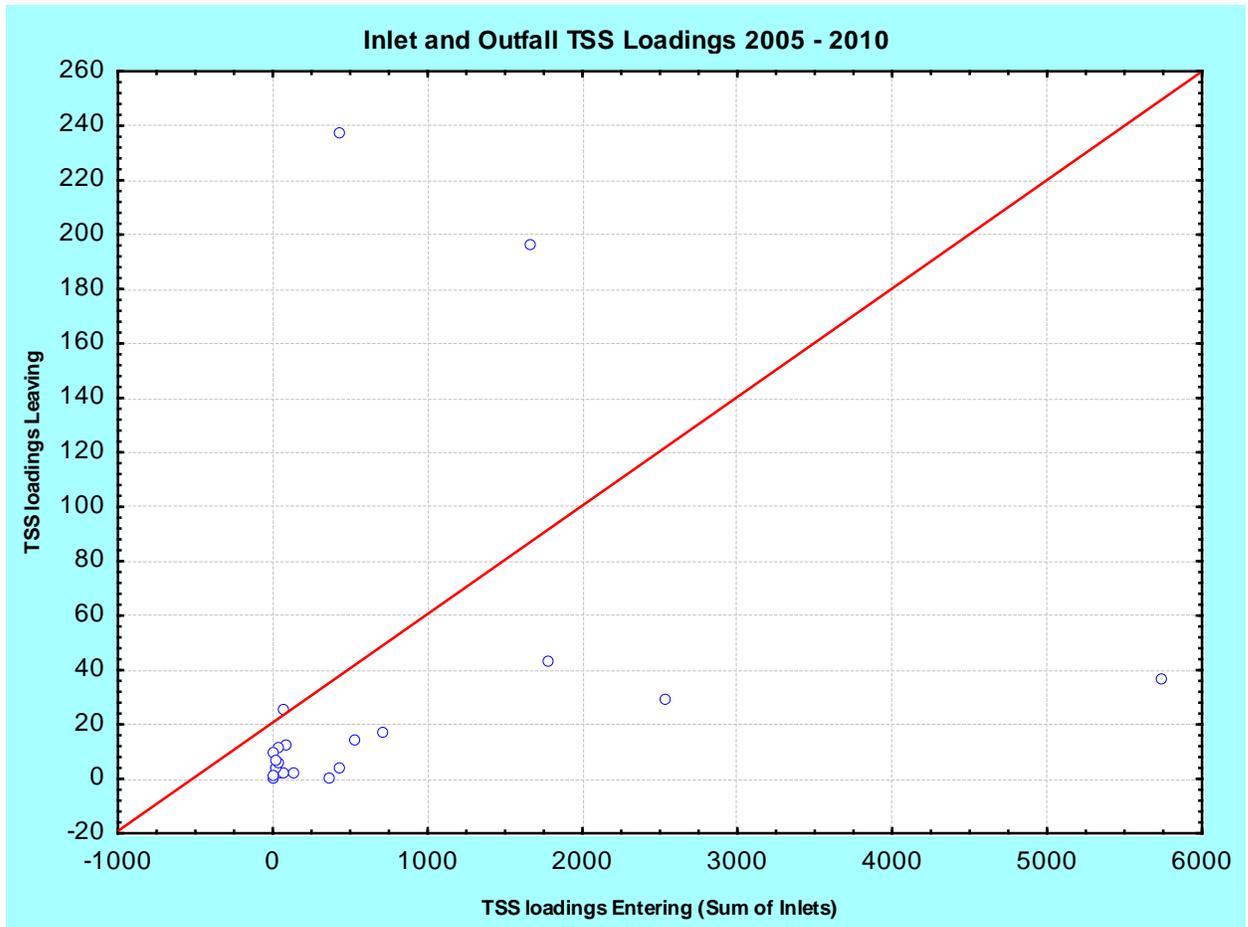
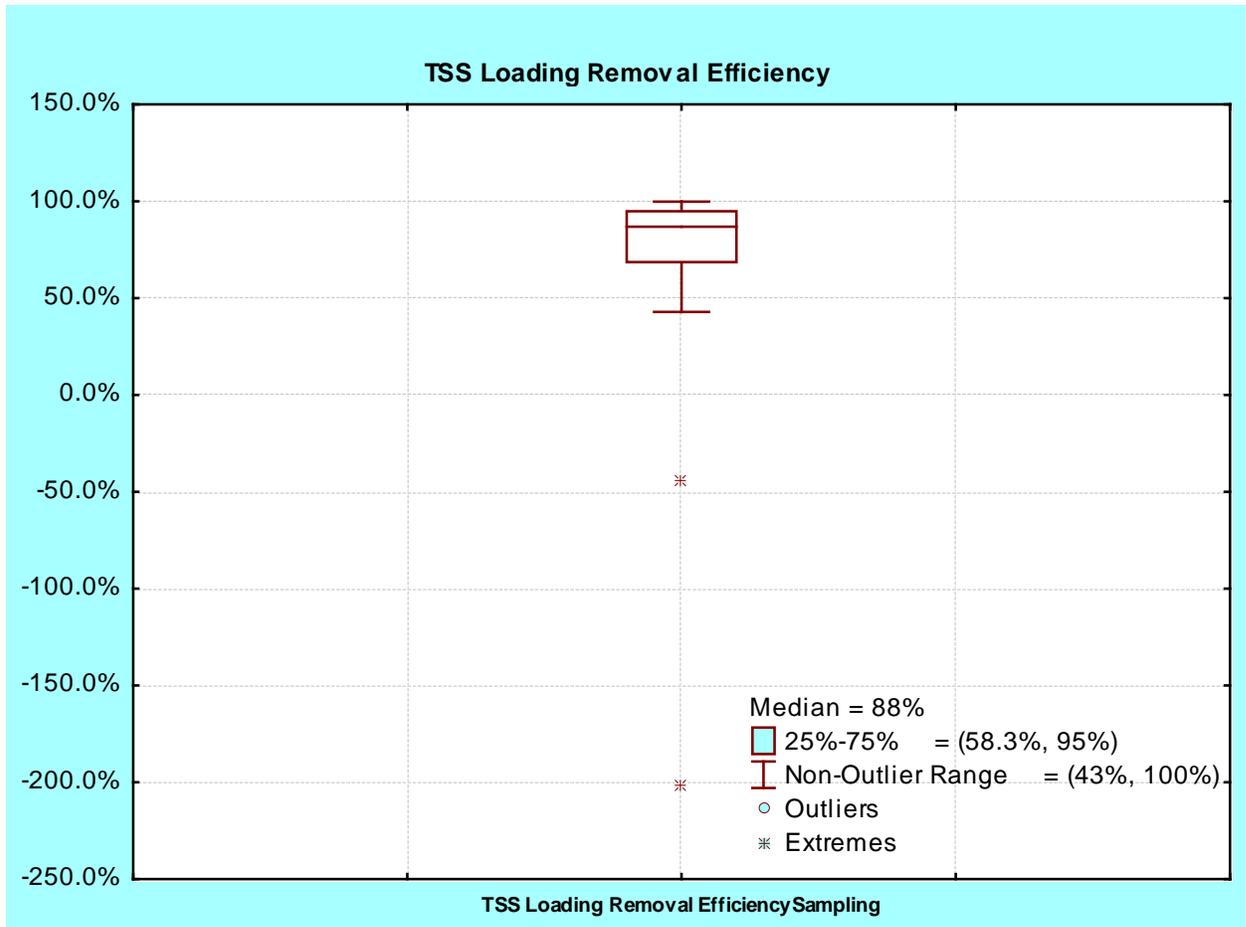
**Figure 3.11. Average, Maximum, Minimum, and Median TSS Removal Efficiencies for monitored S&EC basins through 2010 (Automated Sampling Data).**

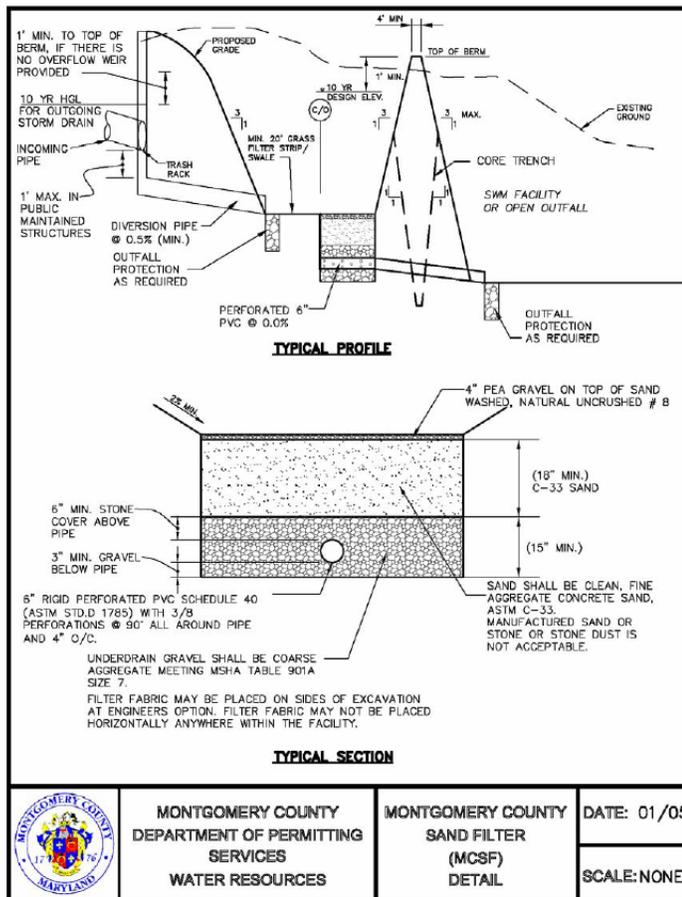
Figure 3.12. DPS Montgomery County Sand Filter detail diagram.

A surface sand filter is a media filter. It is best-suited for managing the high concentration of pollutants in the volume generated by the first inch of rain (also known as the first flush). The Montgomery County Sand Filter design is essentially a shallow, dry stormwater management facility which incorporates a sand filter and an underdrain. Montgomery County Sand Filter (MCSF) design details are provided in Figure 3.12. Photographs of representative sand filters in Montgomery County Special Protection Areas are also featured (Fig TA-3.19). Pre-treatment is provided by a grass filter strip (aka ‘Turf Filter’) or other structural means (DPS 2009).

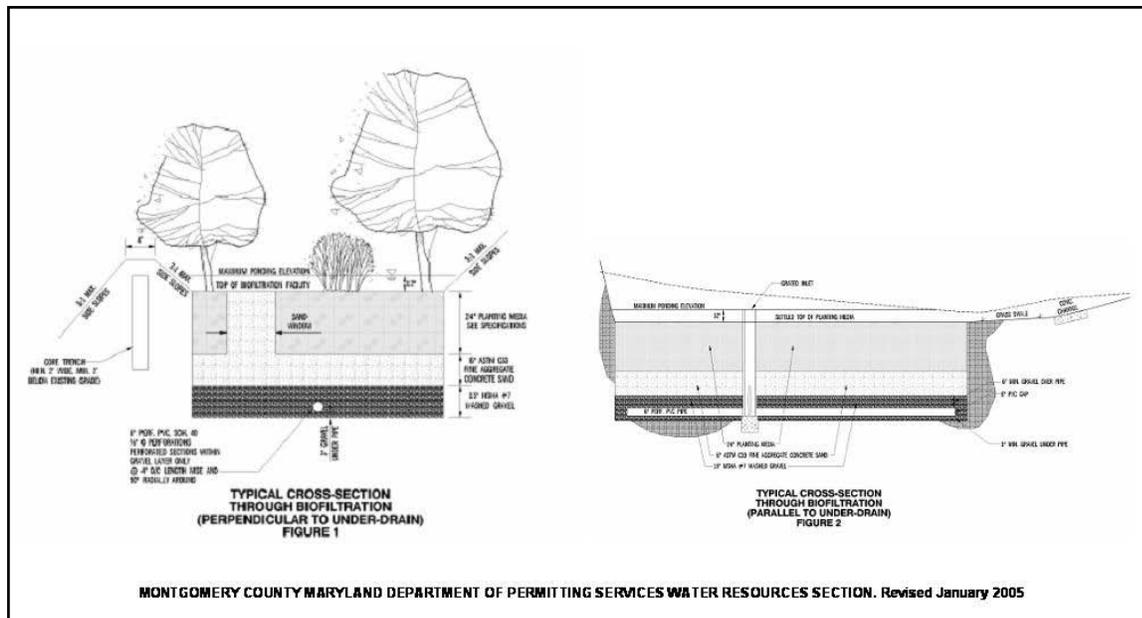
Figure 3.13. DPS Biofiltration diagram.

Bioretention areas like biofilters are a good option in cold water (trout) streams because they hold water for a short period of time, preventing potential thermal impacts from stormwater (SMRC 2010).

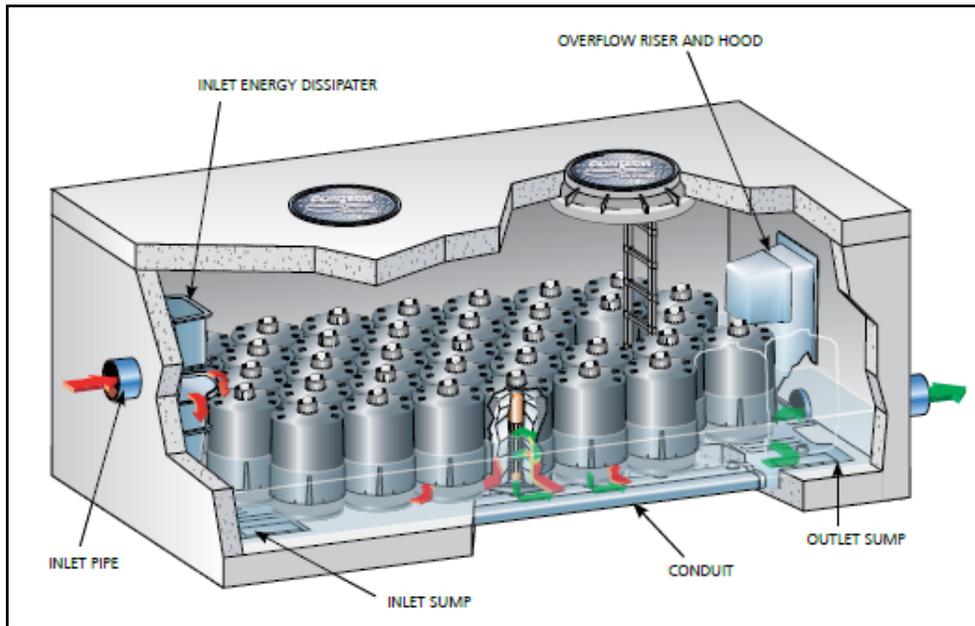
Figure 3.14. Basic design and function of “The Stormwater Management Stormfilter®” (Contech 2007).

composed of three bays: 1) the inlet bay, 2) the filtration bay, and 3) the outlet bay. A structural diagram is provided in Figure 3.14. StormFilters are designed to trap and absorb sediments, oil and grease, soluble heavy metals, organics, and soluble nutrients from stormwater. The StormFilter cartridges can be filled with an array of media, which are typically selected to treat the specific pollutant loadings at each site in order to promote higher pollutant removal performance (Water Online, 2010; Contech 2009, Contech 2007). Montgomery County currently approves one type of filter media.

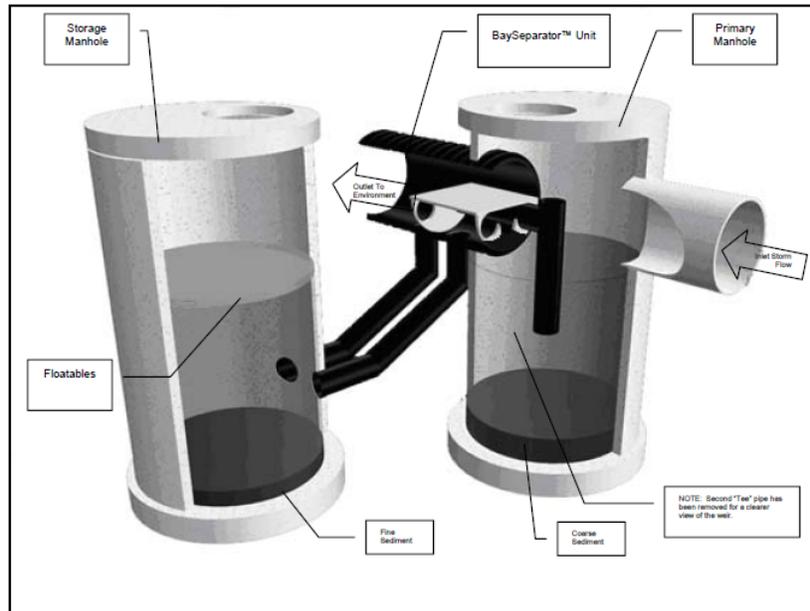
**Figure 3.15. Basic design and function of the Baysaver BaySeparator (Baysaver Technologies, Inc 2008).**

and the BaySeparator re-directs the flow to a Storage Manhole. The Storage Manhole provides further treatment by collecting suspended solids, oils, grease and floating trash and debris. Treated stormwater re-enters the system through the Separator unit. Pollutants remain trapped in the two manholes until they are removed (by a vacuum truck or similar device) during routine maintenance.

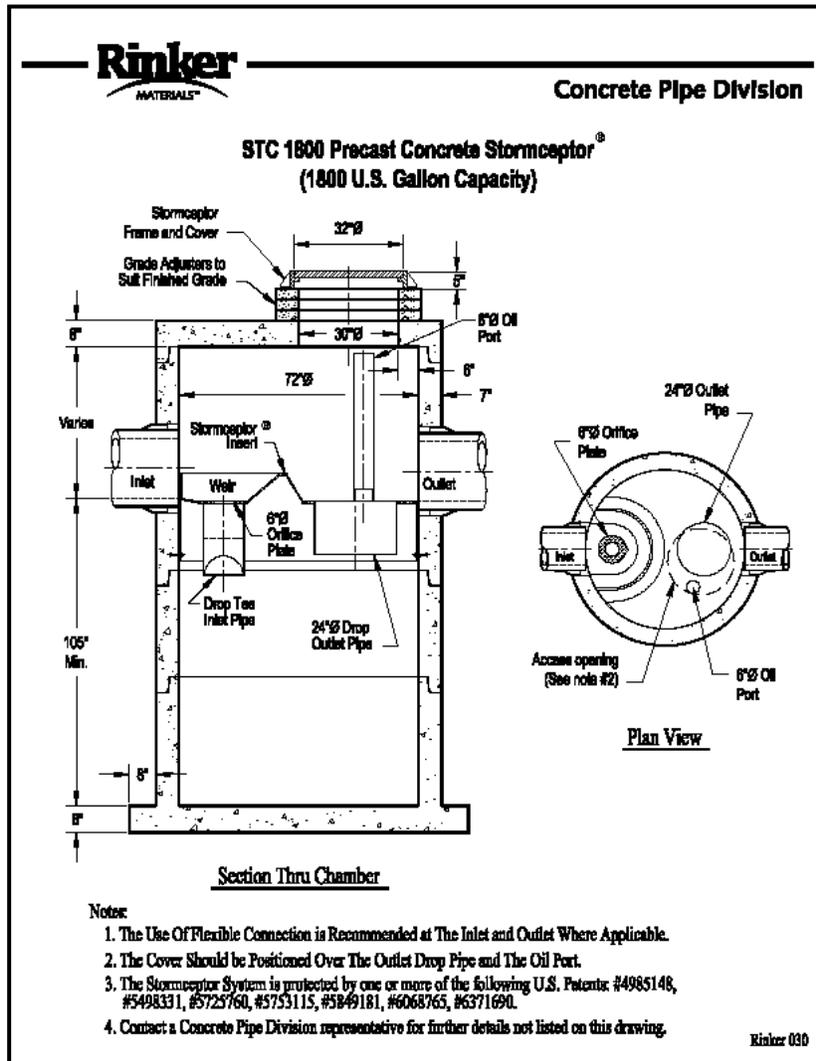
**Figure 3.16. Stormceptor® 1800 Model (1800 U.S. Gallons) Schema  
(Imbrium Systems and Rinker Materials).**

A Stormceptor® (hereafter “Stormceptor”) is another hydrodynamic device that uses the flow and direction of water to remove pollutants. The Stormceptor slows incoming stormwater to reduce turbulence, allowing oils to rise and sediments to settle. All flows greater than the maximum allowed flow rate are bypassed. A structural diagram is provided in Figure 3.16.

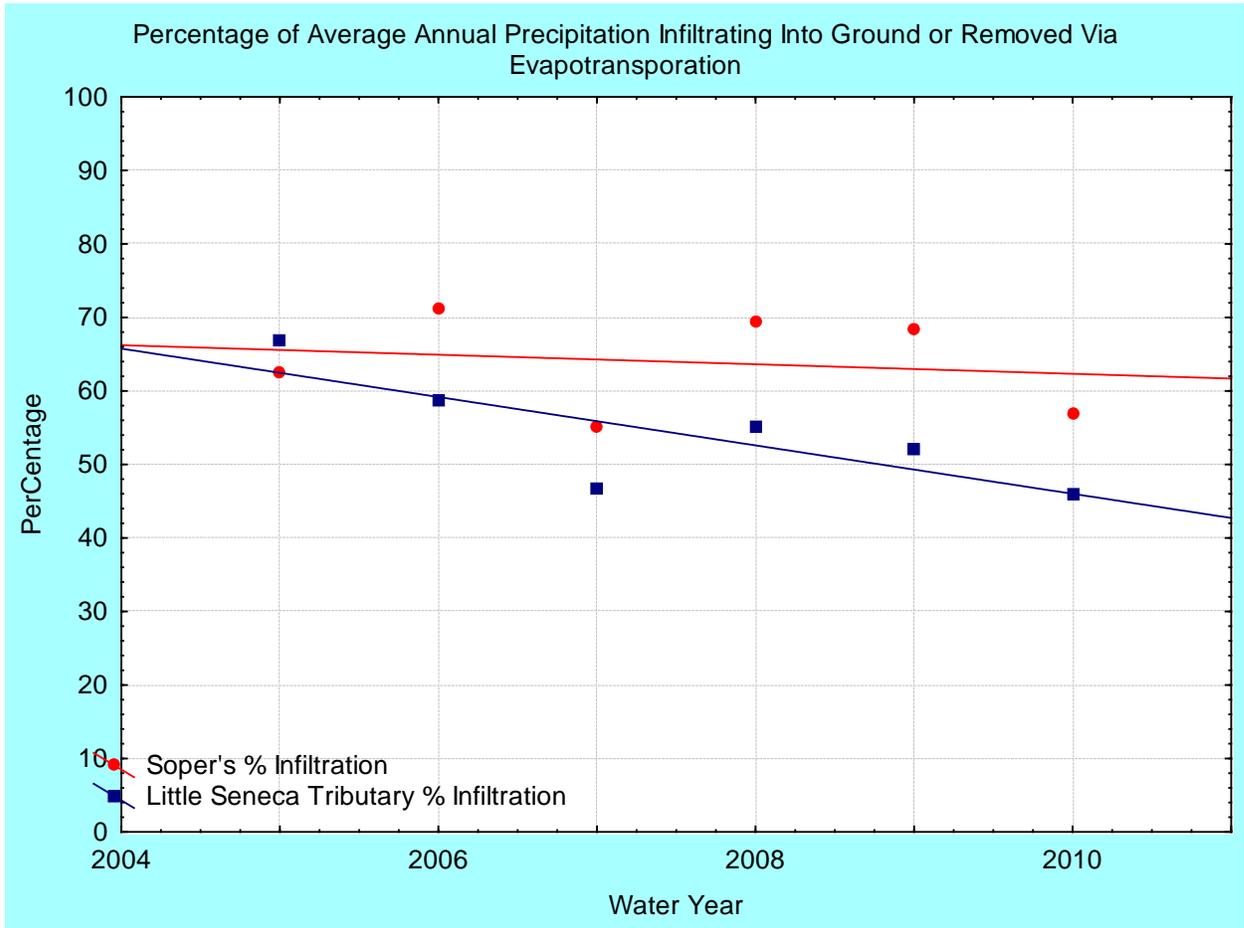
**Figure 4.1. Percentage of Average Annual Precipitation Infiltrating into the Ground or Removed via Evapotranspiration.**

(Fig. 4.1; blue line) as development continues while remaining fairly constant in the Sopers Branch (Fig. 4.1, red line).

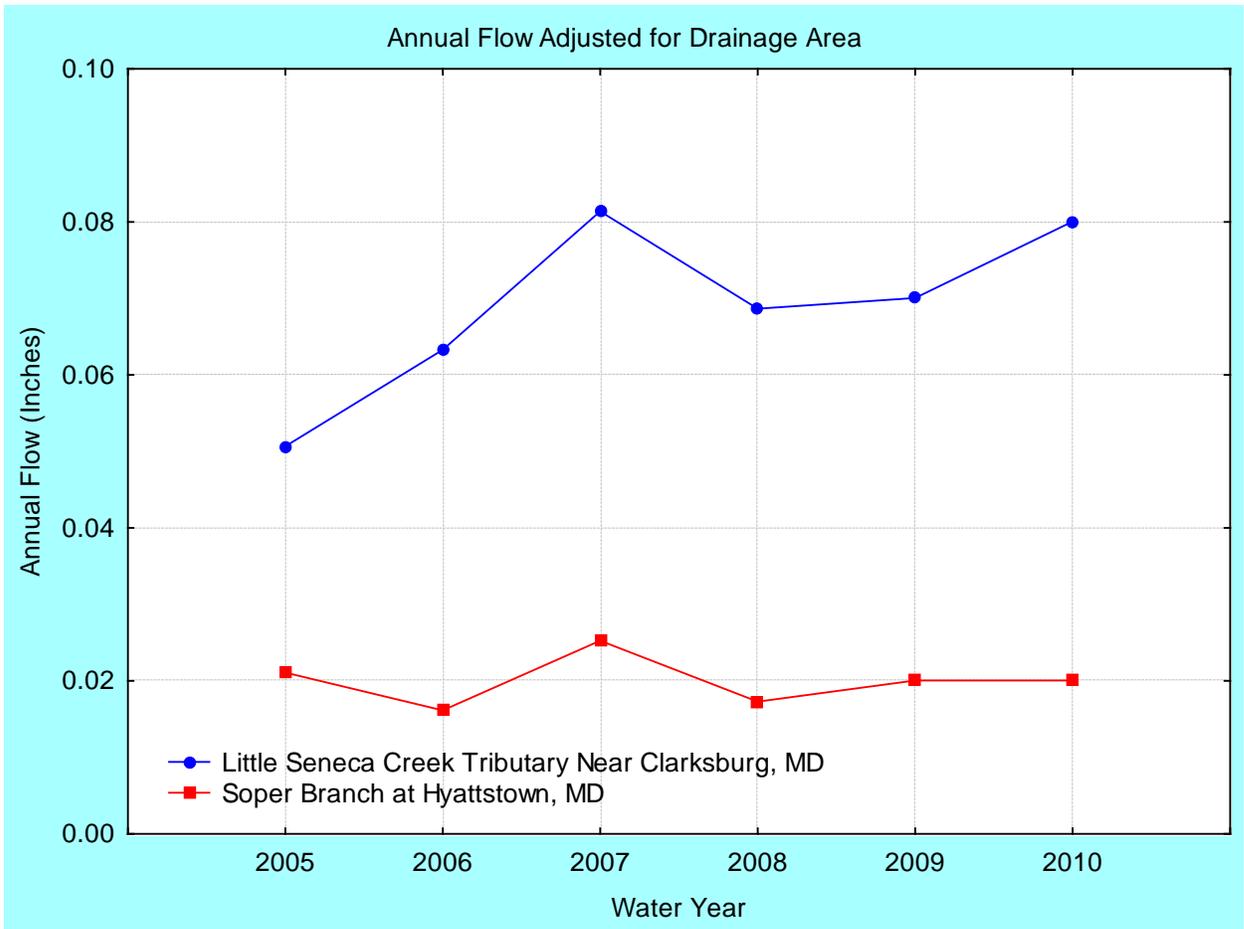
**Figure 4.2. Annual Flow (Adjusted for Drainage Area) from 2005 through 2010.**

**About twice as much rainfall is running directly into the Newcut Road Neighborhood Tributary stream as compared to the control stream, Sopers Branch, for the 2005, 2006, 2007, 2008, 2009 and 2010 water years. This is due to the changes in imperviousness that have occurred in the drainage area as a result of development.**

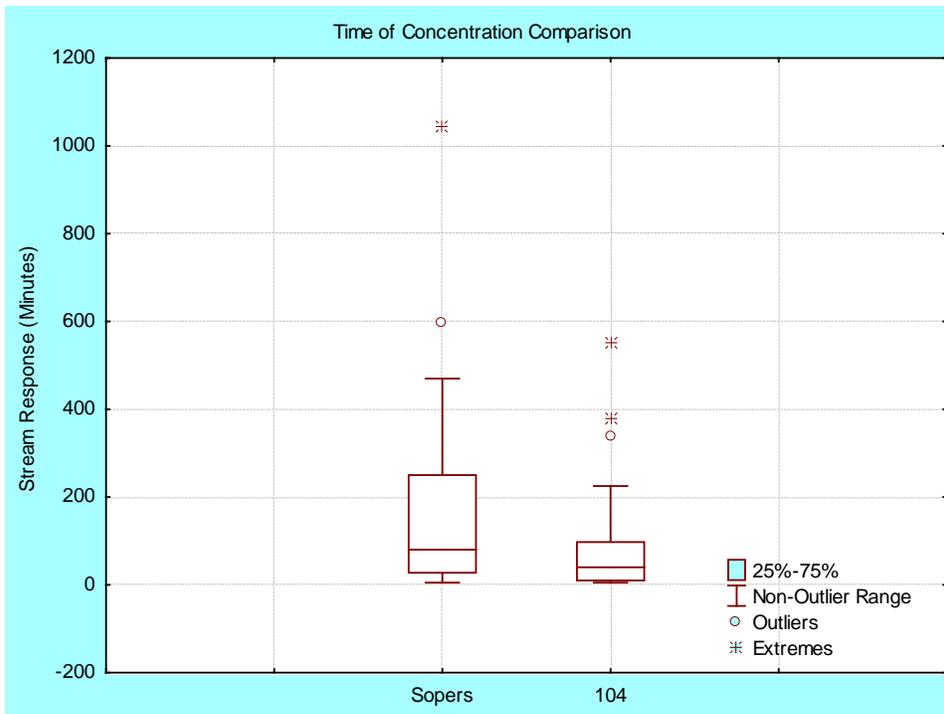
**Figure 4.3. Time of Concentration Differences**

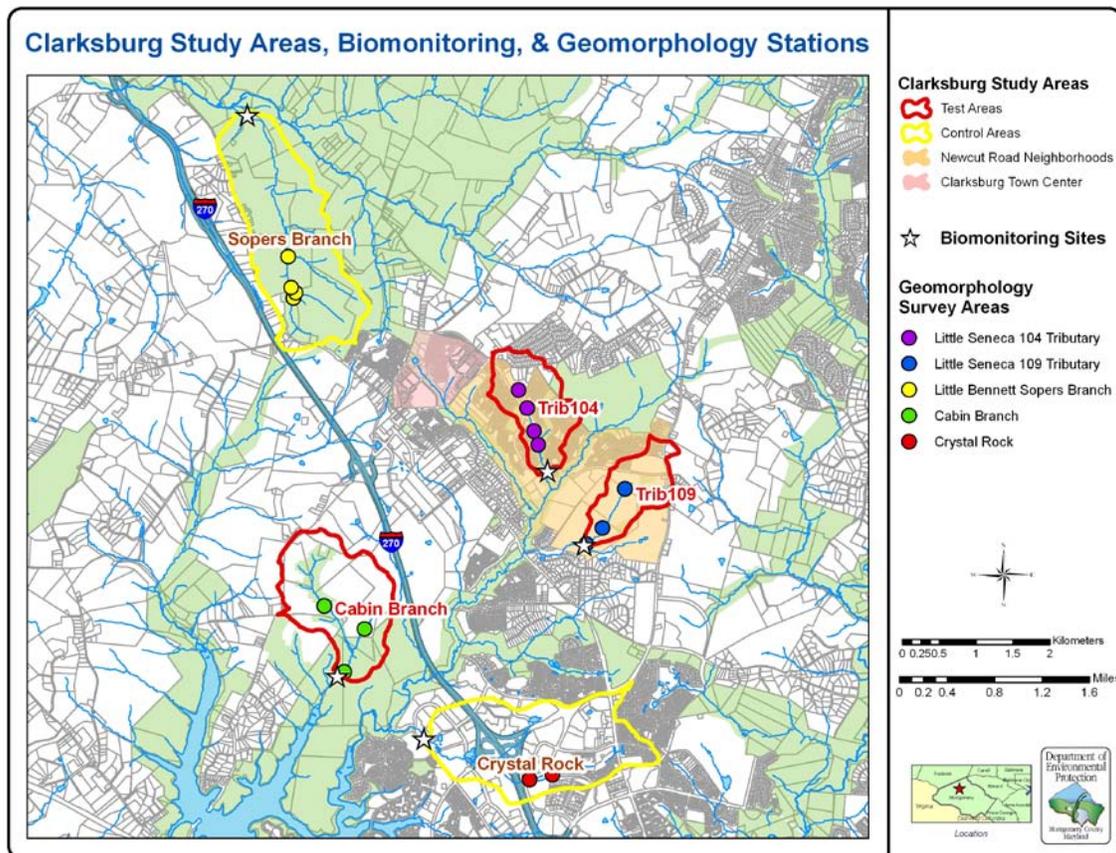
Figure 4.4. Location of the Clarksburg Monitoring Partnership BACI three test areas and two control areas. Also included are biological monitoring stations and geomorphic survey locations.

Geomorphic surveys are conducted in the three test areas (Fig 4.4): two in the Newcut Road Neighborhood (Little Seneca 104 tributary) (Fig. 4.5.a), and one in the Cabin Branch Neighborhood as well as in the undeveloped control area in Little Bennett Regional Park (Soper's Branch) (Fig. 4.5.b) and the developed control in the Germantown area (Crystal Rock) (Fig. 4.5.c). Multiple surveys were completed in all areas to document the temporal change in stream channel morphology. Survey information includes longitudinal profiles, cross sections, bed composition (pebble counts), and sinuosity.
