# Special Protection Area Program Annual Report 2010

Prepared by the Montgomery County Department of Environmental Protection in Cooperation With the Department of Permitting Services and the Maryland-National Capital Park and Planning Commission

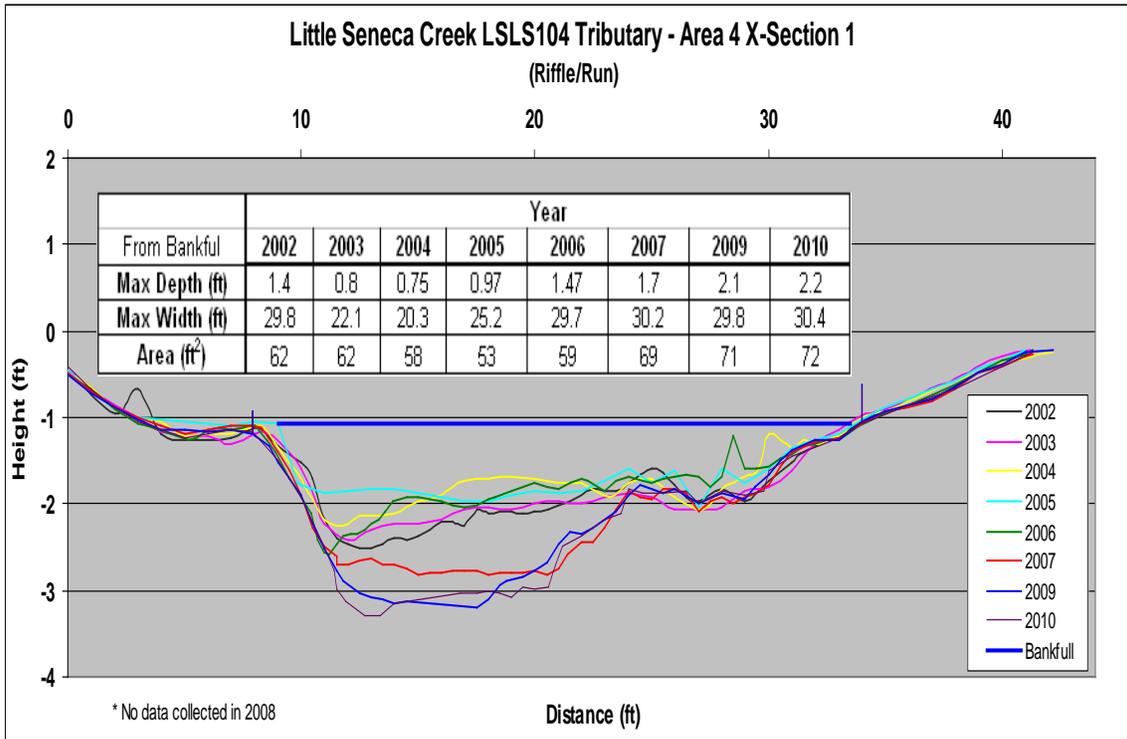
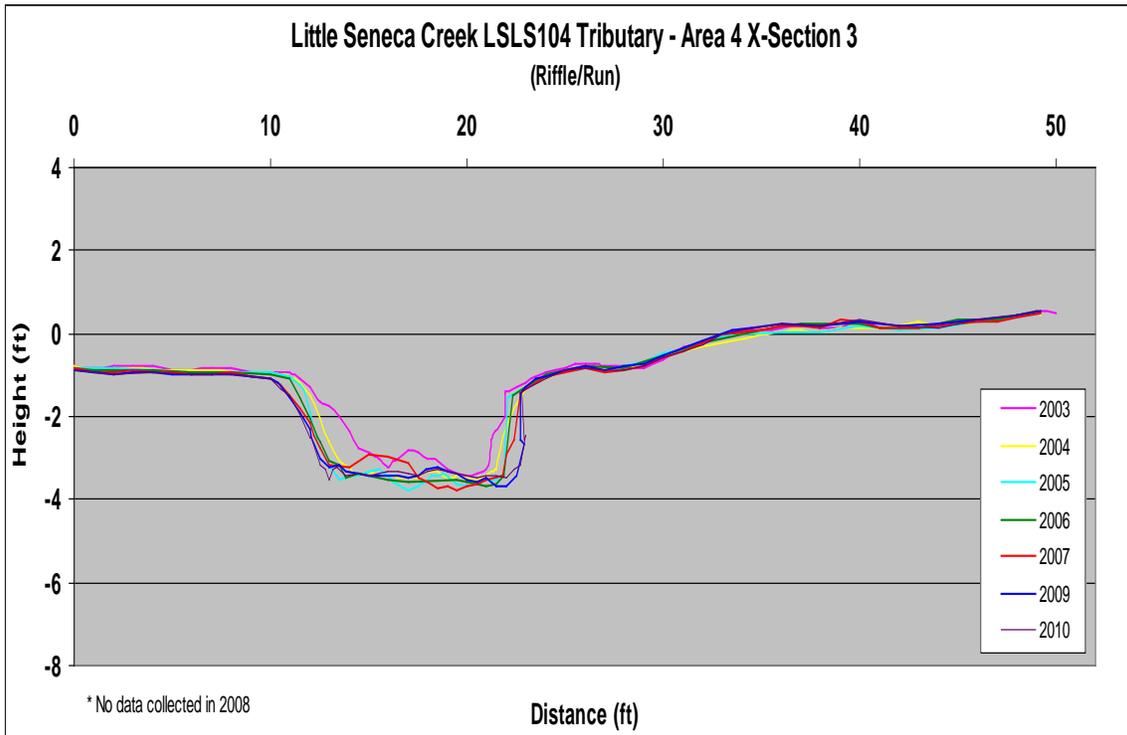
**Figure 4.6. Representative cross sections from Newcut Road Neighborhood, Little Seneca 104 Tributary test location, Area 4. Cross sections are both measured in Riffle/run features.**

Changes in stream morphology would largely be a result of the changes reported in stream hydrology. An increase in runoff rate results in higher peak flows and increased scouring of the stream channel. The average particle size in the Newcut Road tributary has increased (increase in the diameter of 50% of the sampled particles (D-50) at the most downstream study area (Table 4.2). This could signify that increased runoff rates are flushing the finer particles downstream, while the coarser aggregates that characterize the parent material of the stream channel are left in place. The channel depth and channel width at the downstream study area continue to increase in response to changes in hydrology. An examination of the percent of riffle/run to percent pool at the test and the control sites revealed no observable trends.

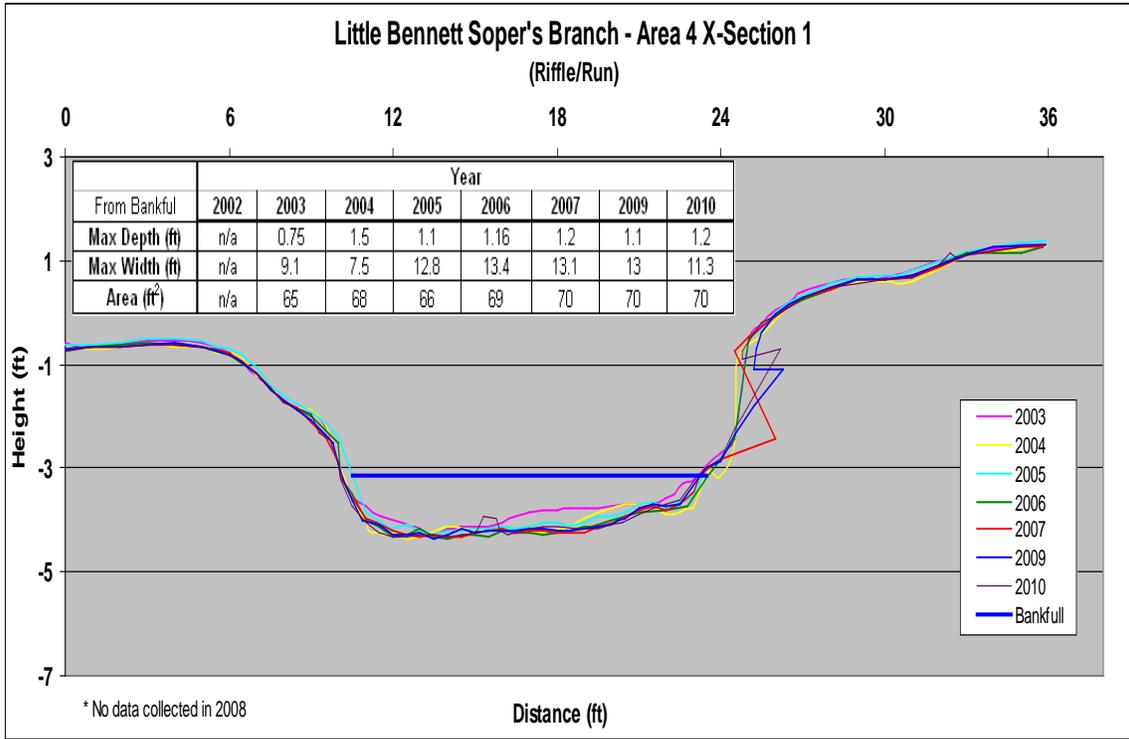
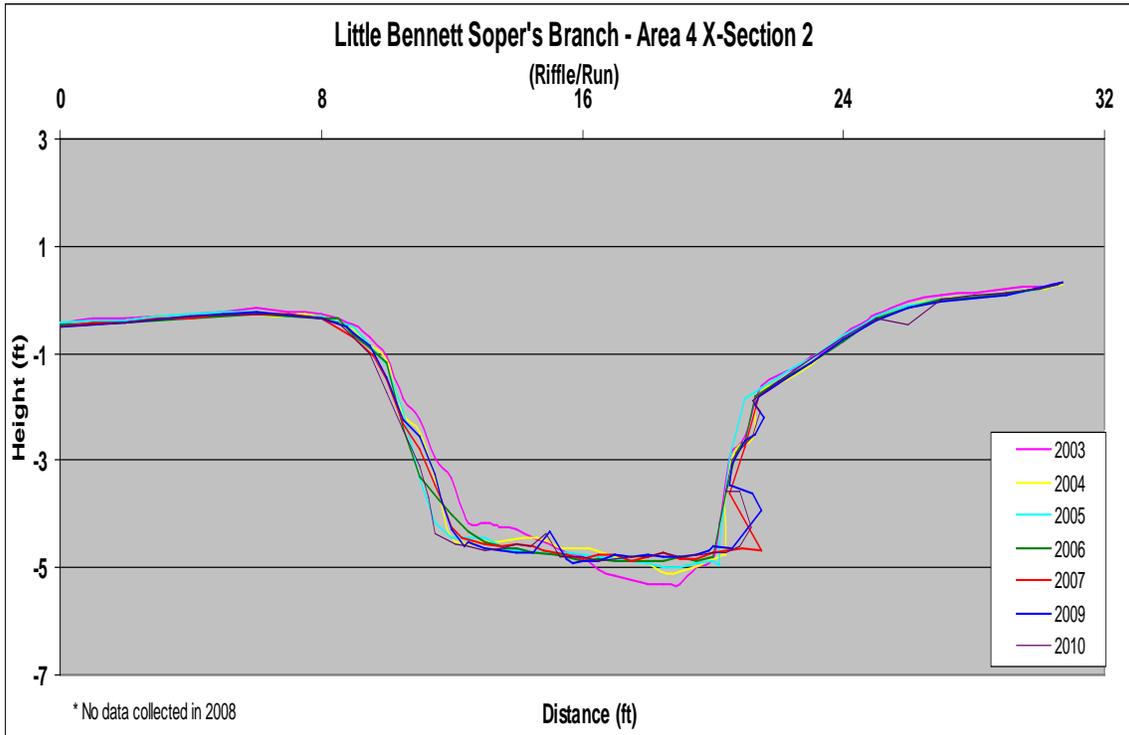
**Figure 4.7. Representative cross sections from Little Bennett Creek, Sopers Branch control location, Area 4. Cross sections both measured in Riffle/run features.**

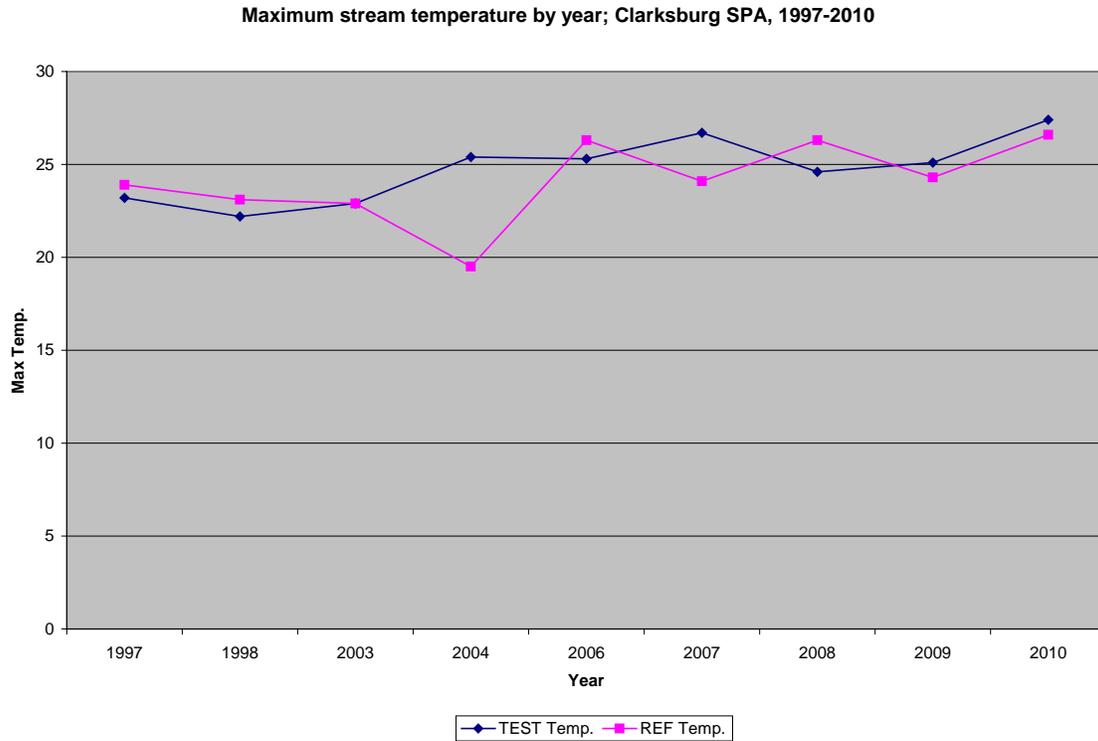
**Figure 4.8.** *Maximum* stream temperature for test and control stations within the Clarksburg SPA from 1997 through 2010.

dampening and similarity of stream temperature, for both *maximum* and *mean* stream temperatures appears to be related with the later stages of development within the Clarksburg SPA after most of the construction has ended.

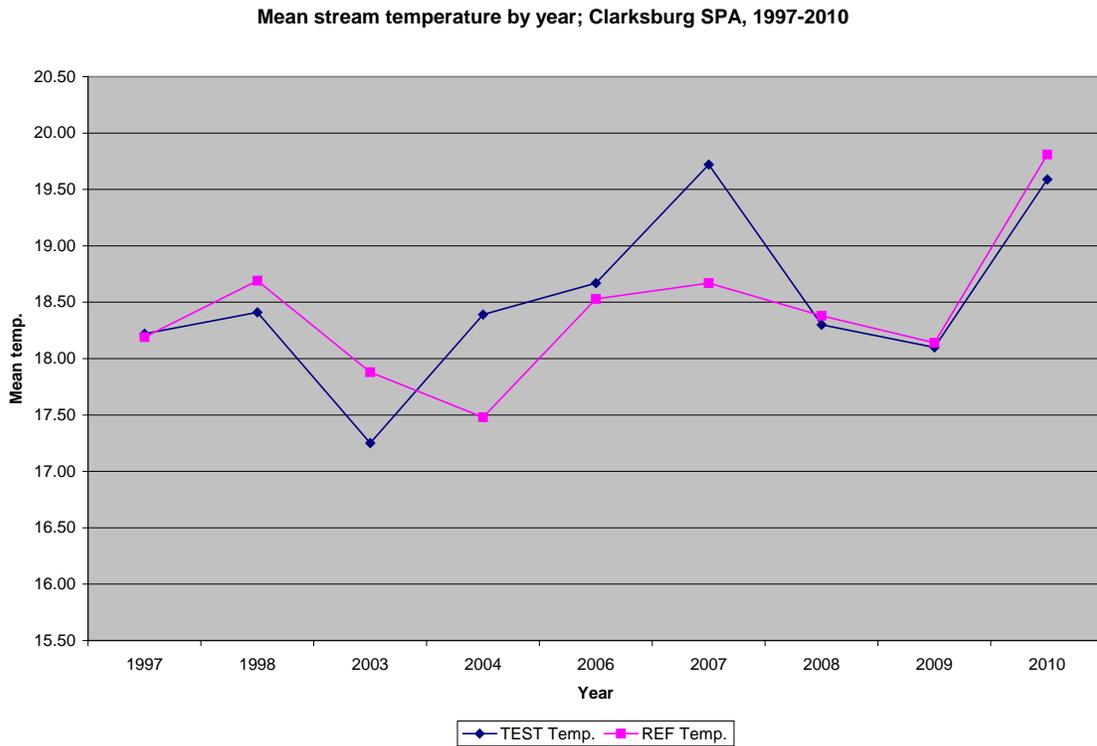
**Figure 4.9.** Mean stream temperature for test and control stations within the Clarksburg SPA from 1997 through 2010.

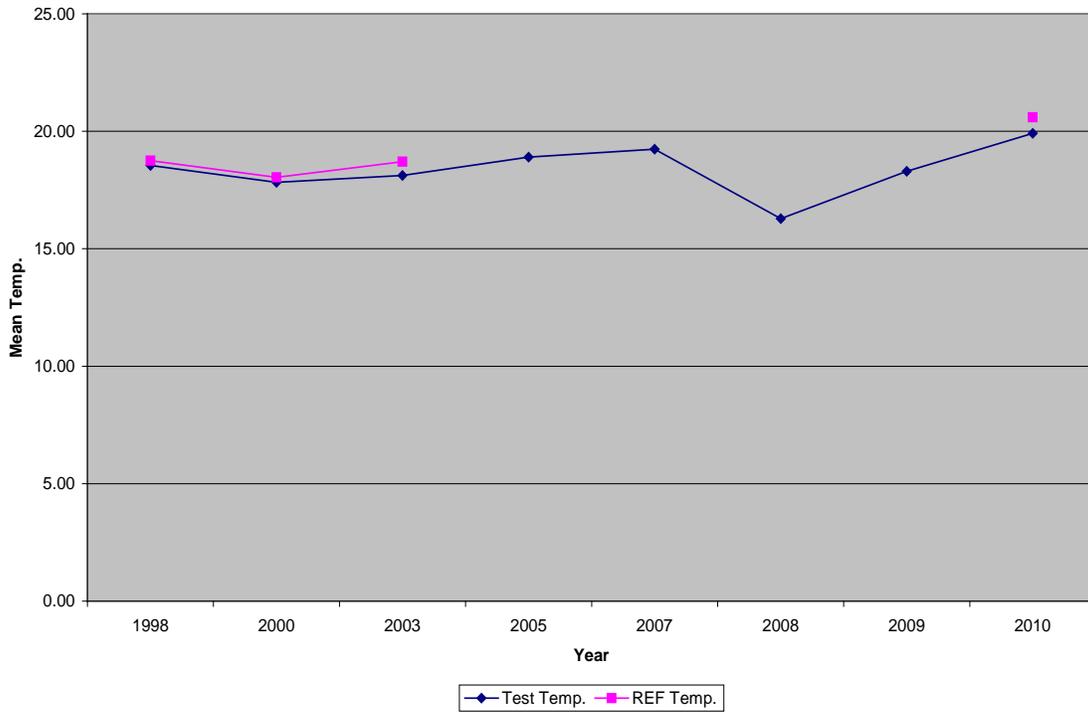
**Figure 4.10.** Yearly *maximum* stream temperature for test and control stations within the Paint Branch SPA from 1998 through 2010.

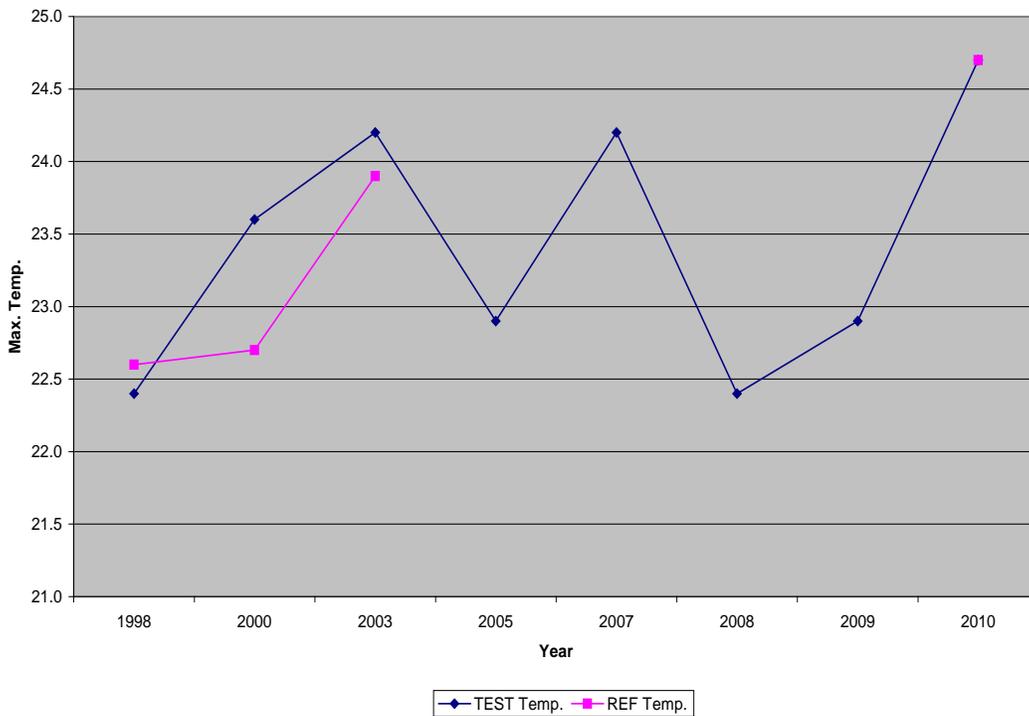
**Figure 4.11.** Yearly trend of *mean* stream temperature for test and control stations within the Paint Branch SPA from 1998 through 2010.

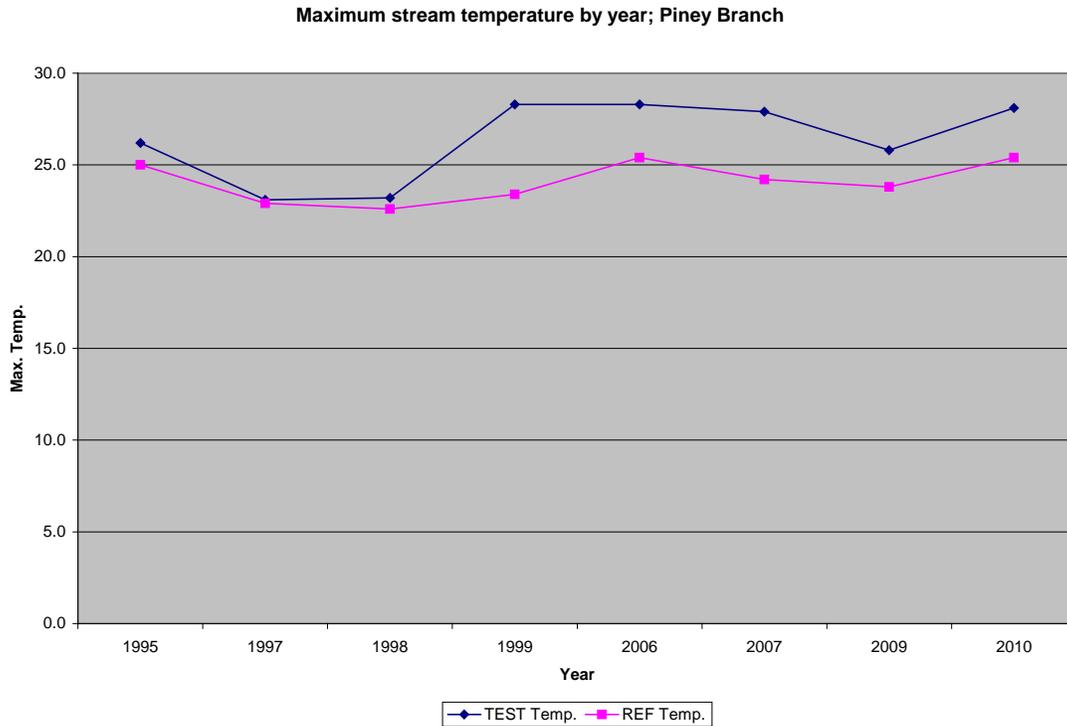
**Figure 4.12.** Yearly trend of *maximum* stream temperature for test and control stations within the Piney Branch SPA from 1995 through 2010.

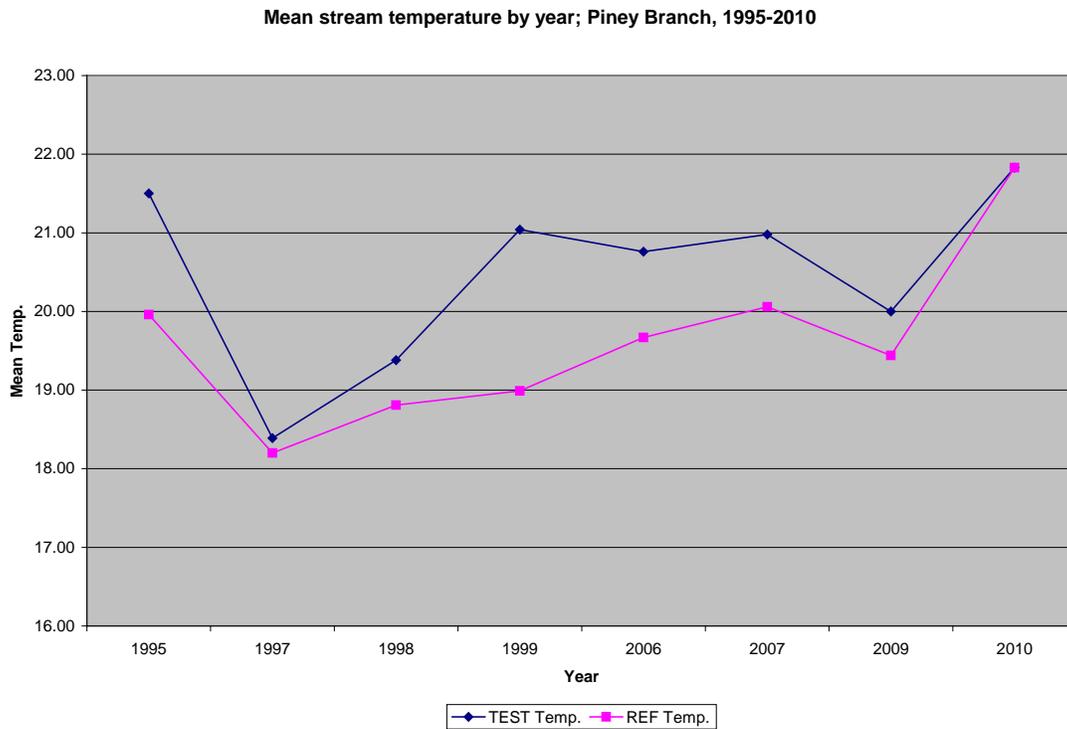
**Figure 4.13.** Yearly trend of *mean* stream temperature for test and control stations within the Piney Branch SPA from 1998 through 2010.

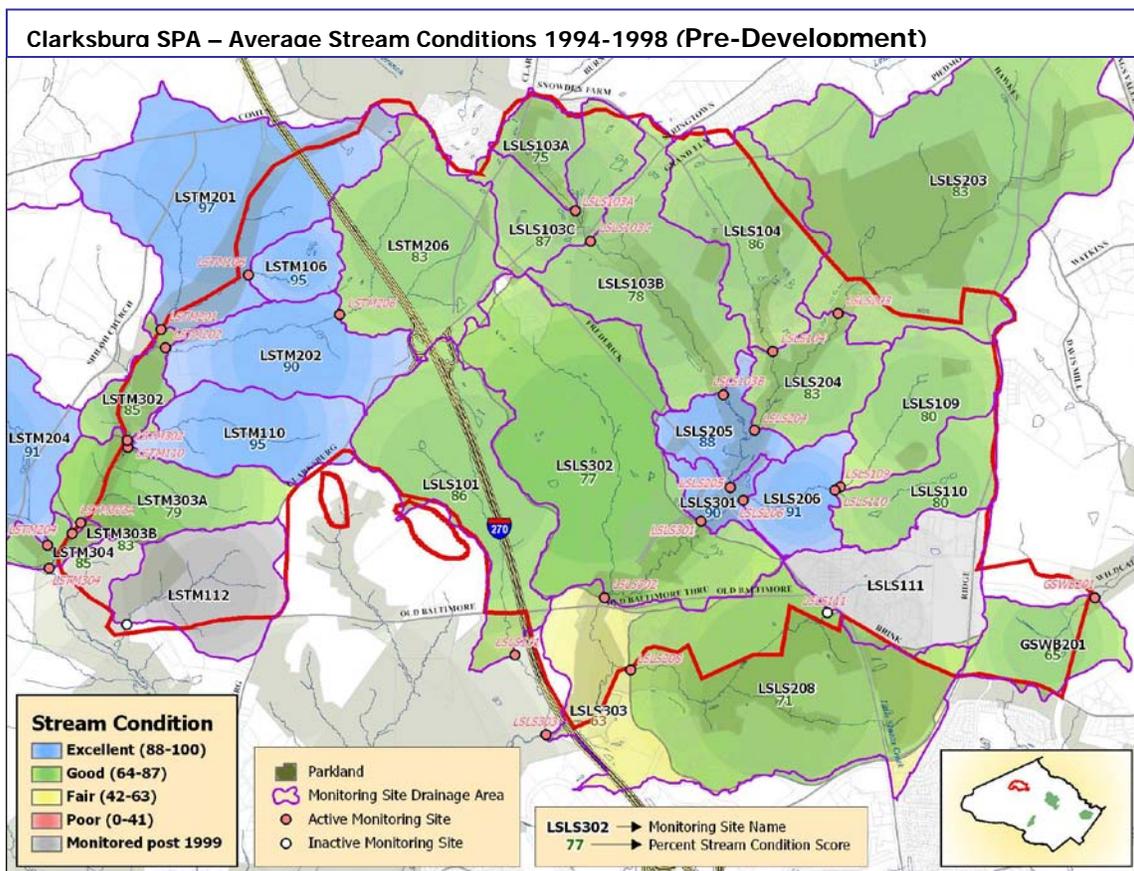
Figure 5.1. Pre-development (1994-1998) Stream Conditions in the Clarksburg SPA.

The majority of new development in the Town Center and Newcut Road Neighborhoods began in 2006, resulting in degradation of stream conditions as areas underwent intensive widespread construction. Development activities have progressed in phases from east to west, with more intense construction in 2006 and 2007 and corresponding biological impairment. In 2008 and 2009, there was less intense development due to the economic downturn, which may have allowed less active construction sites to stabilize and for some completed developments to begin to convert to SWM. A few stream conditions during this time improved their average ratings, perhaps as a result of site stabilization and limited SWM conversion.

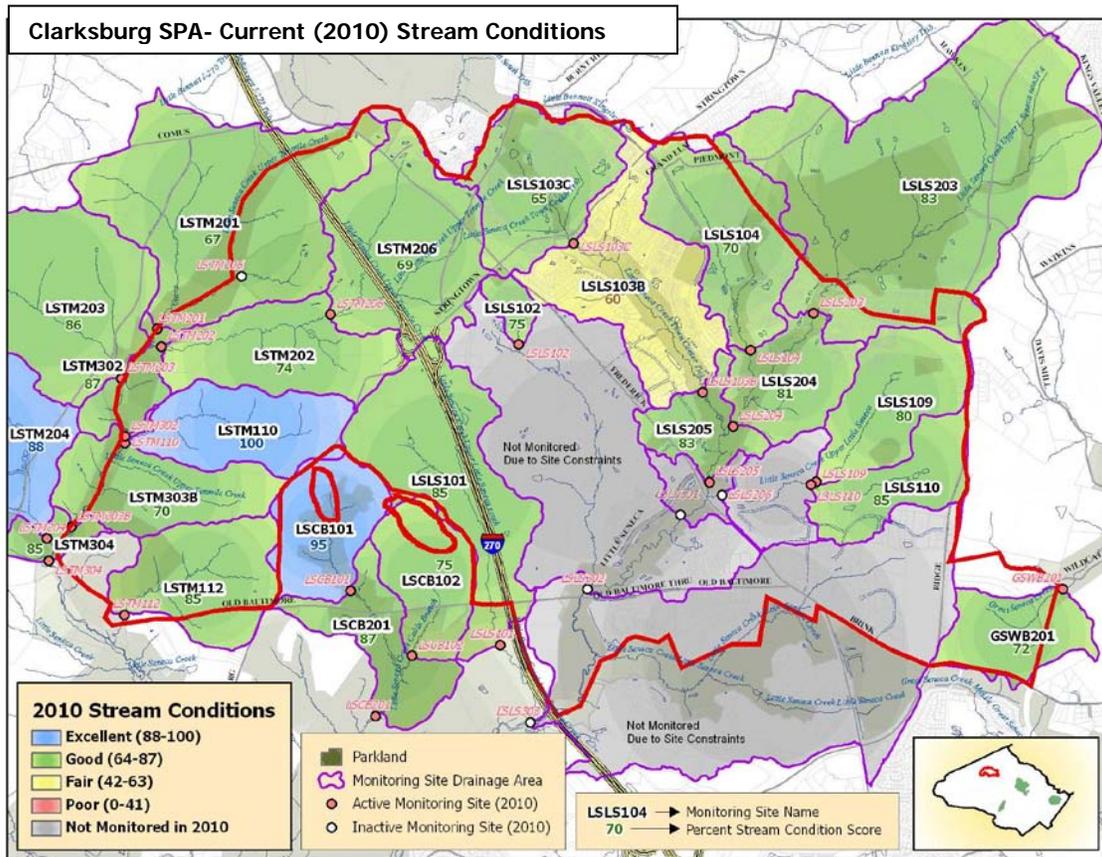
Figure 5.2. Current (2010) Stream Conditions in the Clarksburg SPA.

The LSL104 tributary provides drainage for a large portion of the Newcut Road development. The station was rated *fair* in 2007 and 2008, but improved to *good* in 2009 and remains *good* in 2010. Construction is still ongoing in the lower portion of the drainage area, with some of the S & E devices in the upper portions of the area in the process of being converted to storm water management. The monitoring station is located within the Snowden Farm Parkway right-of-way, and massive changes were made to this area late in 2010, after monitoring was complete. The site will need to be reevaluated and possibly relocated in 2011.

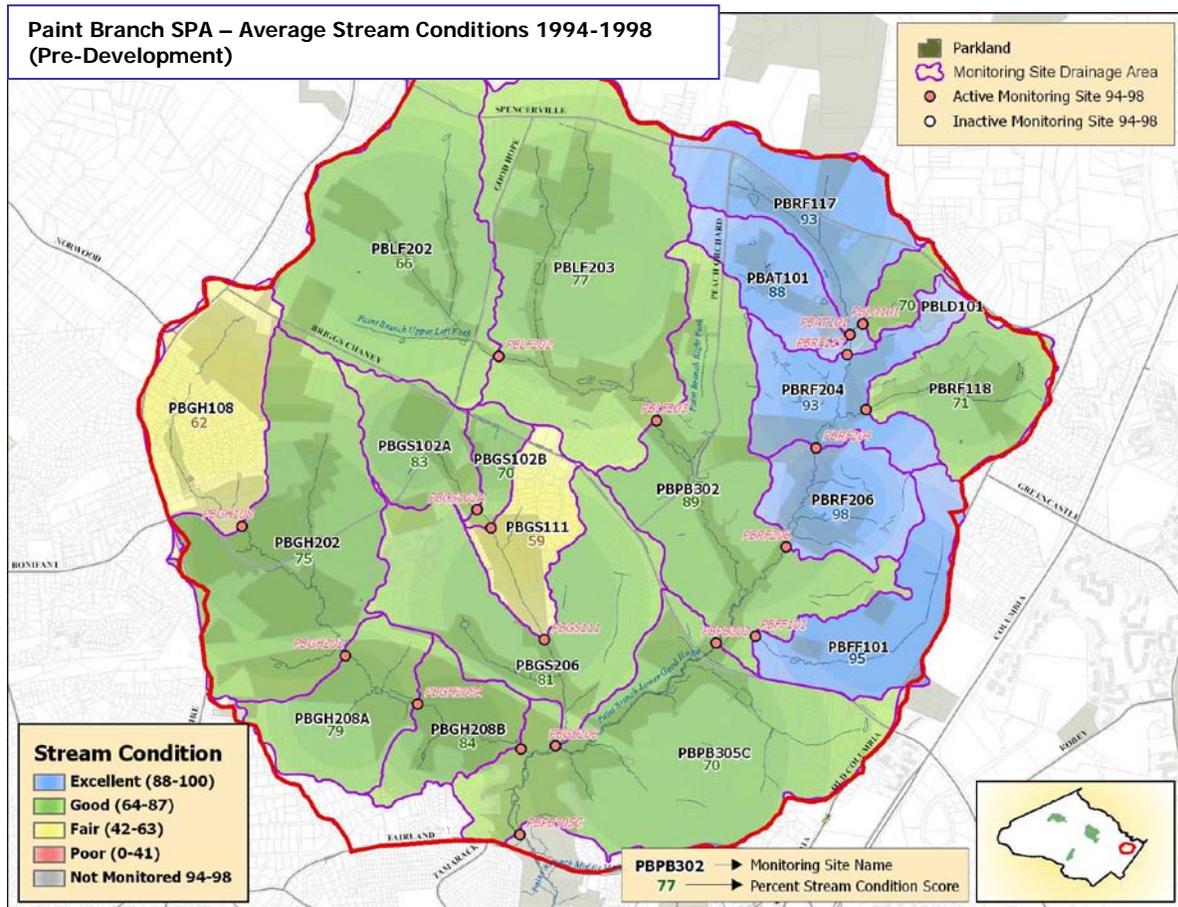
Figure 5.3. Pre-development (1994-1998) Stream Conditions in the Paint Branch SPA.

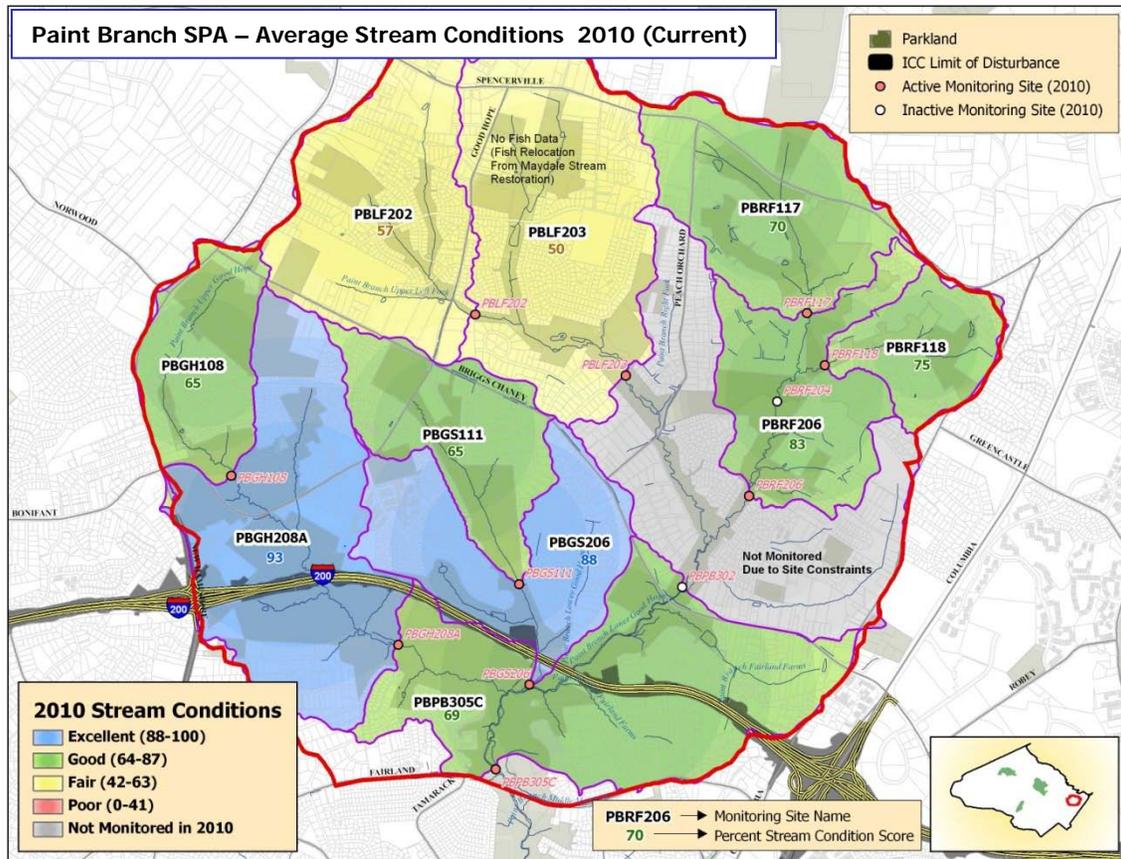
Figure 5.4. Current (2010) Stream Conditions in the Paint Branch SPA.

The Good Hope relies on clean, cool waters as spawning grounds for its naturally-reproducing brown trout population. In 2010, twelve adult brown trout, one of the most sensitive fish species in Montgomery County to stream degradation and water quality impairment, were found in the Upper Paint Branch SPA. Further discussion of Paint Branch Brown Trout is located in the Technical Appendix. Both the Upper Rock Creek SPA and Paint Branch SPA have an 8% impervious surface cap.

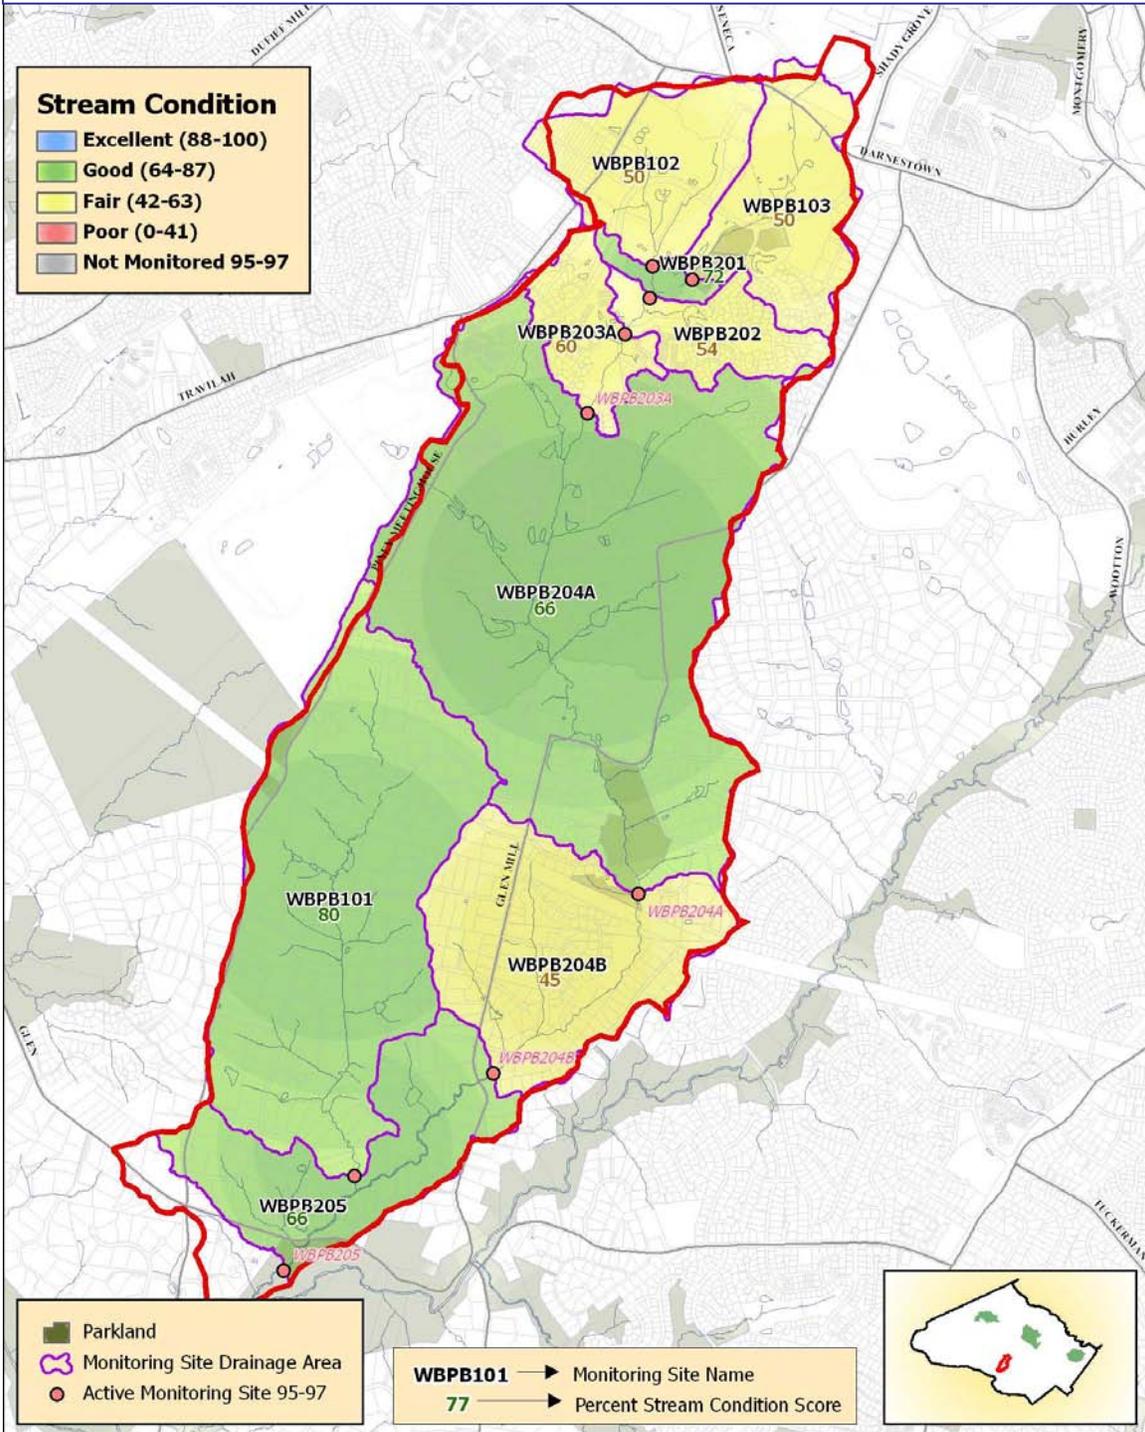
Figure 5.5. Pre-development (1995-1997) Stream Conditions in the Piney Branch SPA.

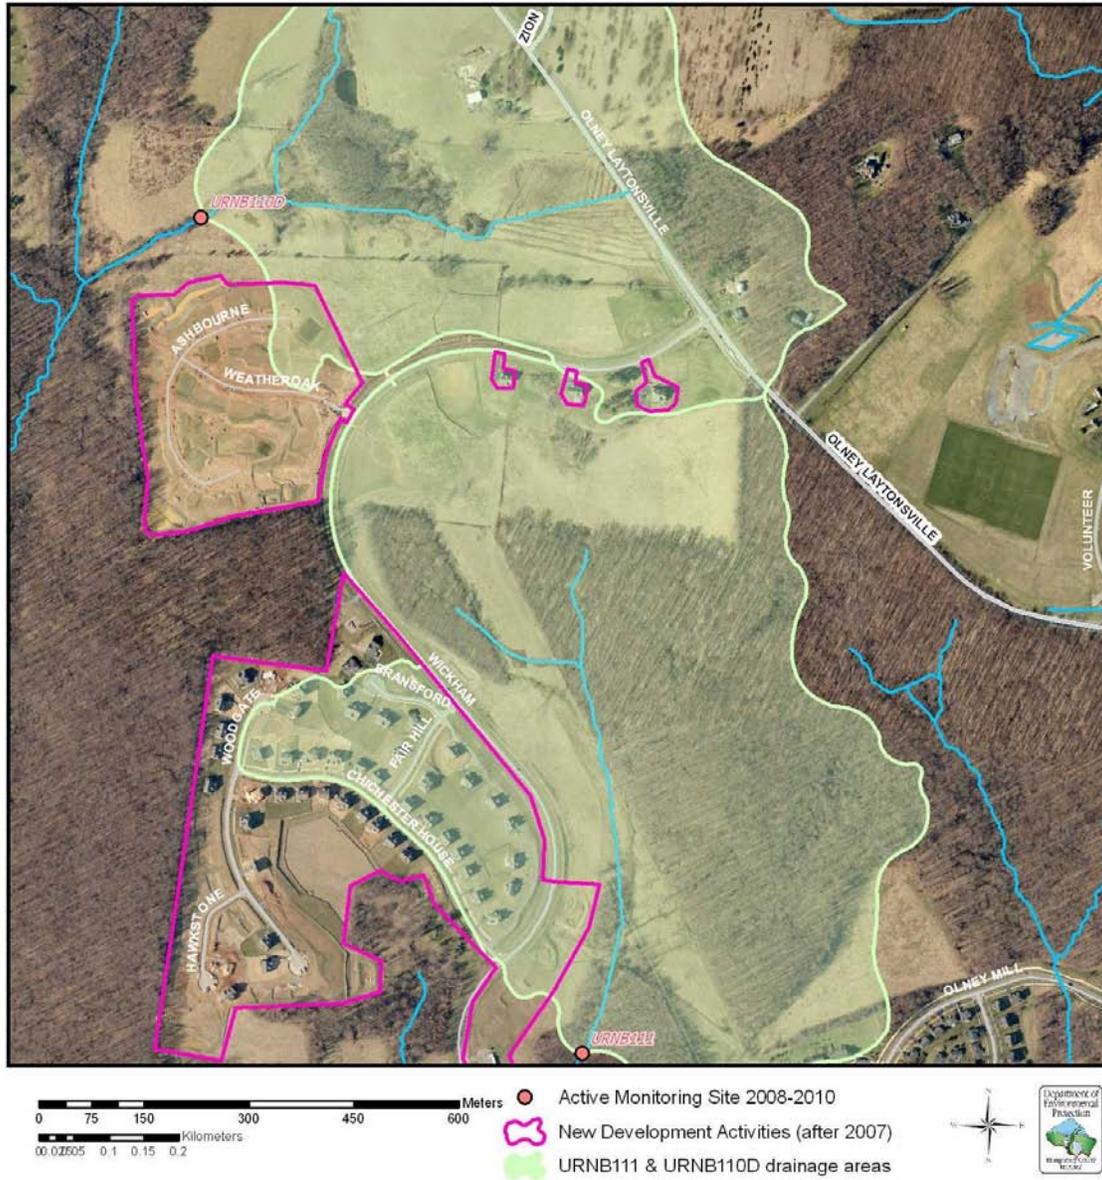
Figure 5.7. Potential (post-2007) Development impacts from Reserve at Fair Hill Project to Biological Monitoring Site URNB111 and URNB110D in Upper Rock Creek SPA.  
 Full drainage areas are shown on Figure 5.9.

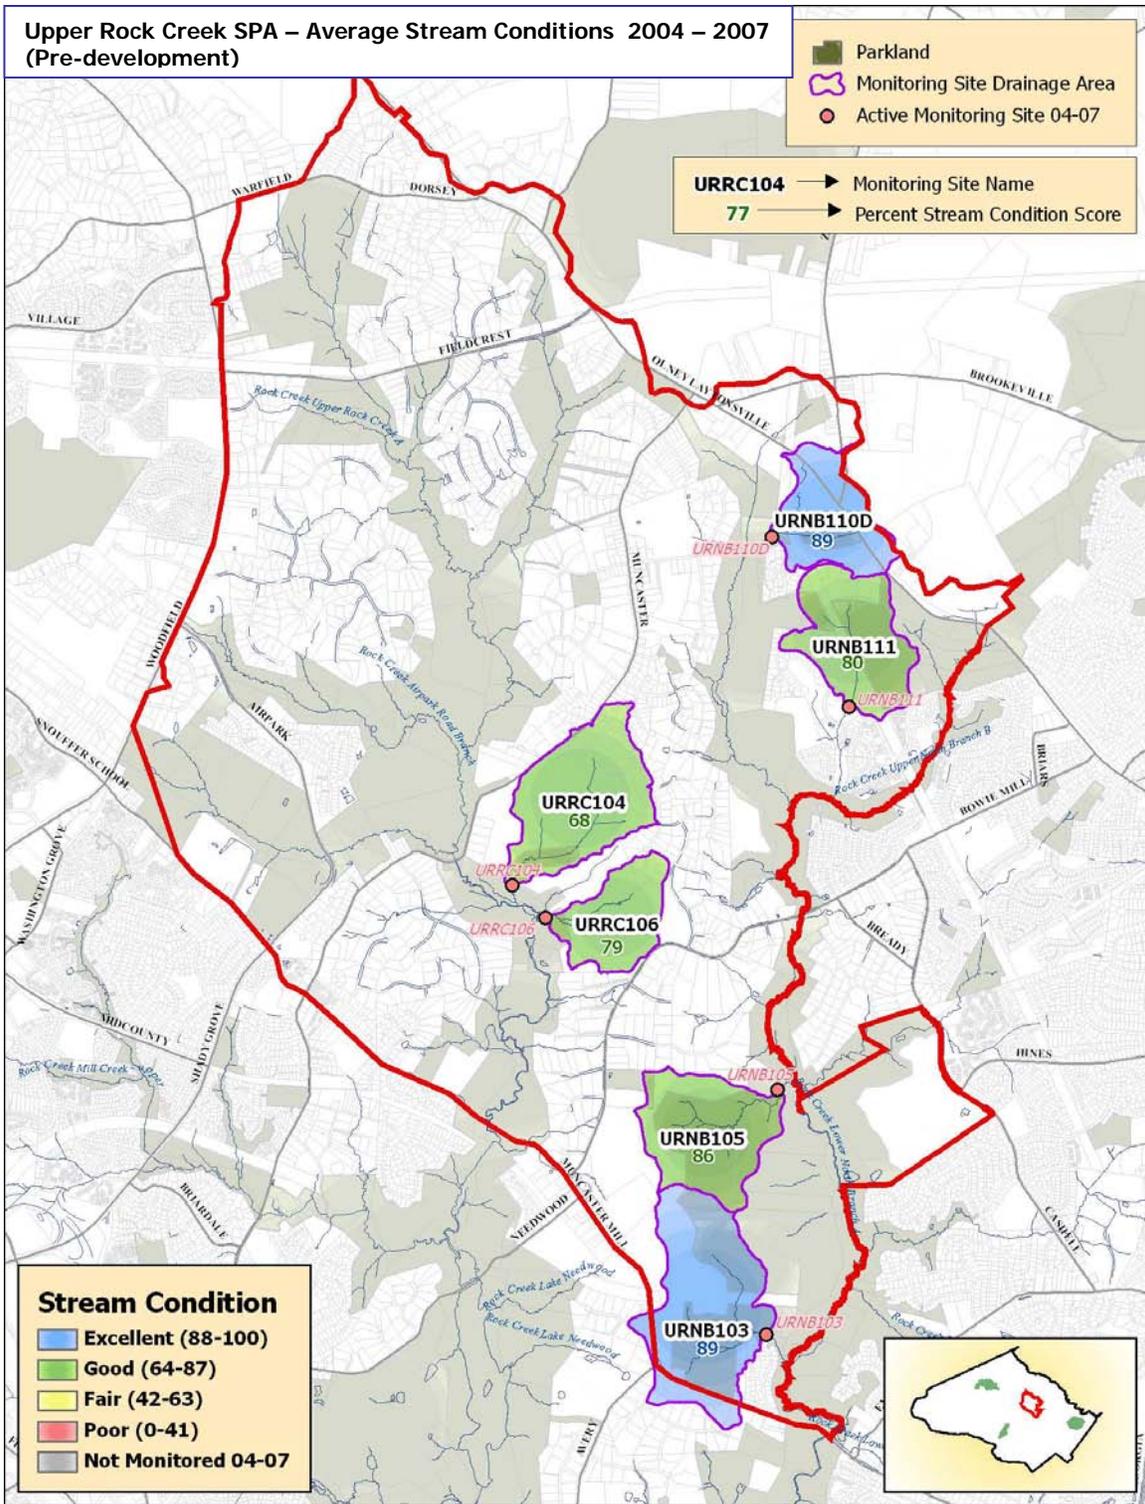
Figure 5.8. Pre-development (2004-2007) Stream Conditions in the Upper Rock Creek SPA.

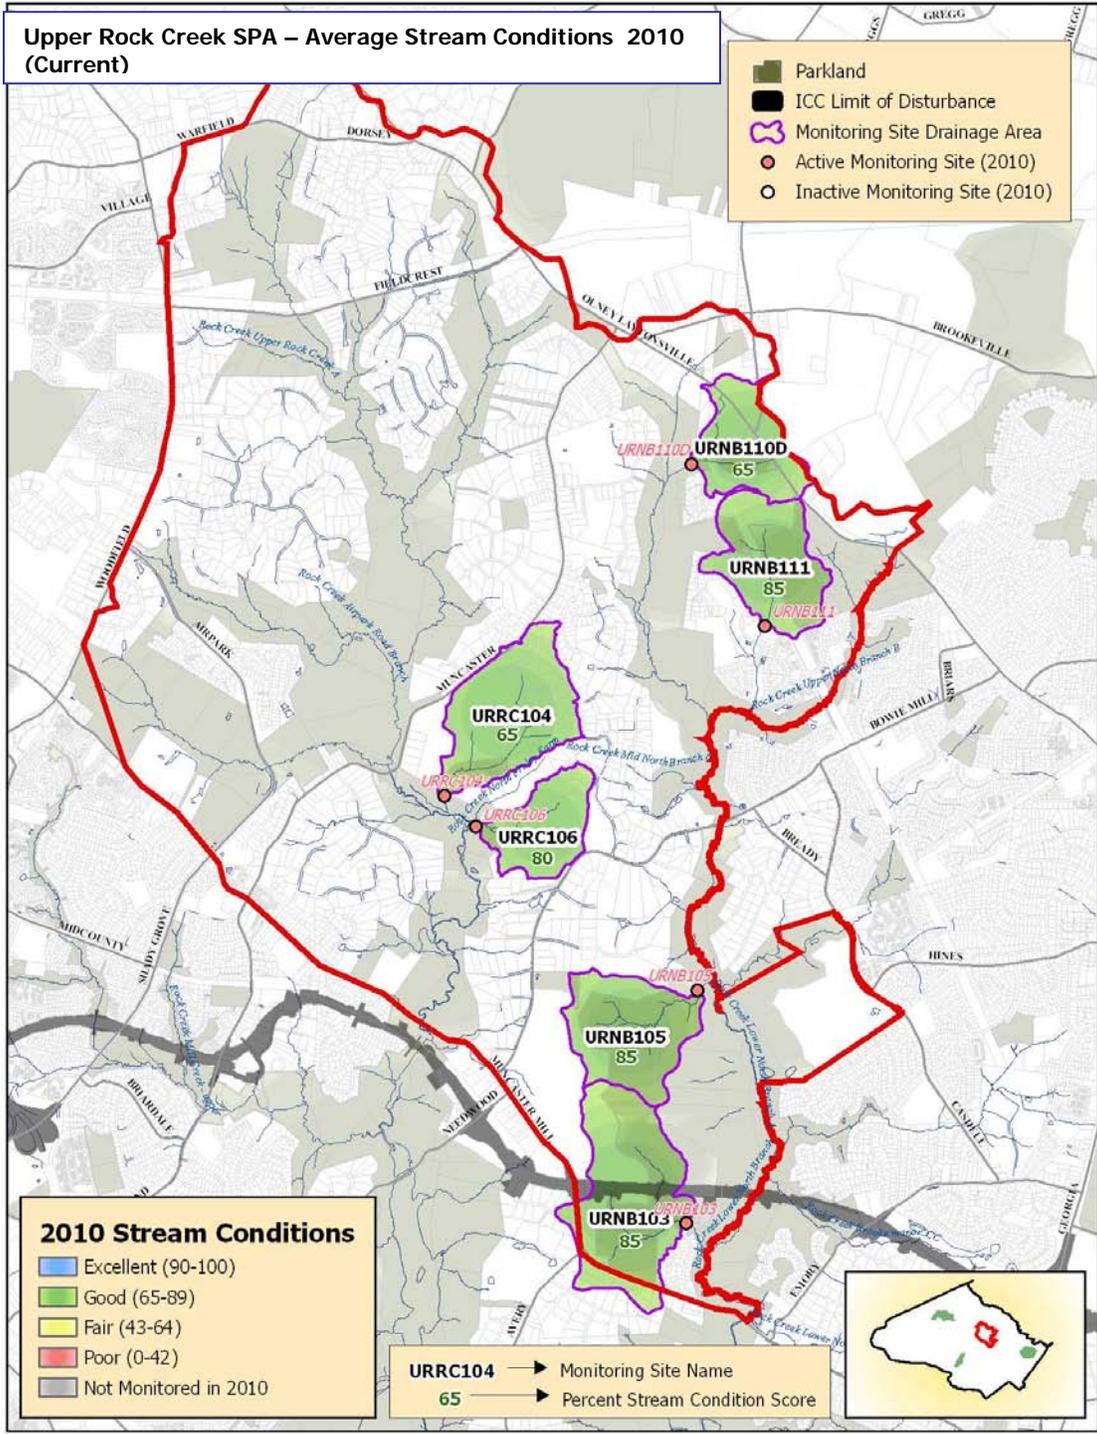
Figure 5.9. Current (2010) Stream Conditions in the Upper Rock Creek SPA.

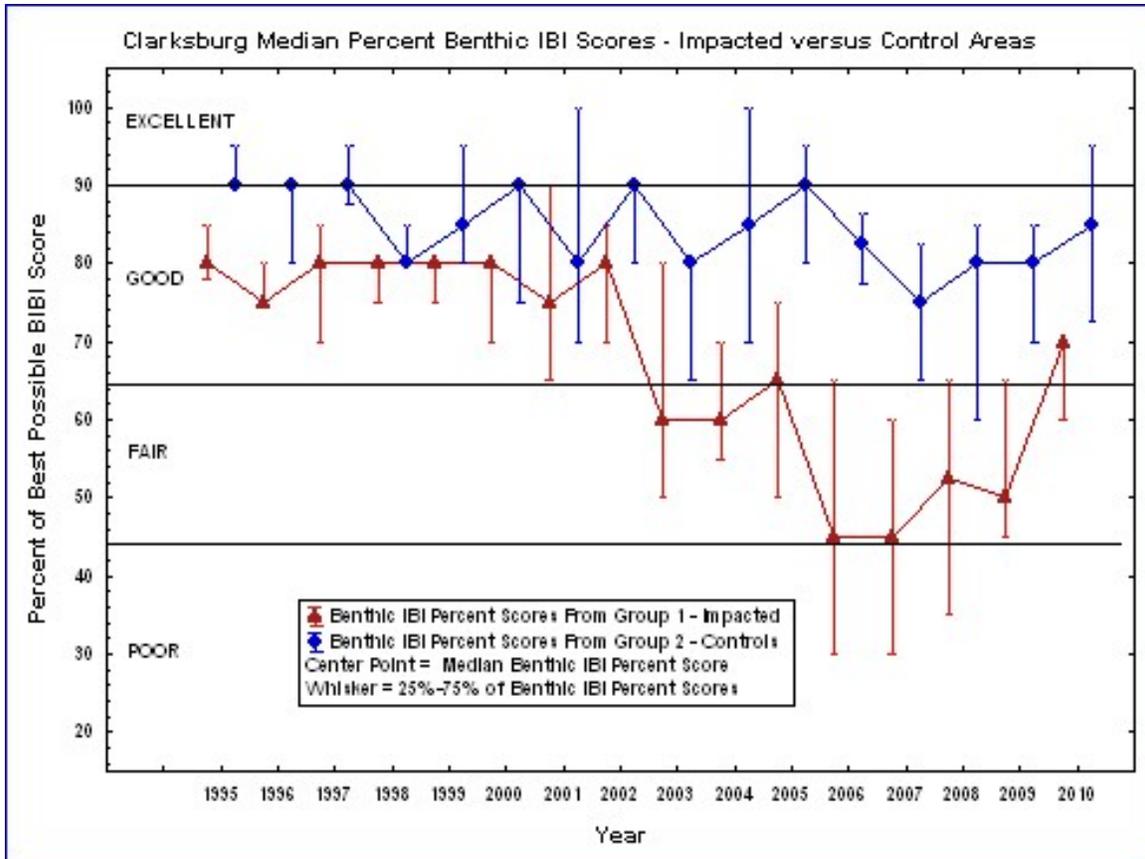
Figure 5.10. Median Benthic IBI Scores for Clarksburg Control and Test Areas.

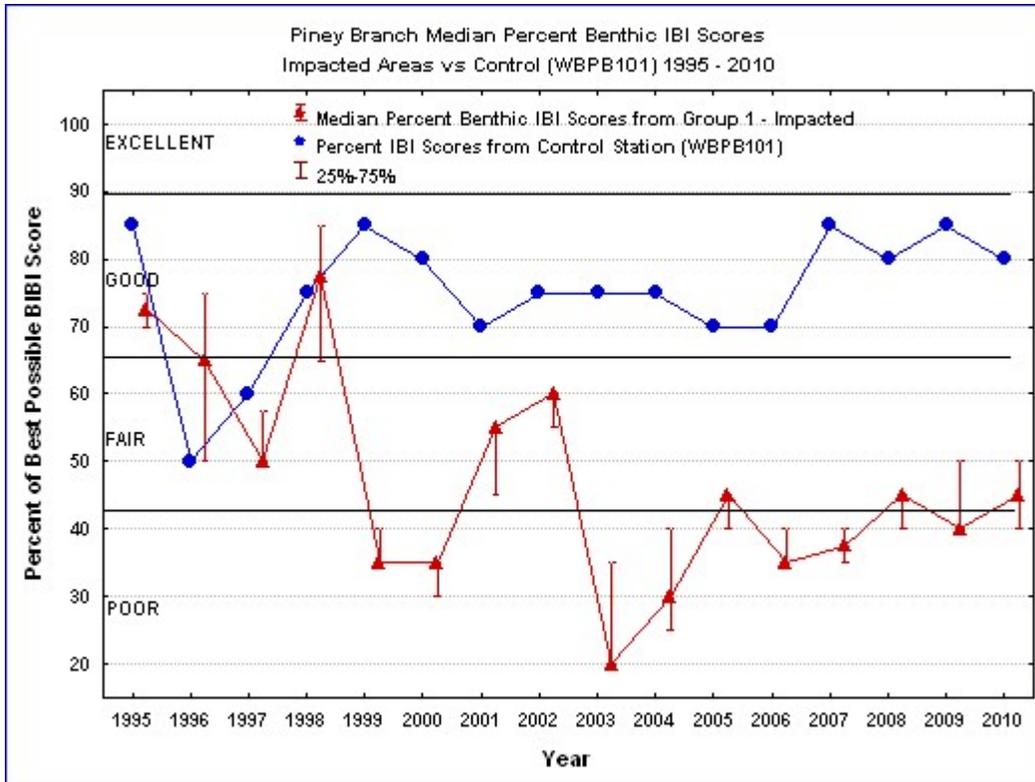
**Figure 5.11. Median Benthic IBI Scores for Piney Branch Control and Test Areas.**

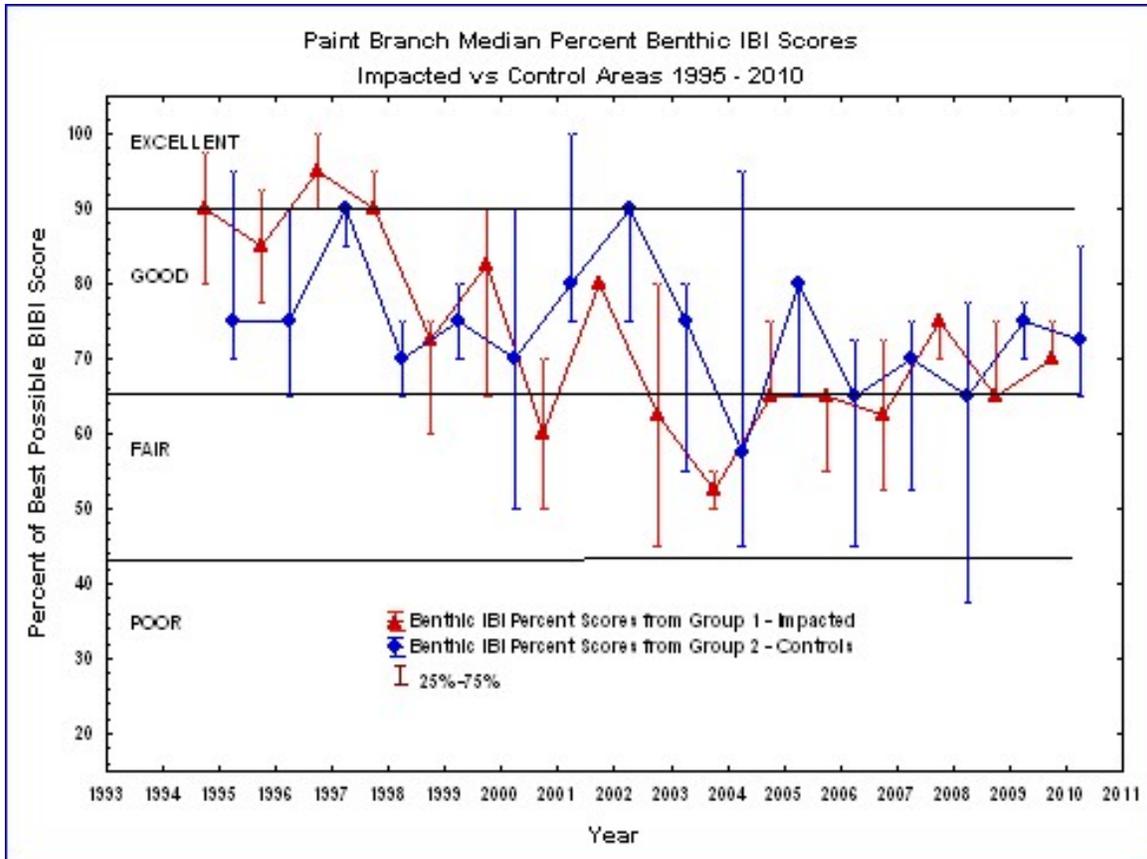
Figure 5.12. Median Benthic IBI Scores for Upper Paint Branch Control and Test Areas.
