# Special Protection Area Program Annual Report 2010

Prepared by the Montgomery County Department of Environmental Protection in Cooperation With the Department of Permitting Services and the Maryland-National Capital Park and Planning Commission

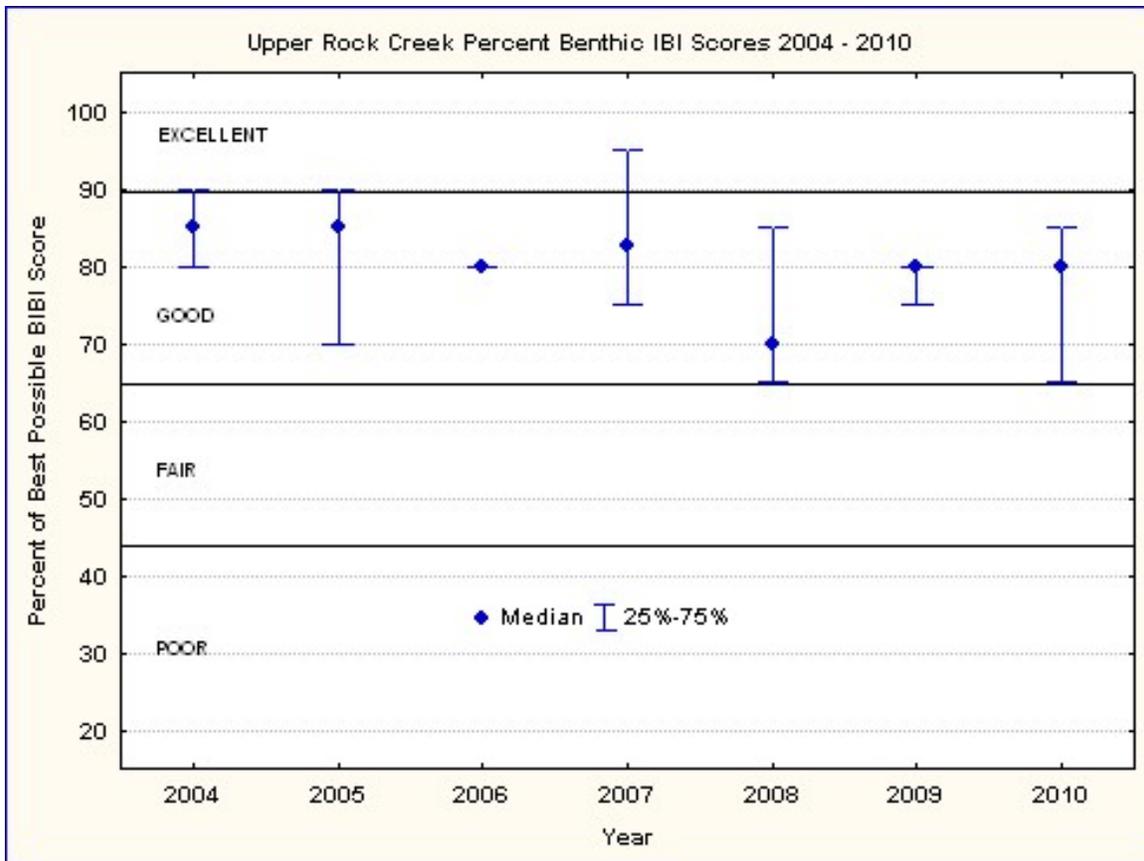
Figure 5.13. Median Benthic IBI Scores for Upper Rock Creek Control Area.
