# Colesville Road (US 29) Pedestrian Road Safety Audit Montgomery County, Maryland

Prepared For:  
Department of Transportation  
Montgomery County, Maryland

October 2012

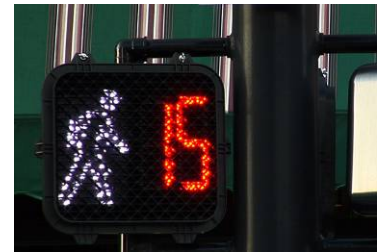
Photo of a countdown signal

- *Accessible and Countdown Pedestrian Signals (APS/CPS):* Pedestrian countdown signals with accessible push-buttons are provided at the Colesville Road/Fenton Street and Colesville Road/Spring Street intersections. Countdown pedestrian signal research has shown that pedestrians easily understand how the signal works and that more pedestrians start during the clearance phase, but fewer people initiate walking late in the clearance phase. Studies have also shown that fewer pedestrians remain in crosswalks during the steady “Don’t Walk” phase where countdown signals are used. Countdown pedestrian signals have also been found to reduce pedestrian injury crashes and improve pedestrian compliance to traffic controls in several national studies.

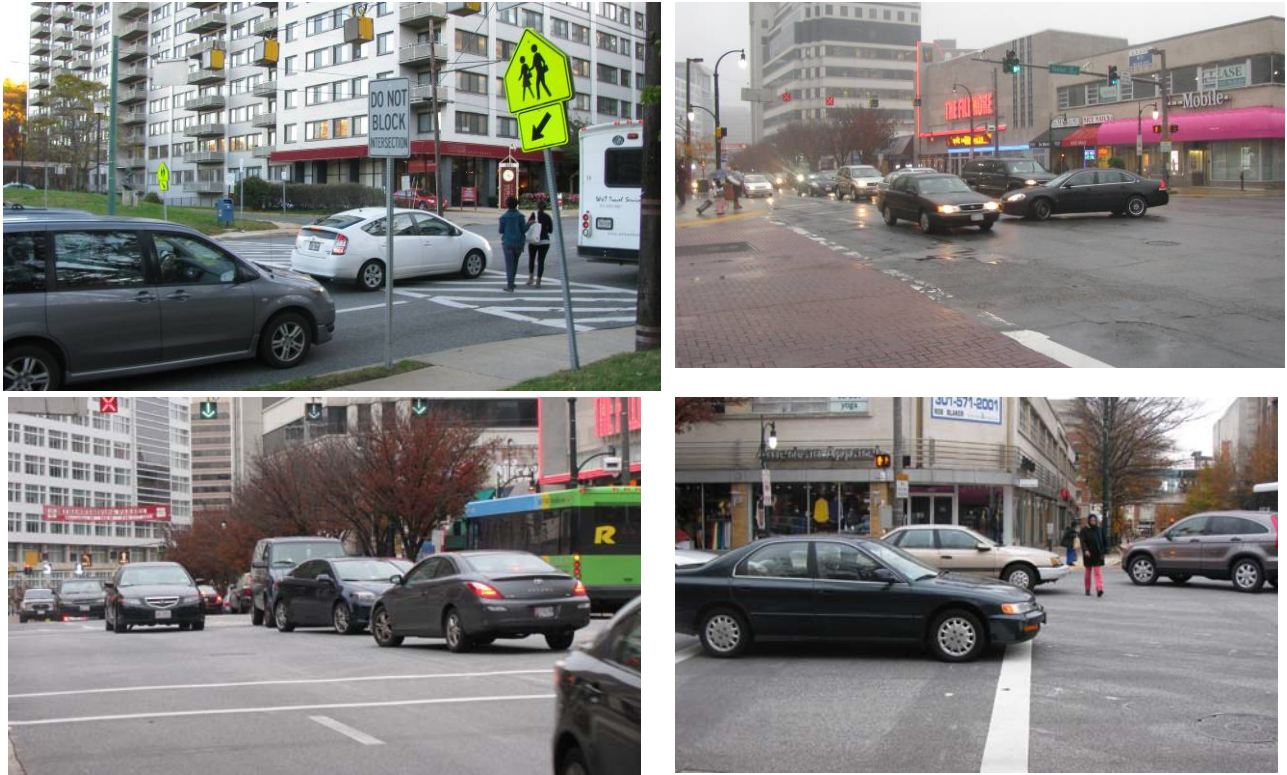
Figure 15: Aggressive Driver Maneuvers

Aggressive driver behaviors were observed at multiple locations in the study area. The most frequently observed behaviors included vehicles failing to yield to pedestrians in crossings, violating red signal indications, violating turn restrictions, turning vehicles accepting short gaps in oncoming traffic, and improperly using reversible lanes during peak periods. Relatively high traffic speeds were observed on Colesville Road, north of Spring Street. Traffic emerging from congested conditions on northbound Colesville Road in the Silver Spring CBD during peak periods tends to accelerate after passing Spring Street. During off-peak periods, drivers were observed traveling at relatively high speeds under uncongested traffic conditions.

Drivers were routinely observed failing to yield to pedestrians waiting to enter the roadway or crossing in an unsignalized crosswalk. Left-turning vehicles were consistently observed waiting until the yellow signal phase to initiate left turn maneuvers or sneaking through all-red signal intervals, particularly during the evening peak period when traffic volumes on Colesville Road are heaviest. Vehicles were also observed disobeying left turn restrictions on Colesville Road and forcing left turn movements to cross up to four lanes of oncoming traffic on Colesville Road during peak periods. Vehicles were observed using the central reversible lanes on Colesville Road as left turn lanes during peak periods. Vehicles were consistently observed stopping well past stop bars, creating conflicts with pedestrians beginning to cross the street in crosswalks.

Upper Left: A vehicle in a central lane blocks the unsignalized crosswalk, forcing pedestrians out of the crosswalk. Upper Right: Vehicles forcing left turns on Colesville Road despite oncoming traffic. Lower Left: Northbound left turn vehicles (oncoming in photo) occupy a center lane designated for southbound traffic during the weekday morning peak period. Lower Right: Vehicles stop past a crosswalk on Colesville Road, forcing a pedestrian into the intersection in front of an opposing vehicle.

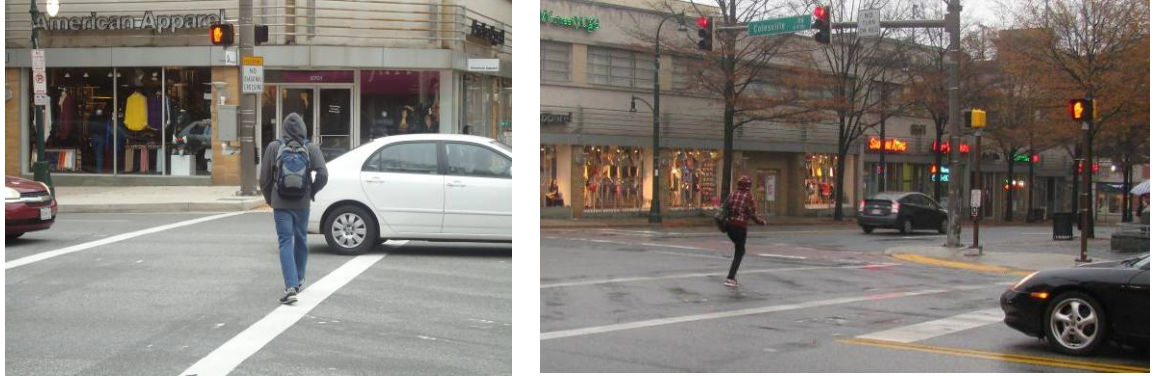
**Figure 16: Limited Pedestrian Compliance with Signals**

Pedestrians were frequently observed violating pedestrian signals. Relatively long pedestrian wait times, long signal cycle lengths, pedestrian impatience, transit activity, and a number of human factors may contribute to the impulse for pedestrians to cross during DON'T WALK indications. Observations during the PRSA and a review of the pedestrian signal timing plans indicated that some existing pedestrian clearance intervals may be shorter than recommended by State standards for pedestrian signal timings. It should be noted that the State and County are currently transitioning to the latest standard recommended in the Federal Highway Administration's (FHWA) Manual on Uniform Traffic Control devices (MUTCD).

**Left and Right: Pedestrians cross Colesville Road during the Don't Walk phase.**

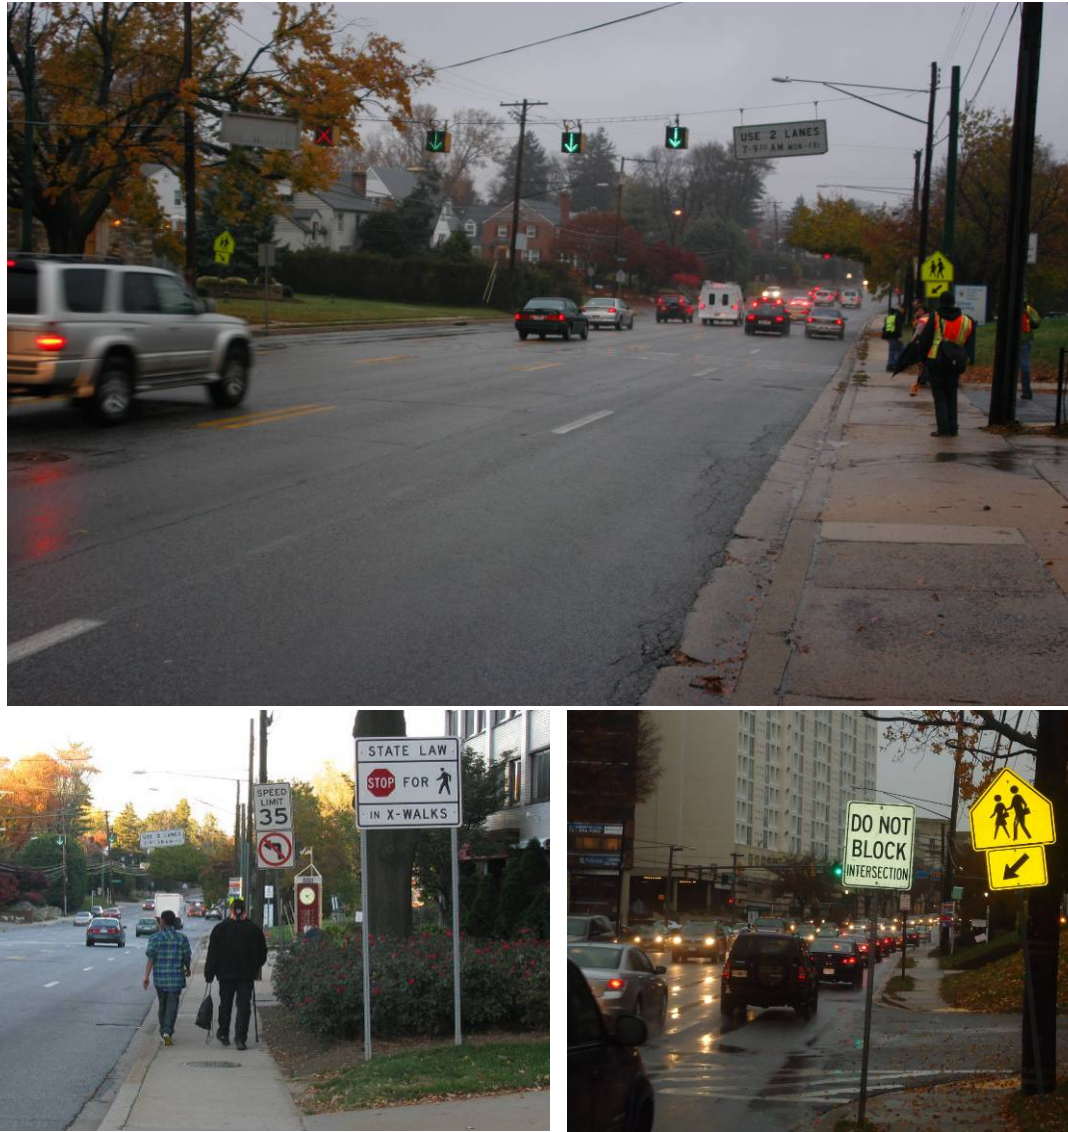
Figure 17: Pavement Marking and Signage Issues

The audit team identified several pavement marking and signage conditions that may contribute to pedestrian safety issues. The issues include crosswalk markings that may not ensure visibility or driver expectation of pedestrians for vehicles traveling at relatively high speeds, reversible lane indications that may distract drivers where focusing on pedestrian activity is a priority, speed limits that allow drivers to maintain an elevated speed prior to an unsignalized crosswalk, undesirable signage placement, and a lack of high visibility pedestrian safety treatments at an unsignalized crosswalk.

**Top:** South Noyes Drive crosswalk during rainy conditions, which highlights crosswalk visibility limitations and the prominence of the overhead lane indications and signage. **Lower Left:** Pedestrian safety and posted speed limit signage (increasing limit to 35 mph prior to an unsignalized crosswalk). **Lower Right:** Pedestrian warning sign along southbound Colesville Road posted outside of Do Not Block Intersection sign.

Safety Issue	Suggestions
<b>Pavement Marking and Signage Conditions</b>	<ul style="list-style-type: none"> <li>▪ Consider relocating speed limit signage to reduce the posted speed limit on Colesville Road in proximity to unsignalized midblock crossings. (ST)</li> <li>▪ Consider installing crosswalks exceeding the standard 10-foot width to enhance visibility to drivers at a longer distance and elevated speeds, at unsignalized midblock crosswalks. (ST)</li> <li>▪ Evaluate and consider restriping crosswalks with high-visibility markings and materials. (ST)</li> <li>▪ Consider installing an advance stop bar and “Stop Here for Pedestrians” signage (R1-5b) at crosswalks, compliant with State standards, where appropriate. (ST)</li> <li>▪ Consider installing overhead “State Law: Stop for Pedestrians” signage (R1-9a) at unsignalized midblock crosswalks. (ST)</li> <li>▪ Consider moving pedestrian warning signage closer to the roadway, where appropriate. (ST)</li> <li>▪ Work with SHA to explore relocating overhead reversible lane indications to reduce signage clutter and driver distraction near unsignalized midblock crosswalks. (LT)</li> </ul>

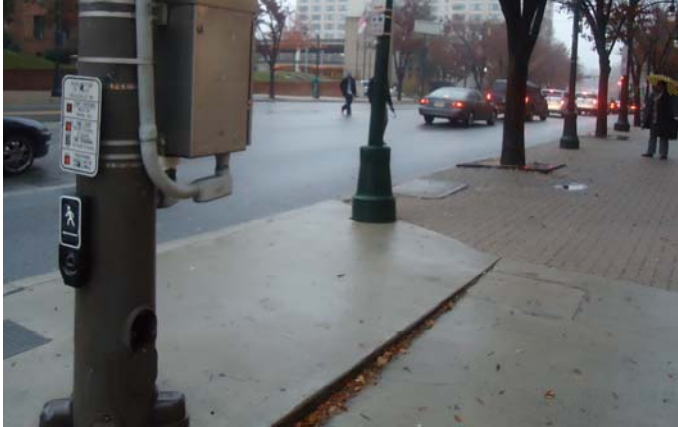
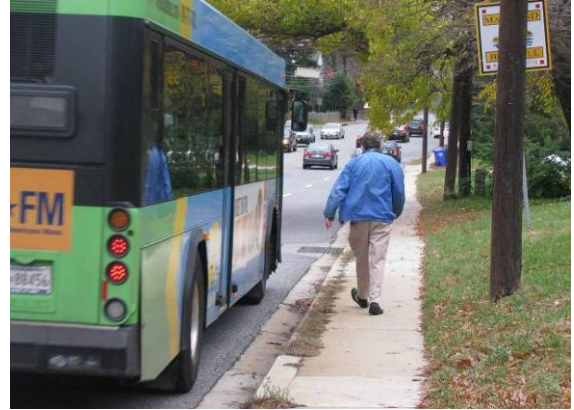
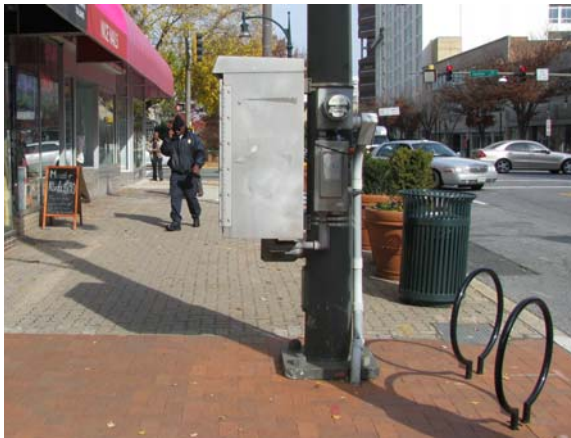
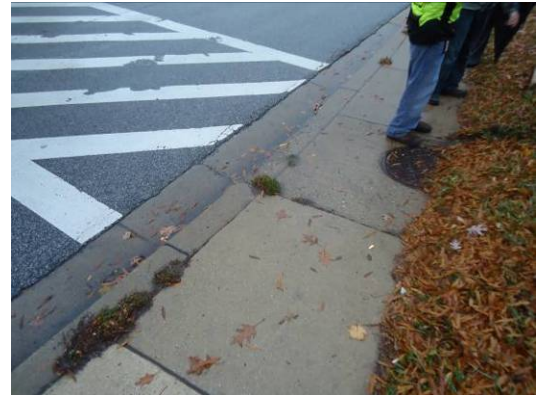
Figure 19: Pedestrian Facility Limitations

Several issues concerning the sidewalk design, continuity of pedestrian facilities, and pedestrian accessibility were observed. These issues include pedestrian signal timings that appeared to be shorter than concurrent vehicle green phases, long crossing distances, lack of crosswalks along some pedestrian desire lines, superfluous curb cuts, substandard sidewalk width, inconsistent application of pedestrian signal voice commands, substandard crosswalk and wheelchair ramp surfaces, vegetation obstructing sidewalks/wheelchair ramps, missing detectable warning surfaces, narrow effective sidewalk widths, lack of pedestrian buffers, and sidewalk obstructions.

Upper Left: The edge of a wheelchair ramp may present tripping issues for pedestrians. Upper Right: Encroaching grass and a lack of a planting strip along Colesville Road contribute to pedestrians walking in close proximity to relatively high speed traffic. Lower Left: A utility cabinet attached to a pole obstructs a sidewalk. Lower Right: A pedestrian landing at a crosswalk is constricted by a manhole cover, vegetative debris, and the absence of a detectable warning surface.

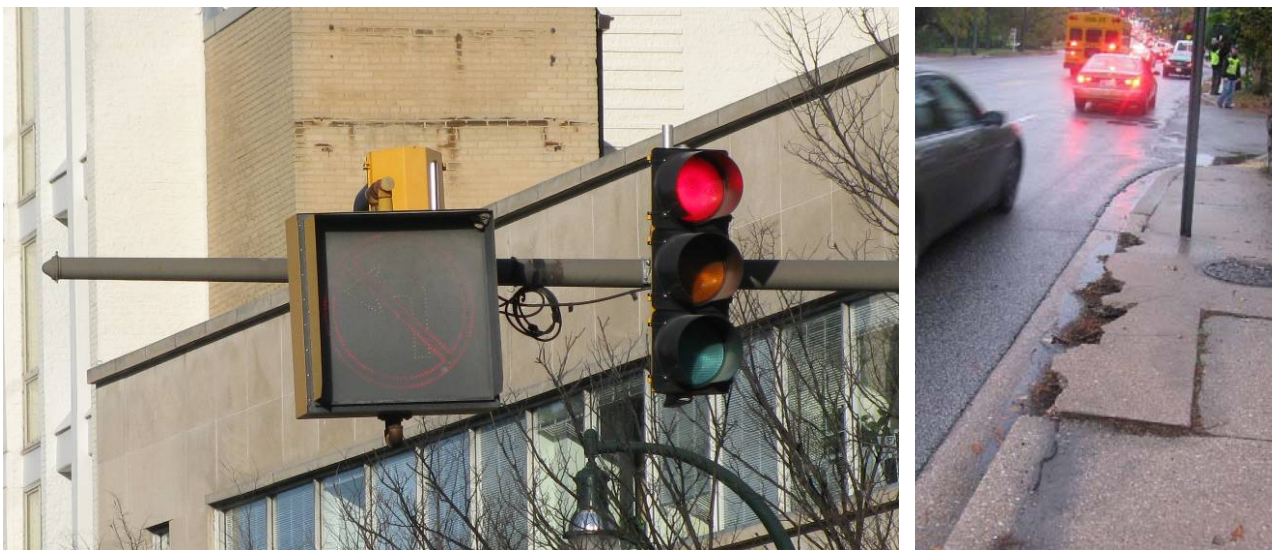
Figure 20: Maintenance Issues

The PRSA team observed a number of conditions that may contribute to pedestrian safety issues and that could be resolved through maintenance actions. These issues include limited conspicuity of variable regulatory signage, non-functional push buttons, outdated and superfluous signage, non-functional street lighting, vegetation obstructing signage, a protruding metal rod in the sidewalk, damaged drainage structures, and faded or deteriorating pavement markings.

**Left: Limited conspicuity of the variable No Left Turn indication display on northbound Colesville Road during sunny conditions. Right: A damaged drainage structure along the west sidewalk on Colesville Road.**

Safety Issue	Suggestions
<b>Maintenance</b>	<ul style="list-style-type: none"> <li>▪ Consider replacing variable/changeable turn indication(s) with new device(s) displaying greater conspicuity during bright conditions. (ST)</li> <li>▪ Consider refreshing crosswalk striping, where appropriate. (ST)</li> <li>▪ Consider installing high visibility crosswalk markings at signalized intersections in the study area, where appropriate. (ST)</li> <li>▪ Consider removing superfluous signage contributing to sign clutter at intersections in the study area. (ST)</li> <li>▪ Consider replacing/repairing non-functioning street lights. (ST)</li> <li>▪ Work with SHA/MCDOT to repair/replace unresponsive pedestrian signal push buttons. (ST)</li> <li>▪ Remove hardware protruding from sidewalks that may have the potential to trip pedestrians. (ST)</li> <li>▪ Trim vegetation obstructing signage. (ST)</li> <li>▪ Repair curbside drainage structures, where appropriate. (I)</li> </ul>
