# Dickerson Power Plant

WSSI #MD2258.01

## Waters of the U.S. (Including Wetlands) Delineation

## Dickerson Power Plant (±291.72 acres)

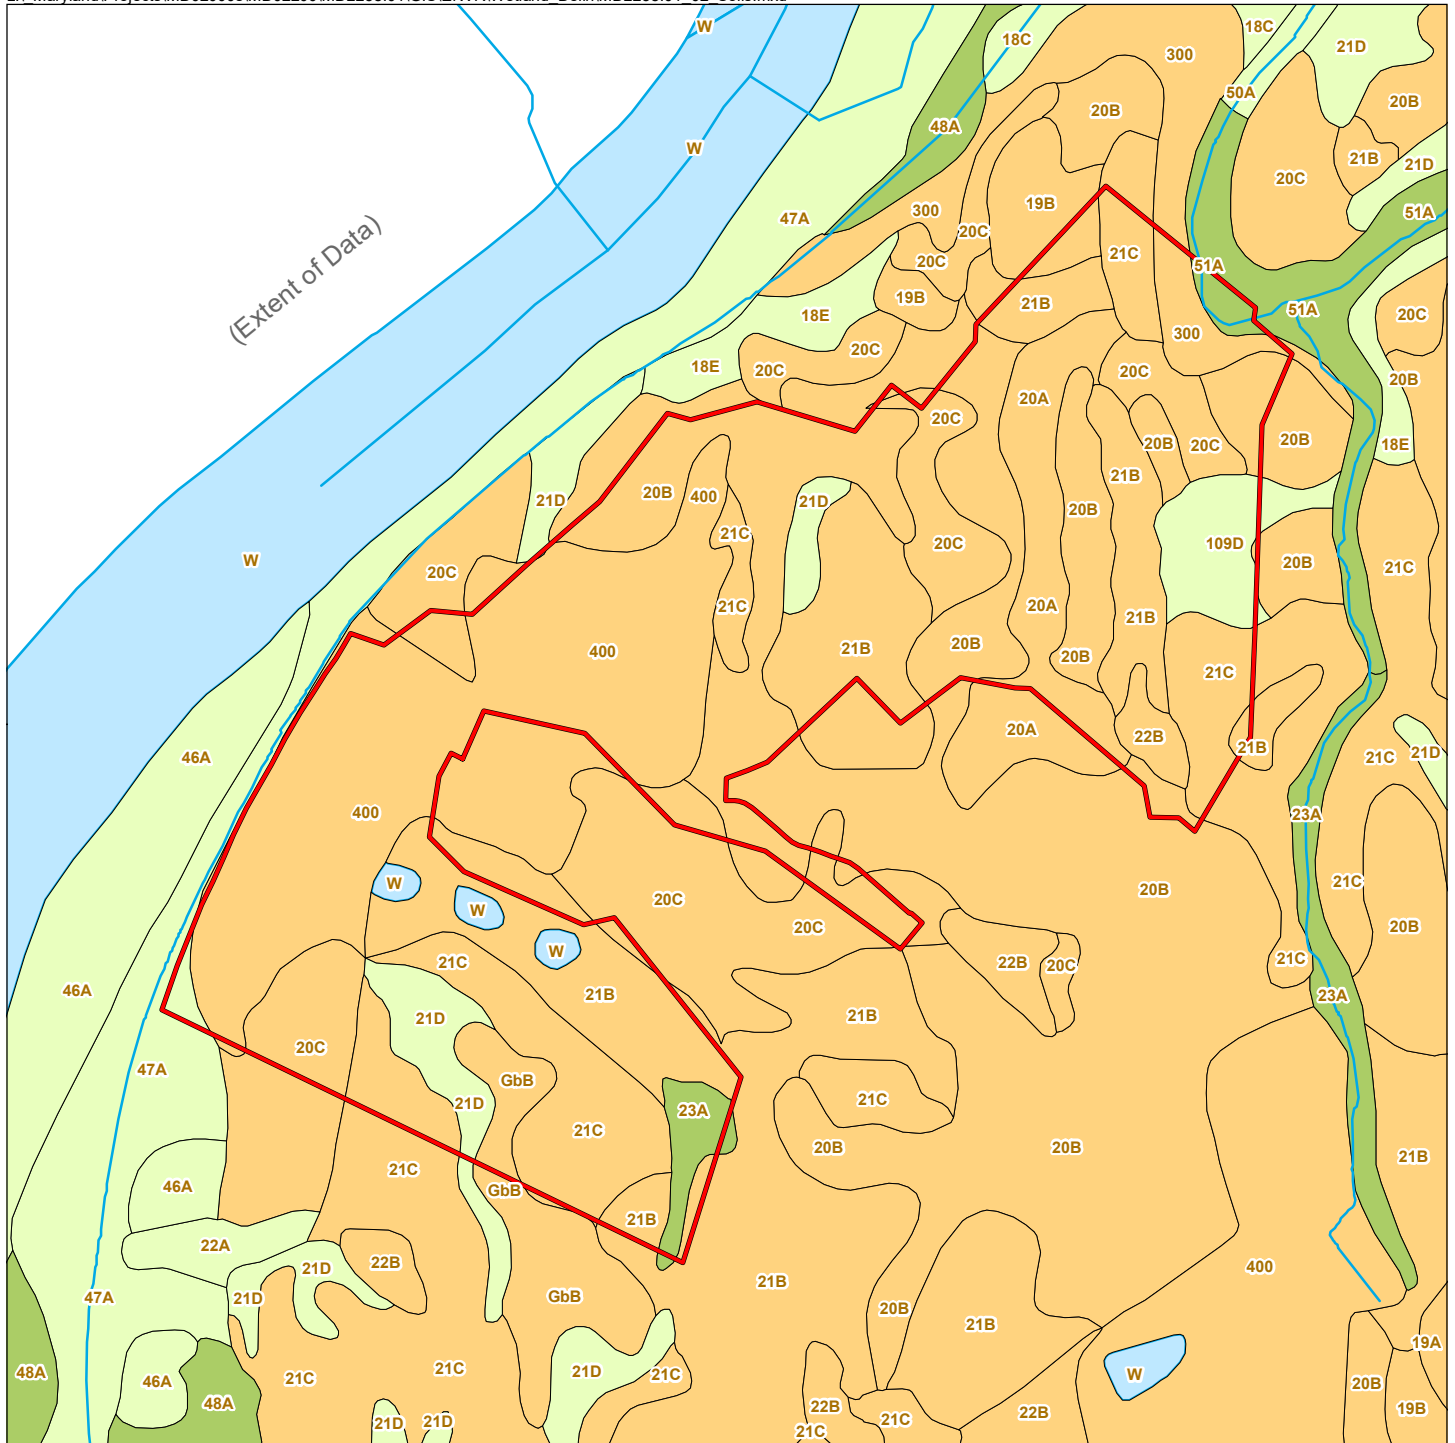
## **EXHIBIT 2**

- Site
- Hydric Soil
- Soil with Hydric Inclusion
- Non-Hydric Soil
- Water

**Soils Map**  
**Dickerson Power Plant**  
**WSSI #MD2258.01**

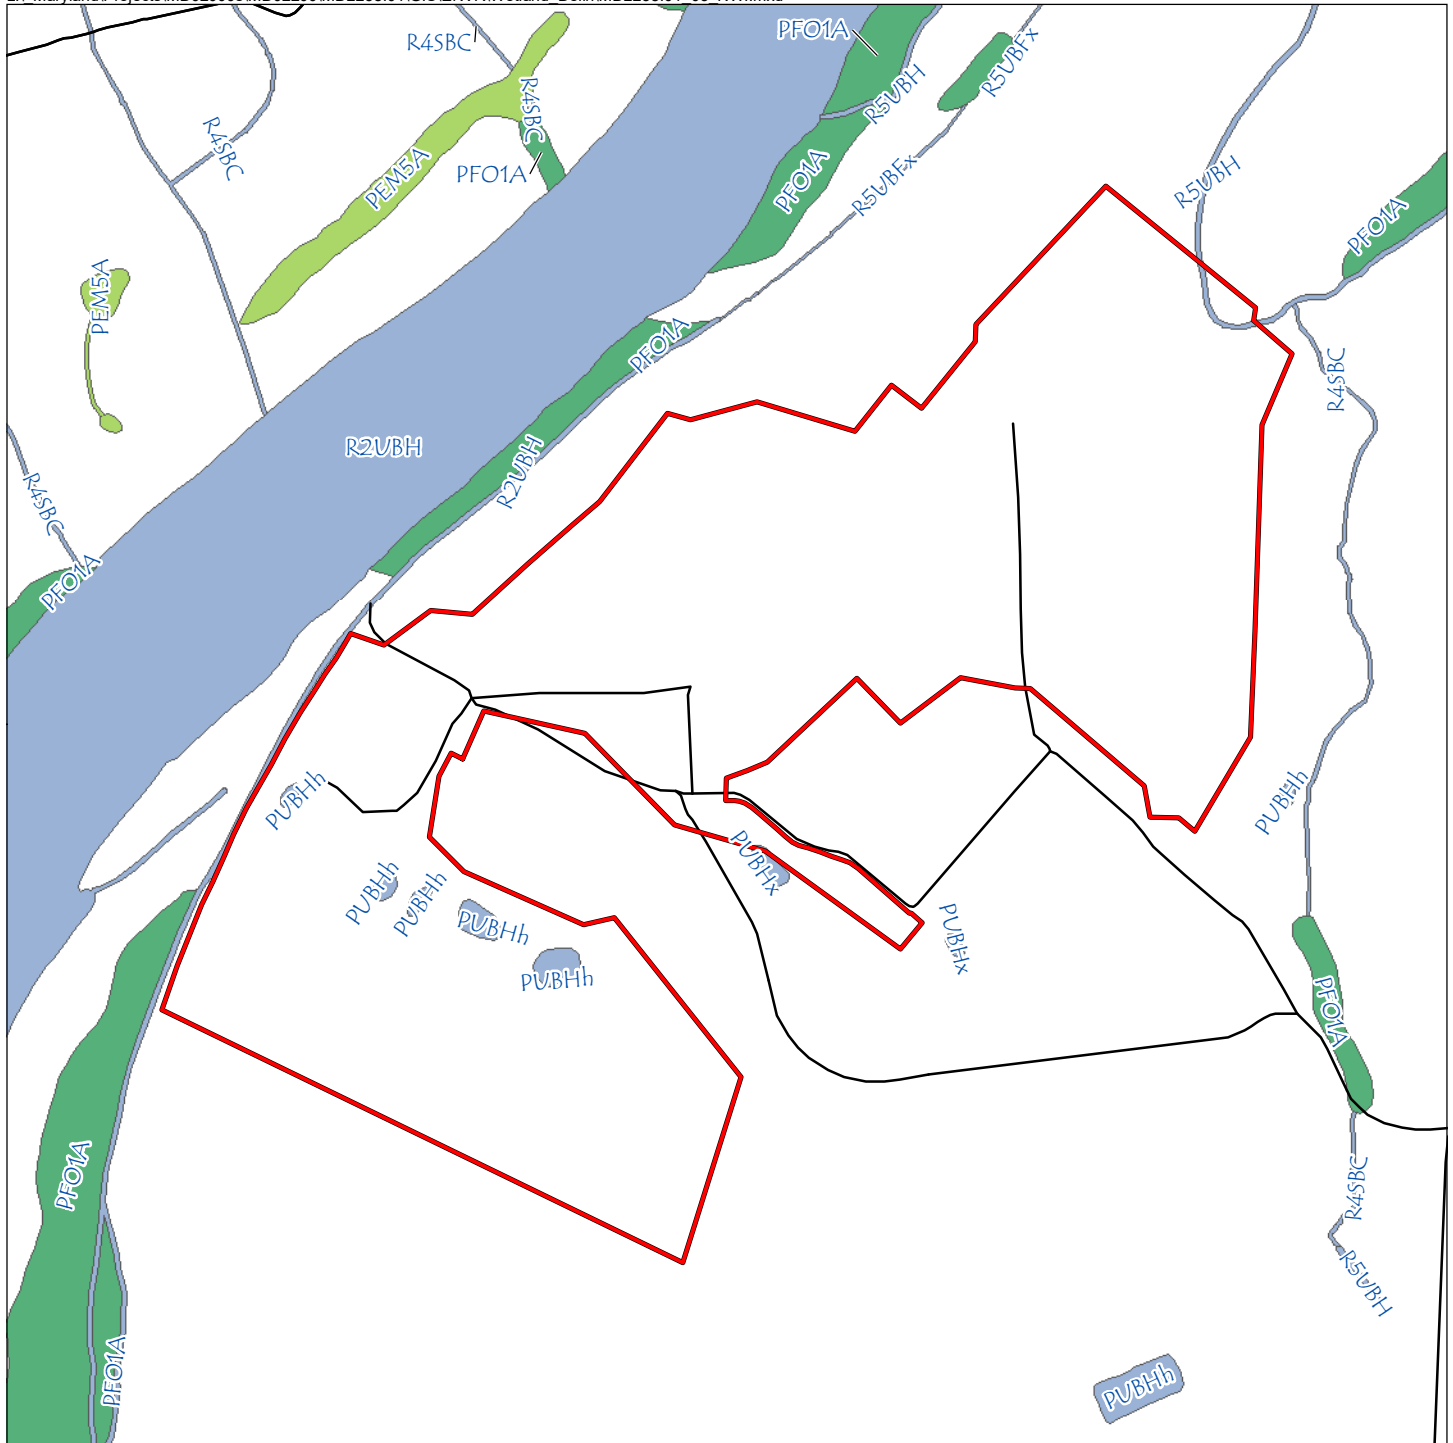
# **EXHIBIT 3**

- Open Water
- Freshwater Forested/Shrub Wetland
- Freshwater Emergent Wetland
- Estuarine and Marine Wetland
- Other

**Digital National Wetlands Inventory Map  
Dickerson Power Plant  
WSSI #MD2258.01**

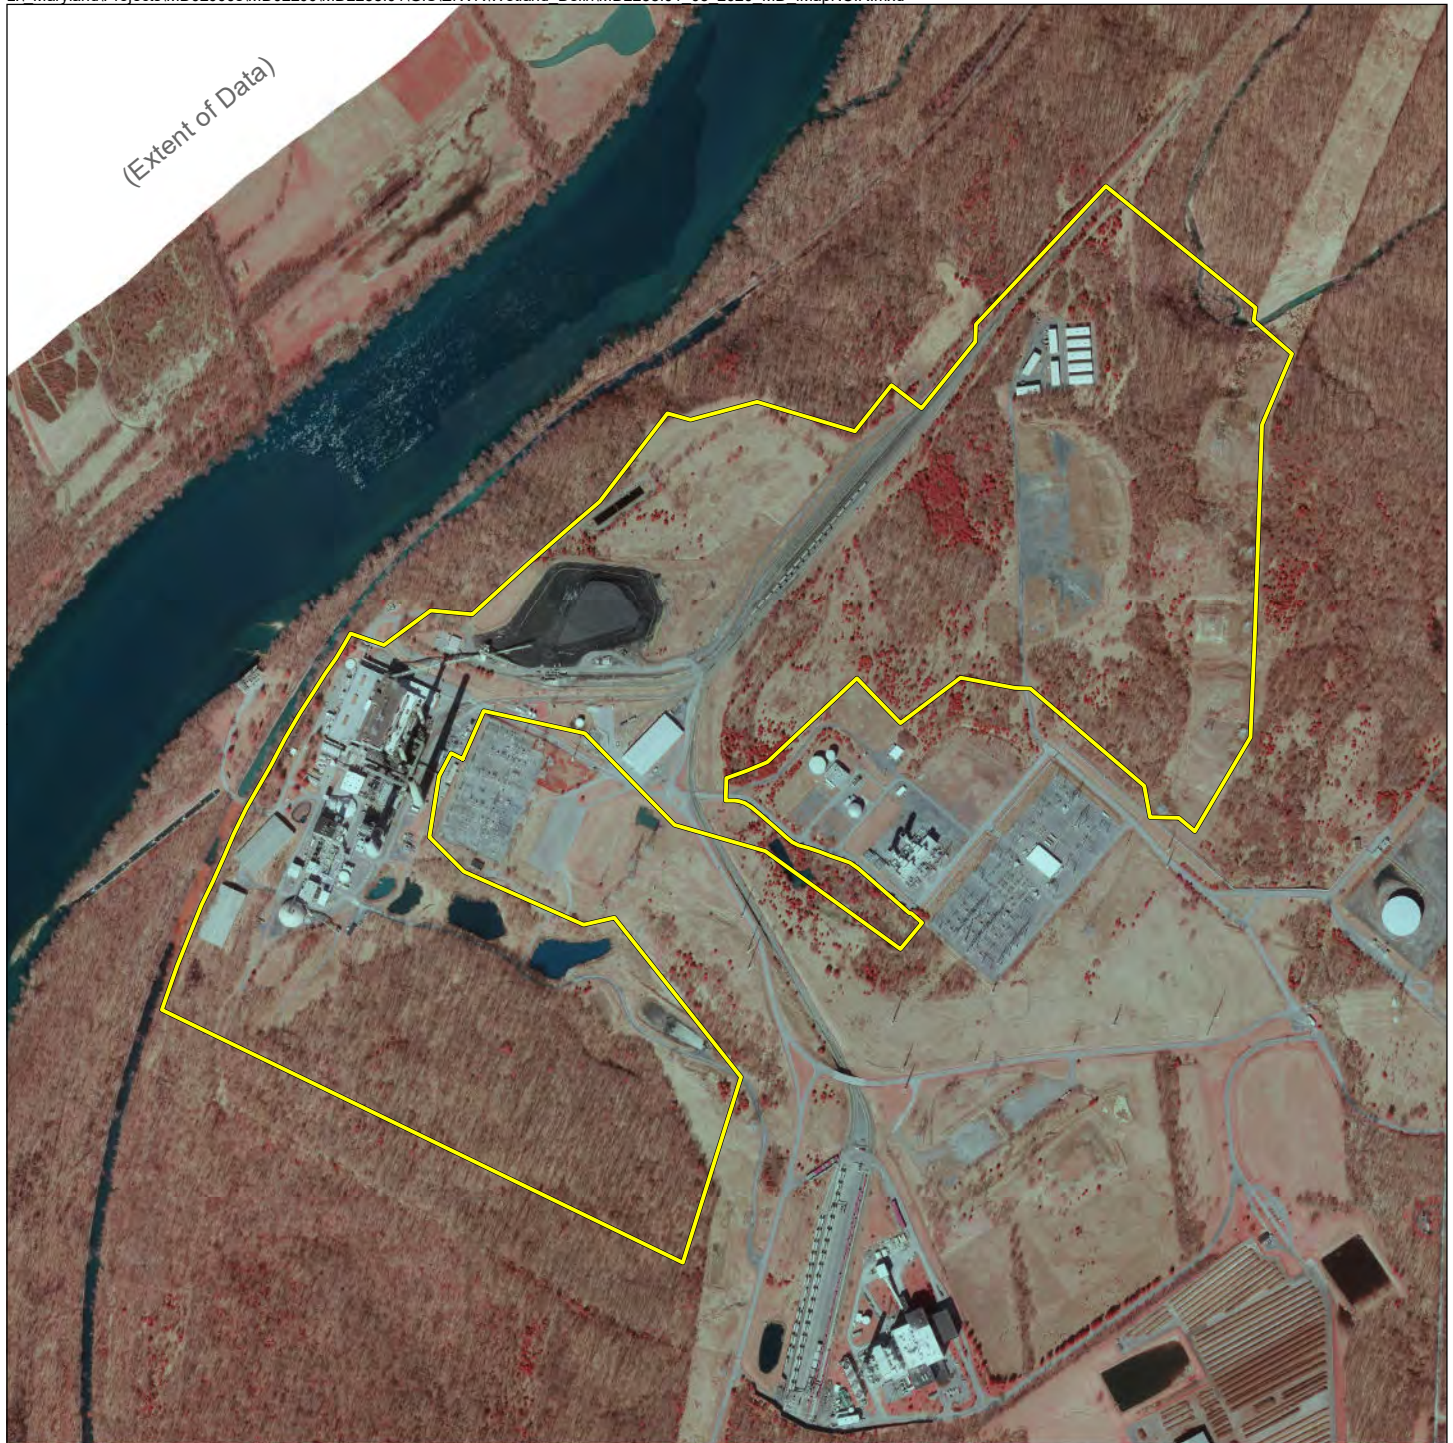
# **EXHIBIT 5**

**Spring 2020 Near Color Infrared Imagery  
Dickerson Power Plant  
WSSI #MD2258.01**
