GUDE LANDFILL

Shady Grove Sector Plan Meeting

Montgomery County

Department of Environmental Protection

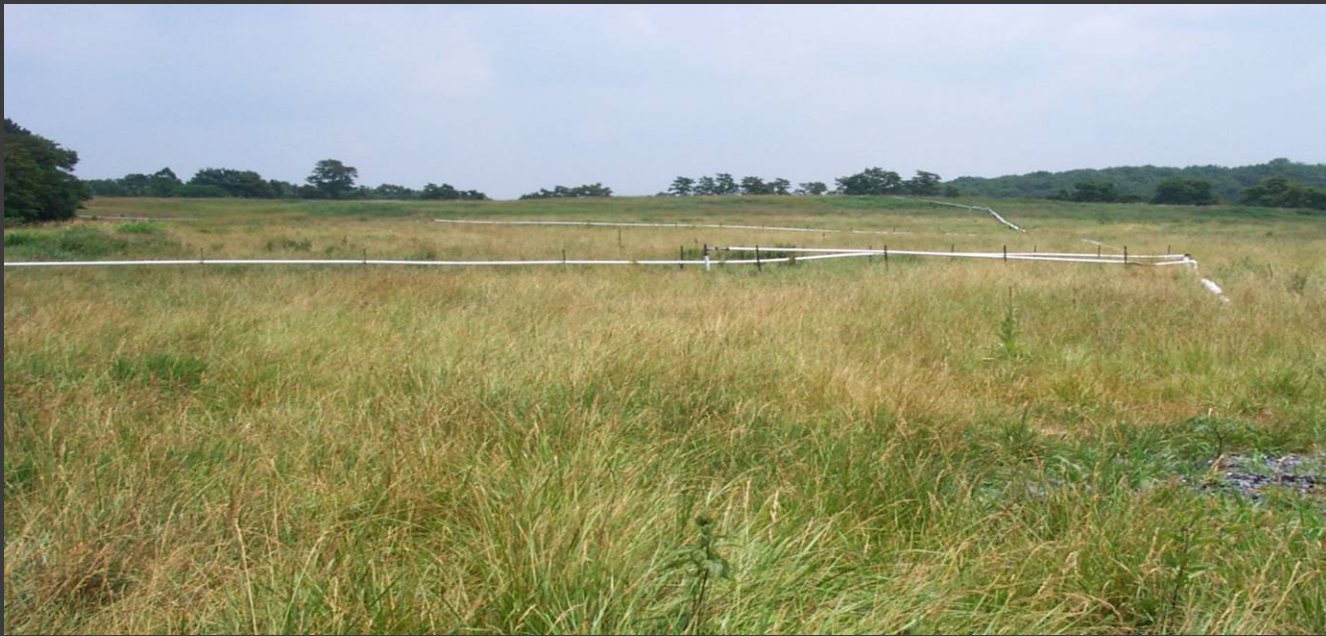
Landfill covered with soil and natural vegetation. Gas collection lines in background

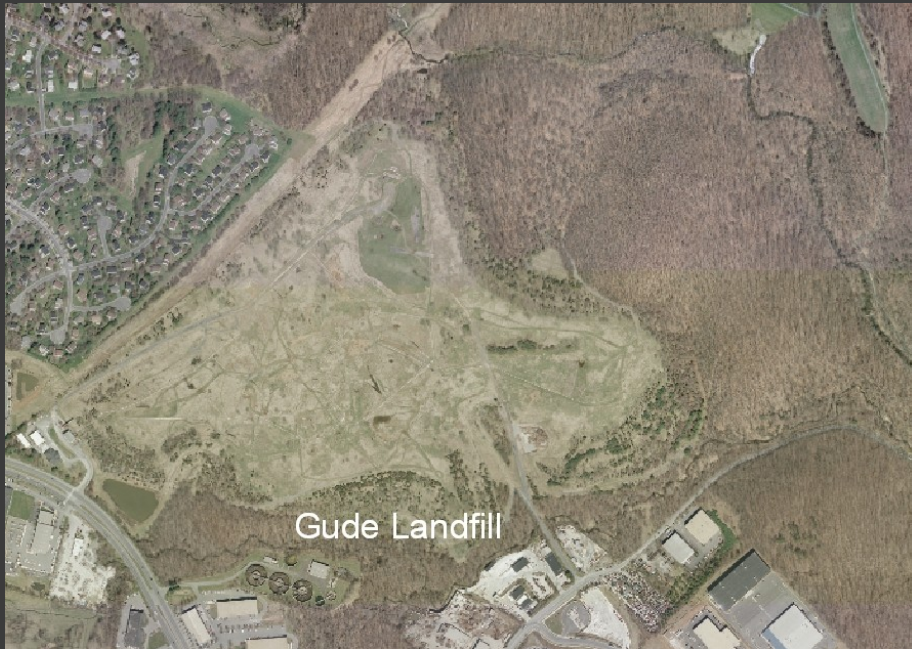
Reasons for Contamination

- 1964 - Began accepting solid waste
- 4.8m tons of waste (msw)
- 100 acres
- Closed in 1982
- 1983-'84 State and County developed Closure Plan in compliance with MD DHMH
- 1984: County began implementing closure plan

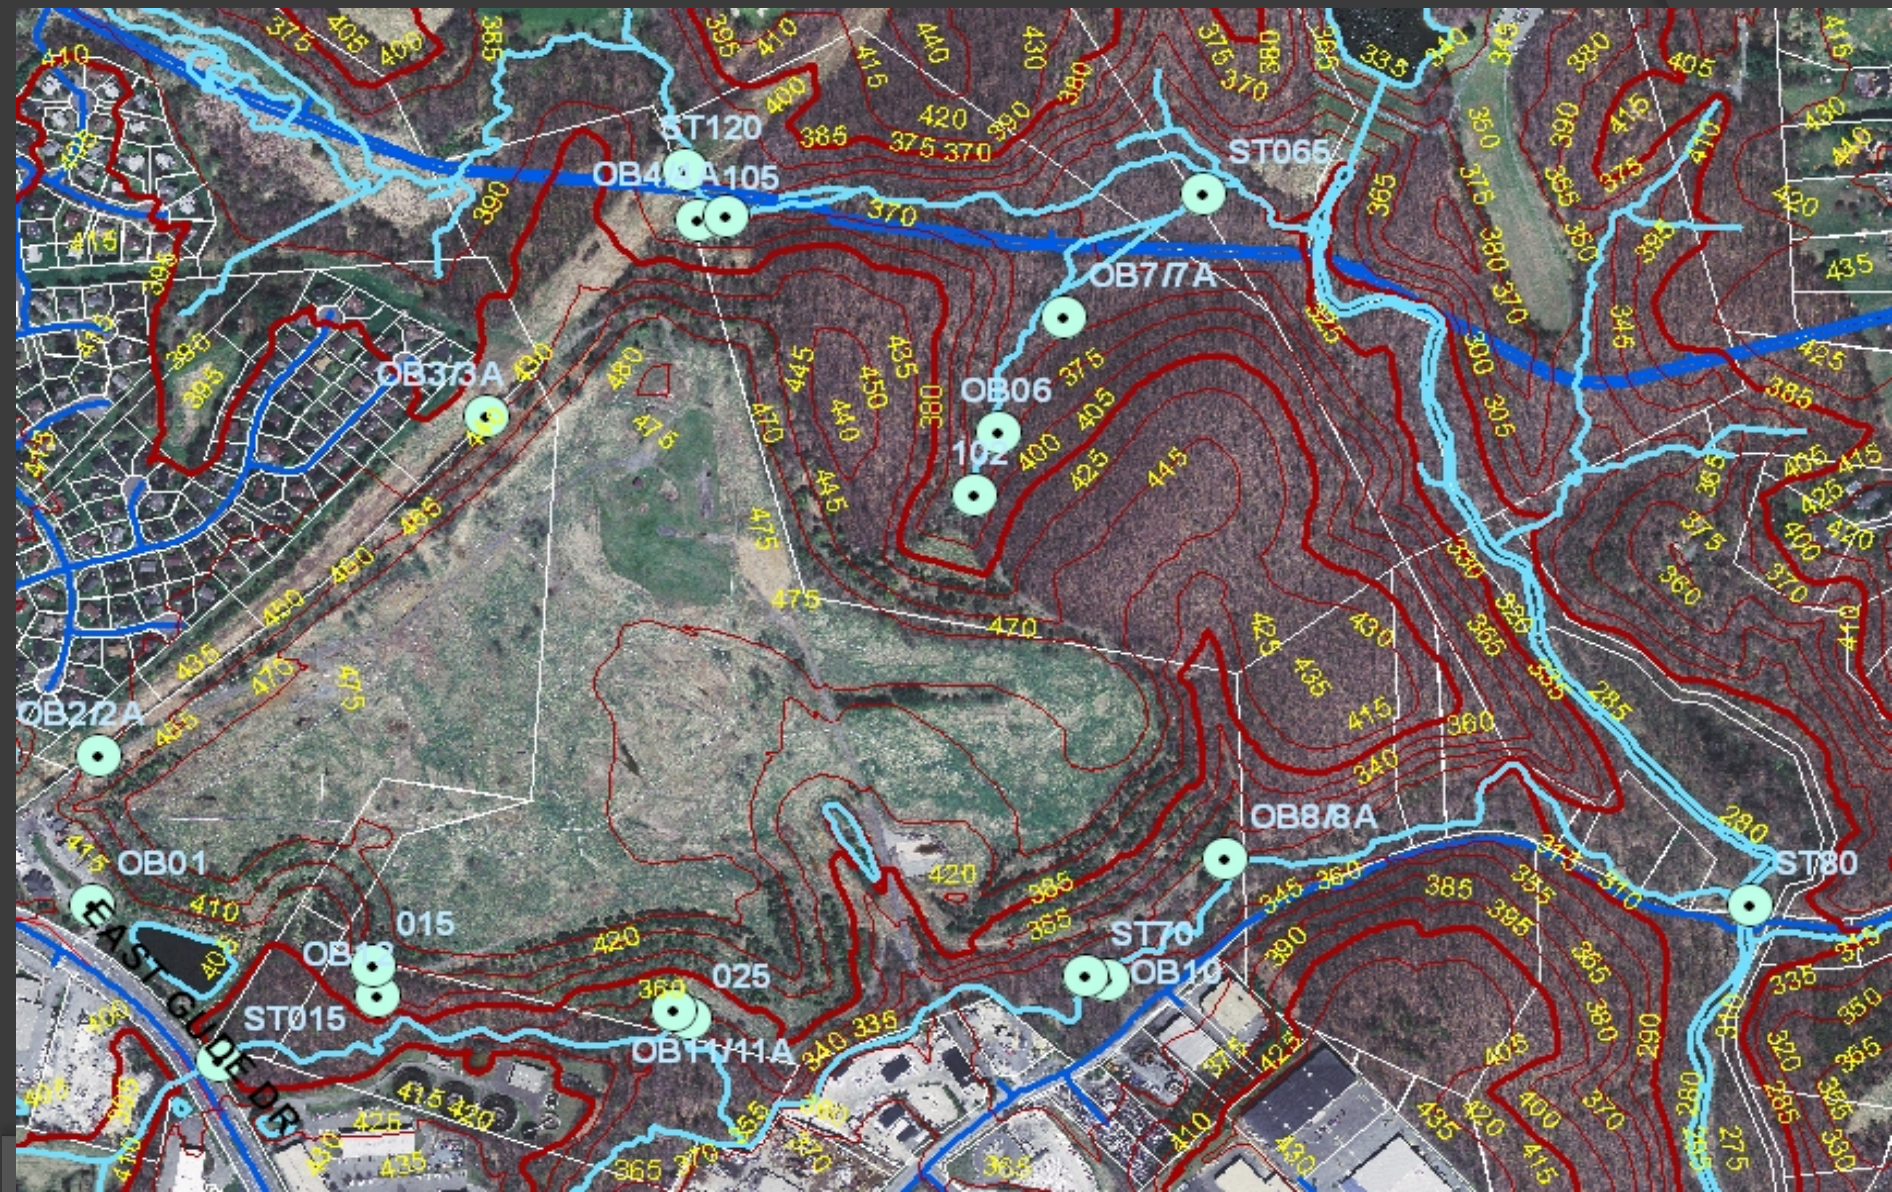
Gude Landfill and Monitoring Sites

- ⦿ DEP now monitors 20 groundwater wells
 - Located on landfill perimeter
 - Permitted by State
- ⦿ Samples taken spring and fall
- ⦿ Parameters
 - Volatile organic compounds (VOCs)
 - Semi-volatile compounds (SVOCs)
 - Pesticides
 - Heavy metals
 - Miscellaneous (including pH, turbidity, conductivity.)

- 52,000 data points since 2001
- < 1% (500+) exceed Maximum Contaminant Level (MCL) established for drinking water
- 70% of samples exceeding MCLs were from wells OB03 and OB11 (see map)

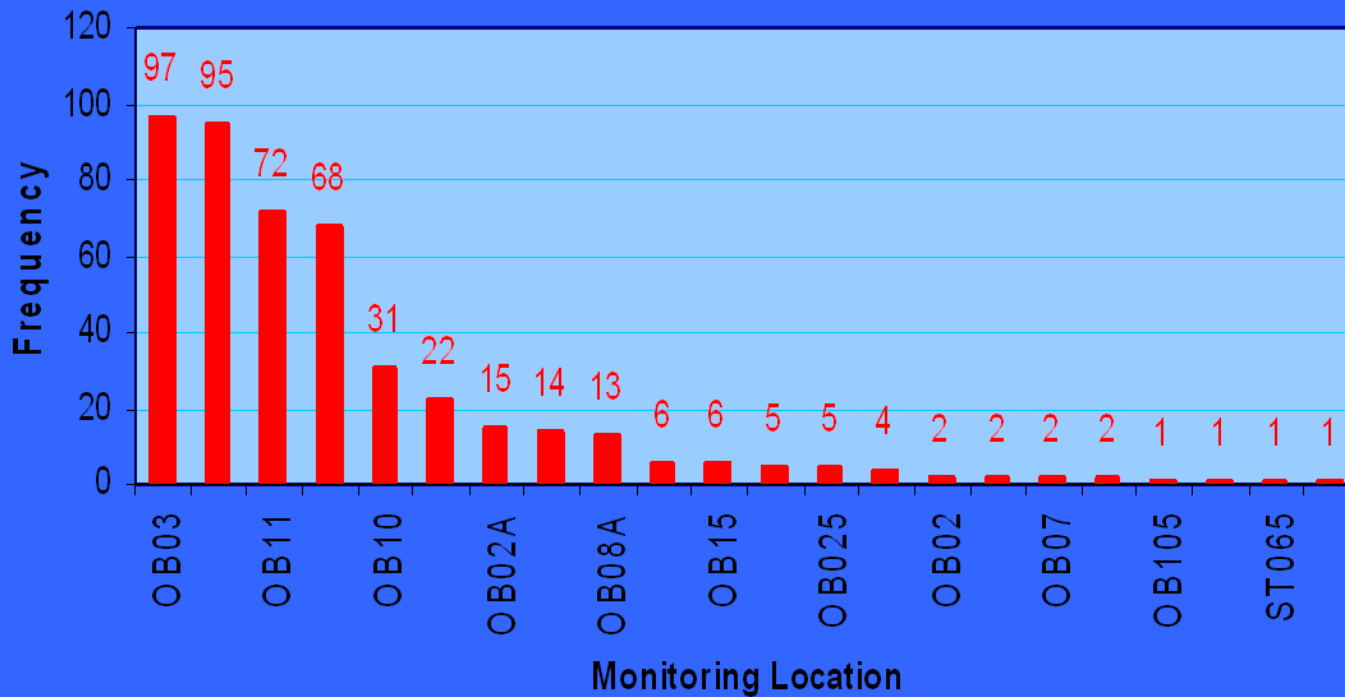
Frequency Distribution of Locations Exceeding MCLs

Gude Landfill - April 2001 Through March 2008

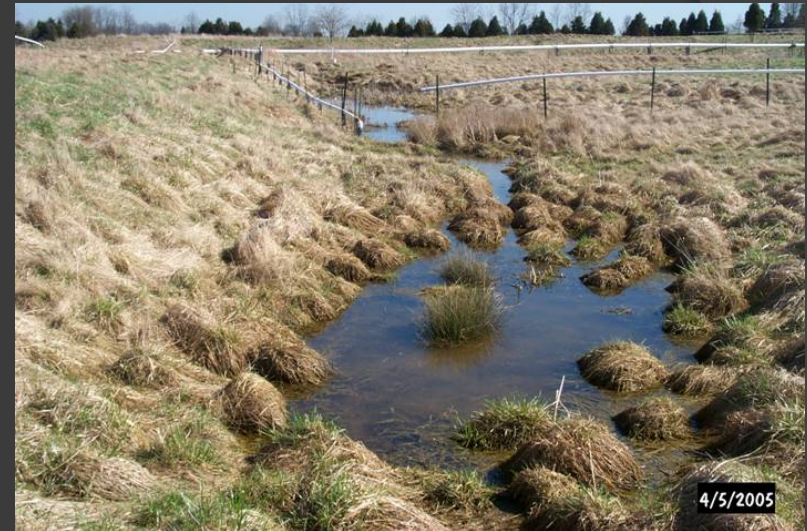
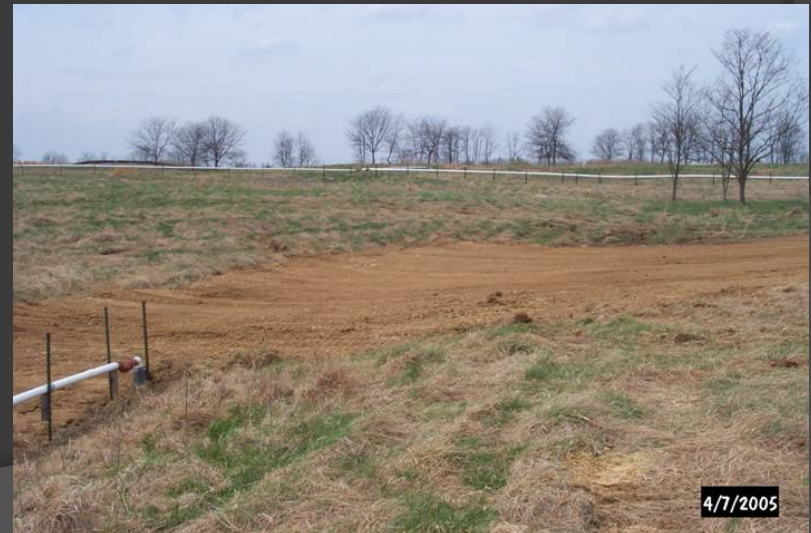
Current Leachate Controls

- Leachate seeps are caused by water in contact with waste and breaking out on a hillside
- Control by promoting drainage from surface to reduce infiltration.
- Uneven settling requires filling and regrading.

- Ultimate remediation goal is no MCL exceedences for any parameter at property line and no methane gas levels above 25 percent of the Lower Explosive Limit (LEL).
- Next step is to conduct a study to better define the problem areas and prioritize areas for remediation.
- Continue maintenance including seep repairs and grading and drainage adjustments to minimize infiltration of rain water into the landfill.

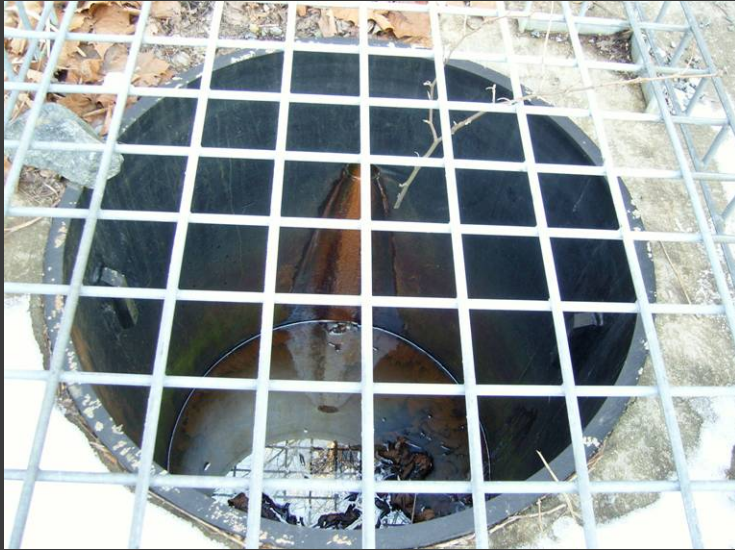
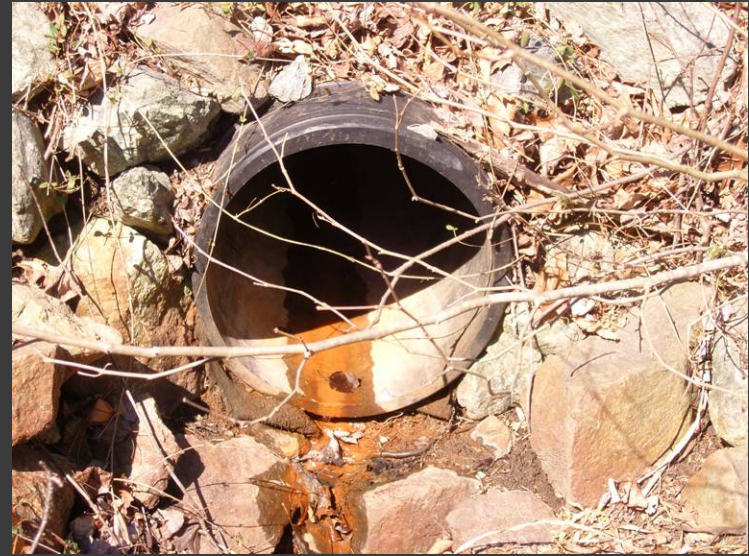
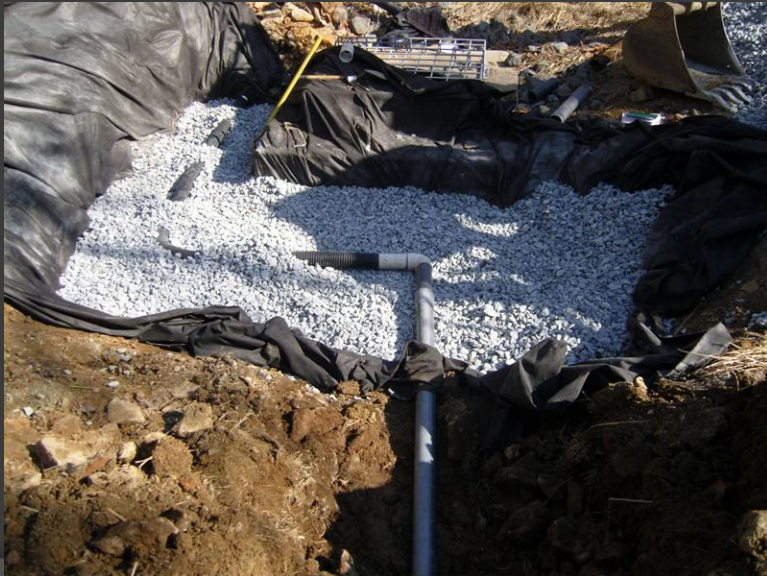
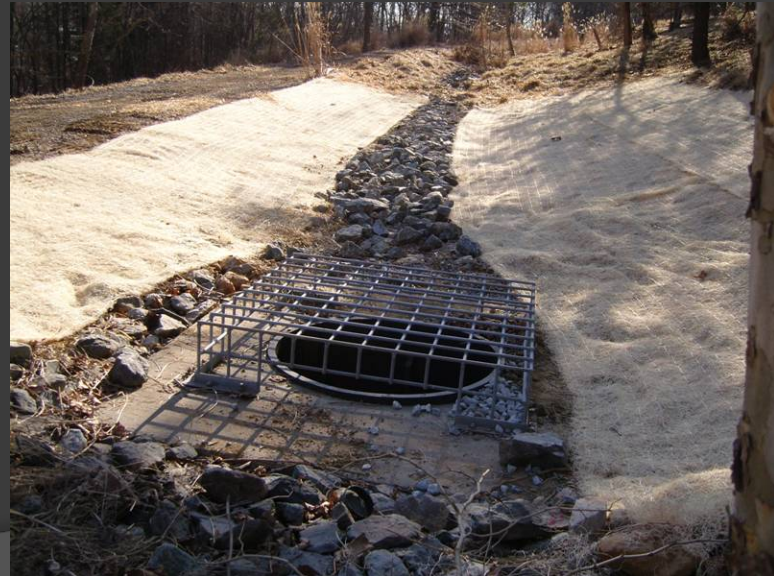
Corrective Action

⦿ Concern

- Oil-like sheen on stormwater in manhole and iron staining on stormwater manhole and discharge pipe at Outfall 006 (SE Landfill)
- Noted in MDE site inspection on 1-23-09

- Cut and cap upgradient discharge pipe into stormwater manhole (no in-flow)
- Construct infiltration trench for flow from upgradient discharge pipe
- Stormwater Sampling Results from Manhole and Outfall 006 indicate no exceedences of MCLs
- Final report to be submitted to MDE by 3-13-09

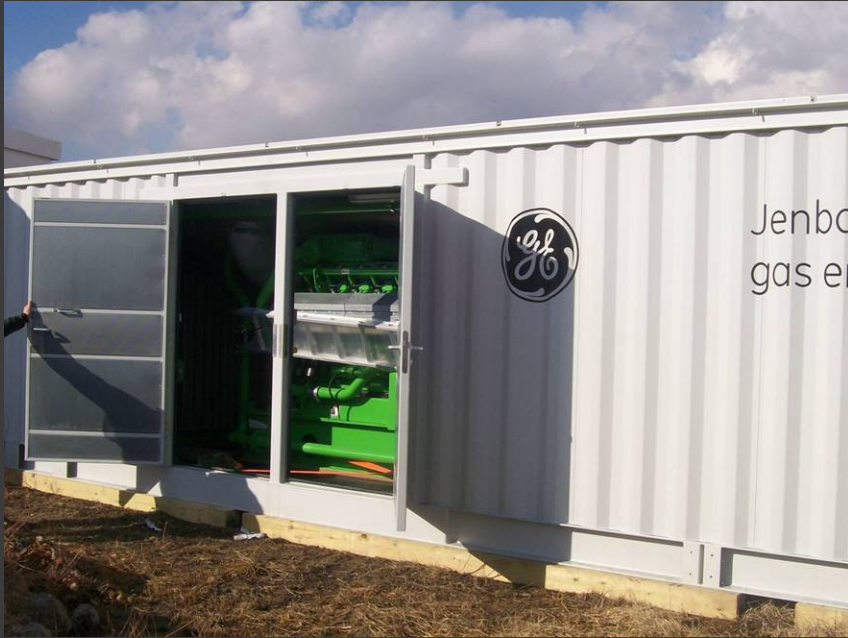
New Landfill Gas to Energy Project

(Will be Operational June 2009)

- Greenhouse gases/carbon dioxide emissions reduced by 4,557 tons.

- Supplying energy to 509 homes
 - Planting 9,506 acres of trees; or
 - Taking 6,671 passenger vehicles off the roads
- Particulate matter slightly increased
 - Automated monitoring adds further redundancy and better oversight of gas management at Gude Landfill.

- Job training and social service facilities for men's shelter near completion at entrance at 600 E. Gude Drive
- Landfill gas-to-energy facility under construction also at entrance off Gude Dr. due to be complete this summer to complement existing flare system
- Potential Yard trim and bulky wood waste receiving and processing area on 7-8 acres off Southlawn Lane
- Opportunity to propose and plan uses for the remaining 80 plus acres
