Montgomery County Department of Transportation  
Division of Transportation Engineering

## Public Meeting

### Replacement of Park Valley Road Bridge No. MPK-03 over Sligo Creek

December 11, 2012

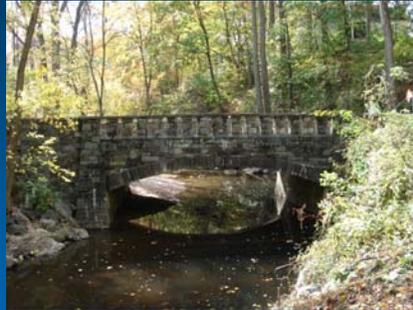
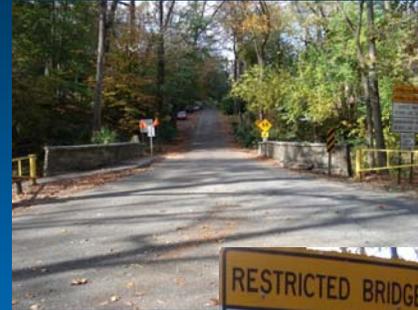
## Existing Bridge

- Built in 1931 (81 years old)
- 30-foot Span
- Concrete Deck/Beams with Asphalt Surface
- Stone Masonry Bridge Barriers
- Concrete Abutments/Wingwalls with Stone Masonry Facade

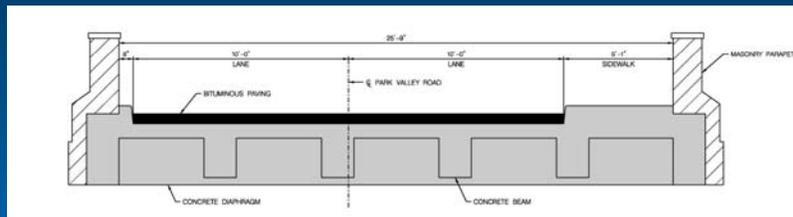
## Existing Bridge

- Lane Width = Two 10 feet Lanes
- Shoulder Width = 0 feet
- Clear Roadway Width = 20 feet
- Sidewalk Width = 5 feet 1 inch

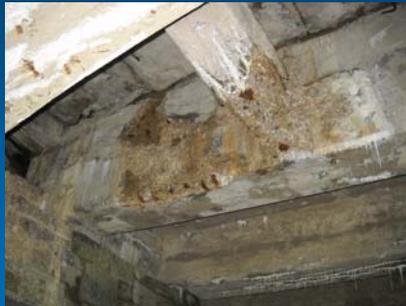
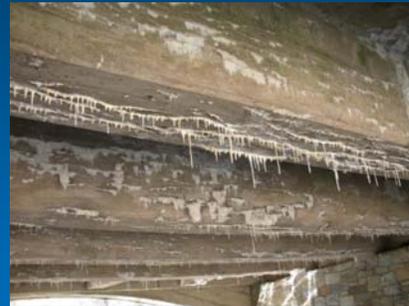
### ◆ Structural Deterioration

- Spalling Concrete Beams and Diaphragm with Exposed Reinforcement
- Cracking Concrete Beams with Efflorescence

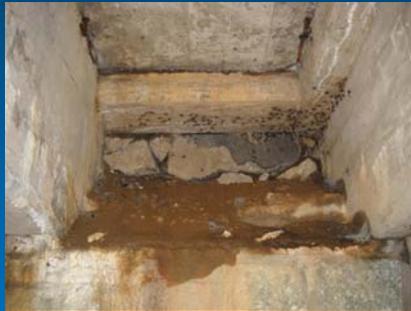
- Spalling Concrete Backwall with Leakage

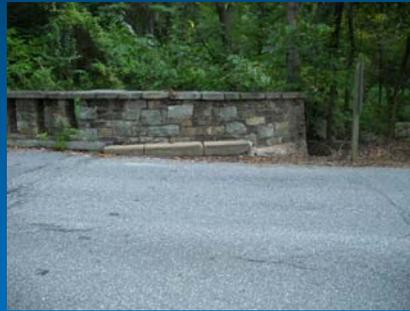
- Spalling Concrete Curb with Settlement

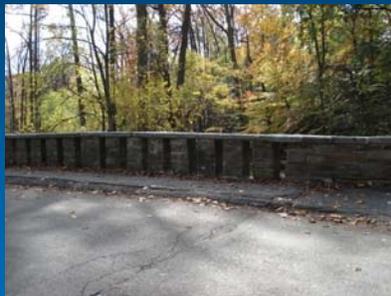
- Does not conform to FHWA Safety Standards

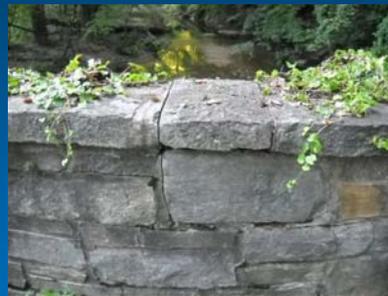
- Cracking and Loose Stone Masonry

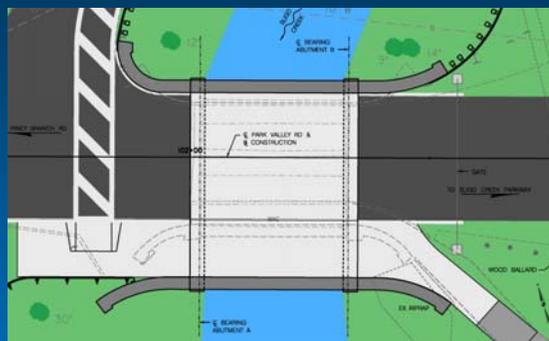
- Provide roadway and pedestrian/bicycle access meeting FHWA requirements
- Consist of concrete structure
- Provide crash tested bridge barriers meeting FHWA safety standards
- Provide new stone veneer
- Match existing bridge opening
- Install scour counter measures

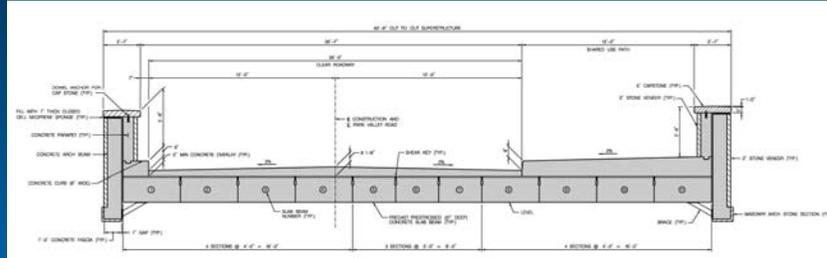
## Proposed Bridge

- Concrete Slab Beams with Concrete Overlay
- Concrete Bridge Barriers with Stone Veneer
- Concrete Abutments/Wingwalls with Stone Veneer
- Lane Width = Two 10 feet Lanes
- Shoulder Width = 3 feet
- Clear Roadway Width = 26 feet
- Shared Use Path Width = 12 feet

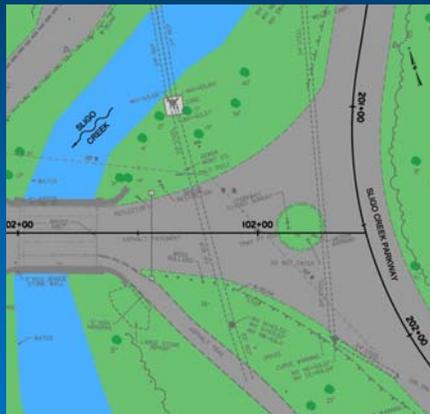
- Existing Intersection with Substandard Mini Circle

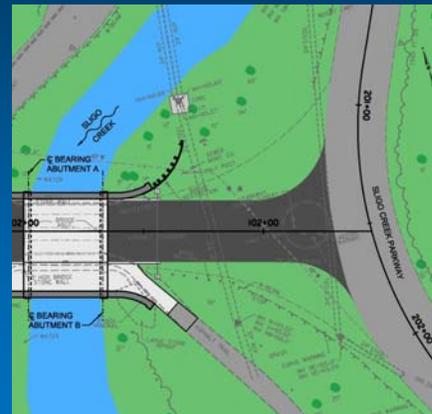
- Proposed Regular T-intersection

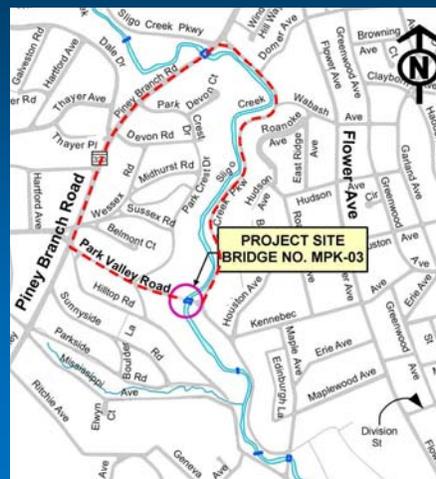
## Traffic Detour

**1.2 Miles Detour Route**  
Park Valley Road – Piney Branch Road (MD 320) – Sligo Creek Parkway

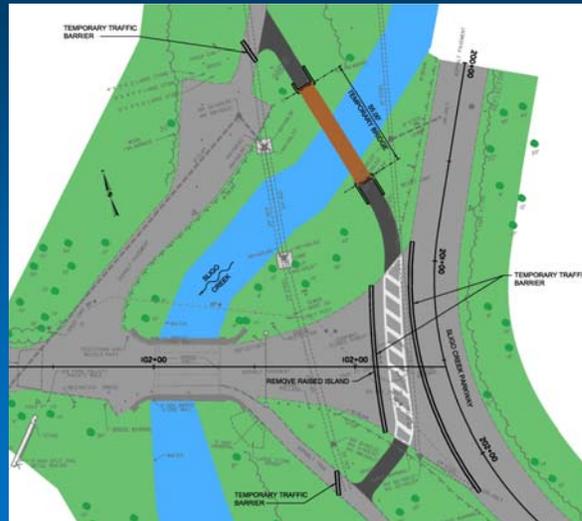
## Temporary Pedestrian/Bicycle Access

- Provide Safe Pedestrian and Bicyclist Access during Construction
- Minimize Impact to Trees
- Avoid Existing Underground Utilities
