BRANNIGAN'S BUILDING CONSTRUCTION FOR THE FIRE SERVICE

Fire Behavior and Building Construction

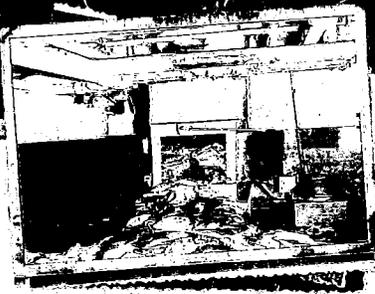
Figure 5-1 The trash compactor in the basement of the Schomburg Plaza complex.

Interpreting and anticipating fire behavior are critical skills for all fire fighters. Such was the case in March 1987, when a fire broke out in the trash chute of a 35-story high-rise in the Schomburg Plaza complex in upper Manhattan (New York City). The fire started in trash jammed between the 27th and 29th floors. Arriving fire fighters were told by building personnel that the fire was in the basement compactor room (**Figure 5-1**); a line was stretched to the compactor and the fire was extinguished. Fire fighters were unaware that burning debris had actually dropped more than 25 floors and ignited the trash in the compactor.

Figure 5-1: Fire, Schomburg Plaza, Inc. (New York City) Photo: Fire Department, New York City
Caption: © Fire-Photo.com/Photo.com

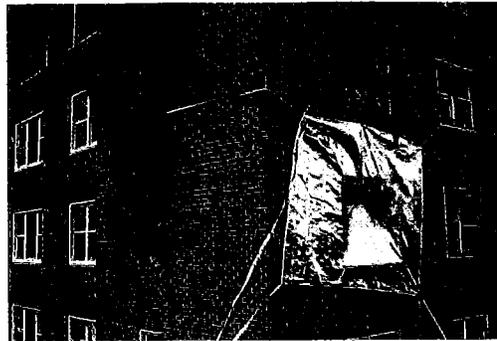
Figure 5-6 The New York City Fire Department deploys a fire blanket.

Wind-driven fires, in which substantial winds accelerate a fire and speed up its spread, have come under recent scrutiny. If winds exceed 10–20 mph, their role in driving the fire within a building must be considered from a tactical standpoint. Current protocols call for attacking the fire from upwind and, in some cases, limiting ventilation. To deal with cases where the fire itself has broken a window on the windward side of a multistory building, the New York City Fire Department has developed a "fire blanket" to place over the opening, allowing fire fighters into that unit **Figure 5-6**.

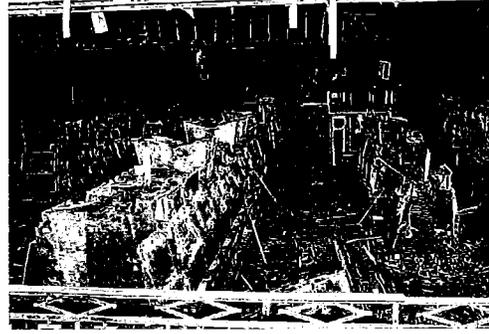
Figure 5-9 The fire effects in the casino area of the Las Vegas MGM Grand.

The Clark County, Nevada, Fire Department report on the MGM Grand Hotel fire in 1980 noted that it required 12 tons (10,886 kg) of adhesive to attach tiles to the ceiling of the casino **Figure 5-9**. The flammable adhesive added a large fuel load to the fire.

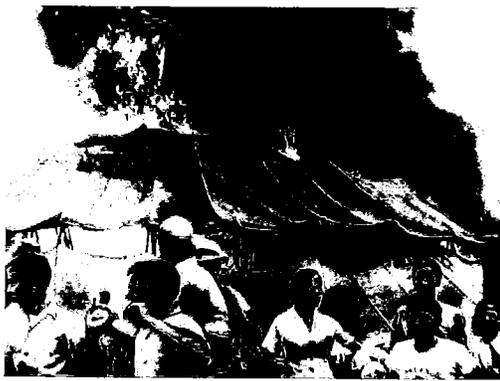
Figure 5-10 The Hartford circus fire of 1944.

The 1944 circus fire in Hartford, Connecticut, in which 168 lives were lost, was fueled by flames spreading rapidly on the gasoline- and paraffin-impregnated canvas that served as the “Big Top” tent (Figure 5-10). Panicked audience members found it difficult to escape because some exits were blocked by circus equipment. The caged runway for the wild animal show that was erected across the main exit was supposed to be up for only 10 minutes. Remember this disaster when you are asked to overlook the “temporary” blocking of exits.

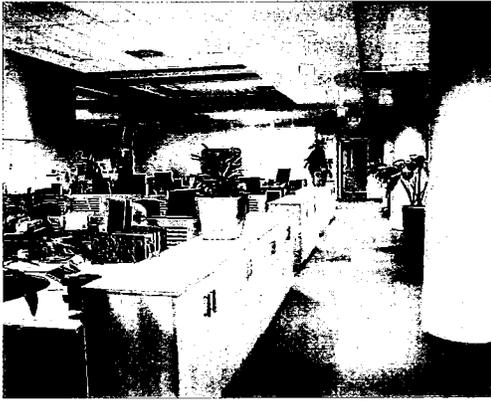
Figure 5-14 An “open-plan” office.

. Where do the corridors begin and end? One fire department solved this dilemma quite simply: if there is no wall, there is no room; it is all a corridor. The strict interpretation of corridors includes the provision that they

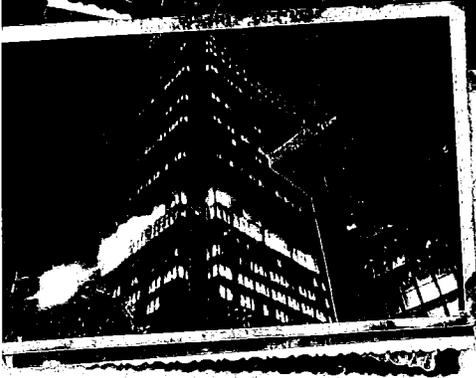
Figure 6-1 The First Interstate Bank fire in Los Angeles.

Fire broke out on the 12th floor of the 62-story First Interstate Bank high-rise in Los Angeles, California, on May 4, 1988 (**Figure 6-1**). The building was of Type I construction—a steel frame with spray-applied fireproofing. Automatic sprinkler protection was in the midst of being installed in the building, but the valves from the risers to the sprinkler system on the fire floors were closed.

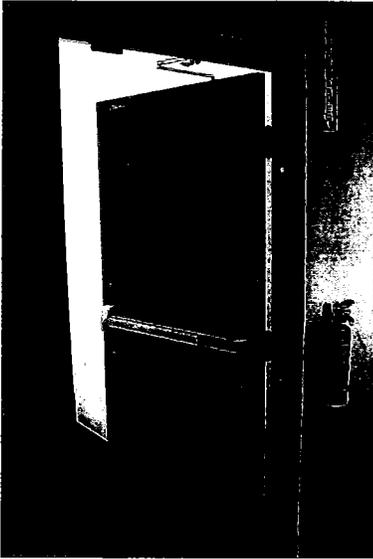
Figure 6-10 A swinging fire door.
Courtesy of Lawrence Doors.
