# Fire-Resistive Construction

# Firefighting Concerns of Green Construction

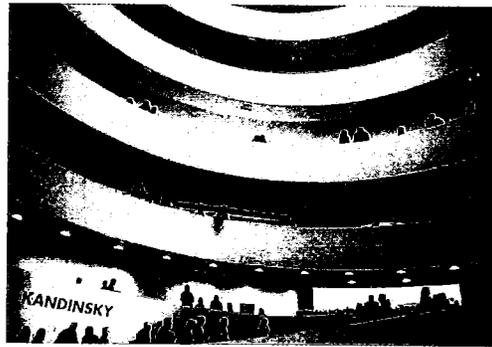
**Figure 11-3** The Guggenheim museum in New York, NY.

In some cases, an architect may wish to emphasize concrete construction. Instead of considering form marks unattractive, architects have accentuated them in some building designs (Figure 11-3). In other cases, decorative brick veneer is used to conceal the concrete construction.

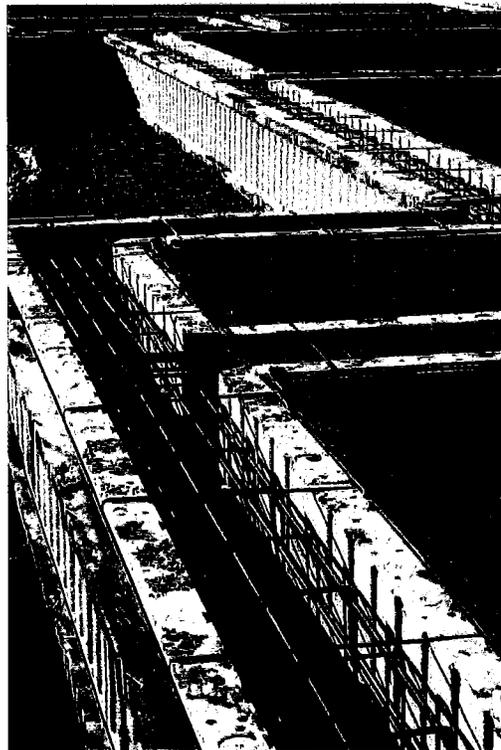
**Figure 11-4** Concrete will be poured into this form, creating a cast-in-place wall.

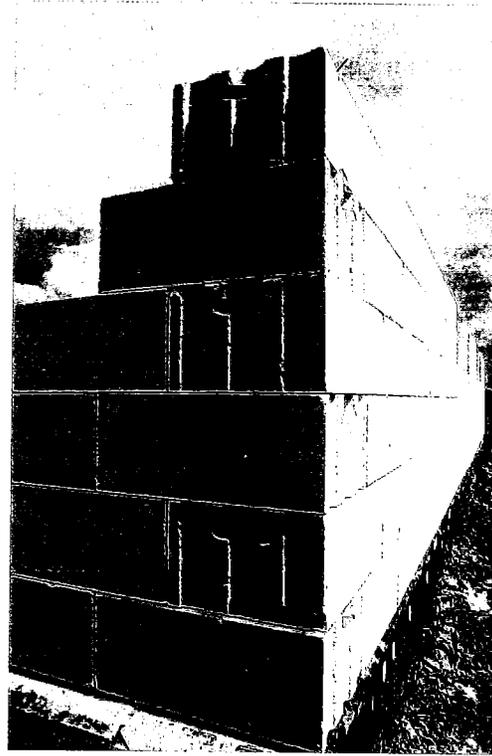
**Figure 11-11** Autoclave aerated concrete.

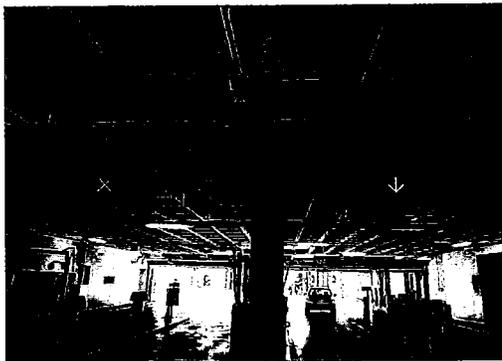
**Figure 11-12** A waffle concrete floor.

In so-called **waffle concrete**, which comprises a two-way structural system, closely spaced beams are set at right angles to one another, and unnecessary concrete is formed out. The lower side resembles a waffle **Figure 11-12**.

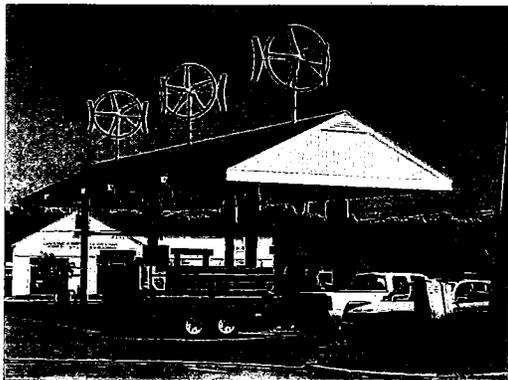
**Figure 12-9** A roof-mounted wind turbine system.

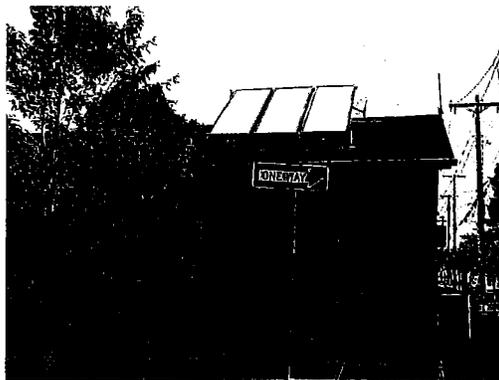
**Figure 12-10** An active solar water heating system.
