**MONTGOMERY COUNTY FIRE AND RESCUE SERVICE
MONTGOMERY COUNTY, MD**

INFORMATION BULLETIN

NUMBER: 07- 11

SUBJECT: Structural Improvements and Fire Tactics – White Flint Mall Garages

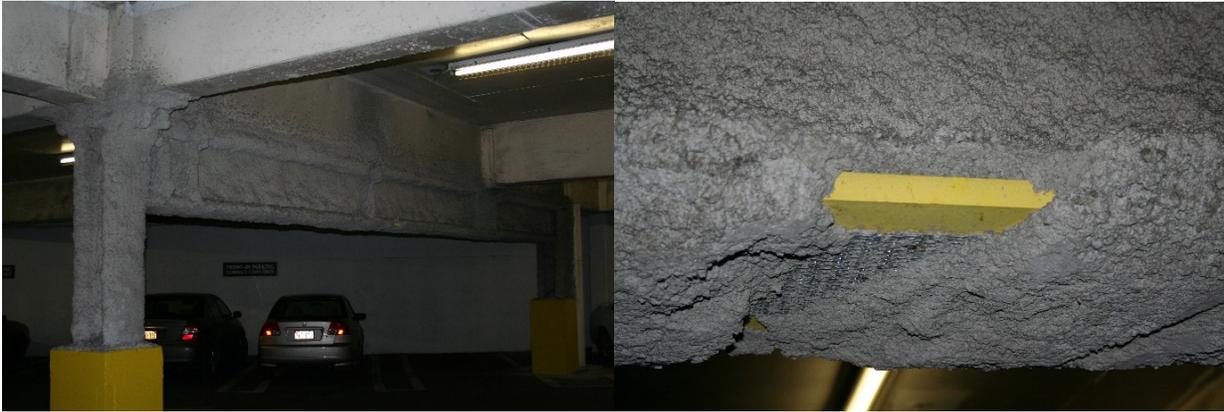
1. **Steel Columns and Beams.** Occasionally found within the affected garages, these structural supports can be easily identified because they are sprayed with fire-resistive materials (SFRM). These materials are generally a composite formed from Portland cement, or gypsum, fibers, and other fillers. *It is critical to note that this coating is actually **fire-resistant**, rather than **fire-proof**.* This *resistance* can be diminished if the coating is damaged.

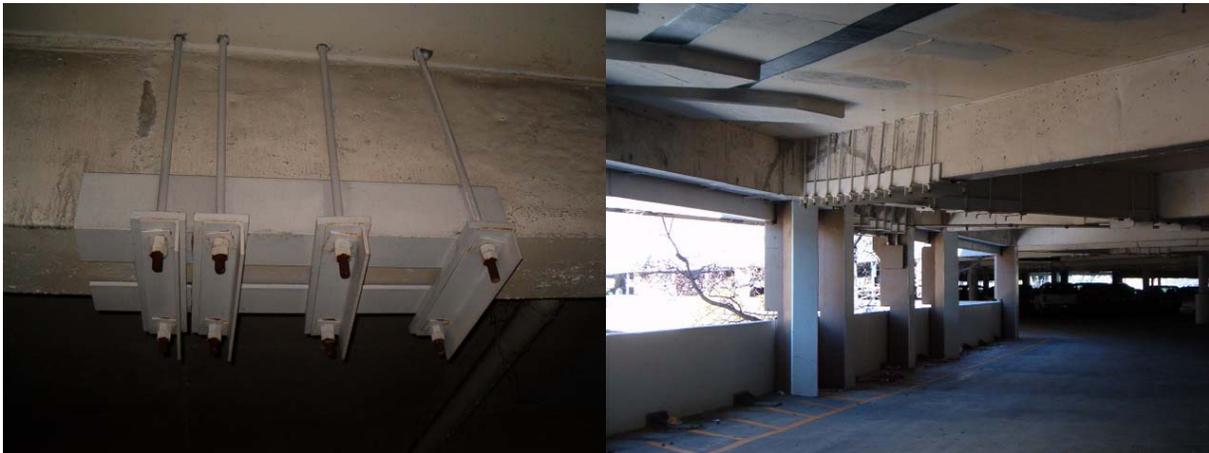
- 2. Vertical Tie Rods.** These elements are exceptionally prevalent within the affected garages, and are designed to stiffen the affected girders. They do not actually carry load, but rather keep the beam intact, allowing the existing girders to transfer load as designed, despite cracks. At the White Flint Mall, vertical tie rods are passed through drilled steel angle plates and secured at both ends (below and above deck) by nuts. These modifications have not been sprayed with SFRM, and pose the potential for failure if exposed to prolonged, high heat. Failure of these modifications may result in falling pieces of concrete, but are not expected to affect short-term structural stability.

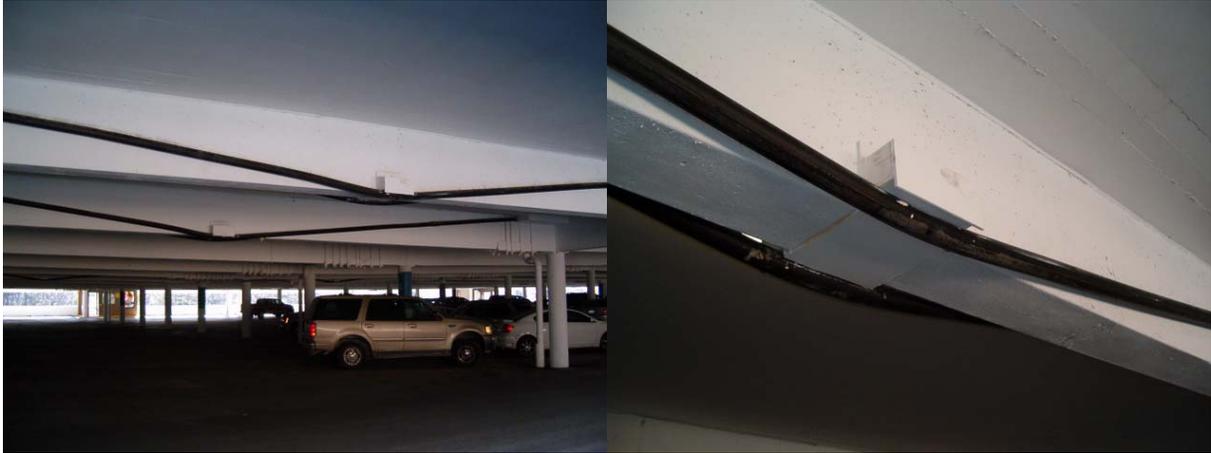
- 3. Exterior Post-Tensioning.** These structural improvements are intended to supplement the post-tensioning cables originally installed in the girders which support the parking decks. The cables are encased in grout, a means of providing fire resistance. Their susceptibility to failure lies with the currently unprotected support saddles at the center of the affected girders. Failure of these improvements may result in visible sagging of the girders, and should be watched closely during operations.
