Stormwater Management Facility Retrofit FACT SHEET: Ballinger Drive Stormwater Management Pond

Ballinger Drive Stormwater Management Facility Facts:

Stormwater Management Facility Retrofit Project Facts:

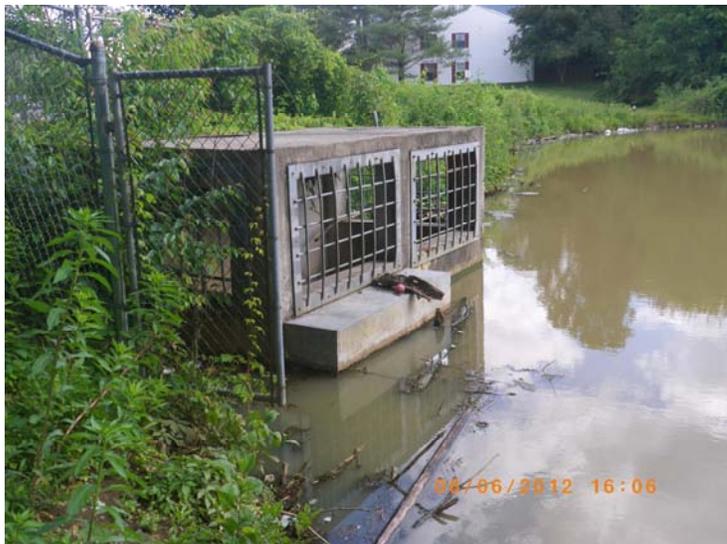
LEFT: The existing riser outlet structure is not designed to meet current stormwater management standards. It will be modified in place to meet those standards.

- Restore the permanent pool, with a new maximum depth of 9.5 feet.
- Pour concrete to fill and permanently abandon the old drain pipe that caused the pond to drain in 2012.
- Modify the riser structure to meet current state and county stormwater criteria.
- Install an impervious liner and erosion protection on the upstream side of the dam.
- Install a forebay at the upstream end of the pond.
- Landscape with native plants around the permanent pool.
- Install a 15 foot wide safety/maintenance access/planting bench around the pond.

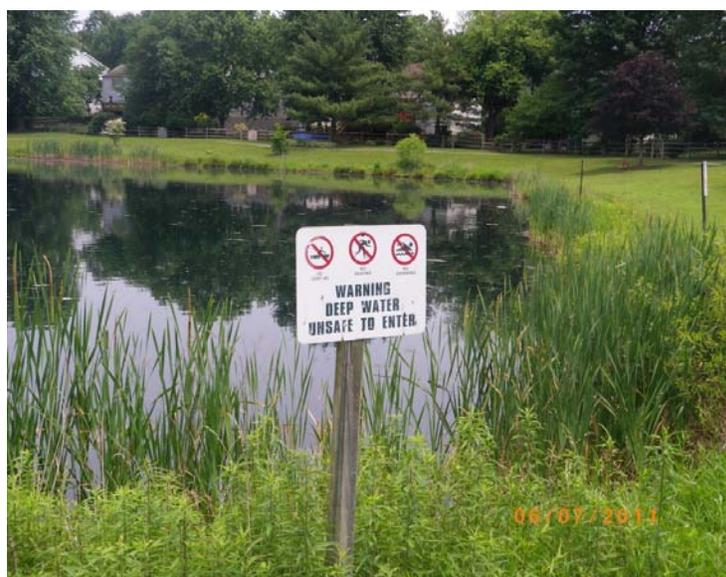
BELOW: Native vegetation will be provided around the periphery of the permanent pool to improve the aquatic habitat of the pond.

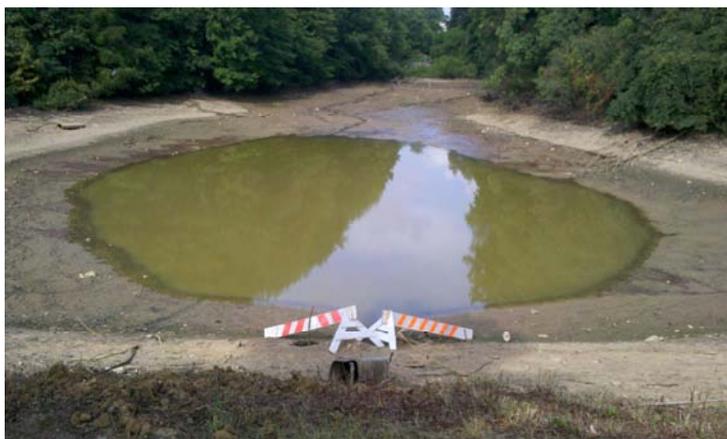
LEFT: The failed drain pipe that caused the pond to drain in July 2012 will be filled with concrete to permanently abandon it. The pond will be re-filled to approximately the same level as before.

The Ballinger Drive Stormwater Management Pond requires a retrofit to improve its overall maintenance condition, exemplified by the failure of an abandoned spillway pipe and the draining of the pond in 2012. The pond does not fully comply with current stormwater management and safety standards.
