Watershed Restoration FACTSHEET:

BREWOOD TRIBUTARY RESTORATION

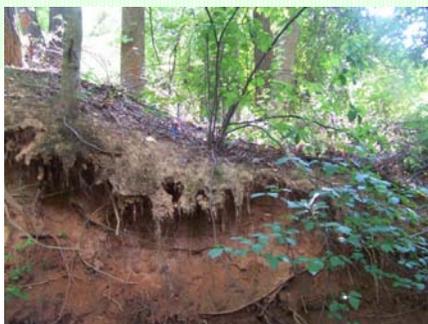
Existing condition: eroded stream banks along existing channel within project area

The existing channel is actively cutting through unconsolidated fill material down to bedrock and groundwater resources, which other than storm flow events account for the minimal flow within the channel.

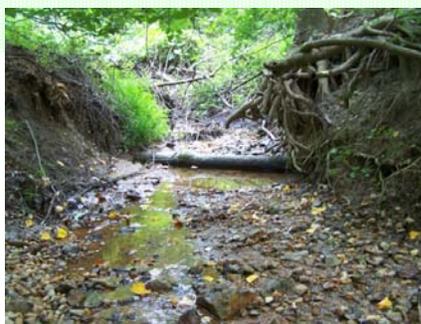
Existing condition: exposed roots of trees imperiled by bank erosion along channel

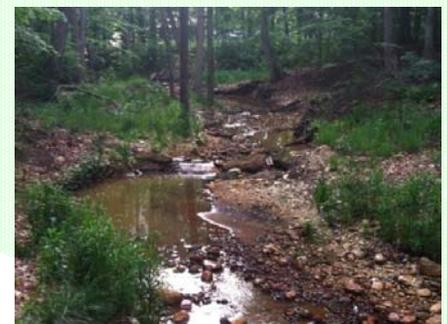
Example: stable Regenerative Stormwater Conveyance System (RSC)

A regenerative stormwater conveyance system (RSC) option was developed for the reaches adjacent to and upstream of the end of Tenbrook Drive. This approach will provide water quality, habitat, and stability benefits.
