# Watershed Restoration FACTSHEET:

## BREWOOD TRIBUTARY RESTORATION

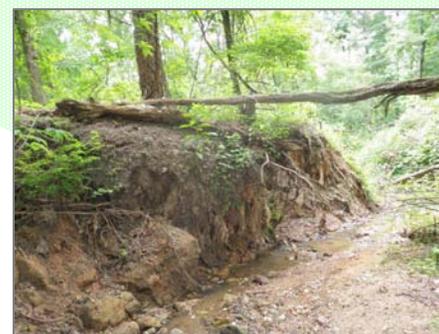
along the Breewood Tributary. The Breewood Tributary is typical of an urbanized stream channel. Much of the tributary has progressively down-cut, with steep, eroding banks. Upland properties have little stormwater management, with piped drainage to the stream.

Eroding stream banks in Breewood Tributary

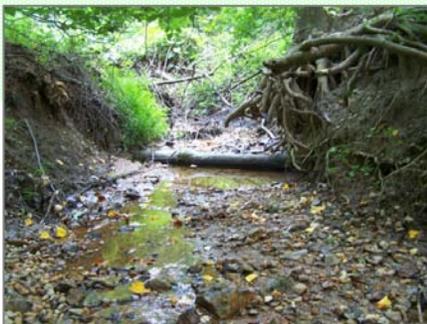
The existing channel is actively cutting through unconsolidated fill material down to bedrock and groundwater resources, which other than storm flow events account for the minimal flow within the channel.

Pre-restoration condition: exposed tree roots and sewer line are imperiled by channel erosion.

Based on pre-existing watershed conditions and instability of the Breewood Tributary, a combination of stream restoration techniques were employed, including in-stream restoration, RSC, and valley restoration. These restoration techniques will improve water quality, increase habitat diversity, and reduce stream bank erosion and downstream sedimentation.

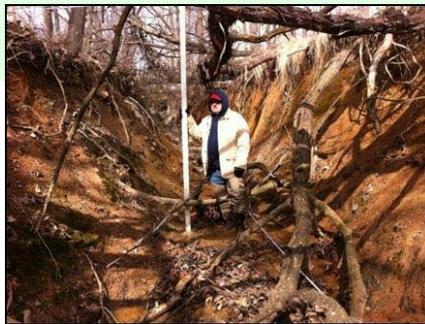
Pre-restoration condition: surveying eroded stream channel

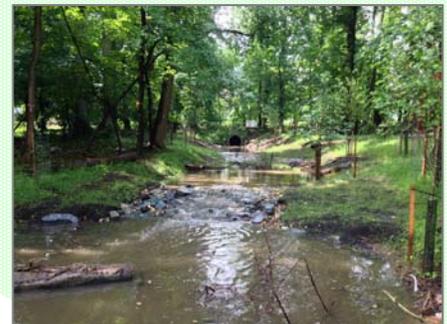
Post-Restoration condition: stable RSC stream channel with native grasses, perennials and trees planted along stream banks (taken from same location as photo to the left).

A regenerative stormwater conveyance system (RSC) was developed for the reaches adjacent to and upstream of the end of Tenbrook Drive. This approach would provide water

quality, habitat, and stability benefits.
