Watershed Restoration FACT SHEET

Grosvenor Stream Restoration

Stream Restoration Projects in Grosvenor Area, Located in Rock Creek Watershed.

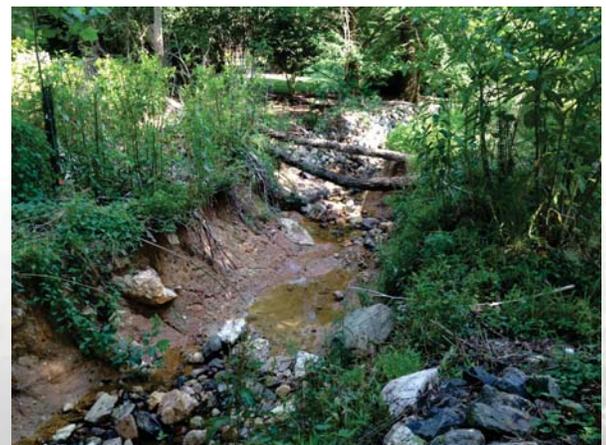
Heavy stormwater flows have eroded the stream banks undercutting trees and damaging private property.

Over time, the stream channels down-cut and widen which limit stream flow access to the original floodplain. Sediment from eroded banks and road grit accumulated in the stream, further degrading stream habitat conditions. The portions of the stream that do not have floodplain access or are not stabilized with rock or vegetation are experiencing moderate erosion and channel incision.

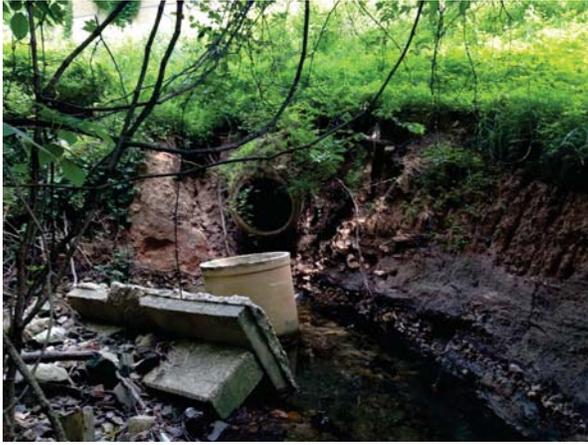
Severe stream bank erosion causing failure to storm drain outfall on Rudyard project area.

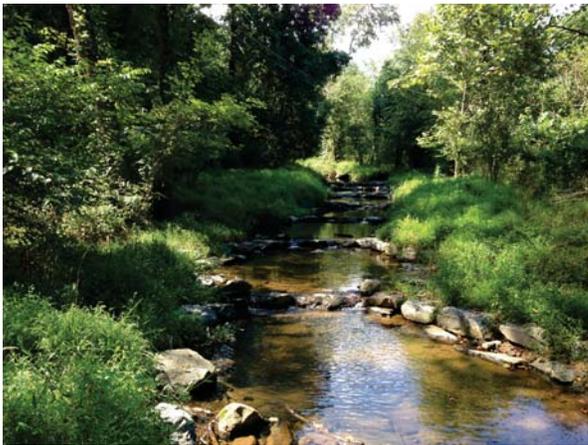
Step pools function as grade control gently routing stream flow through steep sections slowing erosion processes and sediment transport.

The Grosvenor Project will use restoration techniques and reforestation to help stabilize stream banks, storm drain outfalls, and enhance riparian habitat. Newly built instream structures include step pools, cross vanes, imbricated rip-rap walls, stone toe protection, vegetated soil lofts, and stream bank grading. The project attempts to save undercut stream bank trees with supportive rock packing. Damaged trees can be flush cut, allowing the root systems to remain in the bank for stabilization.

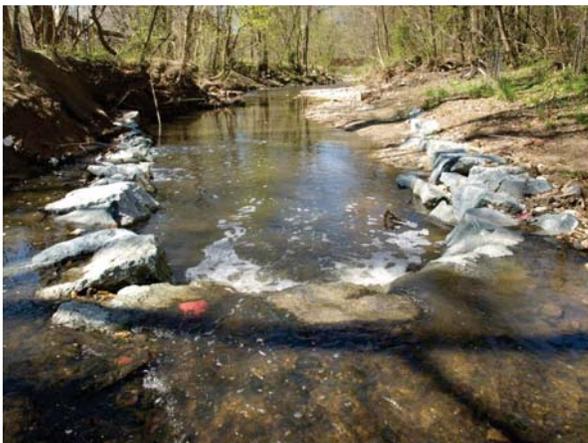
Cross vanes function is to direct the stream flow toward the center of the stream minimizing stream bank erosion and forming pools for fish habitat.

Boulder rocks installed at the toe of the stream bank slope (stone toe protection) stabilized the area of the stream channel subject to the greatest erosive or “shear” stress. The slopes above the reinforced toe are graded back and reinforced to allow for plantings with native trees and shrubs to further stabilize the stream banks. Step pools will be used to gently traverse steep sections of the stream. Cross vanes will direct water away from unstable stream banks, form downstream scour pools, and enhancing aquatic and fish habitat.
