## 3.11 Batchellors Run I and II Stream Restoration

### 3.11.1 Introduction

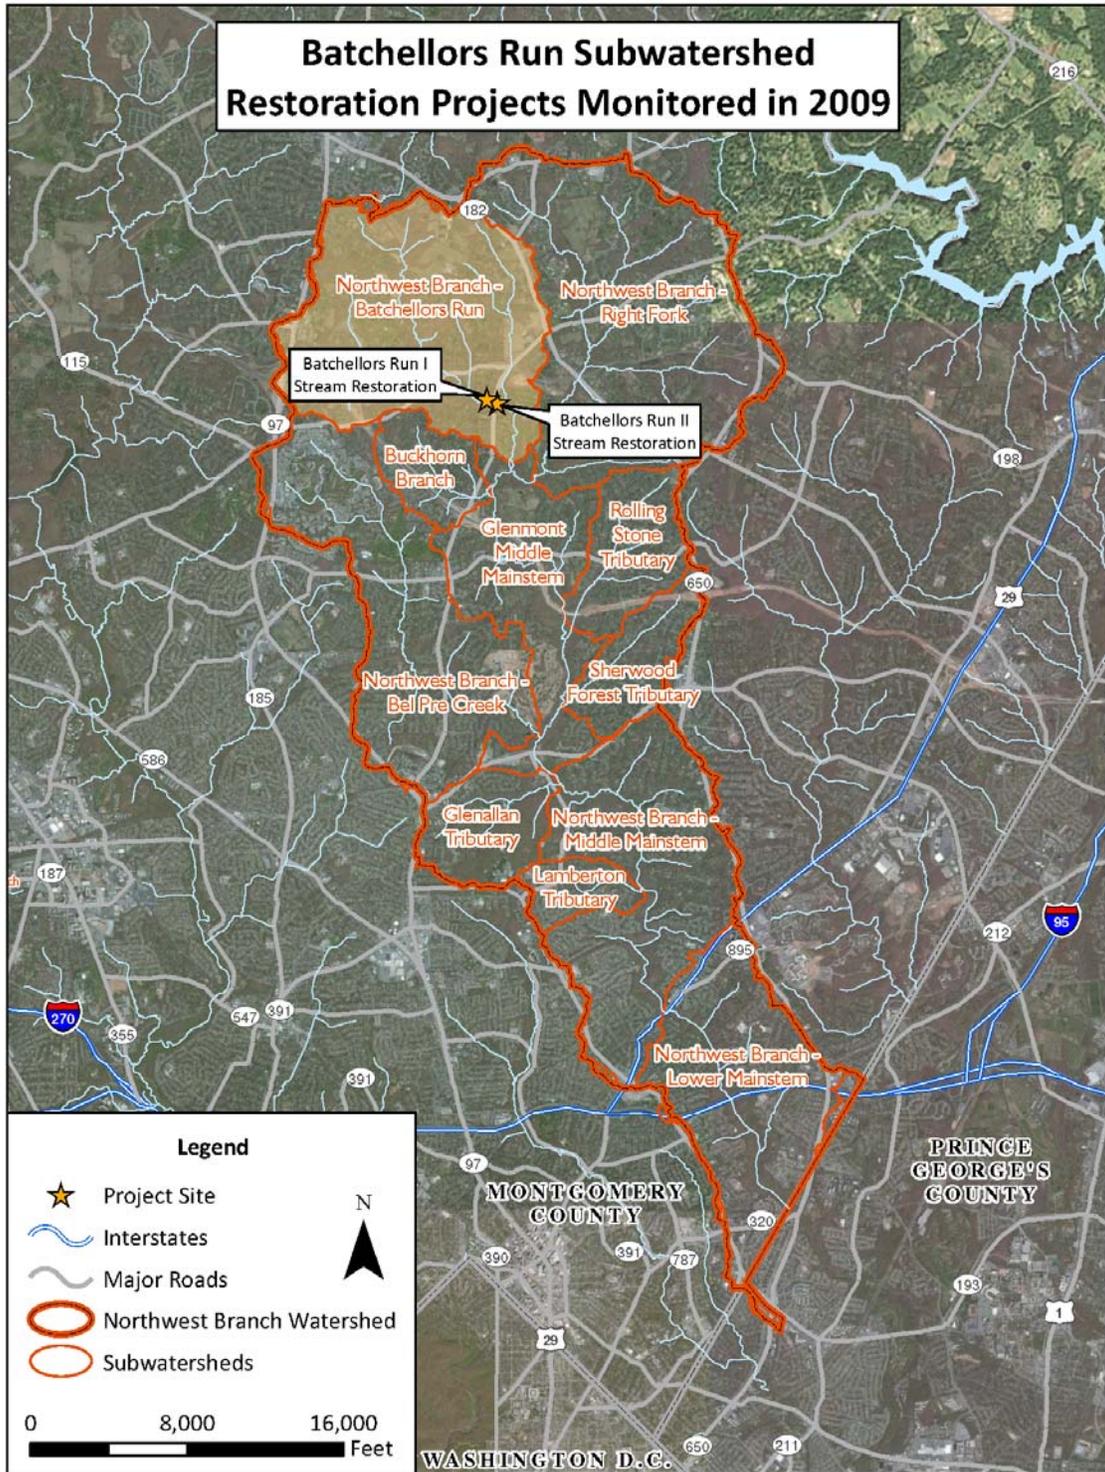
**Figure 3.11.1 – Upper Northwest Branch Batchellors Run Watershed Restoration Projects, Including Batchellors Run I and II Stream Restoration**

The Batchellors Run tributary, along with several other stream reaches, was identified as a priority for restoration in the Northwest Branch Watershed Feasibility Study (July 2000). The Montgomery County Department of Environmental Protection, in collaboration with the M-NCPPC and the USACE, is planning to complete three stream restoration projects for Upper Northwest Branch Package 1 in 2011, which include Batchellors Run East, Upper Northwest Branch, and Bryants Nursery Run. Upper Northwest Branch Package 2 projects include Sherwood Forest I, Batchellors Run I & II, and Woodlawn stream restorations, and are planned to be completed from fall of 2012 to summer of 2013 (*Figure 3.11.1*).

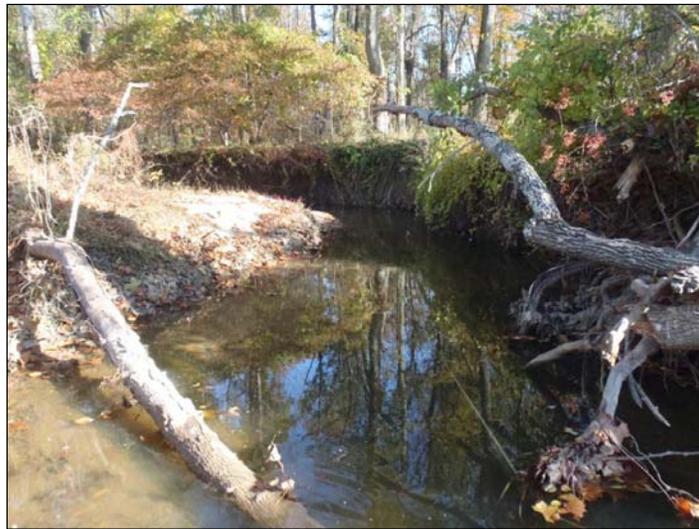
**Figure 3.11.2 – Batchellors Run Tributary Prior to Restoration, Picturing Erosion and Lack of In-stream Cover for Fish Upstream of Layhill Road**

Much of the Northwest Branch Watershed was developed prior to regulations requiring stormwater management control, and the watershed contains a high percentage of impervious surfaces. Uncontrolled stormwater runoff from highly impervious areas creates erosive, high velocity or "flashy" flows that cause damage to receiving streams. The Batchellors Run tributary is characterized by eroded stream banks, unstable channel materials, low flow conditions, minimal access to its floodplain, interaction with wetlands, and a general lack of instream cover for fish (**Figure 3.11.2**). Instream habitat, overhanging vegetative cover, and riparian canopy is particularly lacking on the golf course site. The area upstream of Layhill Road is completely forested with adequate vegetative cover, but lacks instream habitat for fish. While the Batchellors Run site does not currently exhibit serious degradation, there are opportunities, through careful repair and enhancement of habitat, to maintain and improve stream stability that would otherwise continue to deteriorate.

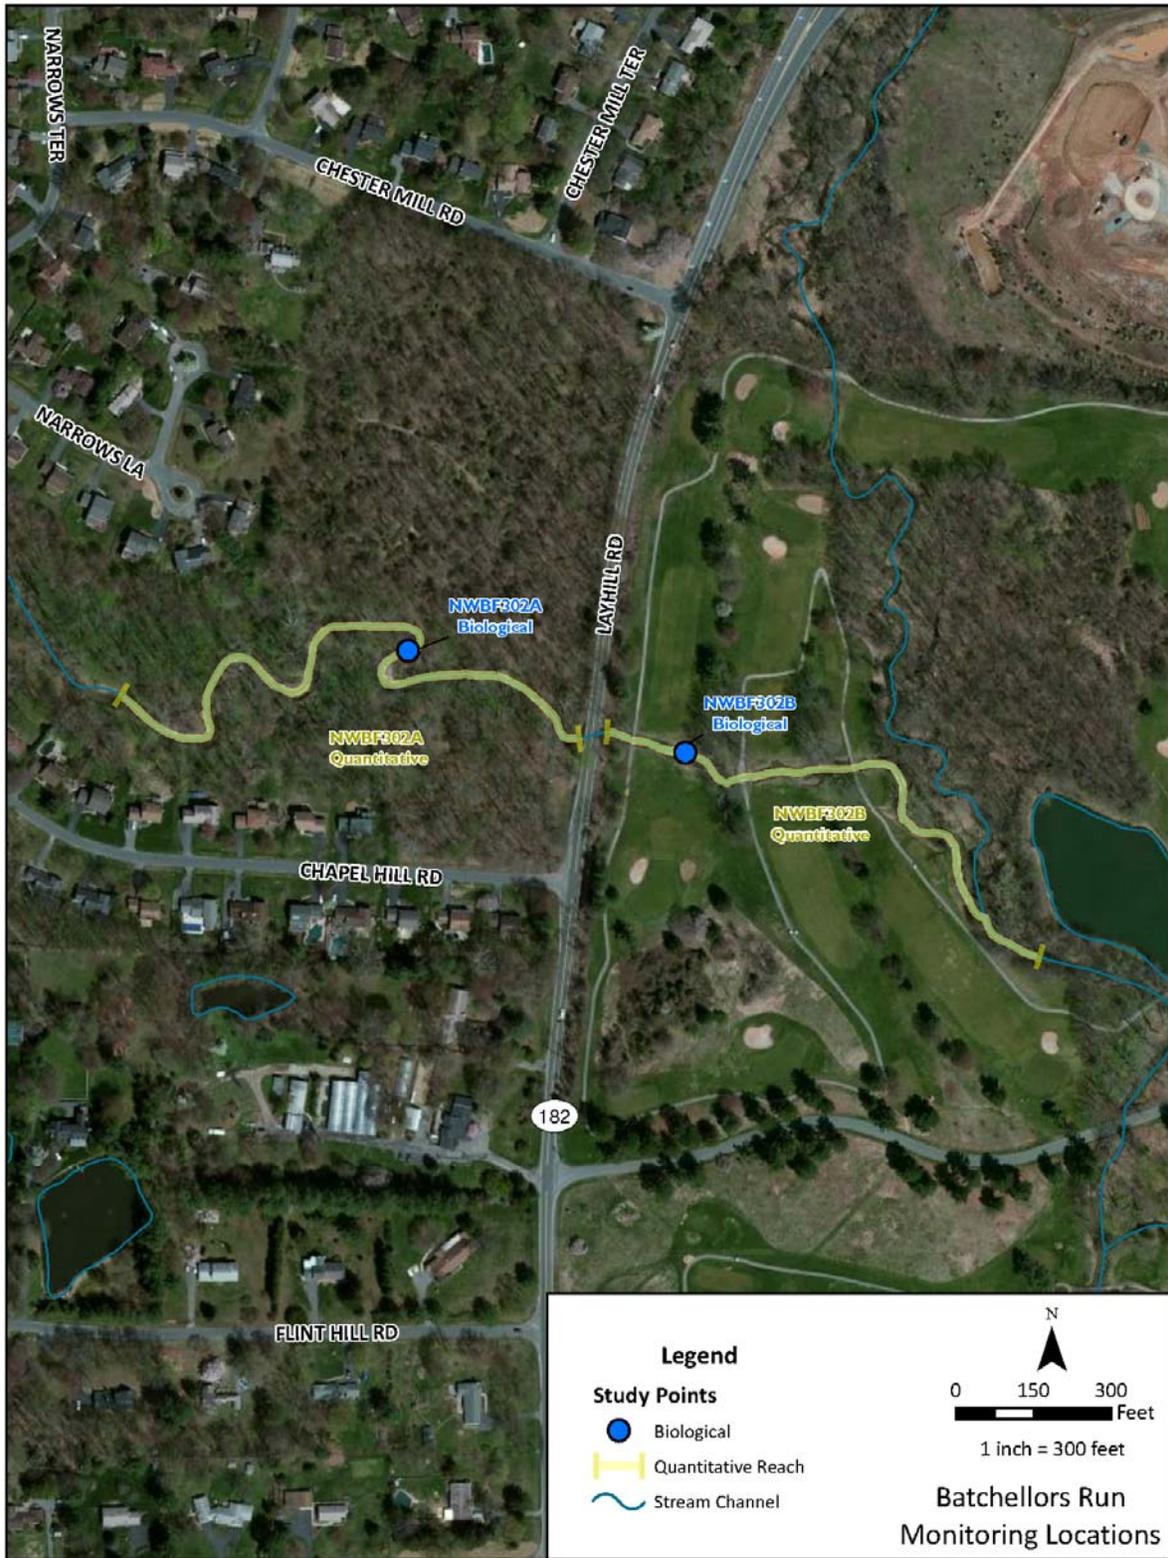
*Figure 3.11.3 – Map of 2009 Monitoring Locations at the Batchellors Run I and II Restoration Sites. Quantitative reaches correspond to the length of proposed stream restoration.*

The basic sampling design for the Batchellors Run Stream Restoration project is pre-restoration (before) and post-restoration (after) monitoring. The County monitored the biological communities (benthic macroinvertebrates and fish), performed rapid habitat assessments (RHAB), and took in-situ water chemistry measurements at two biological monitoring sites (NWBF302A and NWBF302B) to evaluate the aquatic habitat conditions and water quality during the pre-restoration period. Site NWBF302A is located upstream of Layhill Road and NWBF302B is located downstream (*Figure 3.11.3*). The County also performed quantitative survey for the entire project length, but this work was postponed until 2011 due to missing benchmarks. Wetland and botanical surveys are planned for the post-restoration period, once the wetlands are created and trees are planted. If the project is completed as planned in fall 2012, all data collected prior to fall 2012 will be considered pre-restoration data and all subsequent data will be considered post-restoration. Pre-restoration monitoring was performed in 2004 and 2009 at site NWBF302A and in 2009 at NWBF302B. Post-construction monitoring is planned for at least years one, three, and five years after restoration.

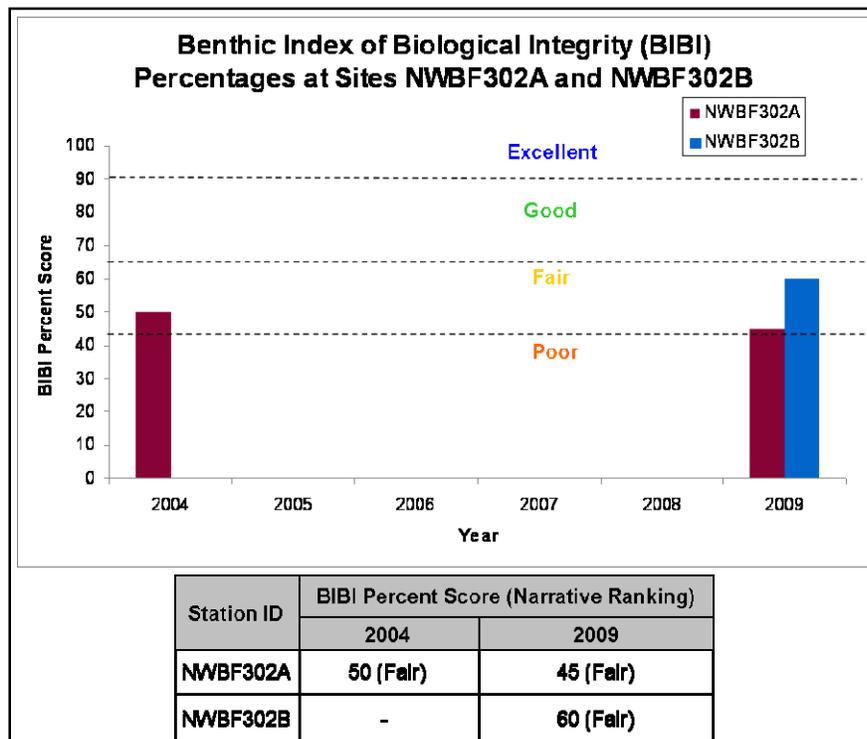
Pre-restoration benthic macroinvertebrate assessments were conducted at site NWBF302A in 2004 and 2009 and at site NWBF302B in 2009. Both sites were consistently rated by the Benthic Index of Biological Integrity (BIBI) as Fair, but site NWBF302A declined in BIBI percentage from 2004 to 2009 (**Figure 3.11.4**). At site NWBF302A, the proportion of scrapers metric was rated as high, the number of Ephemeroptera (mayfly), Plecoptera (stonefly), and Trichoptera (caddisfly) taxa, collectively referred to as EPT, was in the low range, and the proportion of EPT individuals and shredders metrics were also in the low range. Most individual metrics were in the median range at NWBF302B, except for the proportion of dominant taxa, which was in the high range and the proportion of EPT individuals, which was in the low range. Field data sheets for this task from 2009 are included in *Appendix D*.

**Figure 3.11.4 – Pre - Restoration Benthic Index of Biological Integrity (BIBI) Percentages at NWBF302A and NWBF302B**

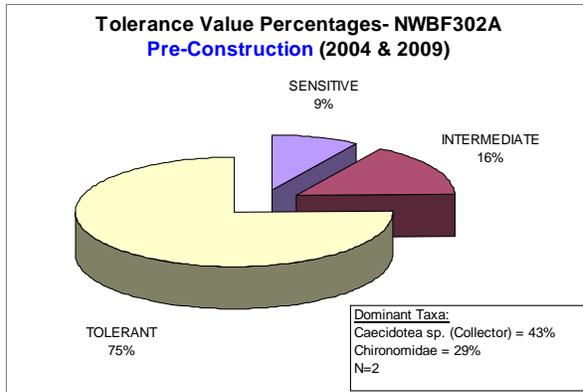
A genus of Isopoda (sowbug), *Caecidotea* sp., was the most dominant taxon collected at NWBF302A (**Figure 3.11.5**). *Caecidotea* sp. is considered tolerant to urbanization. Individuals from the family Chironomidae (midges) were the second most dominant taxa present at NWBF302A; midges are also tolerant to urbanization. Midges were the most dominant taxon of the benthic macroinvertebrate community at NWBF302B during the pre-restoration period (**Figure 3.11.6**). A genus of black fly larva (*Simulium* sp.) was second most dominant and is considered intermediate in sensitivity. Tolerant individuals were dominant at both NWBF302A

and NWBF302B (43 and 61 percent, respectively) prior to restoration, individuals intermediate to sensitivity were second most dominant (16 and 33 percent, respectively), and sensitive individuals were least abundant (nine and six percent, respectively).

**Figure 3.11.5 – Benthic Macroinvertebrate Tolerance Composition and Dominance at NWBF302A**

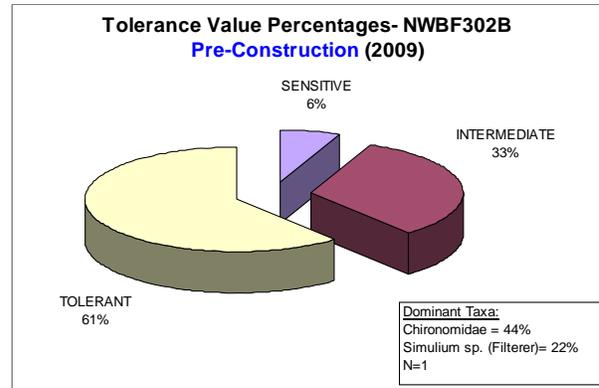
**Figure 3.11.6 – Benthic Macroinvertebrate Tolerance Composition and Dominance at NWBF302B**

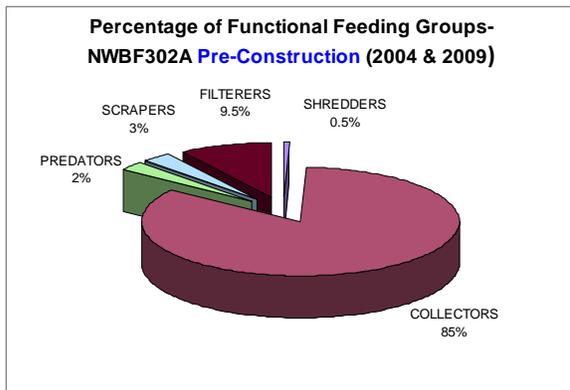
Collectors represented the most dominant feeding group at both Batchellors Forest sites, comprising 85 percent of the community at NWBF302A and 60 percent at NWBF302B (**Figures 3.11.7 and 3.11.8**). More specialized feeders, including scrapers and shredders, comprised a total of 3.5 percent of the community at NWBF302A and eight percent of the community at NWBF302B in the pre-restoration period.

**Figure 3.11.7 – Benthic Macroinvertebrate Functional Feeding Group Composition at NWBF302A**

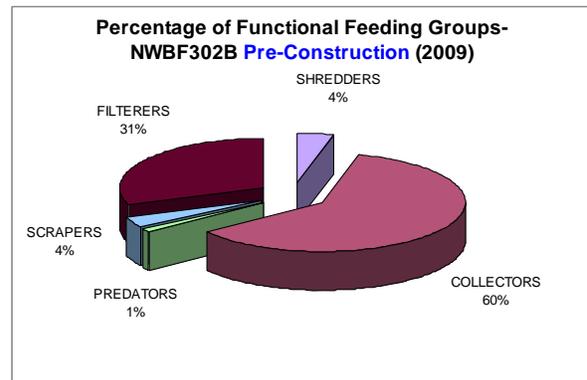
**Figure 3.11.8 – Benthic Macroinvertebrate Functional Feeding Group Composition at NWBF302B**

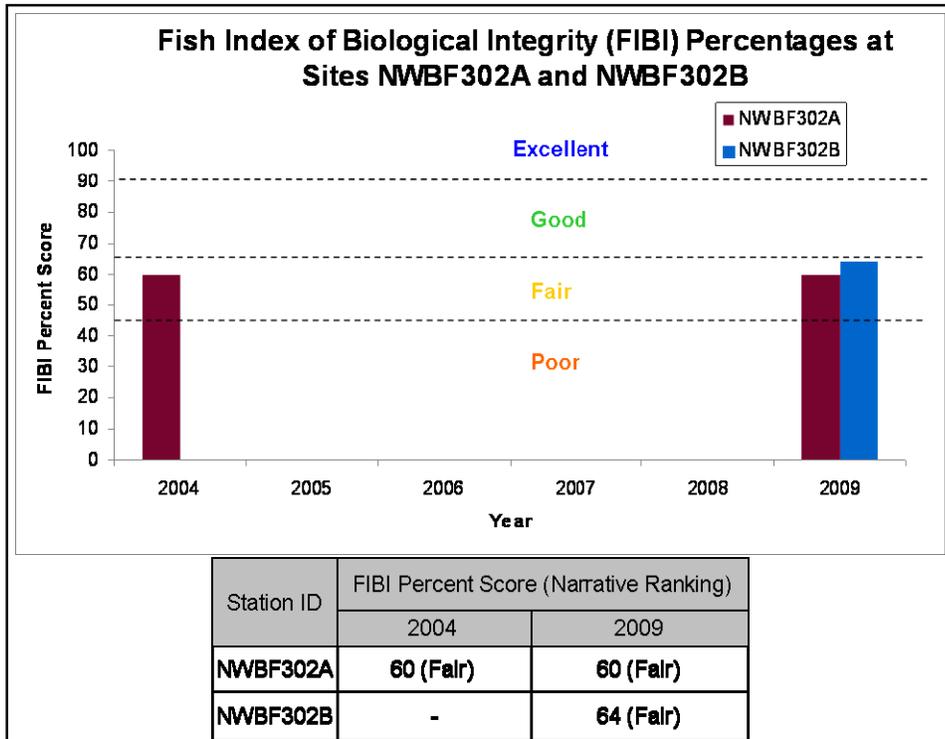
Pre-restoration fish community assessments were conducted at site NWBF302A in 2004 and 2009 and at site NWBF302B in 2009. Both sites were consistently rated by the Fish Index of

Biological Integrity (FIBI) as Fair (**Figure 3.11.9**). Site NWBF302B scored slightly higher than site NWBF302A did in 2009. The difference in FIBI score was due to two individual metrics scoring in the high range at NWBF302B that scored in the low range at NWBF302A. These metrics included the number of riffle benthic insectivorous individuals and the total number of individuals. Three individual metrics were consistently in the high range at both sites, including the total number of species, the number of minnow species, and the proportion of fish with disease/anomalies. Most other metrics were in the low and median ranges. Field data sheets from the 2009 fish monitoring are included in *Appendix D*.

**Figure 3.11.9 – Pre - Restoration Fish Index of Biological Integrity (FIBI) Percentages at NWBF302A and NWBF302B**

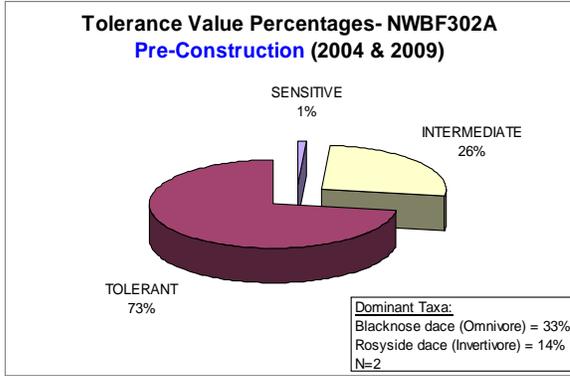
*Rhinichthys atratulus* (blacknose dace) was the most dominant fish species collected at site NWBF302A followed by *Clinostomus funduloides* (rosyside dace). *Pimephales notatus* (bluntnose minnow) was the most dominant species collected at NWBF302B and blacknose dace was second most dominant. Both blacknose dace and bluntnose minnow are tolerant to urbanization and rosyside dace are considered intermediate in sensitivity. Tolerant fish were dominant at both sites, comprising 73 percent of the community at NWBF302A and 78 percent of the community at NWBF302B (**Figures 3.11.10 and 3.11.11**). Individuals intermediate in sensitivity were second most dominant at both sites. Individuals sensitive to stressors made up one percent of the community at NWBF302A, represented solely by *Hypentelium nigricans* (northern hogsucker). Sensitive individuals were absent from site NWBF302B.

**Figure 3.11.10 – Fish Tolerance Composition and Species Dominance at NWBF302A Prior to Restoration**

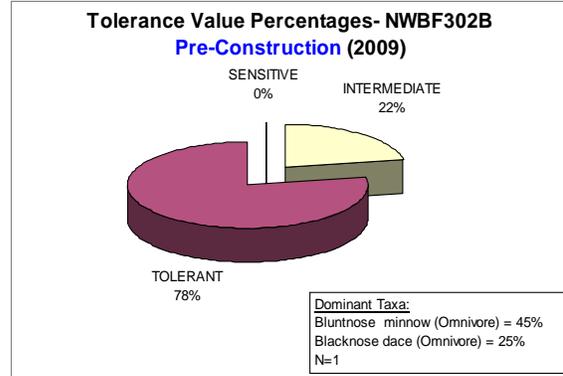
**Figure 3.11.11 – Fish Tolerance Composition and Species Dominance at NWBF302B Prior to Restoration**

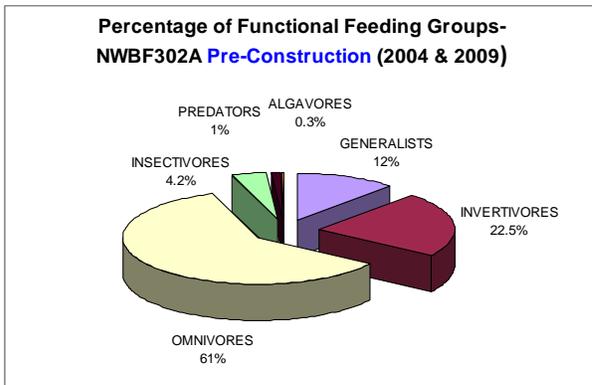
Omnivores represented the most dominant functional feeding group at both sites, comprising 61 percent of the community at NWBF302A and 82 percent at NWBF302B (**Figures 3.11.12 and 3.11.13**). At site NWBF302A, invertivores were the second most dominant feeding group, making up over 22 percent of the community. Invertivores are considered a specialized feeding group and often require less impaired substrates to feed. Species of invertivores collected at NWBF302A included rosyside dace, *Etheostoma olmstedii* (tessellated darter), northern hogsucker, *Lepomis gibbosus* (pumpkinseed), *Lepomis macrochirus* (bluegill), *Exoglossum maxillingua* (cutlips minnow), and *Cyprinella analostana* (satinfin shiner). This feeding group made up six percent of the community at NWBF302B. Insectivores, another specialized feeding group, comprised four percent of the community at NWBF302A and nine percent at NWBF302B and were represented solely by *Etheostoma flabellare* (fantail darter).

**Figure 3.11.12 – Fish Functional Feeding Group Composition at NWBF302A Prior to Restoration**

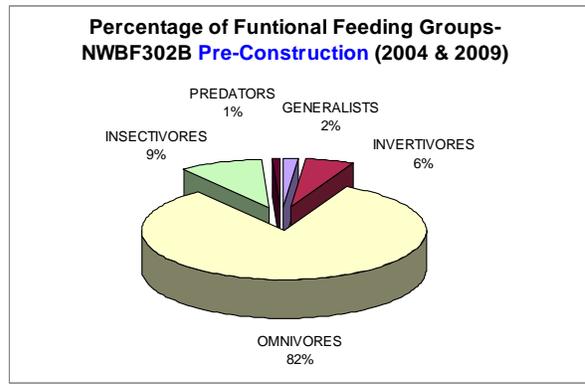
**Figure 3.11.13 – Fish Functional Feeding Group Composition at NWBF302B Prior to Restoration**

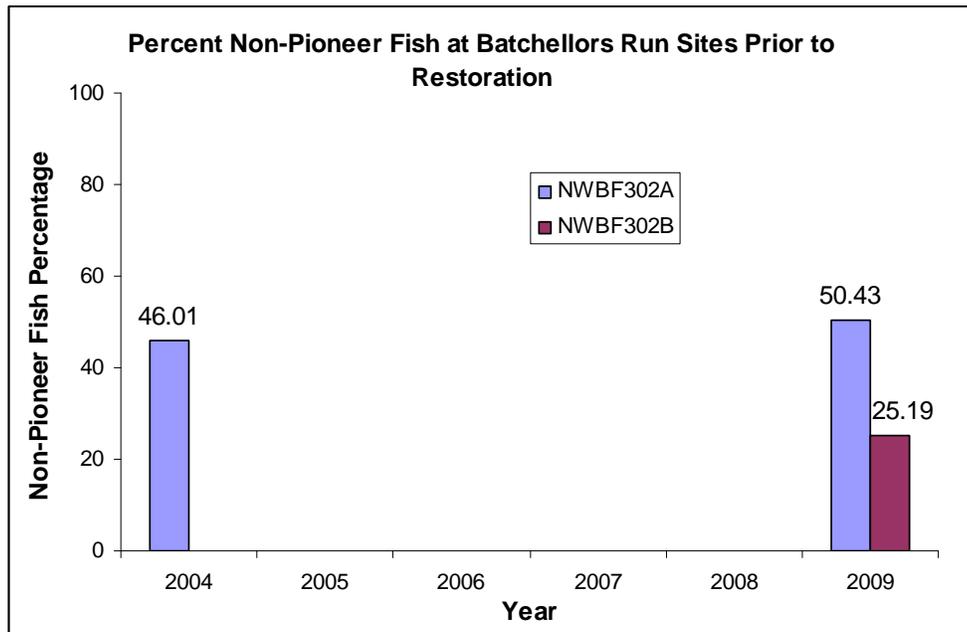
Non-pioneer fish comprised approximately half the pre-restoration community at NWBF302A, increasing slightly from 46 to 50 percent between 2004 and 2009 (**Figure 3.11.14**). The

variation among years was generally due to a decrease in the percentage of blacknose dace, a pioneer species. However, the diversity of pioneer species increased from 2004 to 2009 at NWBF302A. At NWBF302B non-pioneer fish comprised 25 percent of the pre-restoration community. This site was heavily dominated by pioneer fish species including, blacknose dace and bluntnose minnow. Species that are considered non-pioneers are generally more sensitive to disturbed aquatic habitats than pioneer species.

**Figure 3.11.14 – Non-Pioneer Fish Present at NWBF302A and NWBF302B Prior to Restoration**

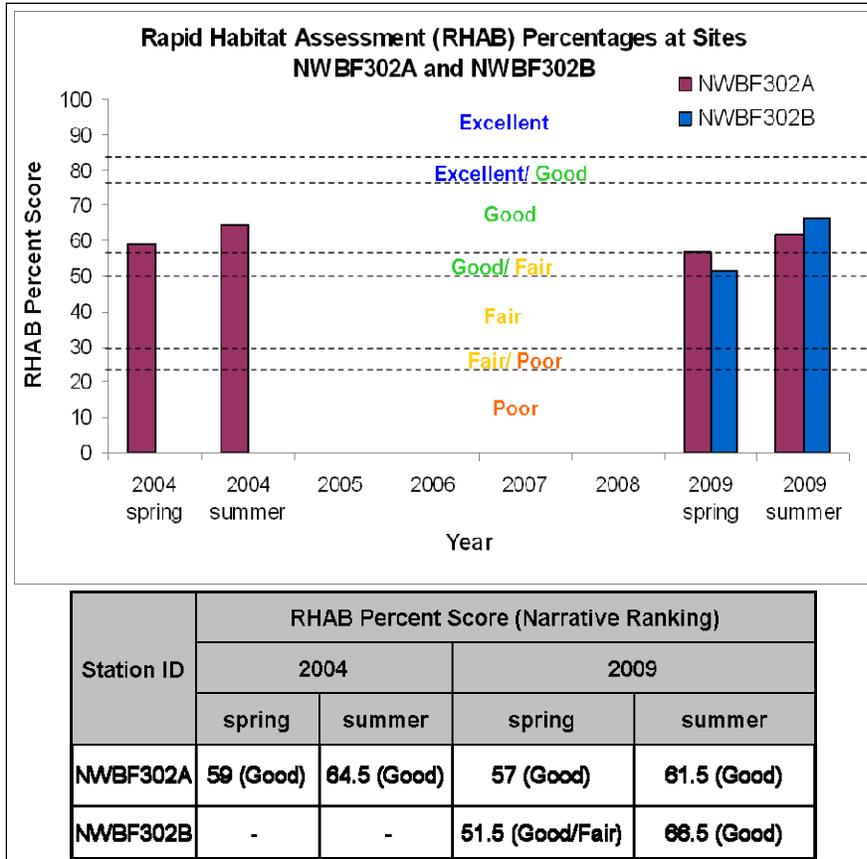
Aquatic habitat was evaluated at NWBF302A in the spring and summer of 2004 and 2009 and at NWBF302B in the spring and summer of 2009. Percent scores were generally rated as Good at both sites, with the exception of site NWBF302B in the spring of 2009, which was rated at Good/Fair (**Figure 3.11.15**). In-stream cover for fish was generally considered suboptimal at both sites. Epifaunal substrates for benthic macroinvertebrates were rated as marginal at NWBF302A and suboptimal at NWBF302B. Moderate sedimentation was also documented at both sites. Streambanks were considered moderately unstable at NWBF302A and moderately stable at NWBF302B. The width of the riparian zone was considered optimal at NWBF302A and poor at NWBF302B, due to its location in a golf course (**Figure 3.11.16**).

**Figure 3.11.15 – Rapid Habitat Assessment (RHAB) Percentages at NWBF302A and NWBF302B Prior to Restoration**

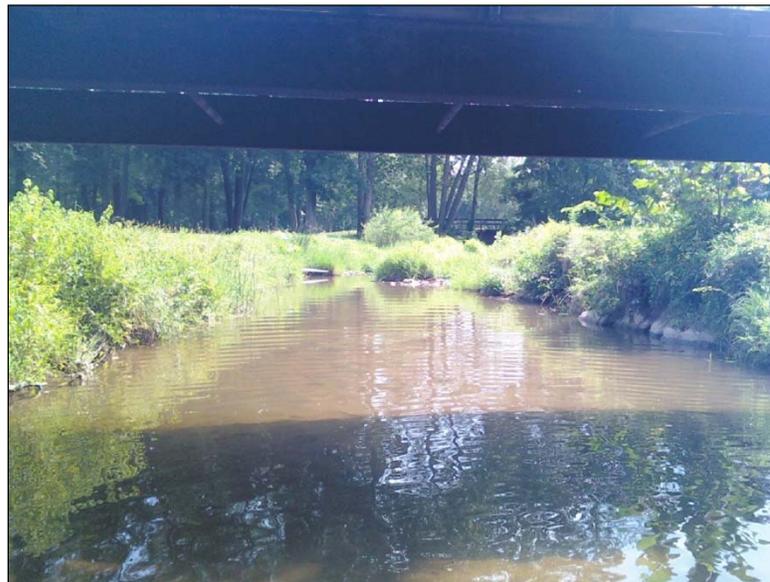
**Figure 3.11.16 – Site NWBF302B, on Northwest Park Golf Course, Showing Poor Riparian Buffer, Poor Instream Habitat, and Moderately Stable Streambanks**
