3 Individual Restoration Projects

3.1 Hawlings River Stream Restoration

Restoration goals were defined during the planning and implementation of the Hawlings River Stream Restoration project. Pre- and post-restoration monitoring was conducted within the stream and in the floodplain of the project area. This is a fifth and final year post-restoration monitoring report and summarizes the pre- and post-restoration conditions within the Hawlings River project area. The quantitative habitat monitoring was delayed and will be included in a 2011 update report. *Table 3.1.1* below presents the restoration goals, monitoring performed to evaluate the success of the goals, and when and where the monitoring occurred.

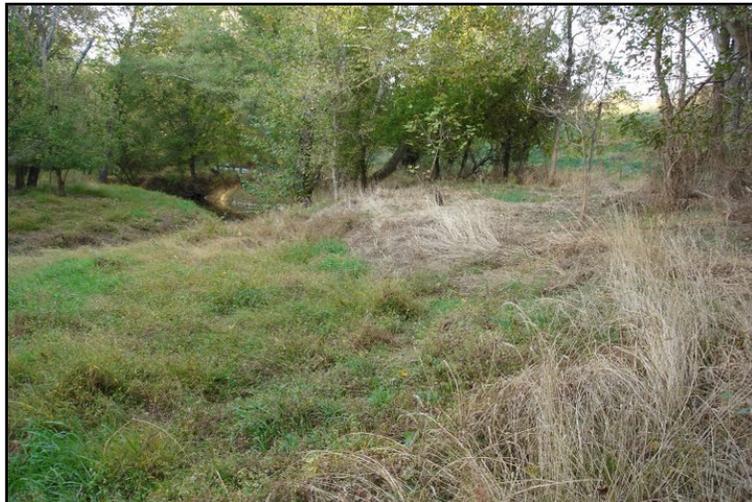
Figure 3.1.1 – Hawlings River Stream Restoration 2009

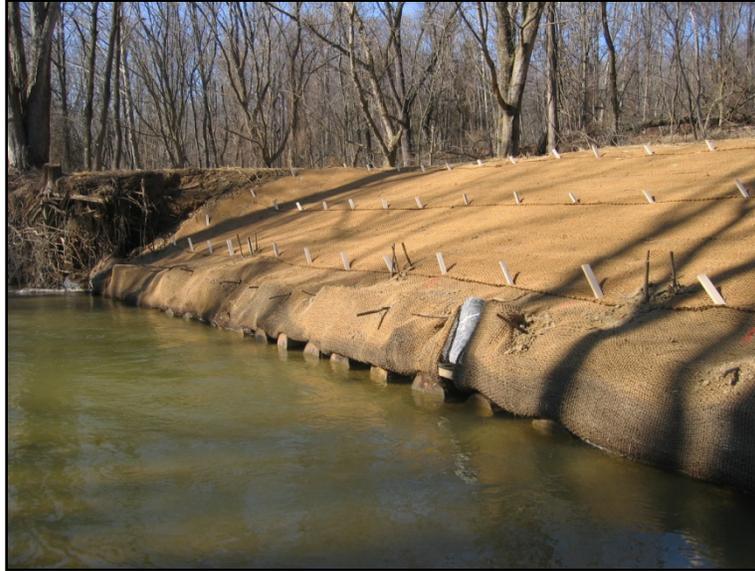
Project Area: The Montgomery County Department of Environmental Protection (MCDEP) performed a stream restoration project along the Lower Hawlings River mainstem. The project, located just upstream of Brighton Dam Road, stabilized a 2,800 foot degraded stream channel that flows through County parkland (*Figure 3.1.3*). The Hawlings River is a tributary to the Rocky Gorge Reservoir, a Washington Suburban Sanitary Commission (WSSC) drinking water supply reservoir located in the Patuxent River watershed. The contributing drainage area is mainly characterized by low-density single-family residential use with agricultural use interspersed.

Figure 3.1.2 – Hawlings River Stream Restoration 2005

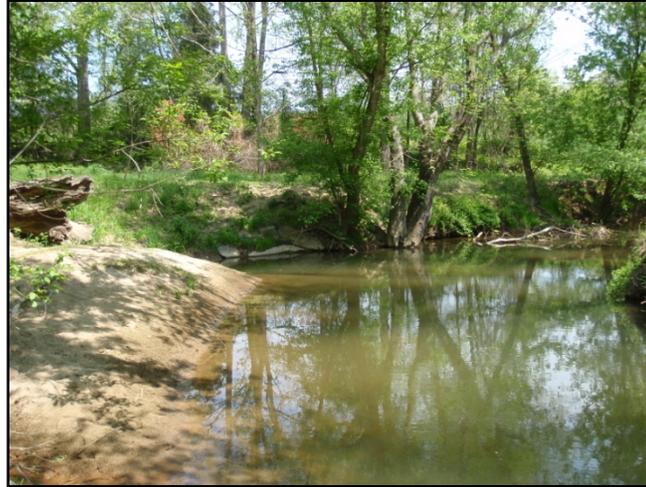
Aquatic habitat evaluated at HWHW314D generally showed an improvement from the pre-restoration period to 2010. During this time, overall narratives ranged from the Fair and Good/Fair ranges to the Good/Fair and Good ranges (**Figure 3.1.18**). The post-restoration aquatic habitat improvements were due to higher ratings of epifaunal substrates for benthic macroinvertebrate communities, less embedded substrates, more frequent riffle habitats, and a decline in erosion severity on one streambank. Conversely, the summer habitat assessment in 2010 showed a decrease from the other post-restoration assessments to the Fair range. This decrease was due to lower estimates of in-stream cover for fish, and an increase in sedimentation and embeddedness estimates. **Figure 3.1.19** shows the sedimentation that was present in 2010.

Figure 3.1.19 – Hawlings River in Summer 2010, Showing High Sedimentation

The restoration area is a third order stream and fish habitat conditions may be variable due to flashy flows and channel instability. Anecdotally, there were also more frequent above-average flooding events that have occurred within the post-restoration period that may have contributed to sedimentation and channel instability. The results of the 2011 quantitative assessments will assess the stability of the channel to see if that could be having an affect on the fish population.

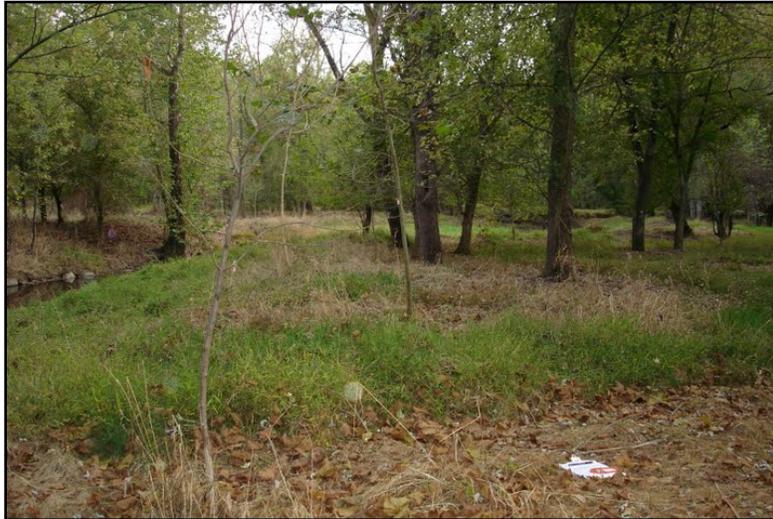
In 2009 and 2010, a different methodology was used; each individual planting was located, measured, and notes were taken on the health and problems with its growth, using the planting plan. In 2009, this site was characterized as having a success rate of 73 percent, with 66 percent of the plantings surviving to 2009 and 7 percent growth from volunteer trees. However, many of the trees observed were considered to be unhealthy. **Figure 3.1.20** shows an image of the botanical reforestation site on the day of the 2009 monitoring.

Figure 3.1.20 – HWHW314D in 2009, photo taken on the right bank looking downstream, showing sycamore plantings with a dense groundcover of Nepalese browntop and other herbaceous species

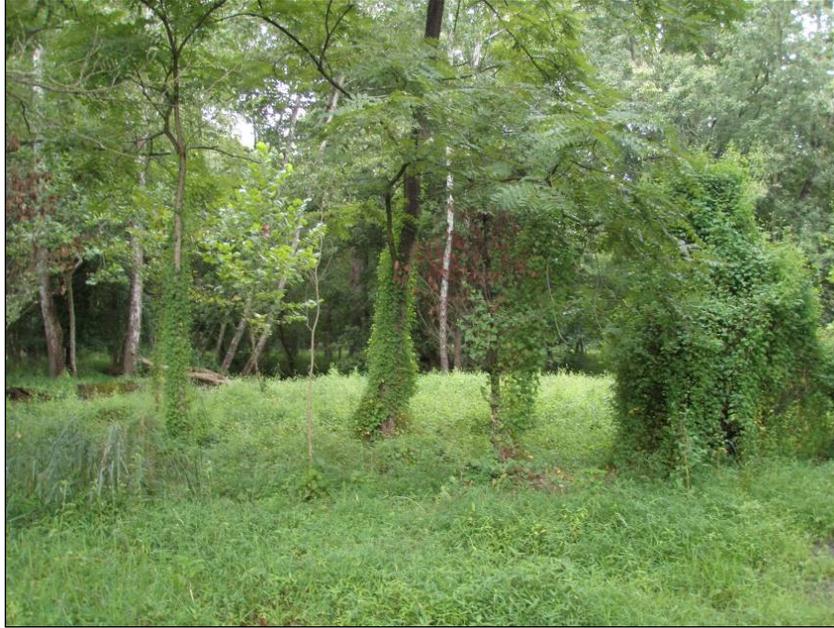
In 2010, the site was characterized as having a success rate of 64 percent in the fifth and final year of monitoring (**Table 3.1.3**). Ninety nine stems were counted, but only 15 percent were considered healthy, 27 percent appeared dead, and the remaining trees had invasive species impeding their growth or were damaged by deer or beaver. **Figure 3.1.21** shows an image of the botanical reforestation site on the day of the 2010 monitoring. All five planted species were identified. The two volunteer tree species that were found in 2009 were also found in 2010 (white pine (*Pinus strobus*) and river birch (*Betula nigra*)). This site was in a similar condition to what was observed in 2009, except the number of healthy red maple declined from 2009 to 2010, from 80 to 25 percent. Invasive vines, such as *Polygonum perfoliatum* (Asiatic tearthumb) and *Celastrus orbiculatus* (Oriental bittersweet), and dense growth of *Microstegium vimineum* (Nepalese browntop) were abundant.

Figure 3.1.21 – HWHW314D in 2010, photo looking at the floodplain showing abundant invasive coverage, including Asiatic tearthumb and Nepalese browntop

Overall, the Hawlings River stream restoration has partially met three of four project goals. The restoration has enhanced the stream buffer in an area once dominated by herbaceous vegetation; although, many of the plantings have died or are being out-competed by invasive species. There may be some potential to save the remaining plantings from being overtaken by invasive vines by removing them from the plantings. However, large-scale treatment of invasive species at this site is not recommended, since the entire floodplain of this stream system is covered by the same invasive plants that were observed at this site (Nepalese browntop and Asiatic tearthumb).

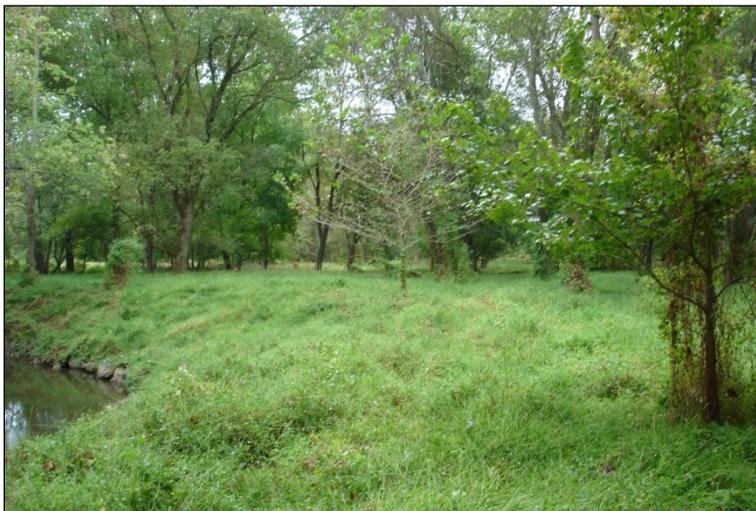
Many areas that were sparsely vegetated prior to construction have been planted as part of this restoration project and the riparian zone is relatively improved. One volunteer tree species was observed in the reforestation area; however, many of the plantings have died and are being out-competed by invasive species. Sixty-four percent of the plantings survived to 2010 (**Figure 3.1.22**).

Figure 3.1.22 – HWHW314D in 2010, photo looking at the floodplain showing plantings and abundant invasive coverage, including Asiatic tearthumb and Nepalese browntop
