### **3 Individual Restoration Projects**

# Hawlings River

## 3.1 Hawlings River Stream Restoration

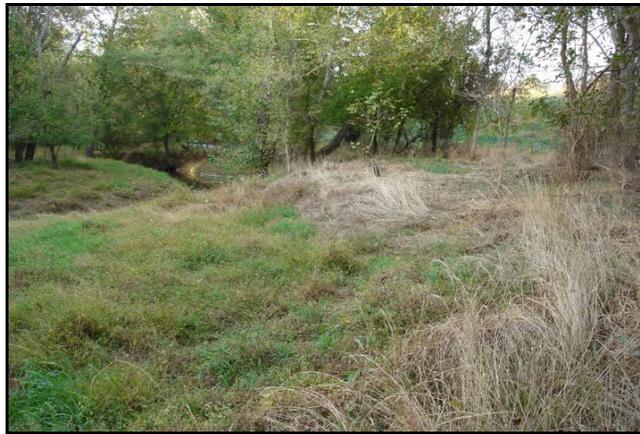
*Figure 3.1.1 – Hawlings River Restoration 2009*

The Hawlings River is part of the Patuxent River watershed and drains directly to the Rocky Gorge Reservoir. This restoration project site was identified by the Hawlings River Watershed Restoration Study (2003) as having highly eroded banks, limited aquatic habitat for stream biota, and a sparsely vegetated stream buffer with a dense groundcover of invasive herbaceous species. The restoration was completed in 2005 and intended to reduce erosion, thereby reducing sedimentation and nutrient inputs to the downstream reservoir, and to improve in-stream aquatic habitat and water quality. The riparian area was also planted with native tree species to improve the stream buffer. *Figures 3.1.1* and *3.1.2* display examples of the restoration associated with the project.

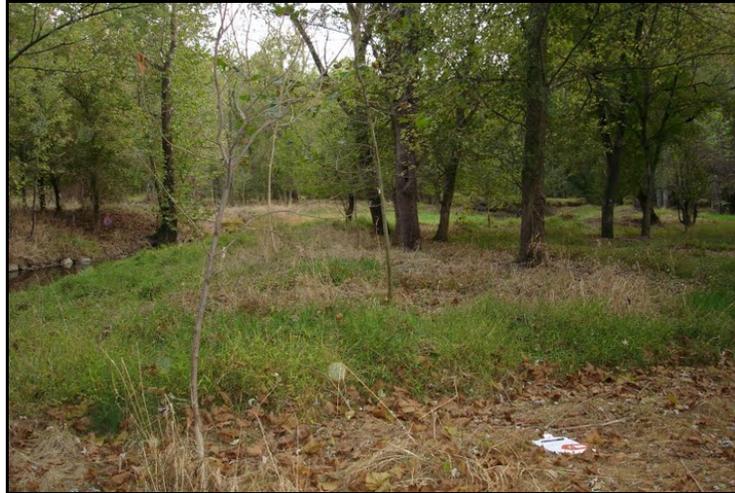
In 2009, different methodology was used; each individual planting was located, measured, and notes were taken on the health and problems with its growth, using the planting plan. This site was characterized as having a success rate of 73 percent, with 66 percent of the plantings surviving to 2009 and 7 percent growth from volunteer trees (**Table 3.1.3**). However, many of the trees observed were considered to be unhealthy. One hundred and twenty one stems were counted, but only 10 percent were considered healthy, 31 percent appeared dead, and the remaining 59 percent of trees had invasive species impeding their growth or were damaged by deer or beaver. One species (*Quercus palustris* (pin oak) increased by 80 percent, with volunteer numbers contributing to the overall reforestation goal. *Fraxinus pennsylvanicus* (green ash) was the only species planted that was not observed in 2009. The remaining four planted species were documented on site and included *Platanus occidentalis* (American sycamore), *Acer rubrum* (red maple), pin oak, and *Acer saccharinum* (silver maple). Three volunteer tree species were also found in 2009 including *Pinus strobus* (white pine), *Betula nigra* (river birch), and *Asimina tribola* (pawpaw), one volunteer shrub species *Cornus amomum* (silky dogwood) was found in the planting area. **Figure 3.1.16** shows an image of the botanical reforestation site on the day of the 2009 monitoring.

**Figure 3.1.18 – HWHW314D in 2009, photo taken on the right bank looking downstream, showing sycamore plantings with a dense groundcover of Nepalese browntop and other herbaceous species**

The caliper sizes of all four of the planted species measured in 2009 were larger than those planted in 2005; sycamore showed the most growth of all planted species (**Table 3.1.4**). Invasive vines, such as *Polygonum perfoliatum* (Asiatic tearthumb) and *Celastrus orbiculatus* (Oriental bittersweet), and dense growth of *Microstegium vimineum* (Nepalese browntop) will likely inhibit success of trees and shrubs for the foreseeable future.

Many areas that were sparsely vegetated prior to construction have been planted as part of this restoration project and the riparian zone is relatively improved. The planting areas have a success rate of 73 percent, with 66 percent of the planted trees surviving and an additional 7 percent recruitment from volunteer trees. However, only ten percent of the species were considered healthy; many of the plantings have died and are being out-competed by invasive species or rubbed by deer or cut by beaver. With the exception of green ash, which was not observed at all, the caliper sizes of the individuals observed in 2009 were larger than those that were planted in 2005. The increase in size of the planted individuals is a measure of successful growth and a sign that these trees are well established. Planted sycamore individuals showed the greatest increase in growth but had the lowest overall survival of the planted species. Pin oak had the best overall survival of all planted species and some individuals have increased in caliper size since they were planted in 2005. Several volunteer tree species and one volunteer shrub species were observed in the reforestation area. Invasive species control along with more planting is recommended for further success of this goal. However, if additional plantings are installed at this site, it is suggested that each planting be protected, from deer to the extent possible, as a large part of the site’s lack of success is likely due to deer browse and rub.
