Annual Report for FY13

NPDES Municipal Separate Storm Sewer System Permit

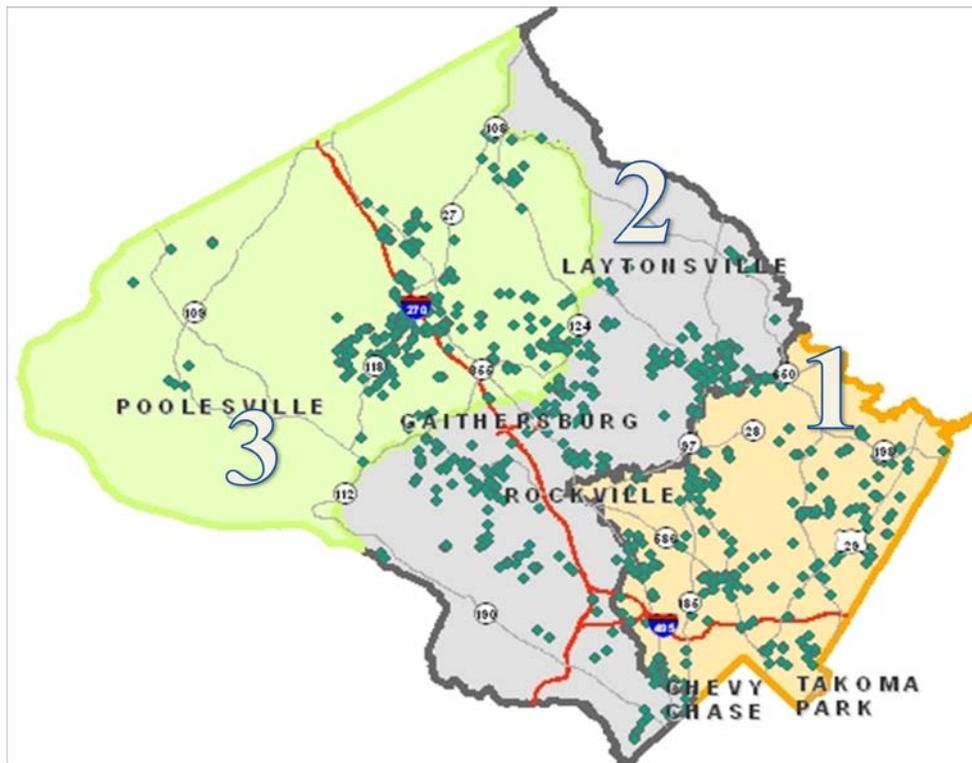
Figure III.E1- Map of the Stormwater Facility Maintenance Regions

The DEP is responsible for inspecting all SWM facilities under County jurisdiction to assess repair and maintenance needs. In FY13, there were over 7,000 SWM facilities. Facilities are inspected every three years (triennial inspections) using contracted inspectors. DEP has separated the County in three geographical Inspection Regions (Figure III.E1).

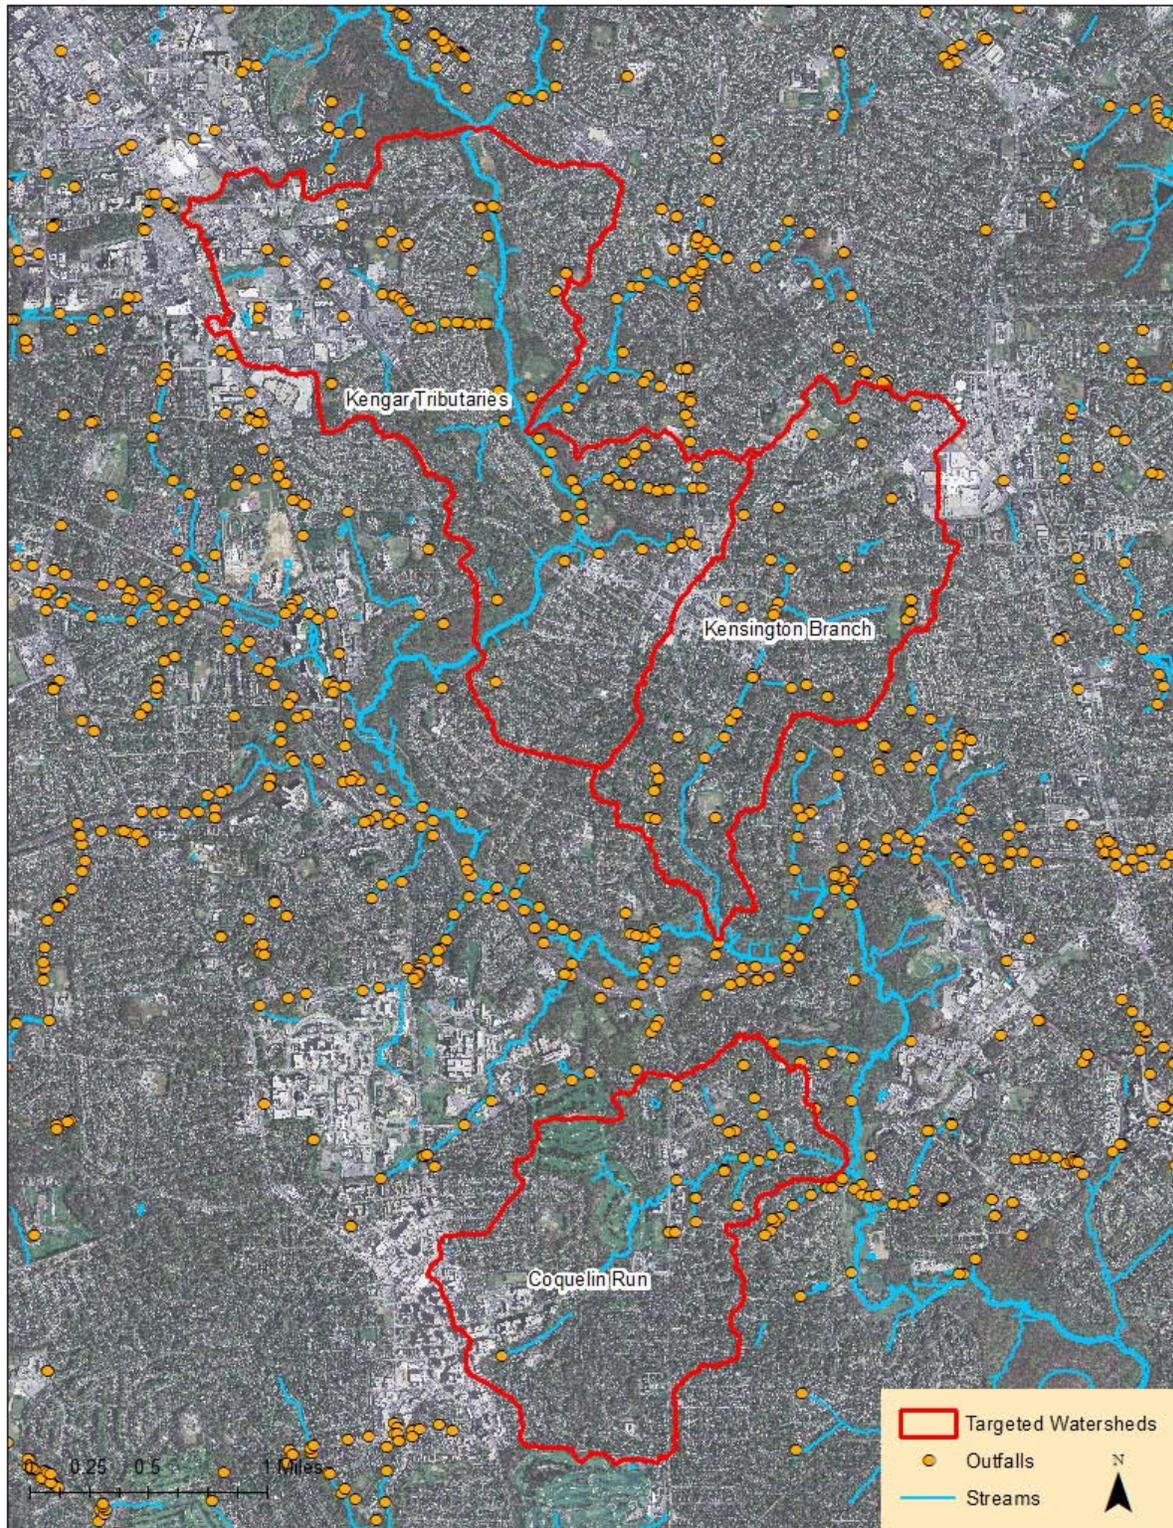
Figure III.E2- FY13 Outfall Screening – Coquelin Run, Kensington Branch and KenGar Tributaries of the Lower Rock Creek Watershed

For FY13, DEP performed outfall screening in the Coquelin Run, Kensington Branch and KenGar Tributaries of the Lower Rock Creek Watershed. DEP screened 156 outfalls and found 35 to have flow (19 with dry weather flows and 16 piped streams). Of the 35 outfalls found to have flow, 11 were flagged for follow up investigations due to elevated water quality parameters measured during the initial screening. Of those 11 outfalls, 8 were found to have normal water chemistry parameters during the follow up visit. One discharge was tracked to a sidewalk cleaning event, and one discharge was referred to WSSC due to elevated chlorine. One discharge is still being investigated by DEP staff.

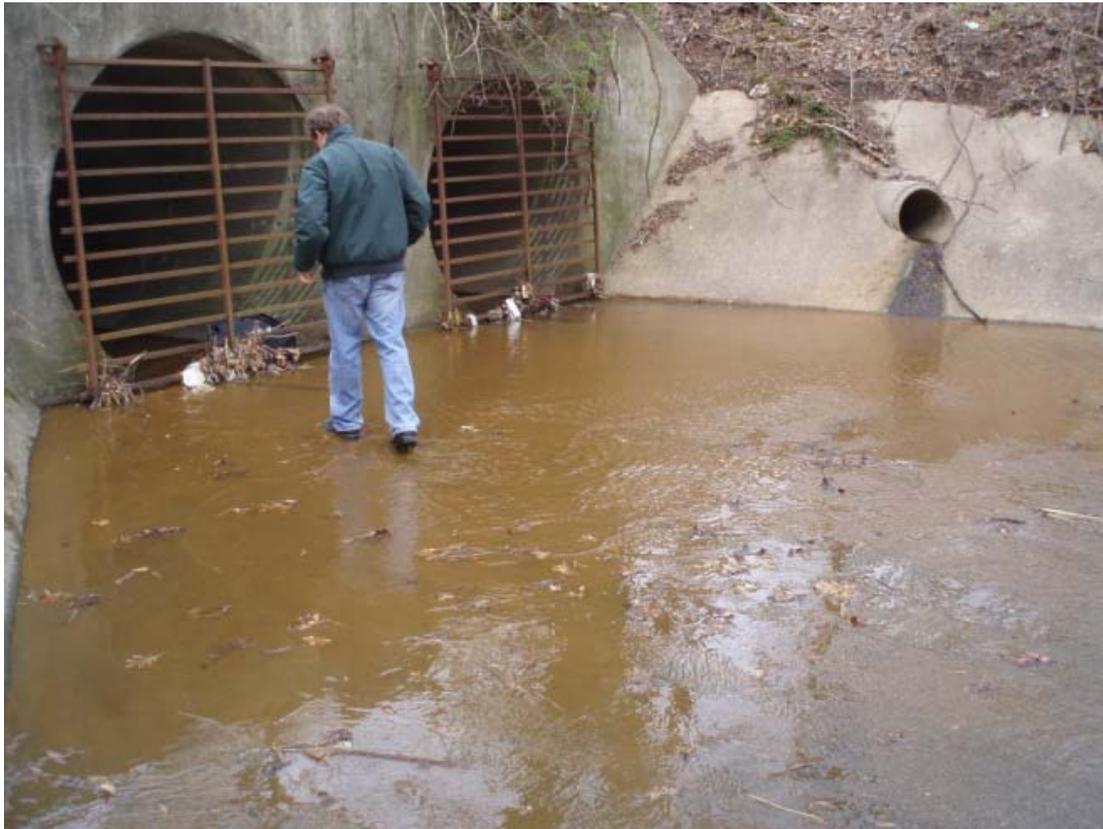
Figure III.E3- Maple Ave. Outfalls

The Maple Ave drainage is over 550 acres with its headwaters in Northeast District of Columbia and its outfall south of the intersection of Maple Ave and Sligo Creek Parkway in Montgomery County. The Maple Ave outfall consists of two 72" concrete pipes (Figure III.E3), and complex underground piping systems in the drainage area.

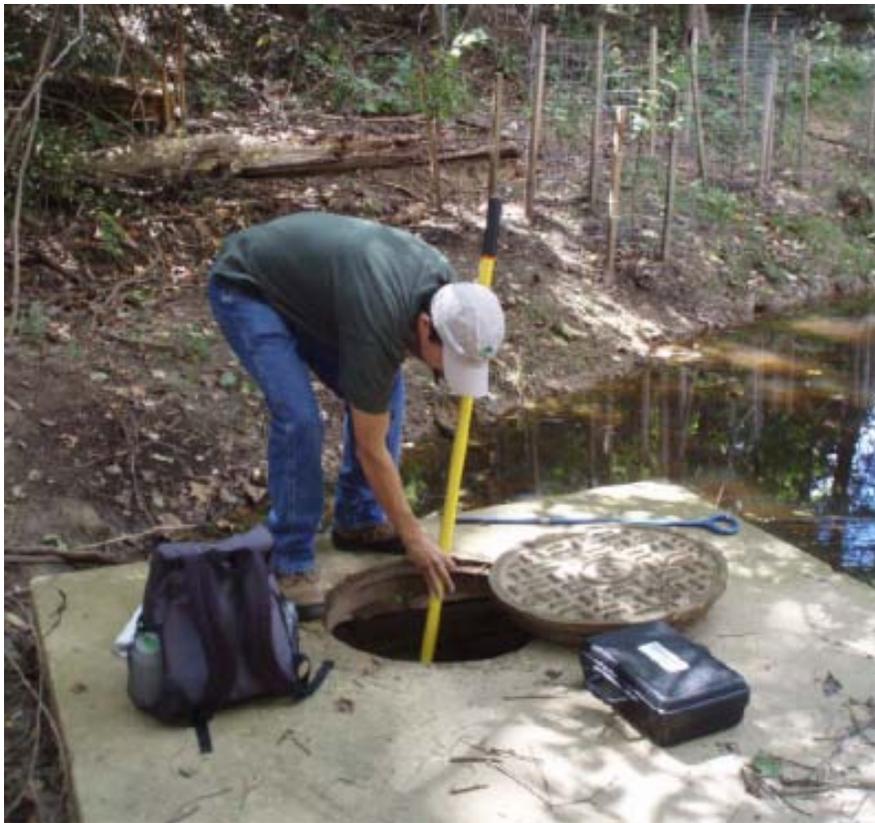
Figure III.E5- DEP Field Enforcement Staff Taking Samples From a Storm Drain Manhole Behind the Park Ritchie Apartments

- One outfall near the Park Ritchie Apartments (Fig.III.E5) was found to have elevated levels of ammonia, detergent, and fluoride. Storm drain mapping for the area is inaccurate, and a source for the discharge could not be determined. Dye testing of the laundry room at the Park Ritchie Apartments was negative. DEP will explore this storm drain area further in FY14 using CCTV.
- One storm drain manhole above the Park Ritchie Apartments had dry weather flow with contamination suggesting sanitary system influence. WSSC videotaped the sanitary lines in the vicinity of the manhole and found problems that will require the relining of the sanitary line. No date has been set for the sanitary line repair.

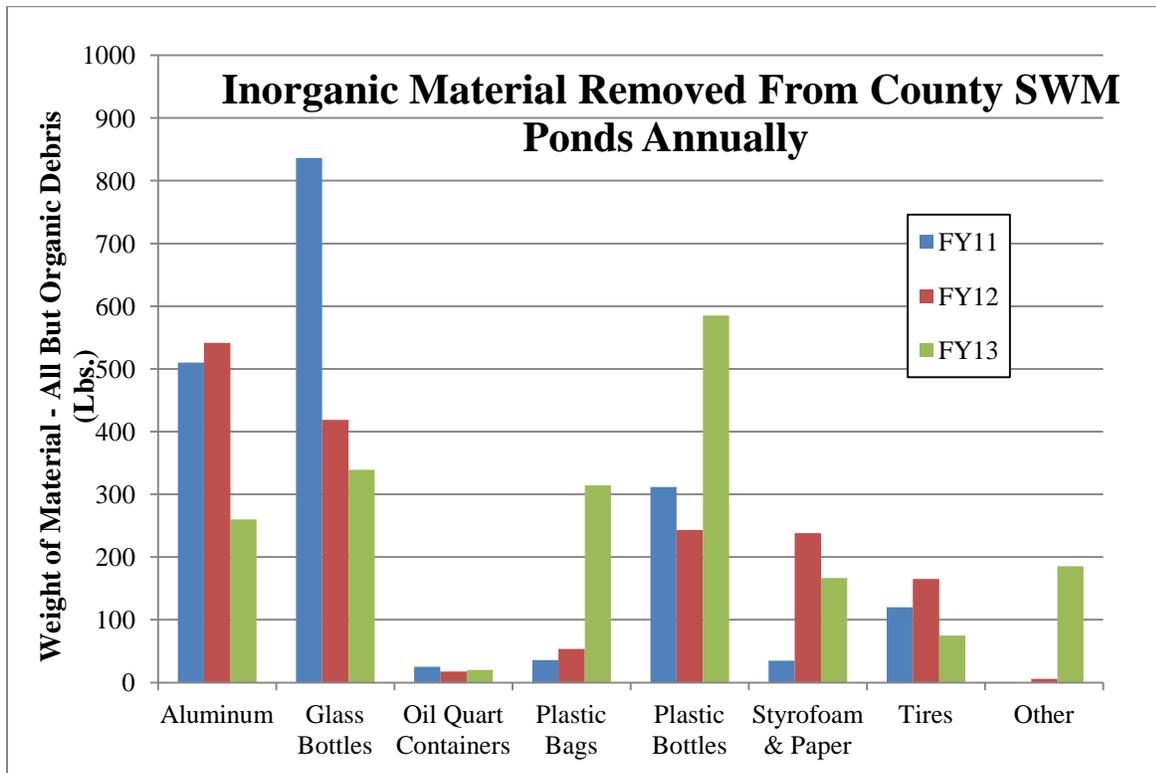
Figure III.E8- Inorganic Material Removed from the SWM Ponds Annually

The Carryout Bag Law which went into effect on January 1, 2012 (FY12) does not yet appear to have affected amount of bags collected at the ponds. As seen in Figure III.E8, the amount of plastic bags collected went up from 54 pounds in FY2012 to 314 pounds in FY2013. The amount of plastic bottles collected also increased from prior years. These increases could be due to more aggressive collection efforts by the county’s new pond maintenance contractor, although some of the increase in plastic bottles appears to be a shift away from glass bottles and aluminum cans. The amount of glass bottles declined greatly in FY2012 and continued to decline in FY2013. Aluminum cans declined from 542 pounds in FY2012 to 260 pounds in FY2013.

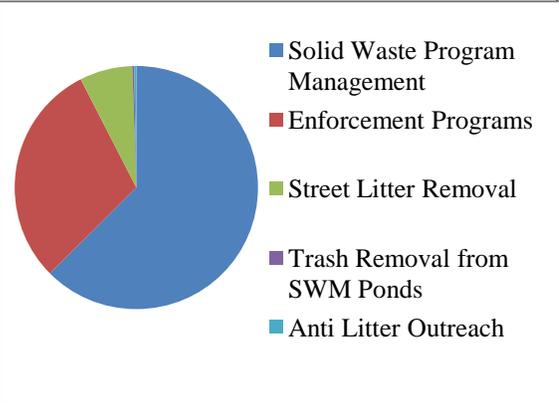
Table III.E7- Estimated FY13 Trash Reduction Costs	
Program	FY11 Cost
Solid Waste Management	\$4,270,353
Enforcement Programs	\$2,041,070
Street Litter Removal	\$479,000
Trash Removal from Stormwater Ponds	\$17,670
Anti-Litter Outreach	\$18,825
Total	\$6,826,918

The pie chart illustrates the distribution of the estimated FY13 trash reduction costs. The largest portion is Solid Waste Program Management at approximately 62%, followed by Enforcement Programs at 30%. Street Litter Removal accounts for 7%, Trash Removal from SWM Ponds for 0.3%, and Anti Litter Outreach for 0.3%.

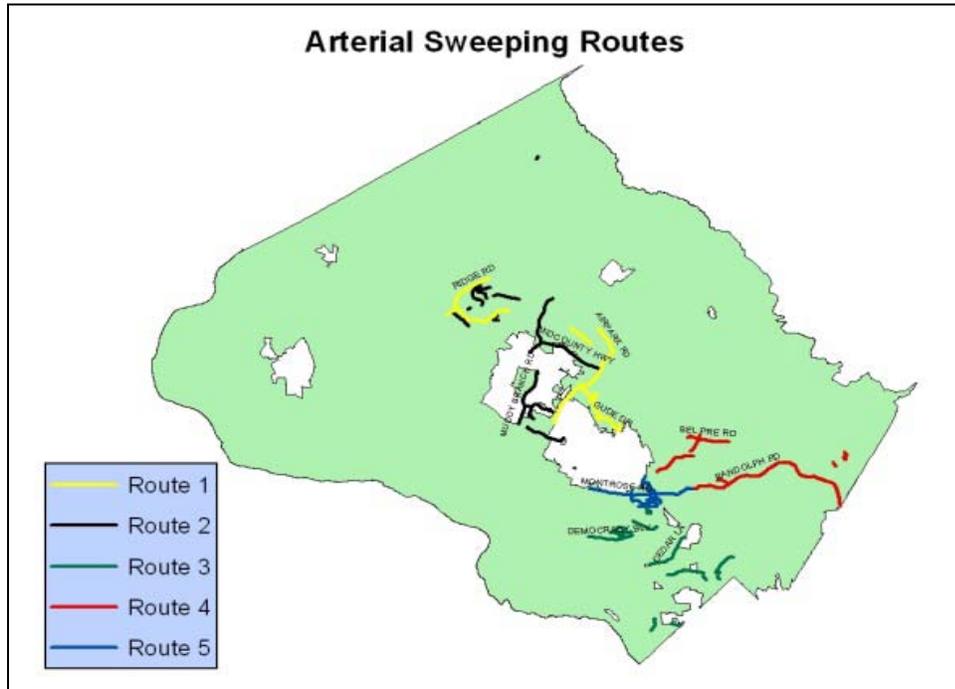
Figure III.E11- Montgomery County Arterial Street Sweeping Routes

The DEP funds sweeping of selected routes, known as “arterial” routes, shown in Figure III.E11. The arterial routes are larger roads with more commercial activity, traffic and more observed trash. These routes total 229 curb miles, are swept at night when traffic volumes are low. Sweeping is only done on segments of the roads without residential housing because of noise considerations.

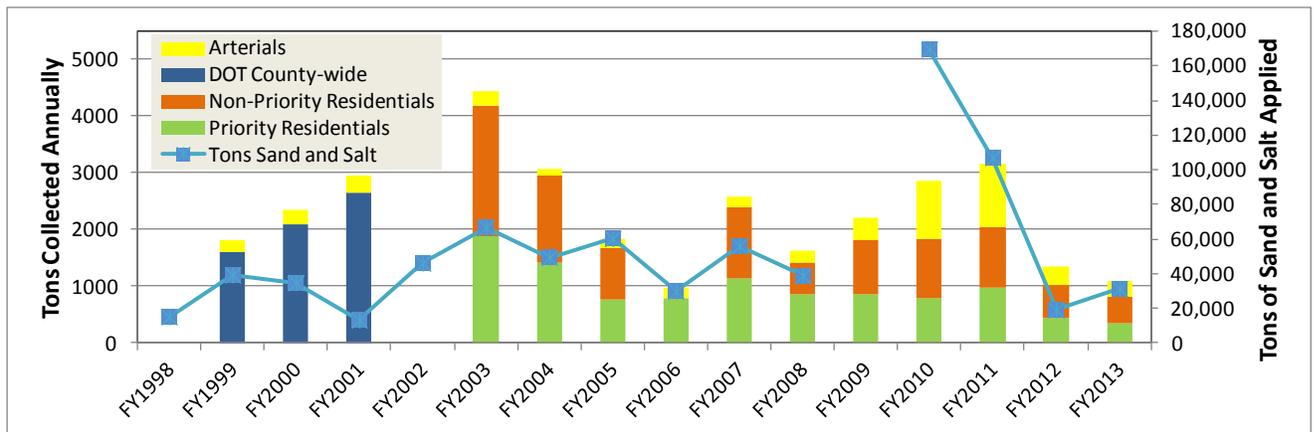
Figure III.E12- Tons of Material Applied During Winter Activities and Collected by Street Sweeping 1998-2012

Figure III.E12 shows the tons of materials removed annually by street sweeping based on route type for records available, from 1999 to present. The tons of sand and salt applied were not reported for FY09 and FY10. In 2002, no County street sweeping was conducted due to lack of funding. The amount of material removed seems directly related to the amount of sand applied for de-icing, which is largely determined by the amount of winter precipitation. More snow and ice increases the need for application of sand to the roads, which then becomes more available for collection during street sweeping. In 2012 DOT stopped mixing sand and salt as a routine practice. DOT now applies a salt brine solution before storms and granular salt to accumulated snow. Sand is still used as a spot treatment and during events with a lot of ice, but the amounts of sand used have declined dramatically.

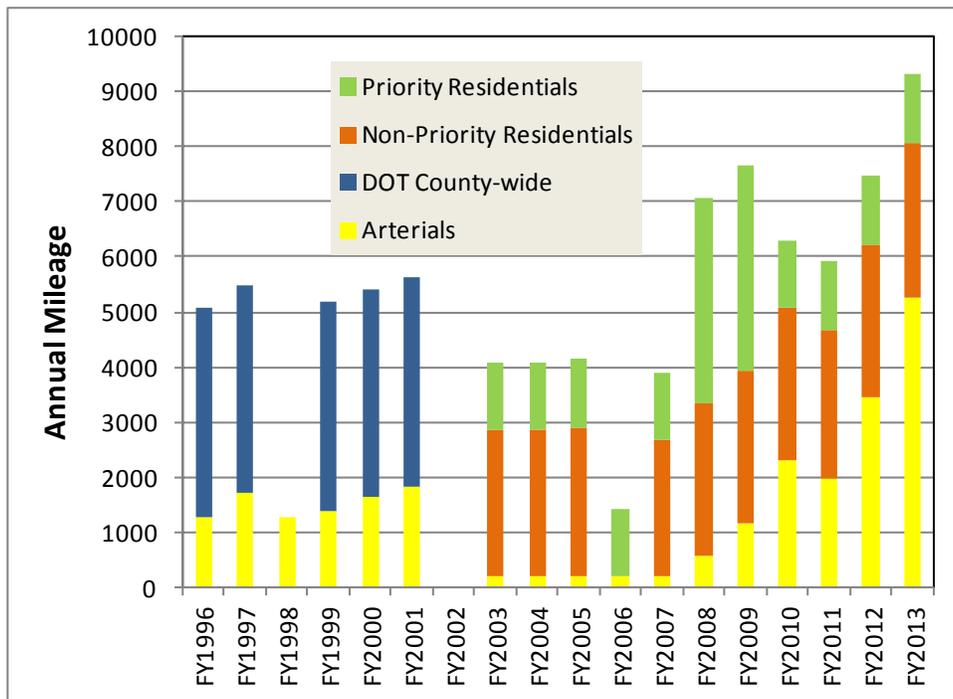
Figure III.E13- Annual Montgomery County Street Sweeping Mileage 1996-2013

Figure III.E13 below shows the mileage swept per year by route category. Sweeping all the arterial routes twice monthly for all of FY13 resulted in an increase in total miles swept. More miles were swept in FY13 than any prior year. Overall average cost per mile has fallen steadily as the county has shifted towards arterial sweeping (Figure III.E14).

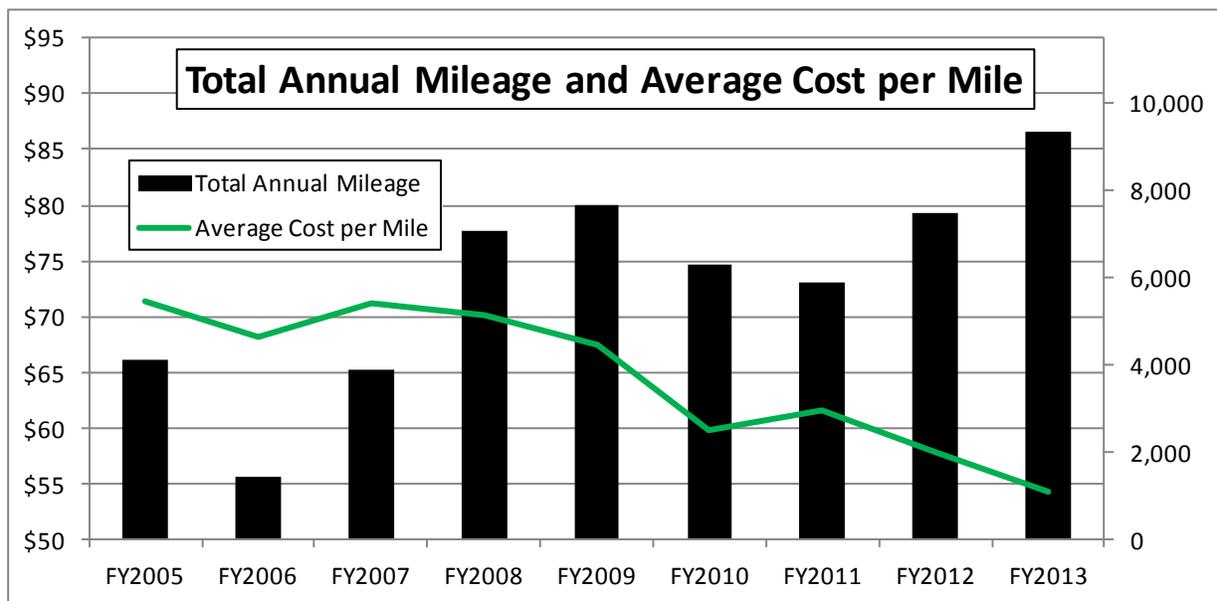
Figure III.E14- Montgomery County Street Sweeping Mileage and Average Cost 2005-2013

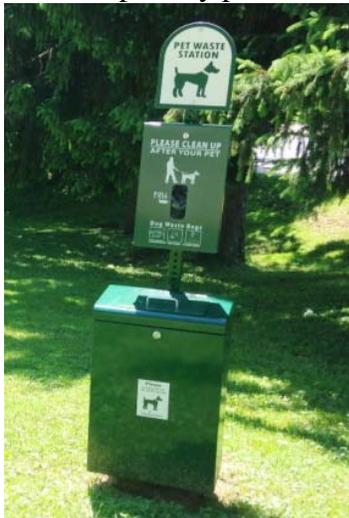
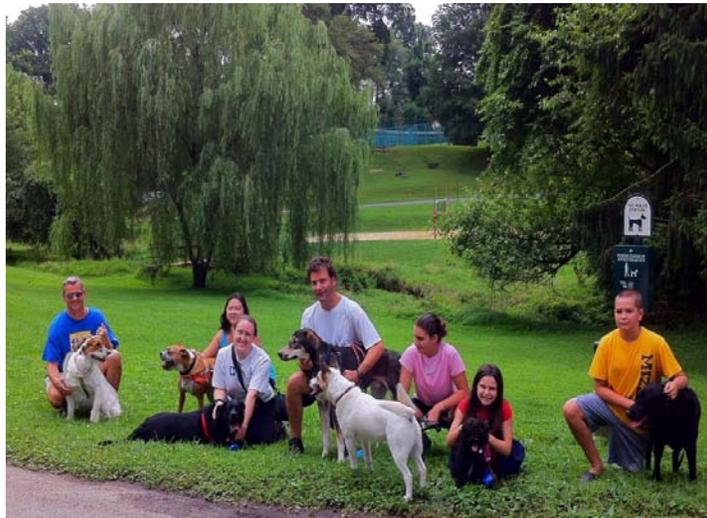
In FY 13, DEP partnered with three HOAs to launch a pet waste pilot project in the Rock Creek Watershed. Five pet waste stations were installed at two HOA properties that had no previous program to remove and dispose of pet waste. By the end of FY13, a total of 172 pounds of dog waste had been collected from the 5 installed stations. This pilot addresses Part III.E.7.b.viii of the Permit and key messages, partnerships to nurture, delivery techniques and measurements of POSWP priority practice #1.

Figures III.E15 (a) Newly Installed Neighborhood Pet Waste Station and (b) Volunteers During a Neighborhood “Dog Walk” to Educate the Neighborhood on Pet Waste Concerns

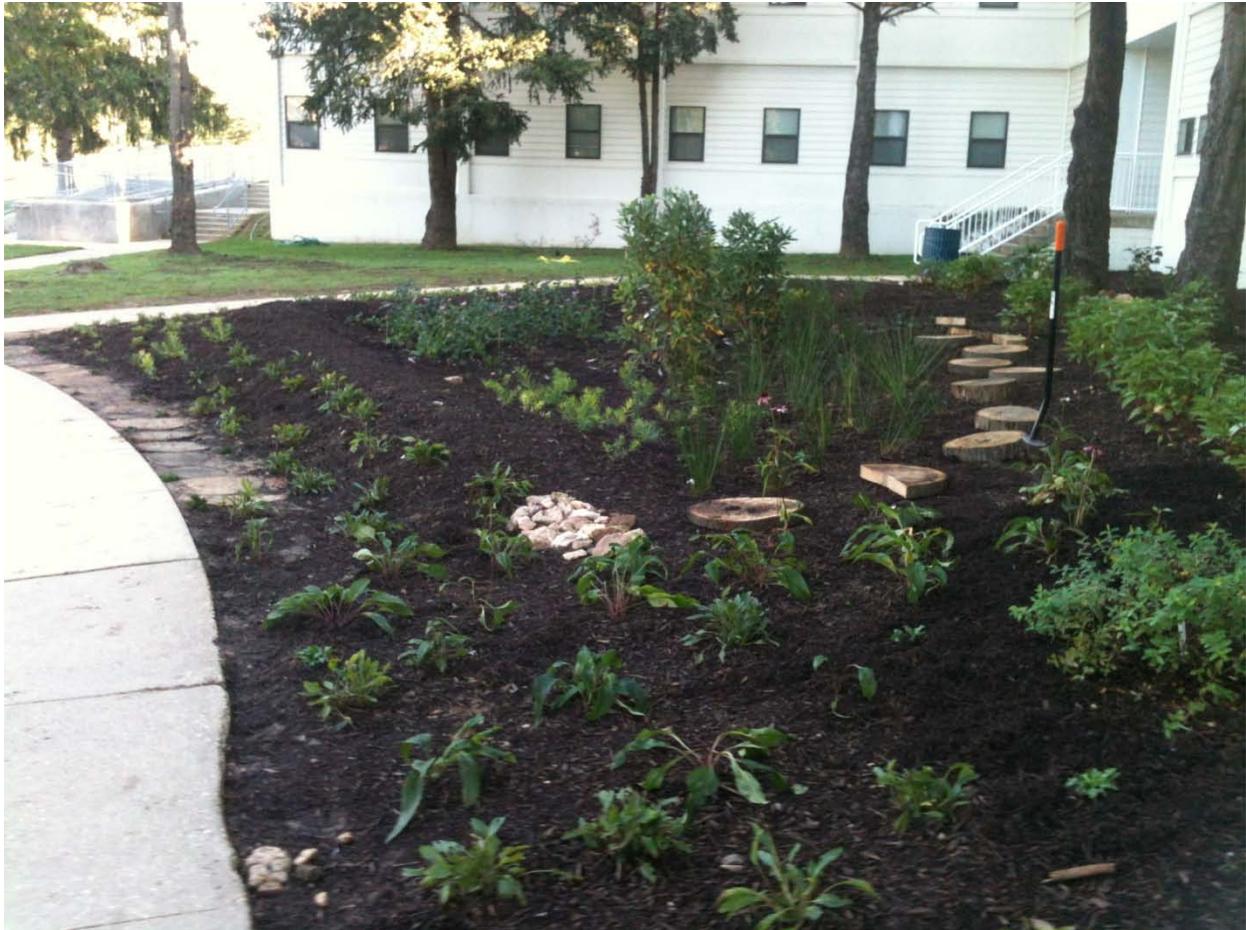
Figure III.E25- Rain Garden and Conservation Landscape at Loiderman Middle School – A Cooperative Project with the Tower Company , MCPS and DEP RainScapes to Manage the Flow From 5000 Square Feet of Rooftop Drainage

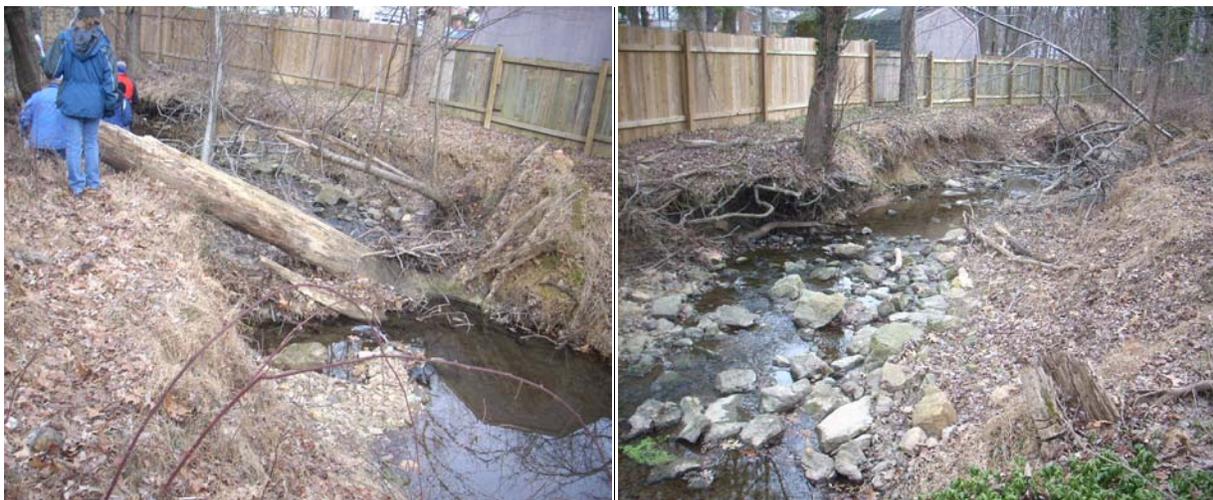
Figure III.G2- Pre-restoration Conditions at Hollywood Branch (Photos taken: 1/4/12)

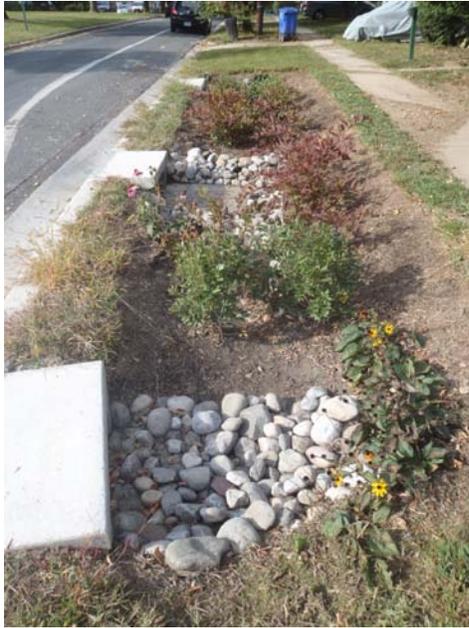
Figure III-G4. Completed Dennis Avenue Green Streets Curb Extensions (Photo taken 9/26/13)

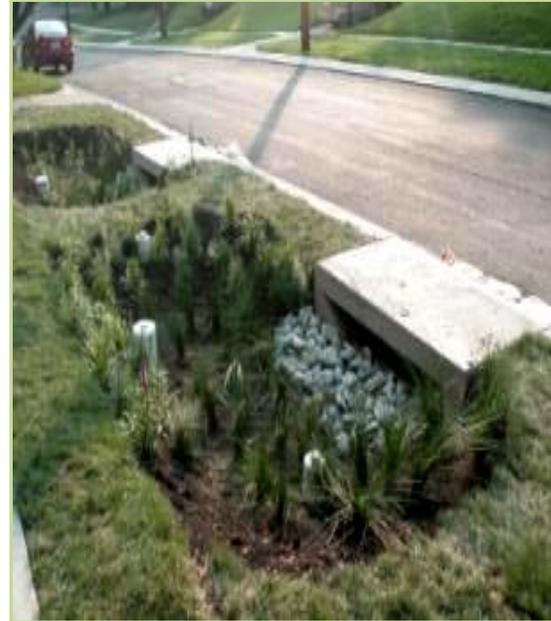
Figure III.G5- Completed Forest Estates Green Streets Project

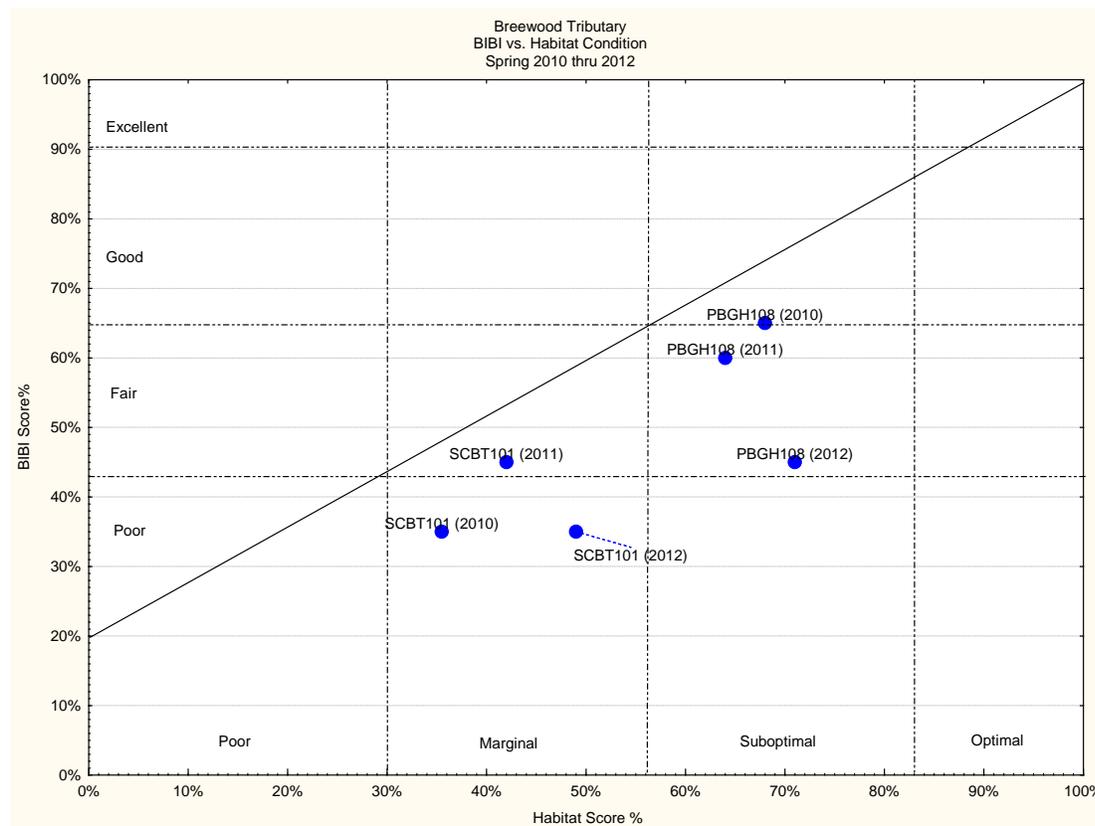
Figure III.H4- BIBI vs. Habitat Condition at Breewood Tributary and Reference Stream, Spring 2010 thru Spring 2012.

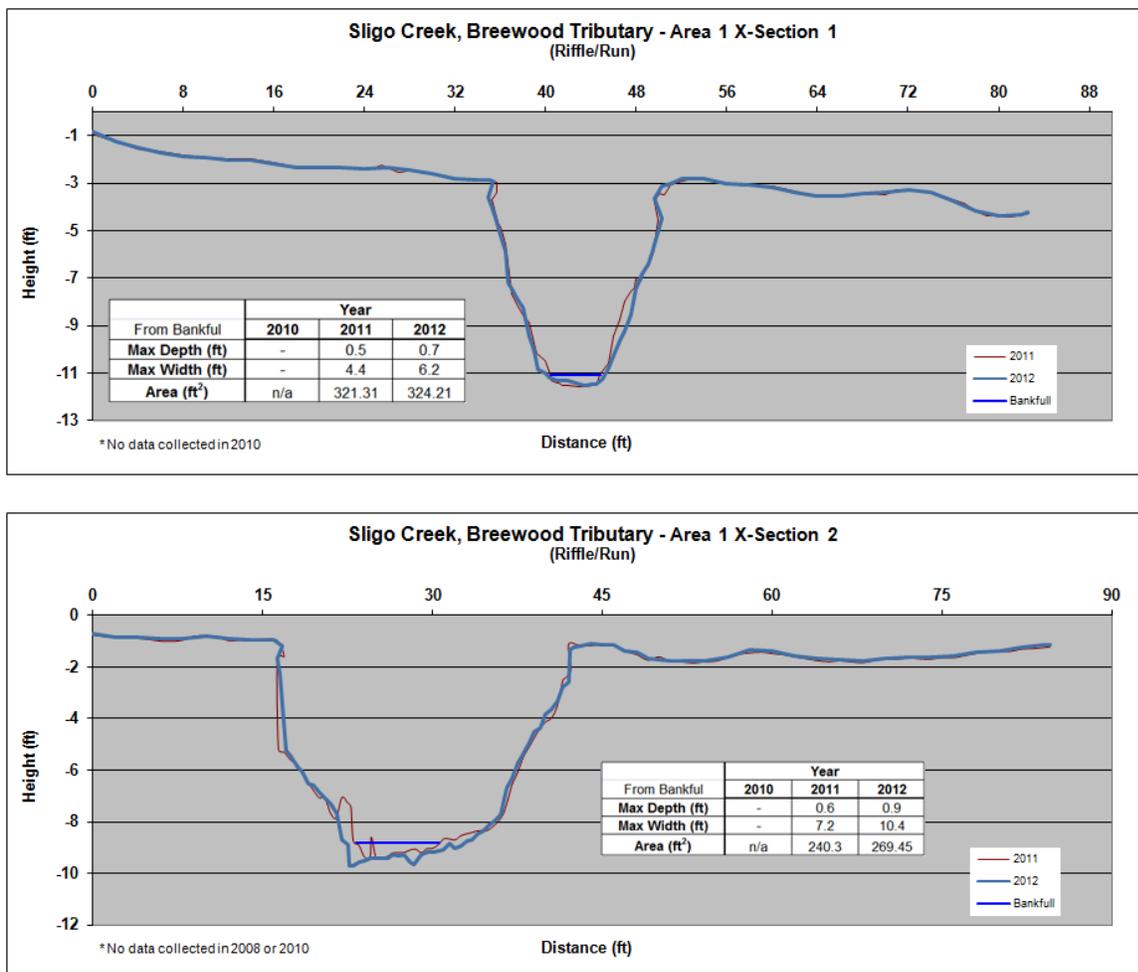
Figure III.H5- Representative Cross Sections From Breewood Tributary, Study Area 1.

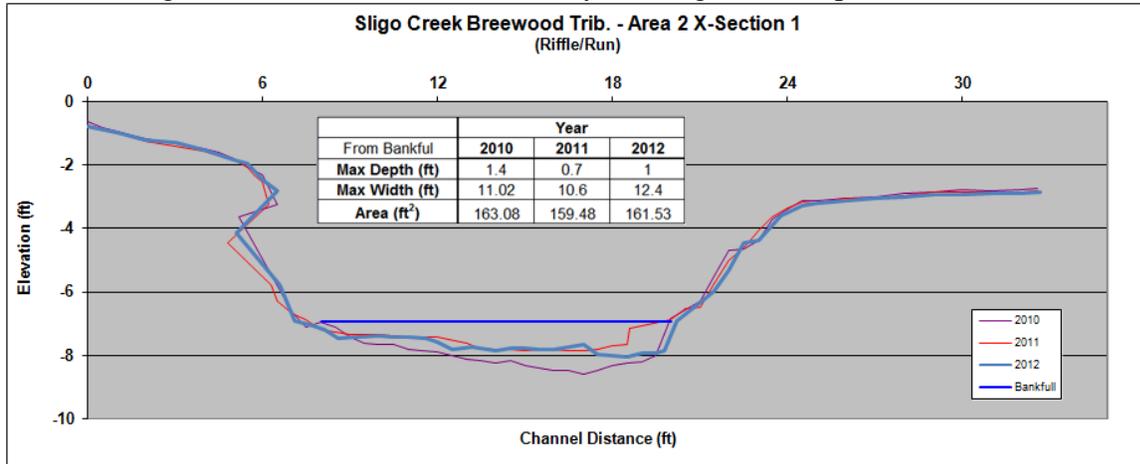
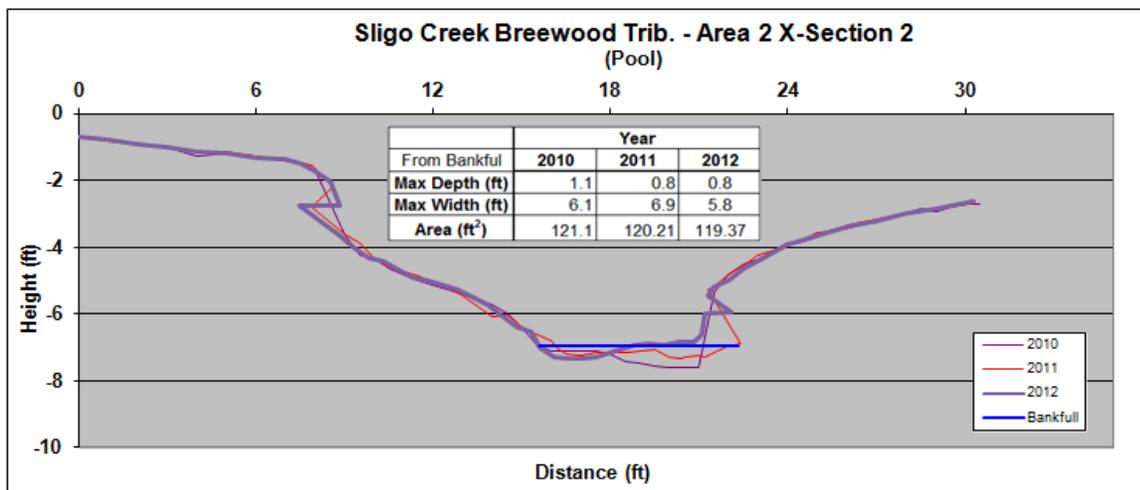
Figure III.H6- Representative Cross Sections From Breewood Tributary, Study Area 2.

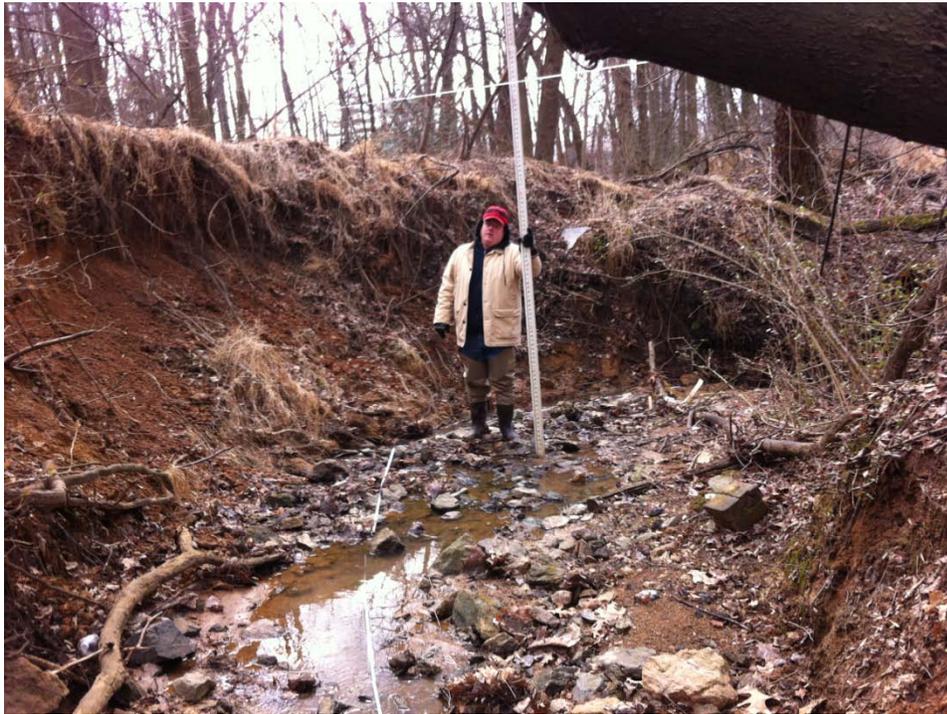
Figure III.H8.-Downstream View of Sligo Creek, Breewood Tributary, Study Area 1- Cross Section 2.

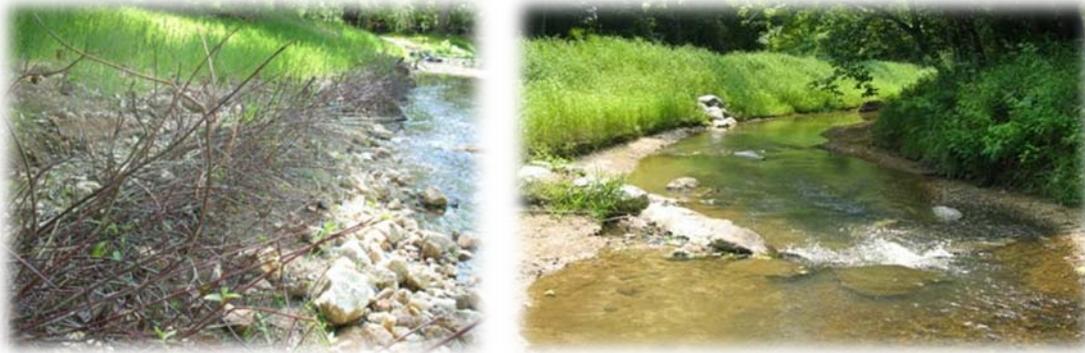
Figure III.H10 – Examples of “Soft” Techniques (Natural Channel Design) With Better Habitat

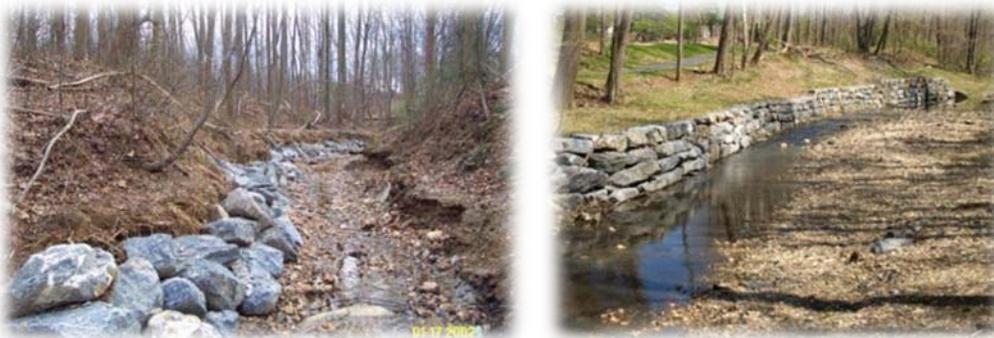
Figure III.H11– Examples of “Hard” Techniques (Armoring) and Poor Habitat

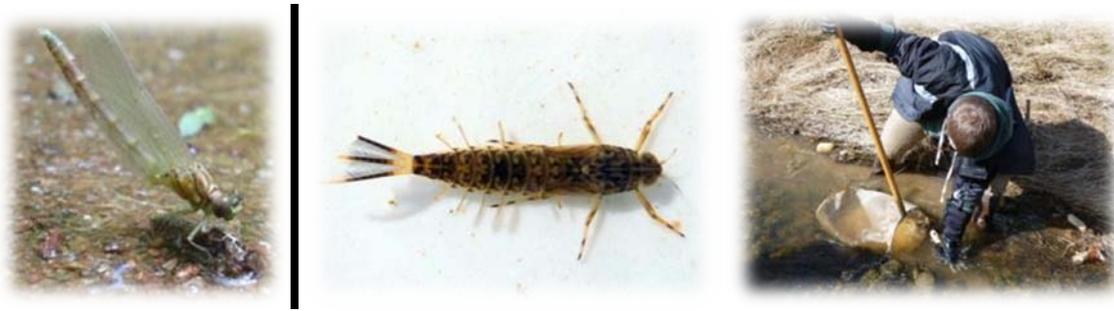
Almost all projects that aimed to improve aquatic communities had more difficulty improving the benthic macroinvertebrates (38% average success rate) than fish (81% average success rate). Benthic macroinvertebrates (Figure III.H12) predominantly re-colonize aquatically from short distances upstream or over short distances from flying adults. In more urban areas, it is possible there may not be sources for re-colonization close enough to project locations. Benthics also are more sedentary (less mobile) and not able to re-colonize as quickly and easily as fish.

Figure III.H12 – Benthic Macroinvertebrate Monitoring Examples (Left- Dragonfly Nymph Emerging; Middle- Brown Dun Mayfly Nymph (*Ameletus* sp.); Right- Benthic Sampling)

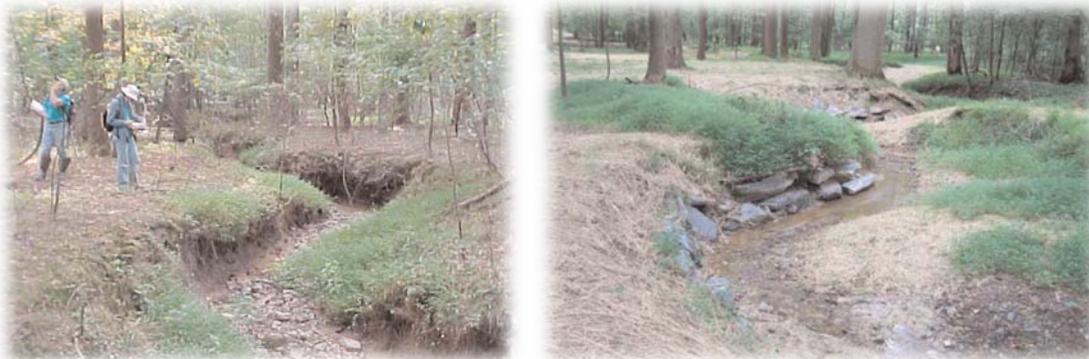
Figure III.H13 – Stream Valley Drive Pre (left) and Post (right) Restoration; Showing Improved Flow and Habitat, but Possibly Not Enough For Diverse Fish Population.

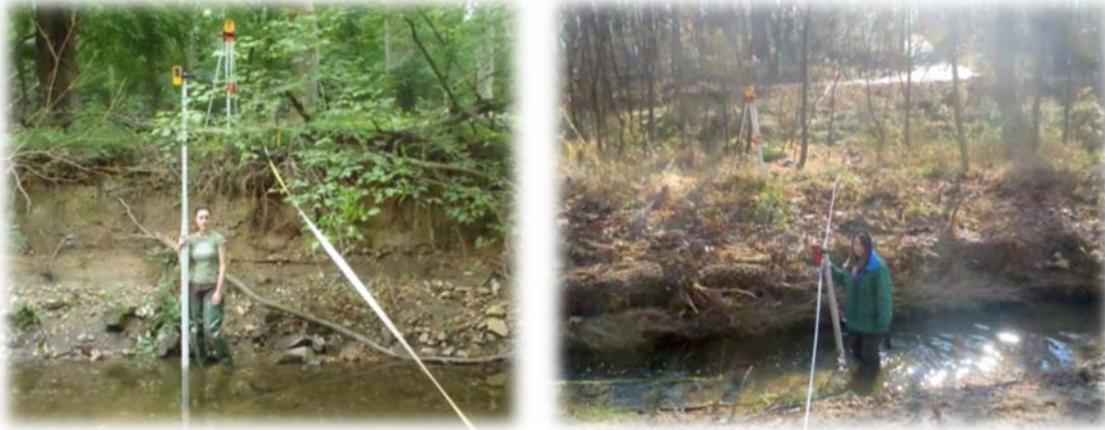
Figure III.H14 – Quantitative Survey of Stream Cross Section Example Before (left) and Example After (right) Restoration

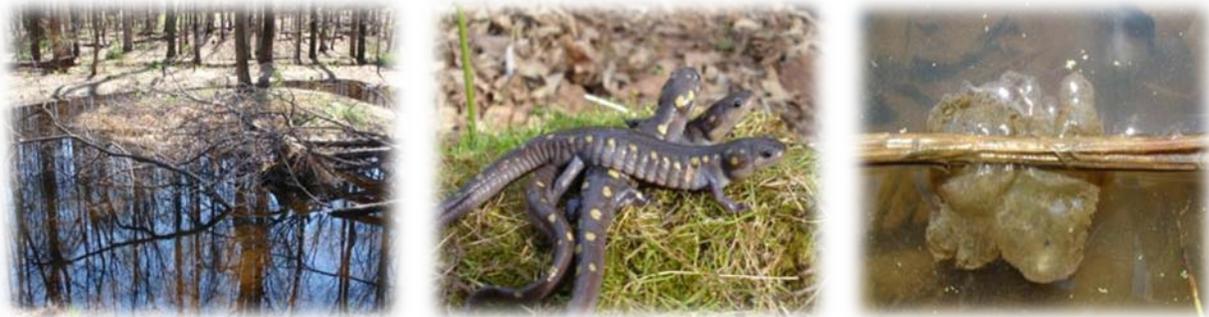
The Stream Valley Drive vernal pool monitoring documented how large tree branches were utilized by spotted salamanders (obligate vernal pool species) to attach their egg masses to (*Figure III.H15*). These branches were not included in the design plans; they either fell in naturally or were placed unofficially. It is recommended that placing branches for habitat enhancement should become an adopted practice in the design and construction of temporary pools and wetlands.

Figure III.H15 – Stream Valley Drive Constructed Wetland, 2009 (left), Spotted Salamander (Ambystoma maculatum) Adults (middle), and Egg Masses Attached to Tree Branch (right).

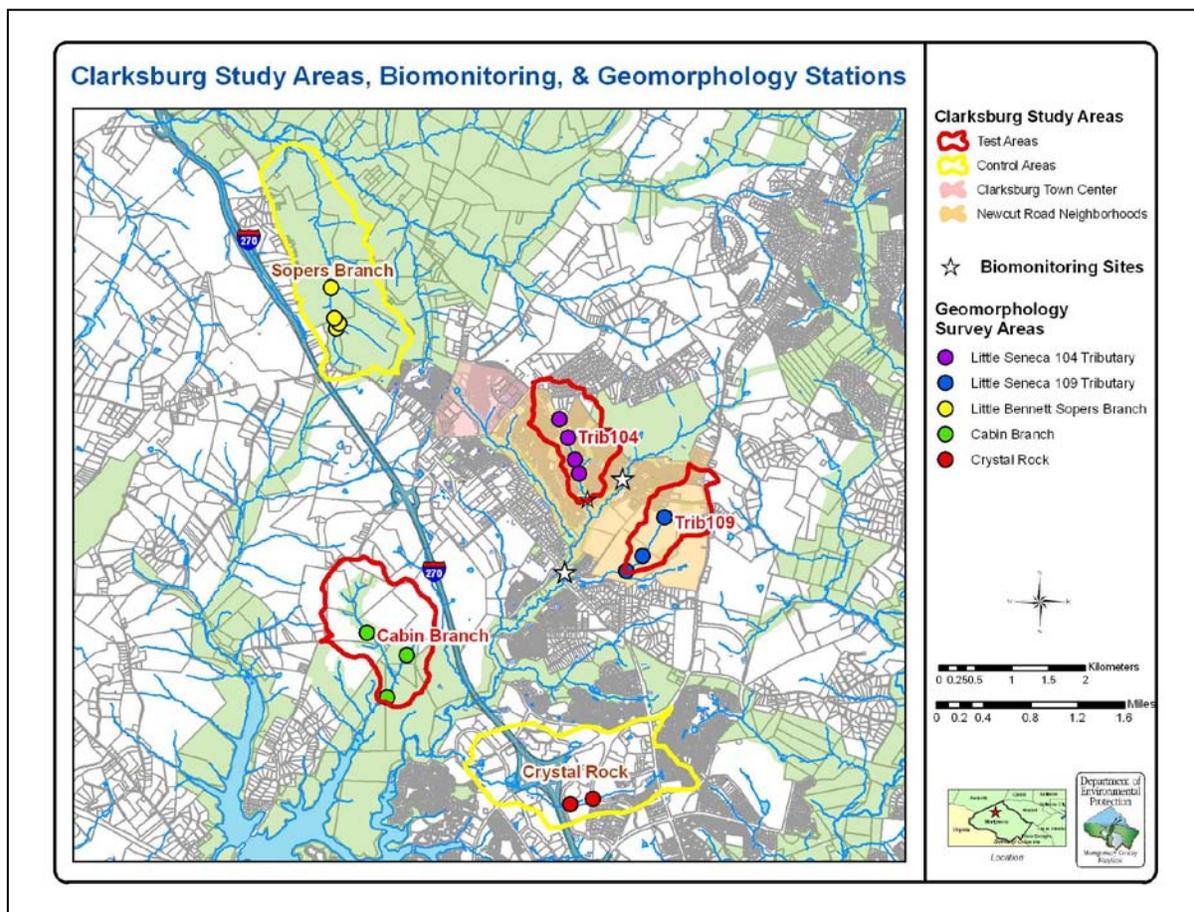
Figure III.H16. Location of the Clarksburg Monitoring Partnership three test areas and two control areas. Also included are biological monitoring stations and geomorphic survey locations.

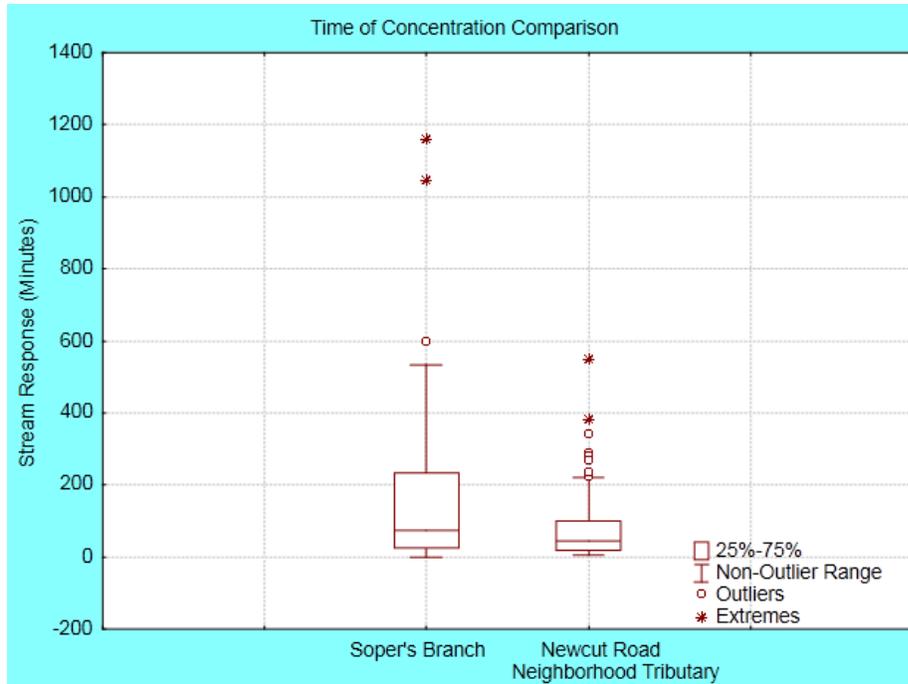
Figure III.H17- Comparison of Time of Concentration (TOC) at the control area (LSLB101) stream gage and at the test area (LSLS104) stream gage for rainfall greater than 1/2" in 24 hours.

The natural hydrology of the test area has been altered dramatically by the development process. On average, the overall amount of precipitation infiltrating into the ground or lost via evapotranspiration has steadily declined in the test area while remaining fairly constant in the

control area. The construction phase of development has impacted the test area channel morphology due to channel straightening, down-cutting, and enlargement. The ability of SWM BMPs to mimic pre-construction hydrologic conditions will be evaluated once the construction process has been completed and the SWM BMPs are on-line.

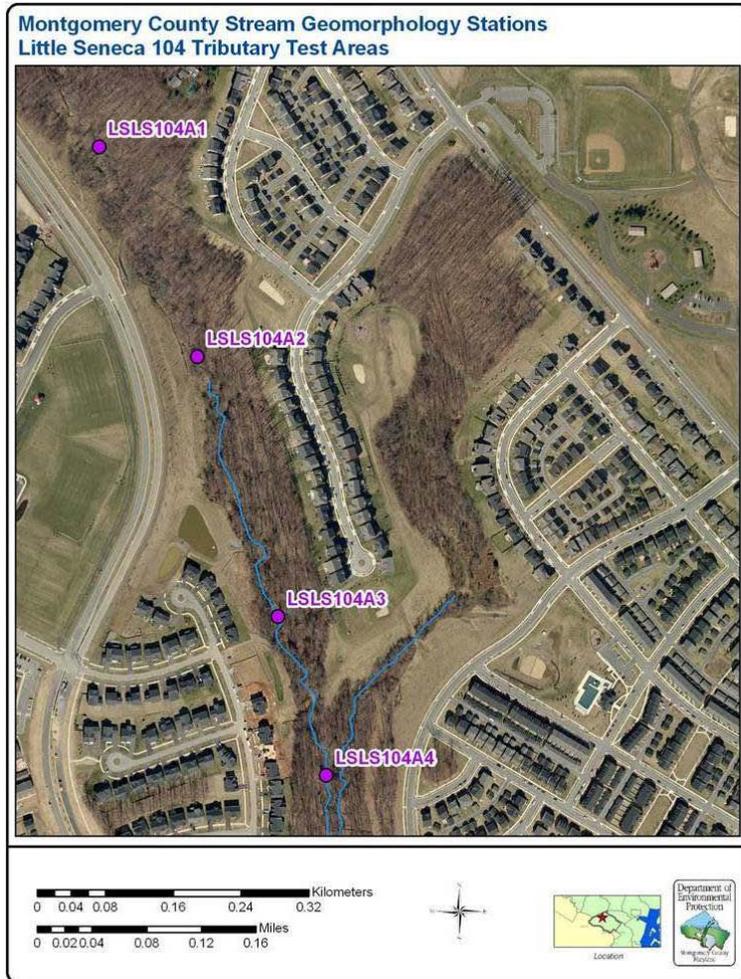
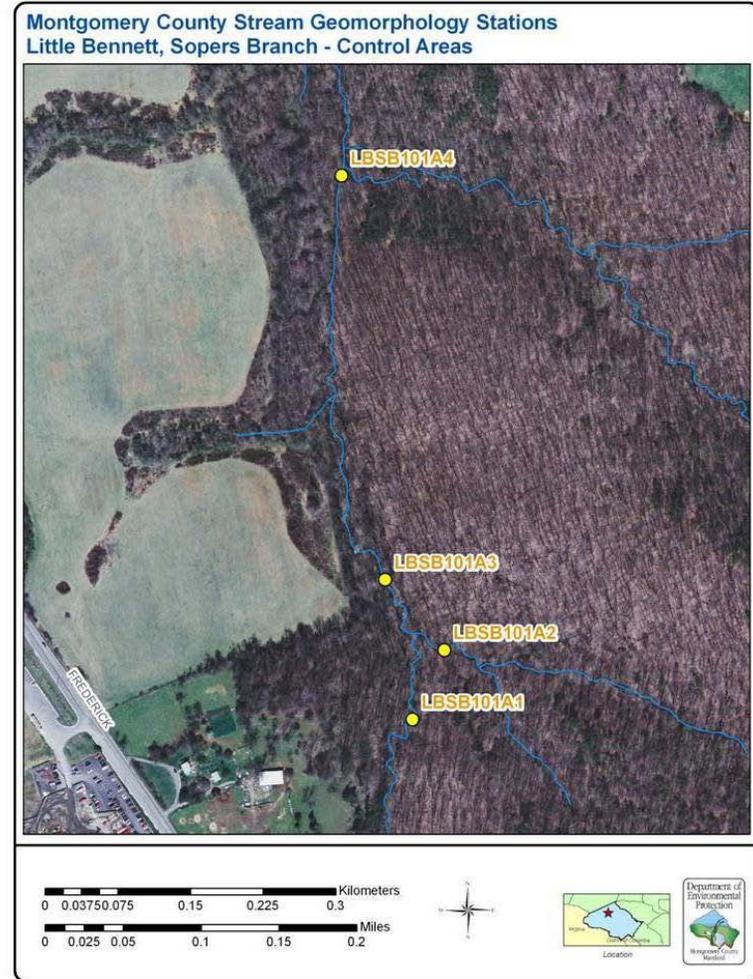
Figure III.H18-Geomorphology Survey Locations: Test Area (A), Control Area (B)
