Annual Report for FY13

NPDES Municipal Separate Storm Sewer System Permit

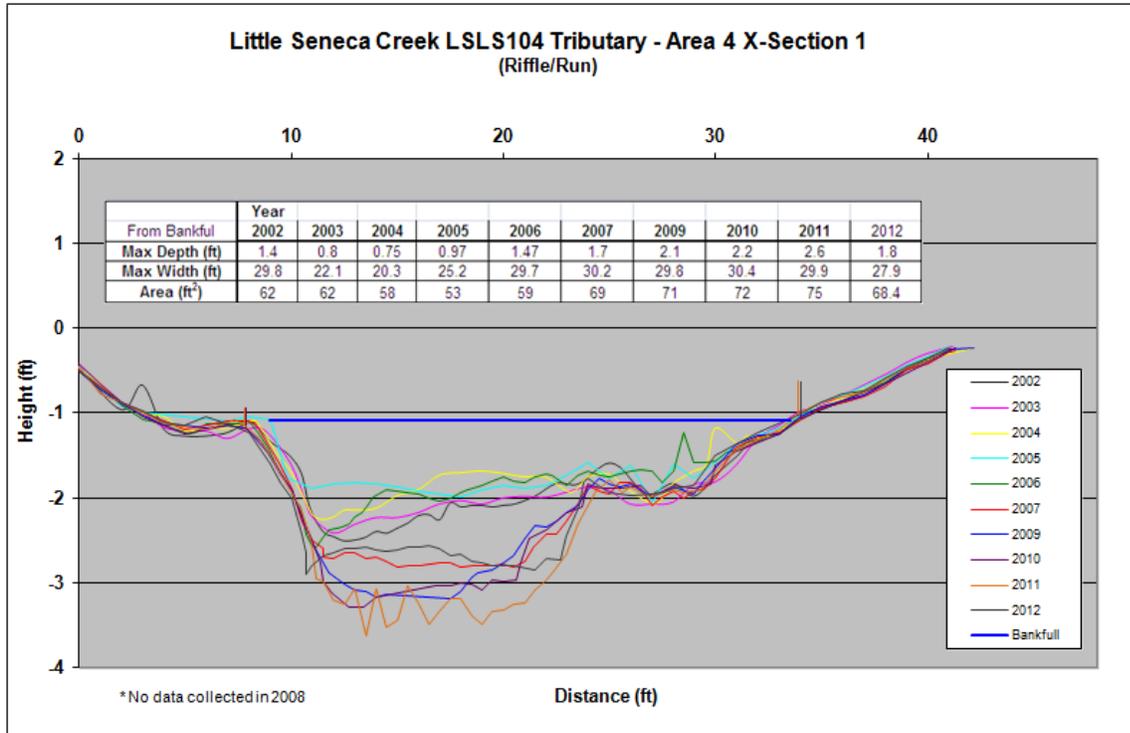
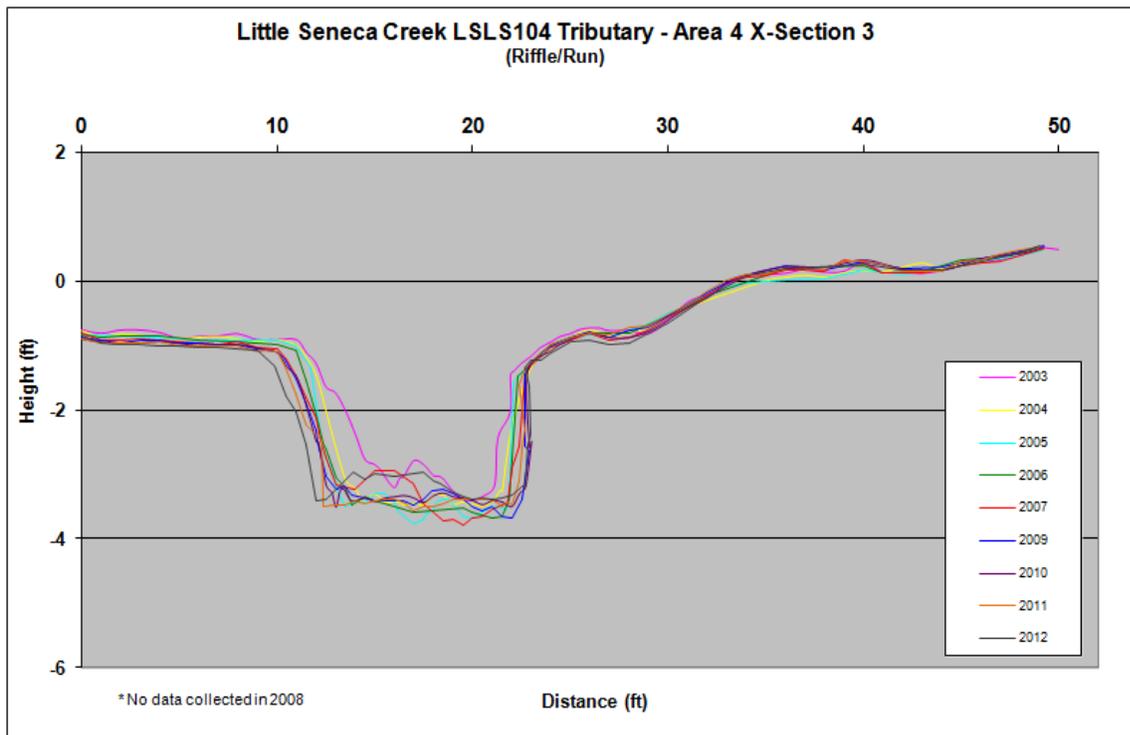
Figure III.H19- Representative cross sections from the test area (LSLS104), cross section location 4 (most downstream location). Cross sections are both measured in riffle/run features.

control area. The construction phase of development has impacted the test area channel morphology due to channel straightening, down-cutting, and enlargement. The ability of SWM BMPs to mimic pre-construction hydrologic conditions will be evaluated once the construction process has been completed and the SWM BMPs are on-line.

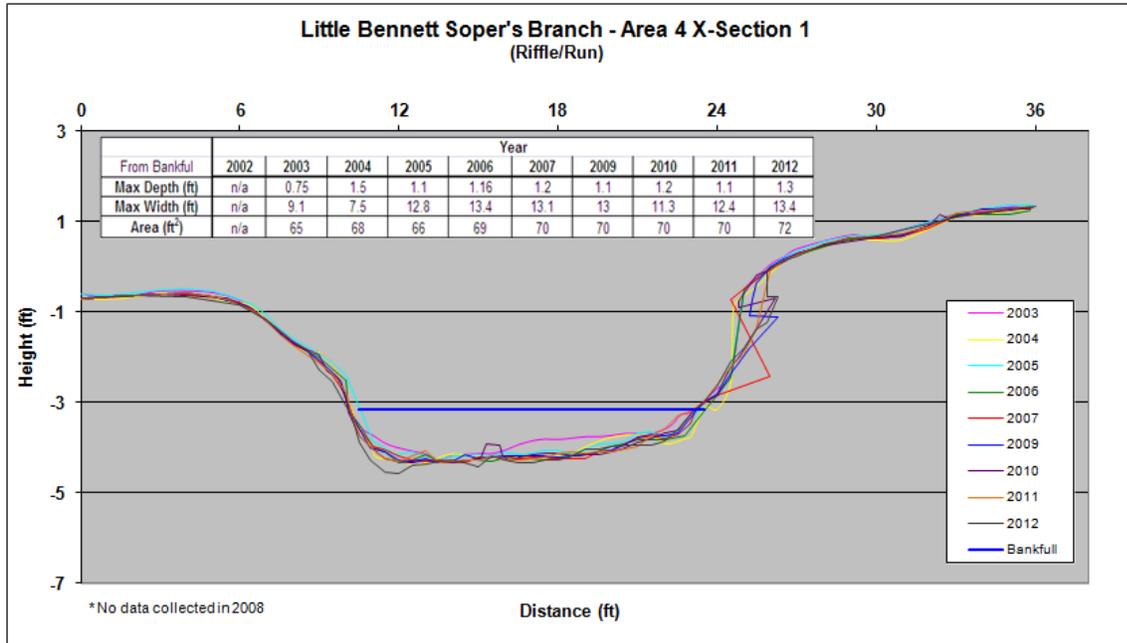
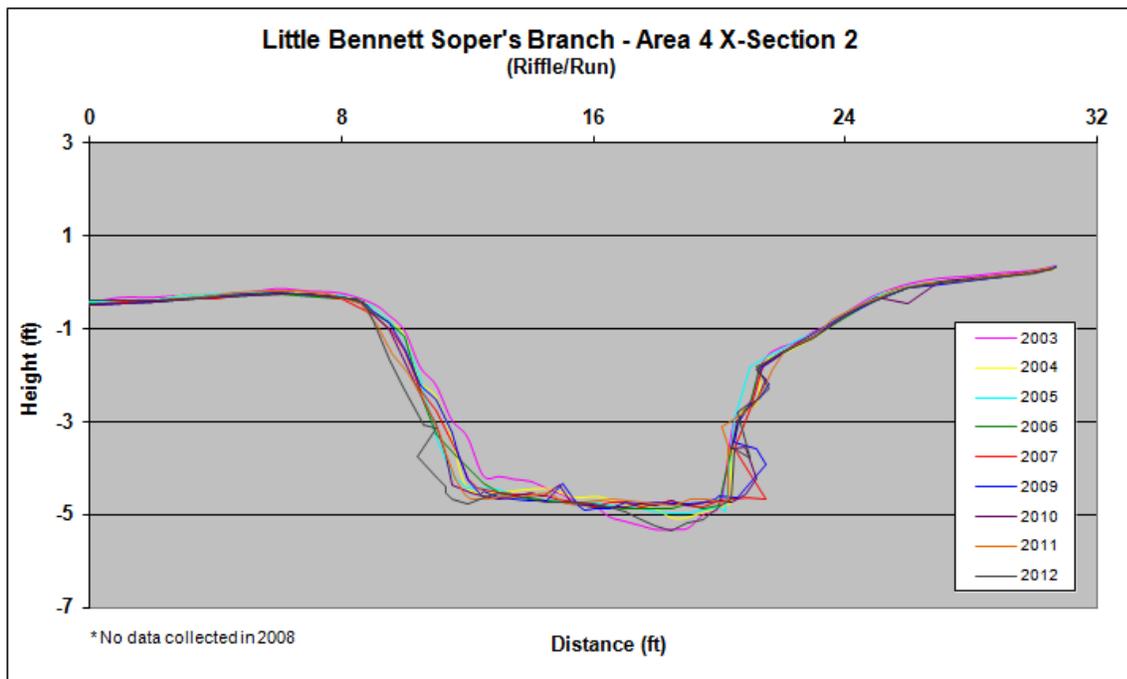
Figure III.H20-Representative cross sections from the control area, cross section location 4 (most downstream location). Cross sections both measured in riffle/run features.

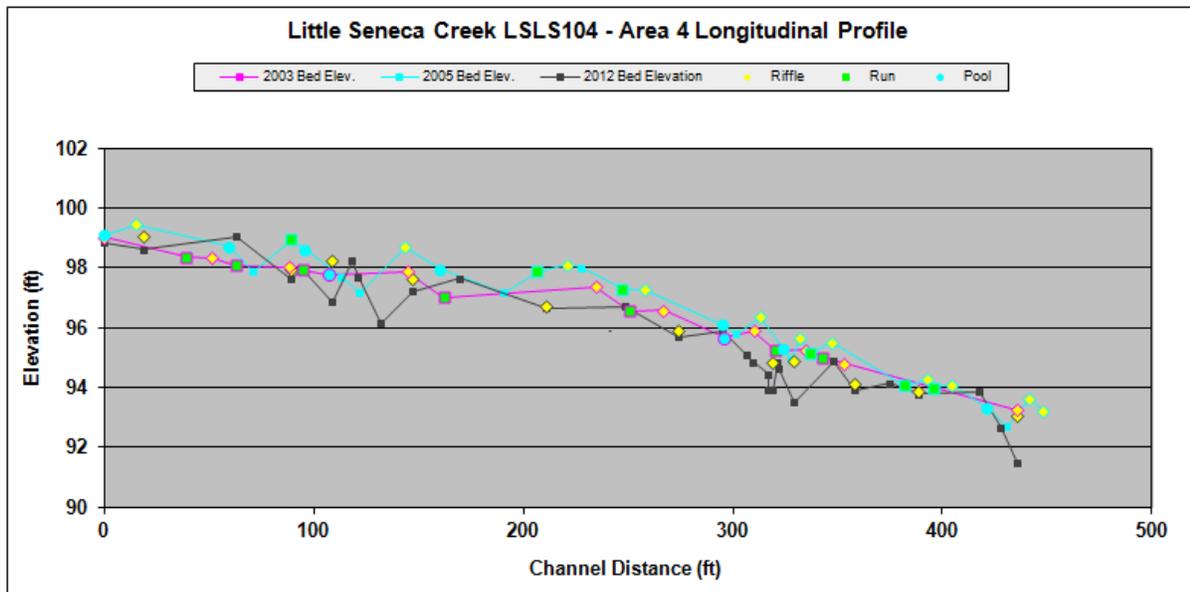
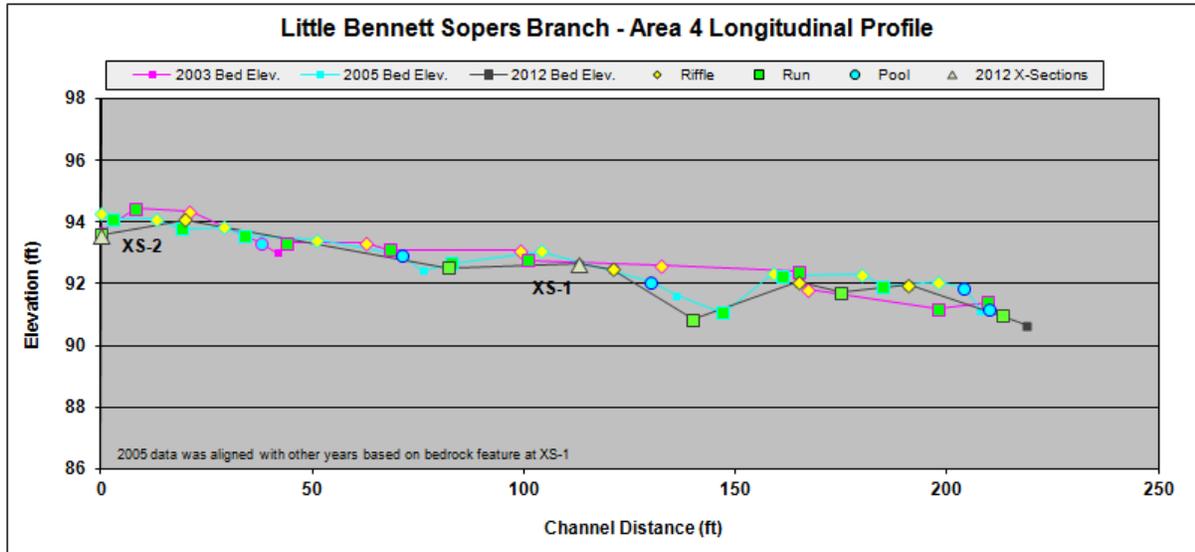
Figure III.H21. Longitudinal Profiles Test Area (LSLS104) and Sopers Branch Control, Study Area Location 4 (Most Downstream Location).
