Annual Report for 2007-2009 NPDES Municipal Separate Storm Sewer System Permit

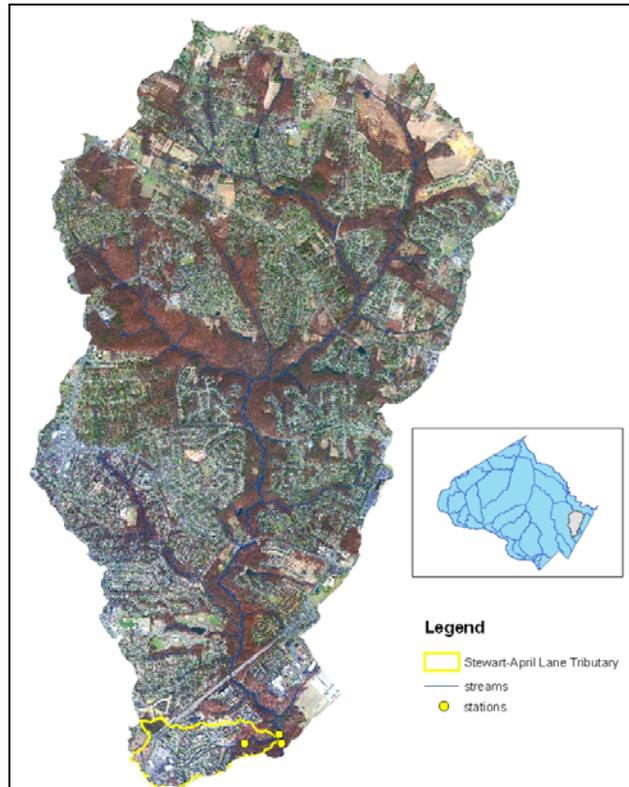
Figure III-D1. Location of the Monitoring Stations on the Stewart-April Lane Tributary and the Paint Branch Mainstem

From 2002 through 2008 the County conducted permit-required monitoring at one outfall and one mainstem station in the Lower Paint Branch Watershed. Stations were located on the Stewart-April Lane Tributary (Tributary) and Paint Branch, below the confluence with the Tributary (Figure III-D1). Drainage area characteristics are shown in Table III-D1. Field teams collected continuous flow data and baseflow water chemistry samples monthly and automated storm samples at a target rate of three events per quarter. Availability of candidate storms, success rate in capturing storms, and other factors influenced the number of storms captured in a given year. Precipitation data was collected in the same watershed at the WSSC laboratory on Tech Road approximately two miles from the stream stations.

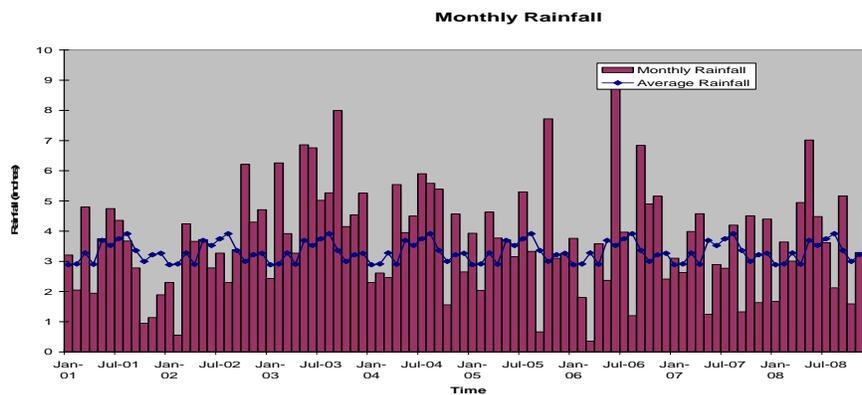
Precipitation patterns in Maryland during 2001 through 2008 varied widely from year to year and from season to season (Figure III-D2). Average annual precipitation over this eight-year period was about 5% above normal. This period began with two below-normal rainfall years in 2001 and 2002, including an extended drought from spring 2001 to October 2002, resulting in record low discharges in the Potomac River and other area waterways. In contrast, the record high precipitation during 2003 produced record high discharges in these same water bodies. Rainfall during October 2005 was over four inches higher than normal due to the contribution by remnants of Tropical Storm Tammy. Rainfall during 2006 was generally below normal until June, when the monthly total was augmented by a persistent wet weather pattern during the final week caused by a stationary front. High flows during this time caused substantial, visually apparent changes (e.g., bank and bottom scour) in the stream channels at both monitoring sites. Fall 2006 was also marked by above-average rainfall. Drought conditions generally prevailed from May 2007 until the end of 2007, leading to a total annual rainfall of approximately 5.5 inches less than the normal 42 inches of precipitation. During 2008, rainfall was generally above normal, especially during the spring months, when rainfall was a total of 46% higher than normal.

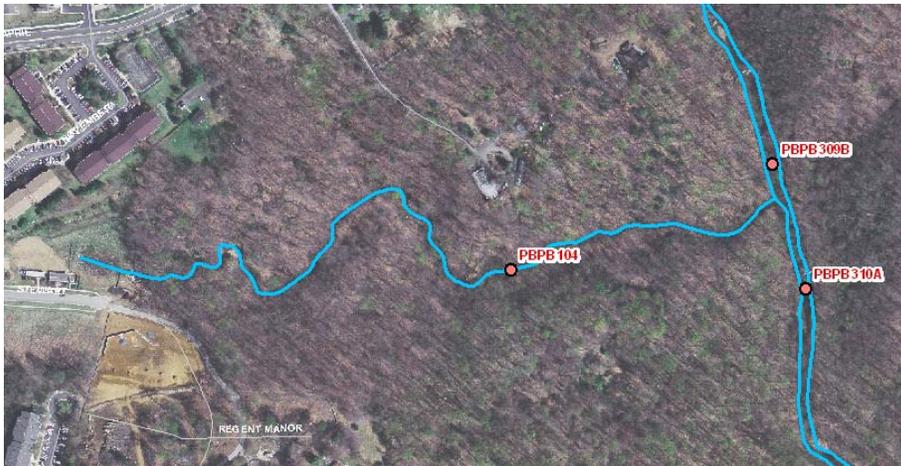
Figure III-D3. Location of DEP Monitoring Locations for Stewart-April Lane Tributary.

DEP has three monitoring stations associated with the Stewart-April Lane tributary (Fig. III-D3).

1. PBPB104 – on the tributary;
2. PBPB309B – upstream of tributary on the Paint Branch mainstem; and
3. PBPB310A – downstream of tributary on the Paint Branch mainstem.

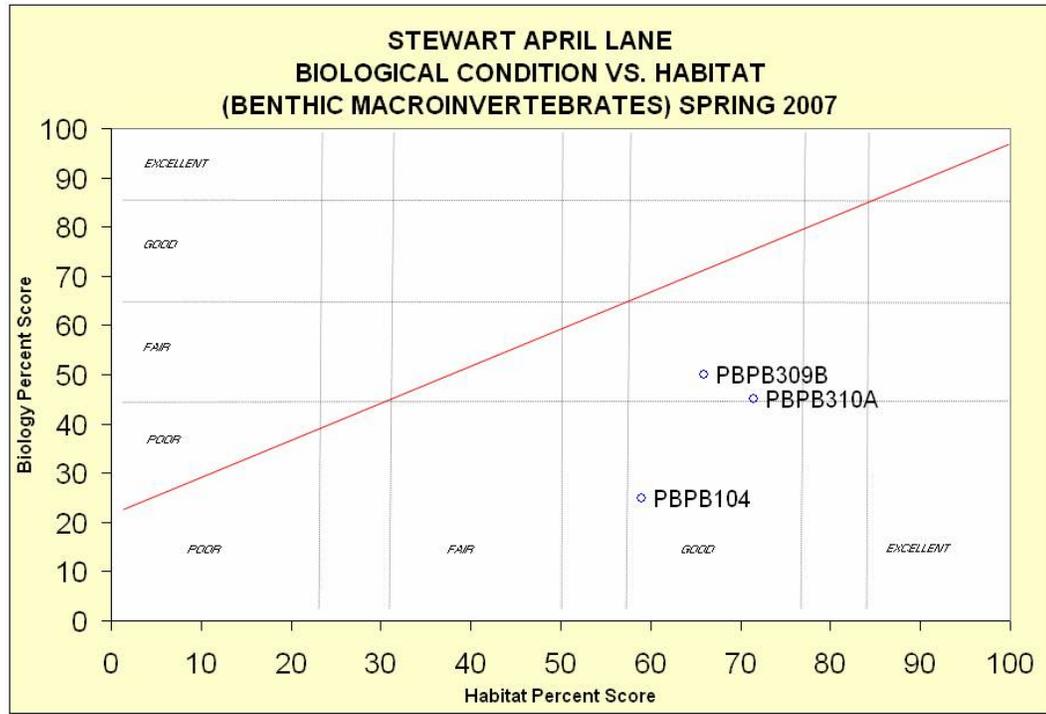
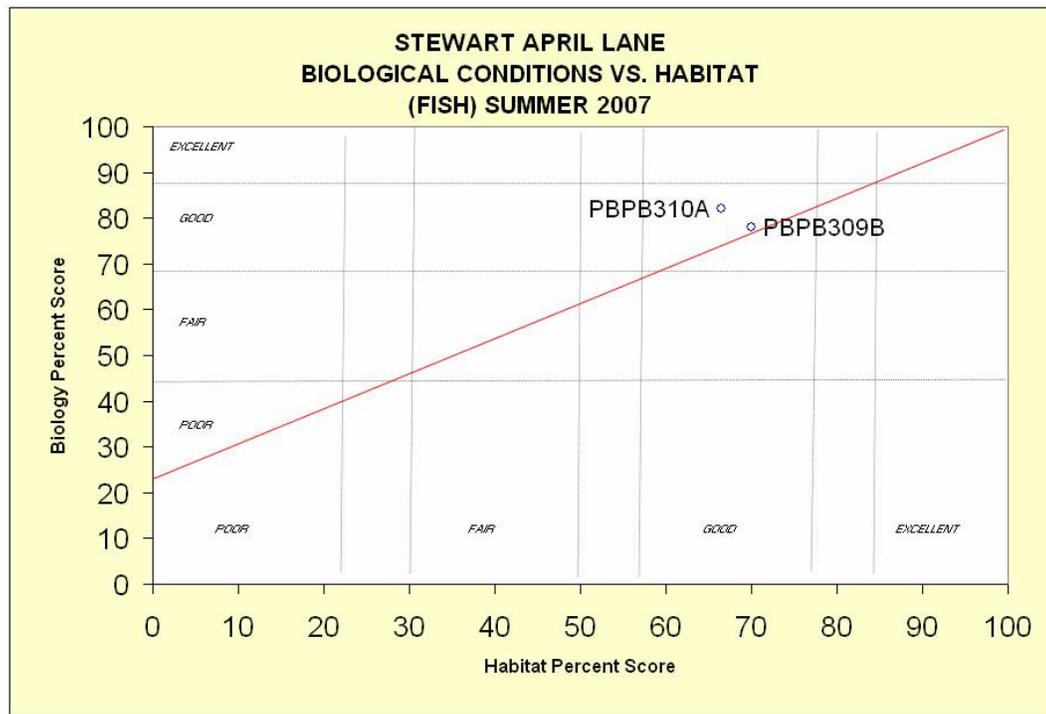
Figure III-D4 Term Discharge Characterization Biology and Habitat Conditions in 2007. Line shows expected direct correspondence between biological and habitat conditions.

Figures III-D4 and III-D5 graphically compare the 2007 and 2008 (respectively) habitat percent scores with the associated biological percent scores for both benthics and fish. Biological communities (benthics and fish) can be degraded by impaired habitat and sometimes by impaired water quality from possible point source pollution. If the station is plotted on the graph under the red line, it means that the biological community is impaired from other than habitat reasons. This graphical screening allows for further investigation into the water chemistry data collected at the site(s) to determine if there is impairment in any particular chemical parameter. According to the graphs, benthics at all sites for both years are impaired despite the habitat being *good*, indicating possible point source impacts to water quality. The mainstem sites sustained high quality (*good* or *excellent*) fish communities in 2007 and 2008. It is possible that fish, being more transient, can escape from point source impacts more easily than benthics.

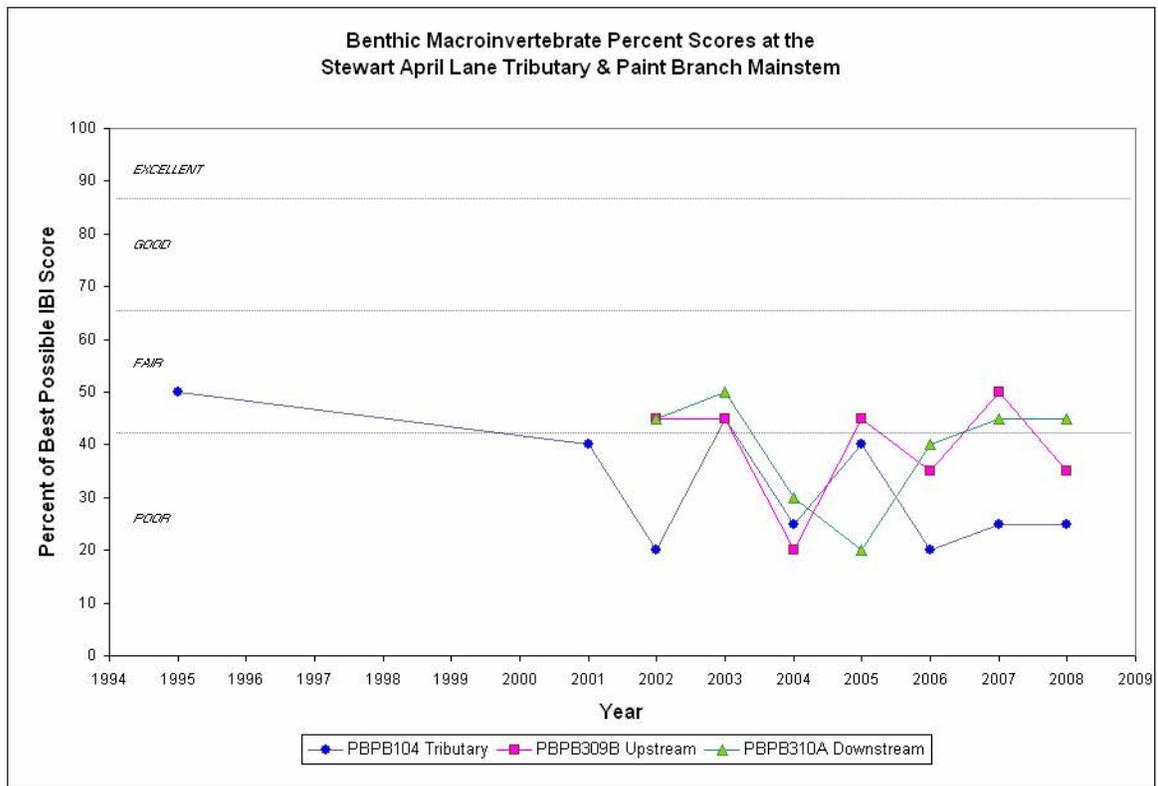
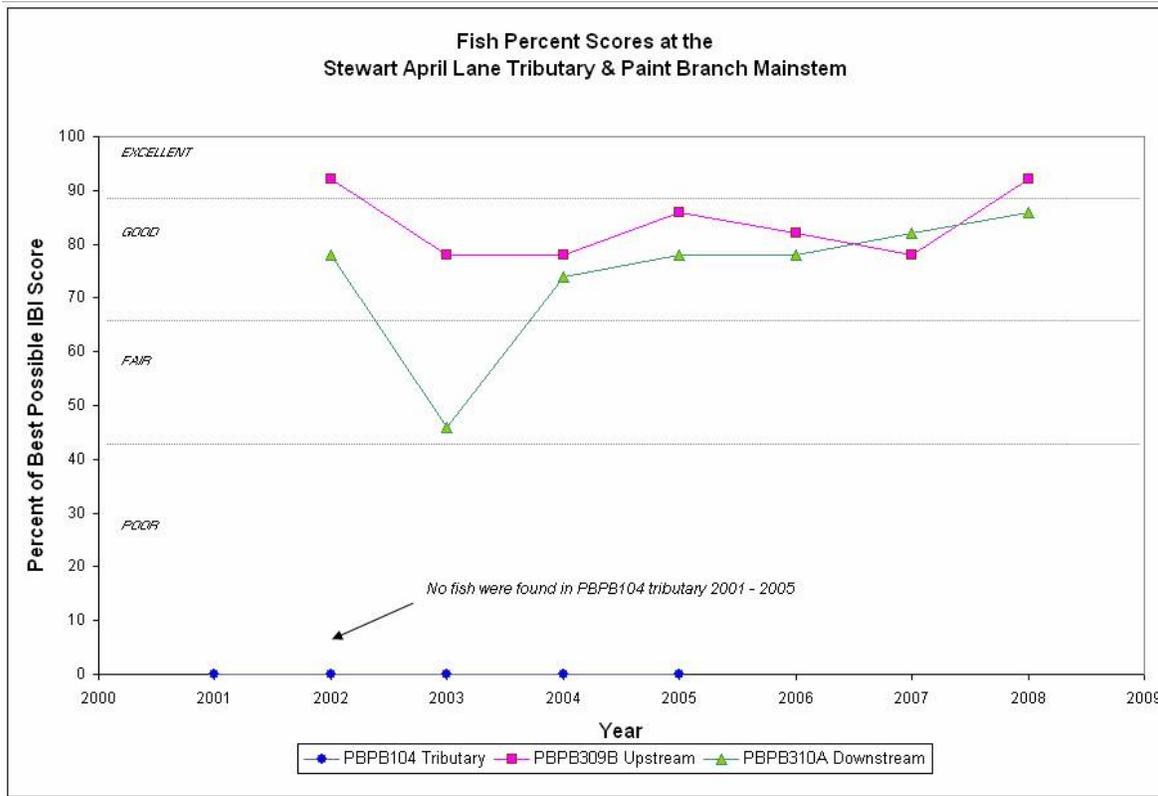
Figure III-D6. Long-Term Discharge Characterization Comparison of Biological Community Over Time.

The biological community scores over time are shown in Figure III-D6. Benthic scores at all three sites have been impaired each monitored year. The PBPB104 tributary has had slightly lower benthic scores than the two mainstem sites (PBPB309B and PBPB310A) for 2006, 2007, and 2008. Fish scores differ drastically from the Stewart April Lane tributary and the Paint Branch mainstem sites. The PBPB104 tributary was monitored for fish from 2001 to 2005 and no fish were found, resulting in *poor* scores. The two mainstem sites have maintained *good* or *excellent* scores, with the exception of 2003 when PBPB310A dropped to *fair*.

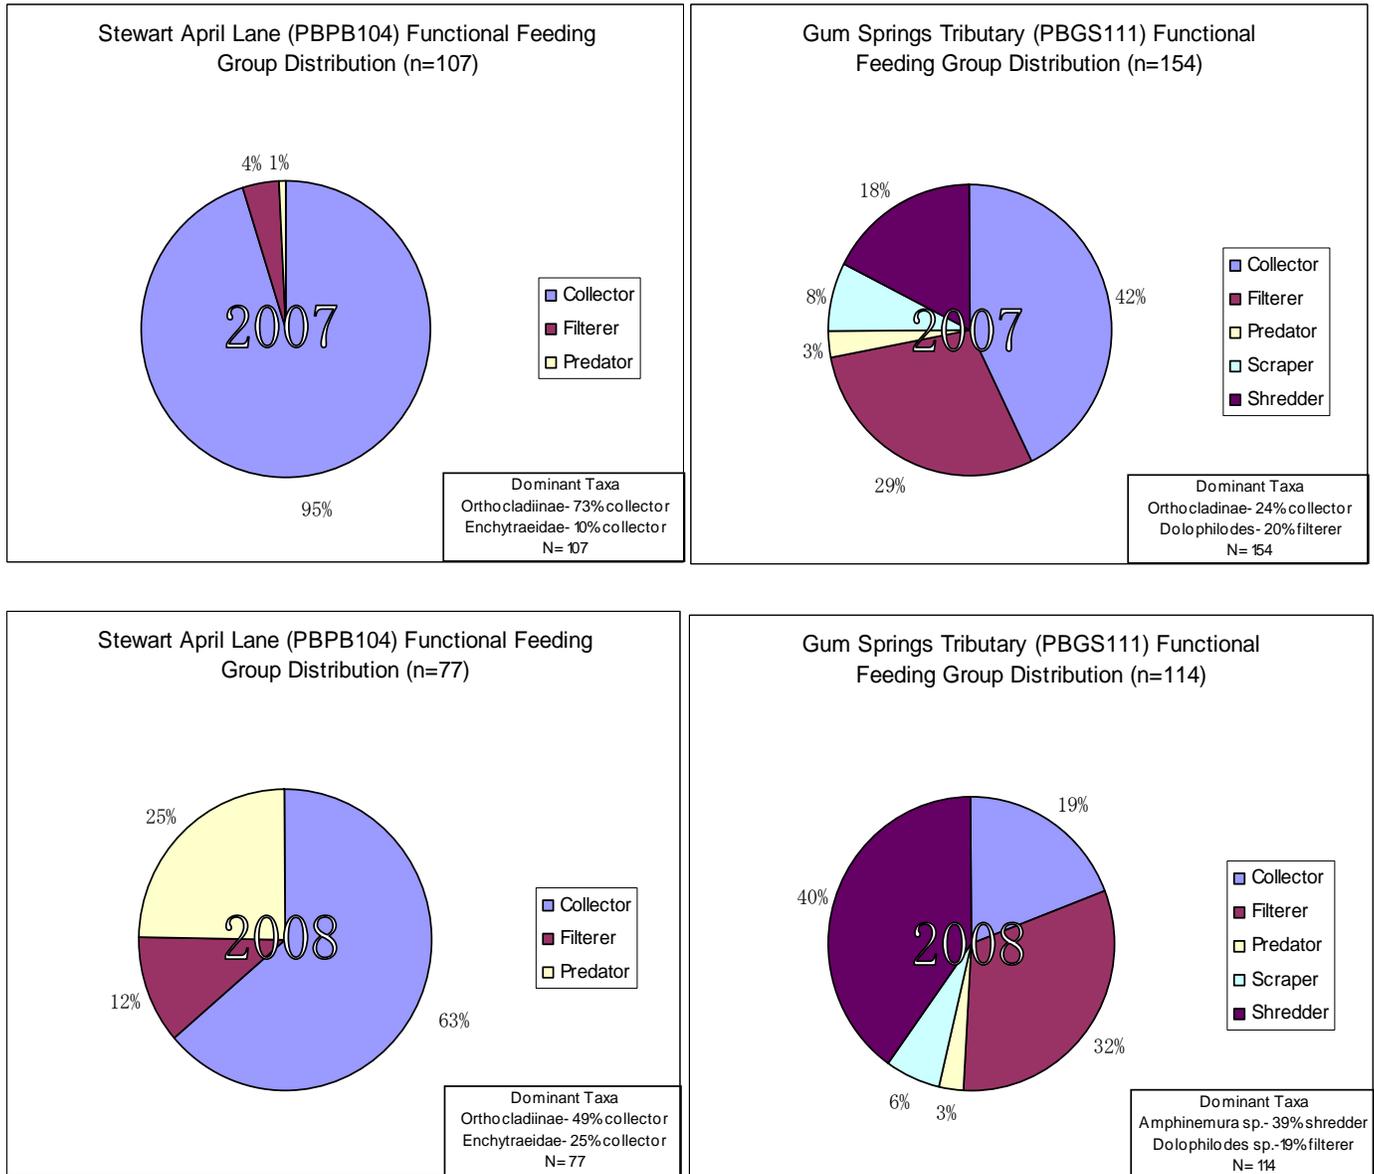
**Figure III-D7. Comparison for 2007 and 2008 by percent functional feeding groups in two first order Paint Branch streams.
 Stewart April Lane Tributary: 39% impervious, Benthic Index of Biological Integrity = poor.
 Gum Springs Tributary: less than 15% impervious, Benthic Index of Biological Integrity = good.**

In 2007, the benthic macroinvertebrate community at PBPB104 was comprised of 95% collectors, 4% filterers, 1% predators, and no shredders or scrapers. In contrast, the PBGS111 station represented 42% collectors, 29% filterers, 3% predators, 18% shredders, and 8% scrapers. The dominant FFGs in small headwater streams are typically shredders and collectors. The shift from sensitive and specialized feeders, such as shredders, to generalist and more tolerant groups, such as collectors and filterers, are characteristic of disturbed streams that have been altered by urbanization processes. PBPB104 and PBGS111 show difference in the dominant taxa and percentages in 2007 and 2008.

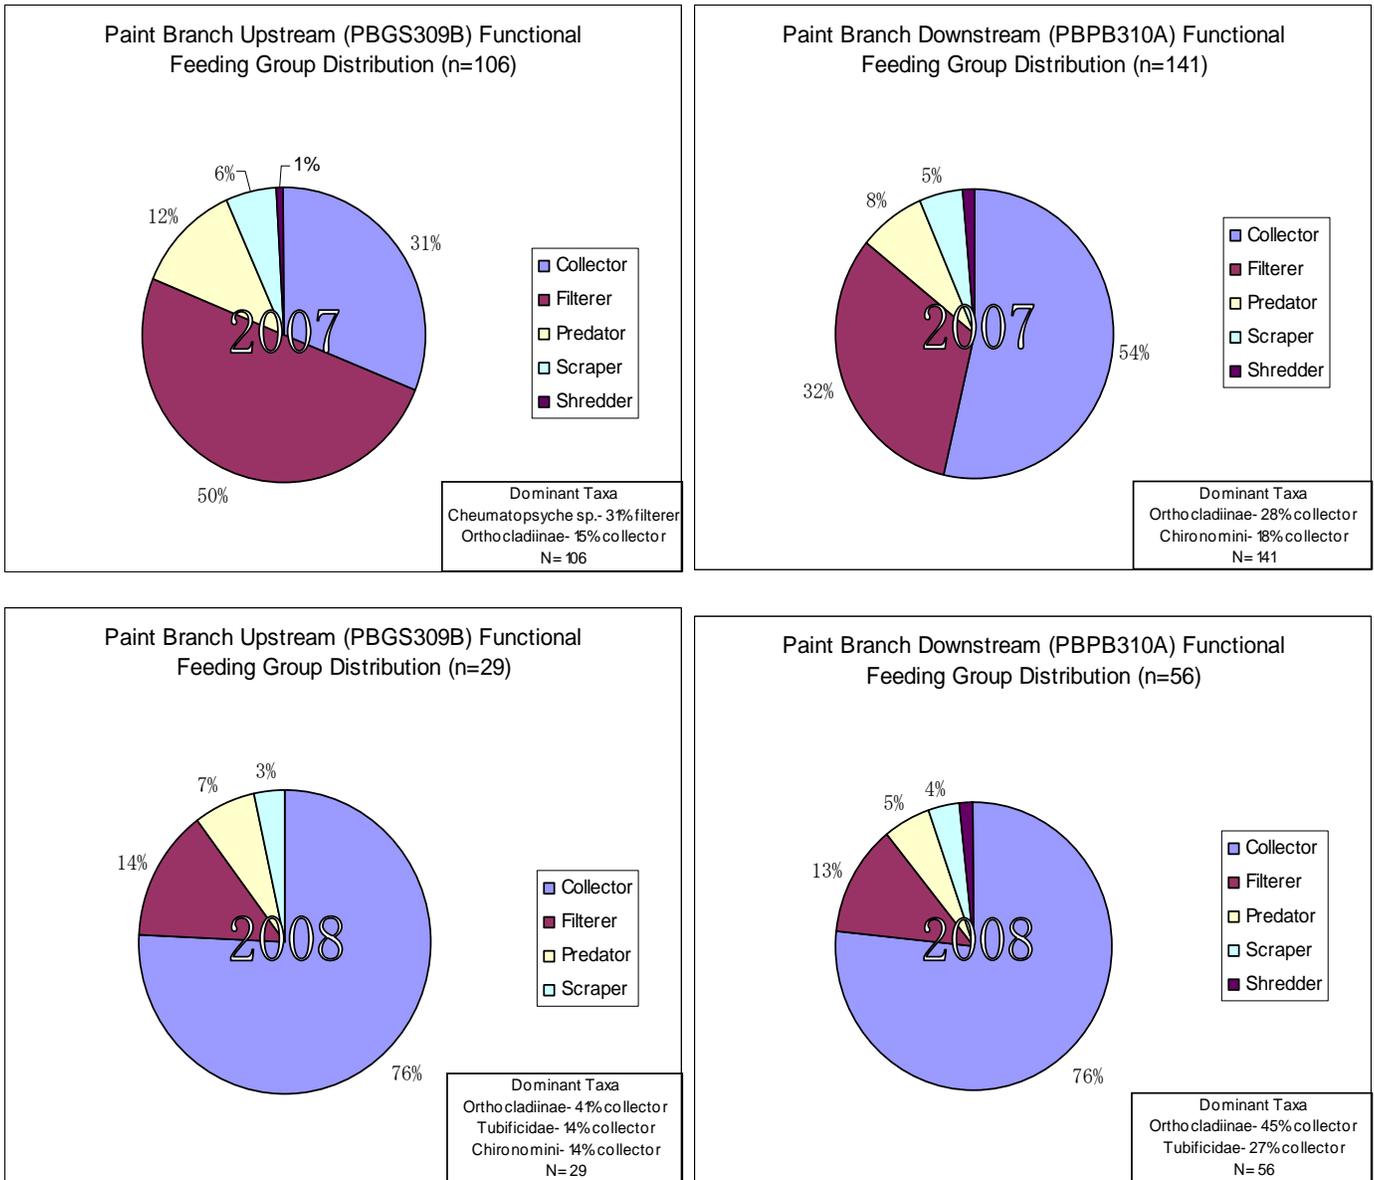
The FFGs diversity at the Paint Branch mainstem stations (PBPB309A and PBPB310B) is shown in Figure III-D8 for both 2007 and 2008. Both sites shifted to having more collectors from 2007 to 2008. The overall FFG composition was as expected for these larger size streams with collectors as the dominant group. Collectors and scrapers tend to be dominant FFGs in higher order streams where food sources are more broken down.

Figure III-D8. Comparison for 2007 and 2008 by percent functional feeding groups in mainstem Paint Branch upstream and downstream of the Stewart-April Lane Tributary. Percent impervious in contributing watershed about 13%. Benthic Index of Biological integrity dropped from fair in 2007 to poor in 2008 at PBPB310A.

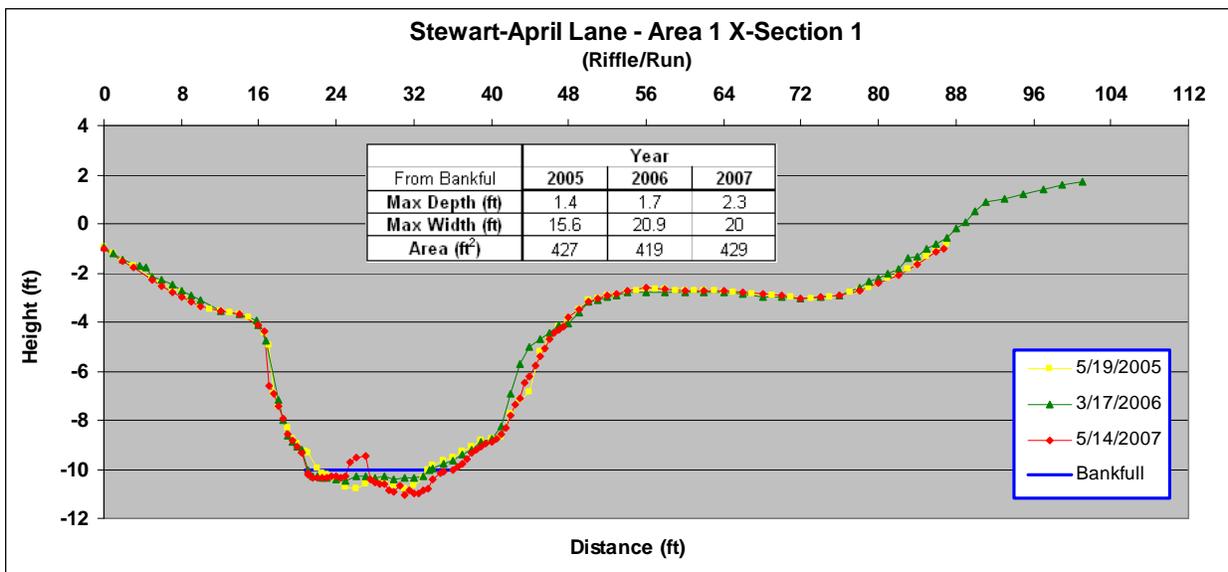
Cross section 1 (Fig. III-D9) shows annual changes to the stream channel both above and below the one and a half year storm mark. The graph indicates that deposition occurred in 2006 and scouring occurred in 2007. A boulder was present in the stream channel in 2007 that had not been recorded in 2006. This is likely a result of the 100 year storm that occurred here in the summer of 2006. This demonstrates that this system is capable of moving large bed particles during significant storm events.

Figure III-D9. Cross section 1 for Stewart-April Lane tributary, Area 1. Cross sections measured in riffle/run features. Drainage Area = 0.33 mi².

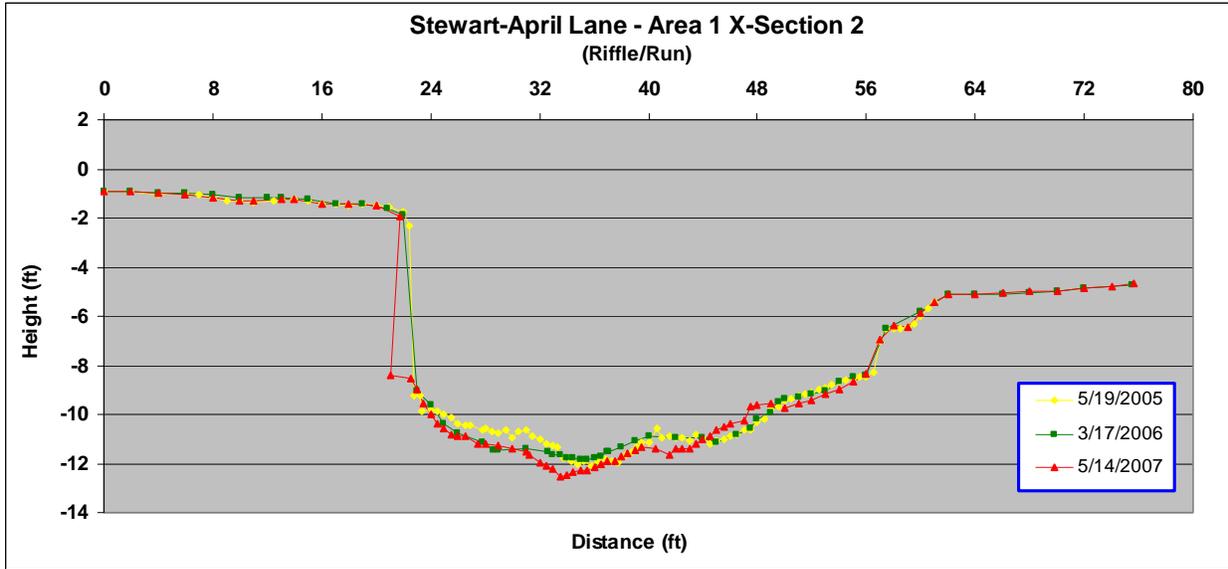
Cross section 2 (Fig. III-D10) also shows that deposition took place in 2006 and scouring took place in 2007 both above and below the one and a half year storm mark. There are indications that a high flow event resulted in approximately 1.5 feet of material being lost from the left bank. Table III-D6 has cross sectional areas for both cross section 1 and 2. The areas show deposition in 2006 (with a decrease in cross-sectional area), and scouring in 2007 (with an increase in cross-sectional area).

Figure III-D10. Cross section 2 for Stewart-April Lane tributary, Area 1. Cross sections measured in Riffle/run features. Drainage Area = 0.33 mi².

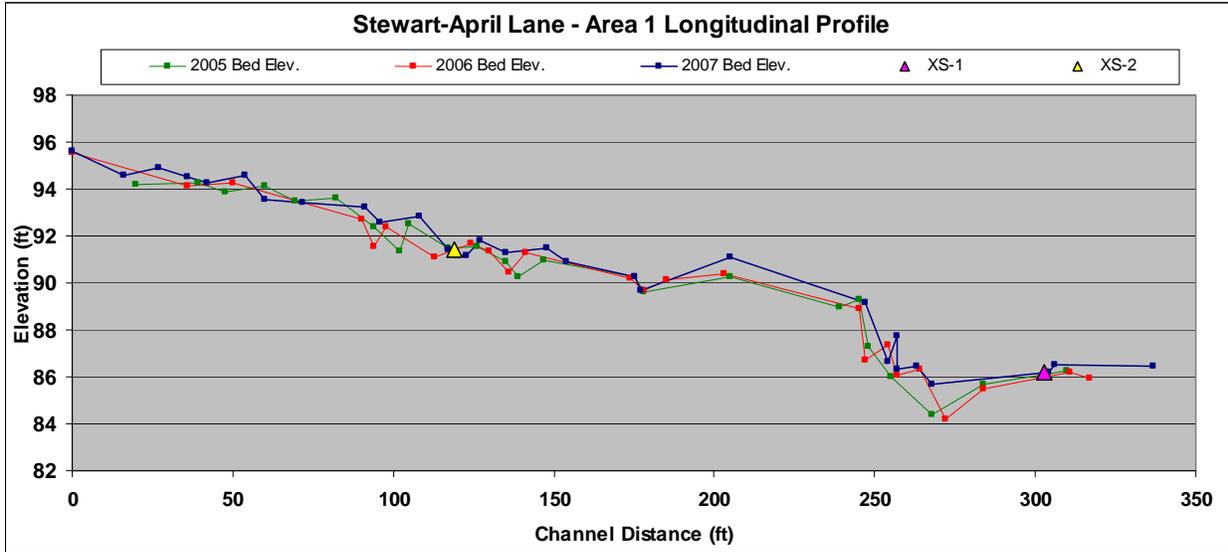
Figure III-D11. Longitudinal profile for Area 1 in the Stewart-April Lane tributary.

The longitudinal profile (Fig. III-D11) shows that in 2007, deposition had taken place at many of the pools and total pool length has increased, compared to previous years. The total longitudinal slope remained fairly constant (Table III-D7). A comparison of slopes of individual features shows an increase in riffle slope, from 2.39% to 7.82% (Table III-D8). Riffles are grade controls; an increase in riffle slope is an indication that the channel is adjusting to the overall increase in channel slope. Sinuosity has also decreased by 17% from 2005 to 2007, demonstrating that the stream has straightened over time in response to high flow volumes (Table III-D7). A pebble count was performed throughout the entire longitudinal reach and proportioned among riffle, run, and pool lengths. The particle sizes are listed in Table III-D9 and the graphed results are shown in Figure III-D12. The tributary is dominated by small particle sizes, with the majority of particles found measuring less than 10 cm in length.

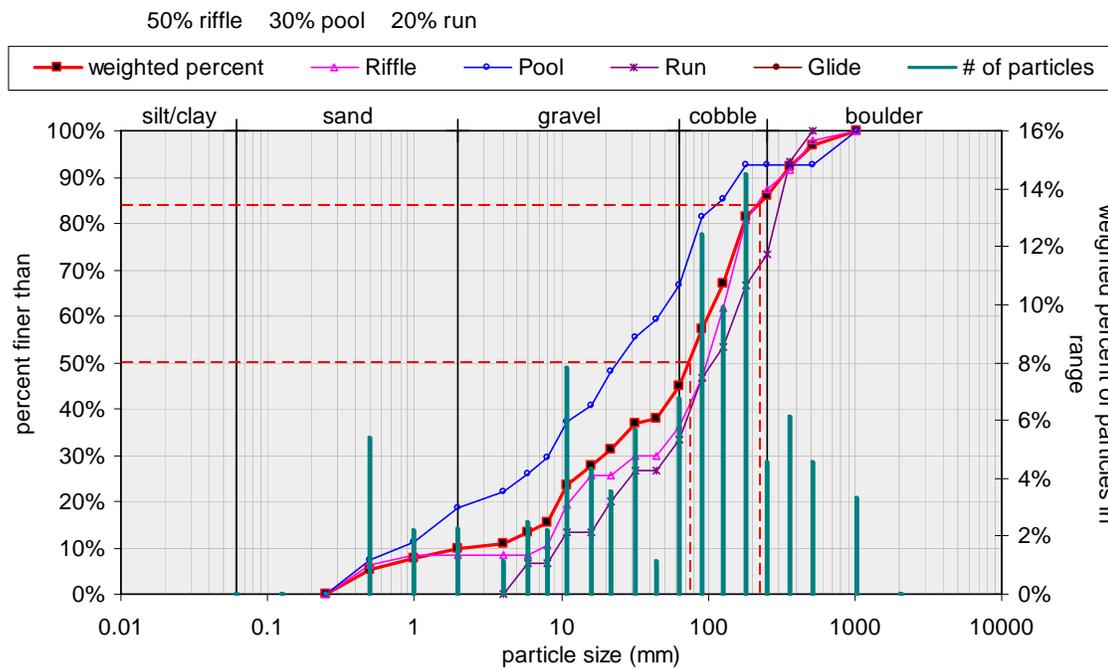
Figure III-D12. Pebble count distributions by bed features for Stewart April Lane tributary.

D50 (mm)			Particle		
	'05	'06	'07	'05	'06	'07
PBPB104	42	38	74	Very Coarse Gravel	Very Coarse Gravel	Small Cobble

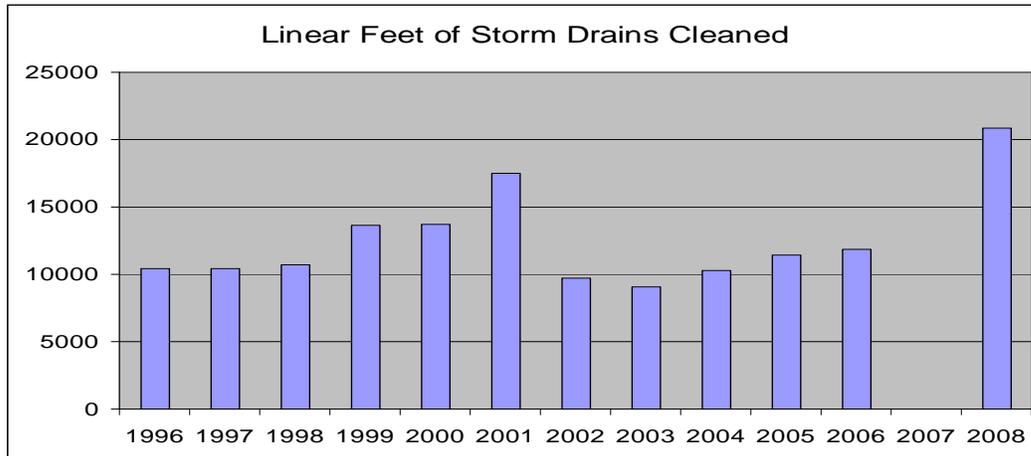
Fig. III-E1 Linear Feet of Storm Drain Cleaned per Year

In 2008 the county cleaned 20,892 linear feet of storm drain which is 76.4% more than the annual average for the years 1996-2006 (11,842). (Fig. III-E1). Material with a weight of 156.69 tons was removed. Storm drains were also cleaned in 2007, but records were lost. There is an estimated 5.72 million total feet of County storm drains. There is no annual schedule for storm drain maintenance, with the countywide program being complaint driven to remove clogged inlets or drainage problems on public or private property. At the current maintenance rate of less than 0.5% of the system per year, it will take 200 years for a first pass of the entire system.

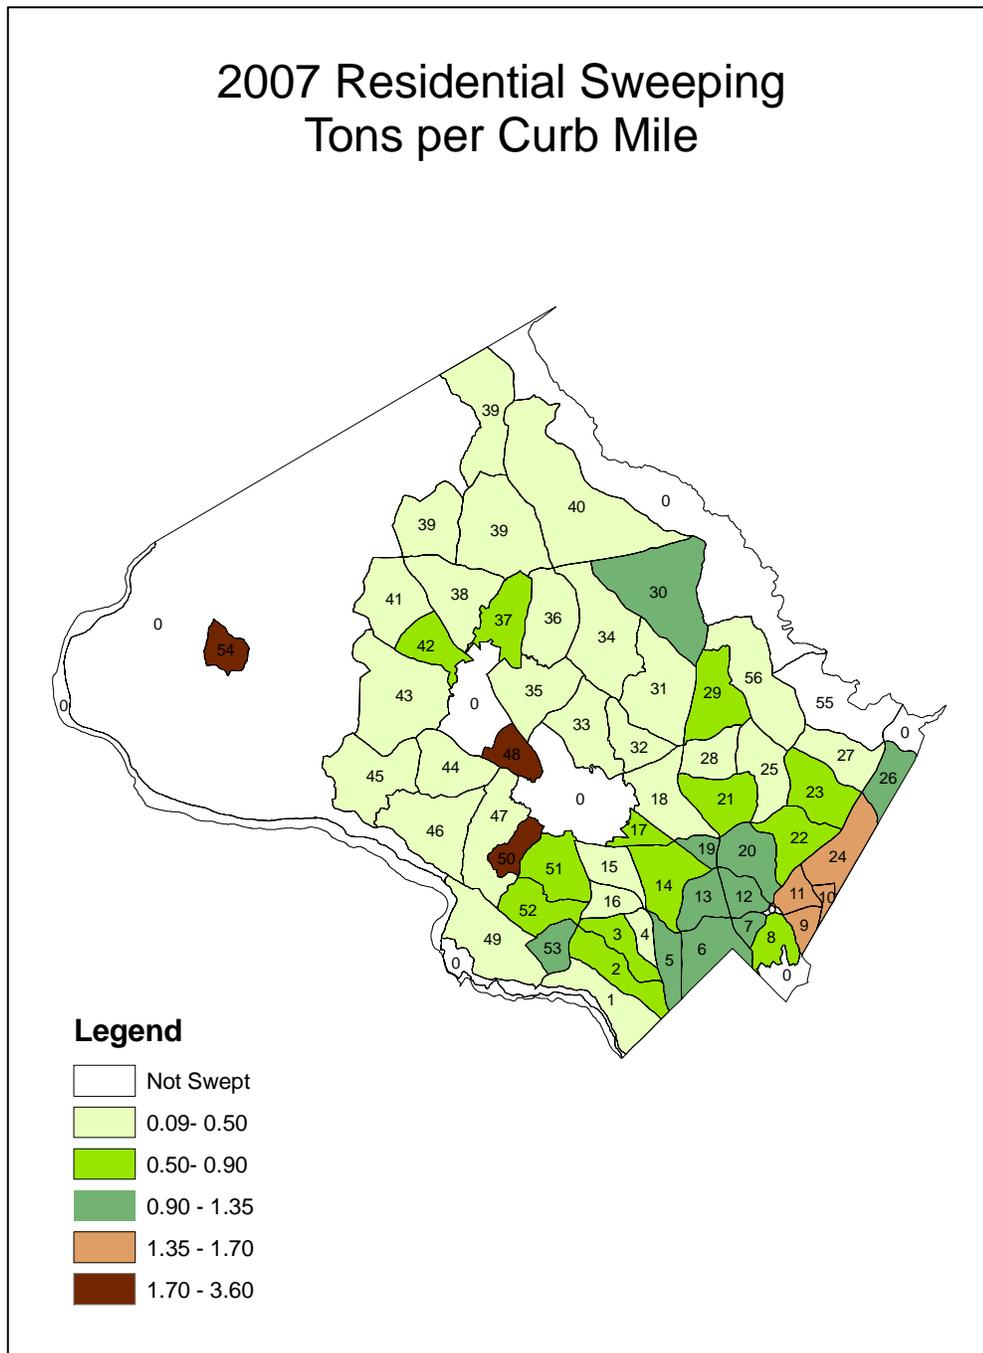
Figure III-E2. 2007 Residential Sweeping Tons Per Curb Mile

Darker coloration on the map indicates greater amounts swept up per curb-mile. Results from 2007 matched prior years with the greatest amount of material removed in the southern part of the county, particularly the Anacostia and Lower Rock Creek watersheds, as well as a district in the western part of the County near Poolesville, one in the County center near Gaithersburg and one near Rockville. The Poolesville values are attributed to the use of grit in addition to sand and salt for de-icing activities in that part of the County. The grit being heavier is presumed to increase the weight of material being collected in the sweeping. The cause of the high removal rates (assumed to reflect application rates) in the routes near Gaithersburg and Rockville remains unknown. Results from 2008 show lower amounts of

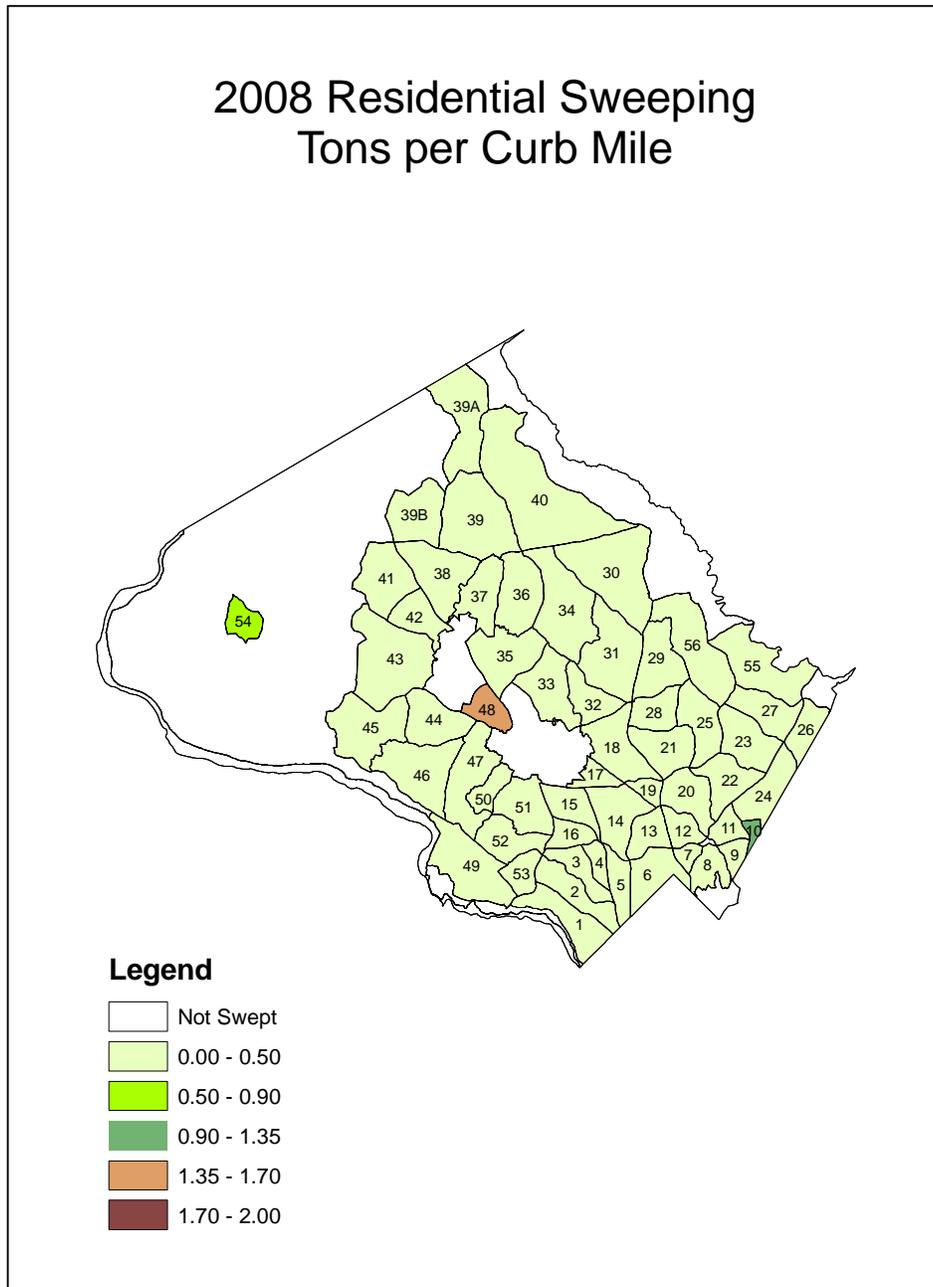
Figure III-E3. 2008 Residential Sweeping Tons Per Curb Mile

material picked up per curb mile. This is probably related to a 31% decrease in the amount of sand/salt mixture applied to the roads that year with no decrease in sweeping activity from 2007 (Fig. III-E5). Of note is the fact that the Anacostia and Rock Creek watersheds did not show the greatest amounts of material collected per curb mile as in past years for 2008 and 2009. That plot also shows that even though the sweeping program only picks up a fraction of the material put on the roads in winter, it does keep many tons of material from entering county BMPs and waterways. Sweeping picked up approximately 3050 tons of material in 2007 and 1383 tons of material in 2008

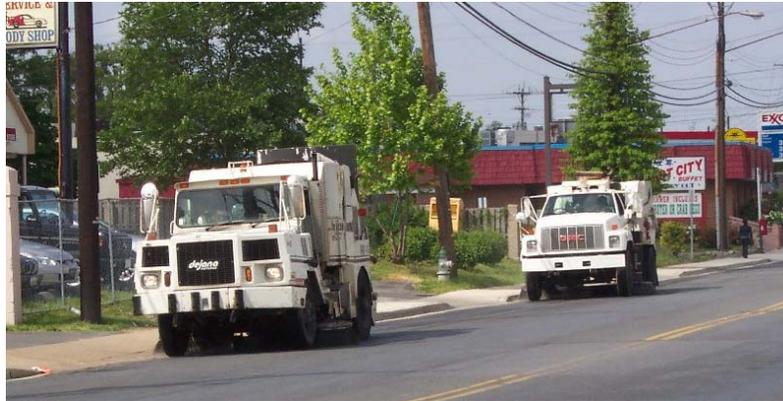
Figure III-E7 Dual Sweeper Formation

Two miles of streets in the watershed were swept every two weeks. Tandem sweeping used a conventional brush sweeper followed by a second regenerative vacuum sweeper to enhance effectiveness Figure III-E7. Trays were also installed in 28 roadway inlets in the watershed to intercept solids before they entered the rest of the storm drain system. To evaluate effectiveness, material collected by the sweepers was weighed twice monthly. Trash items collected were categorized and counted. Material collected by the inlet trays was categorized and counted monthly. Grit collected by the sweepers was also analyzed for pollutants. One liter samples of first flush stormwater were collected at the storm drain inlets and analyzed for pollutants. Stormwater results were compared to rising limb values from the Stewart April Lane and Paint Branch sampling stations.

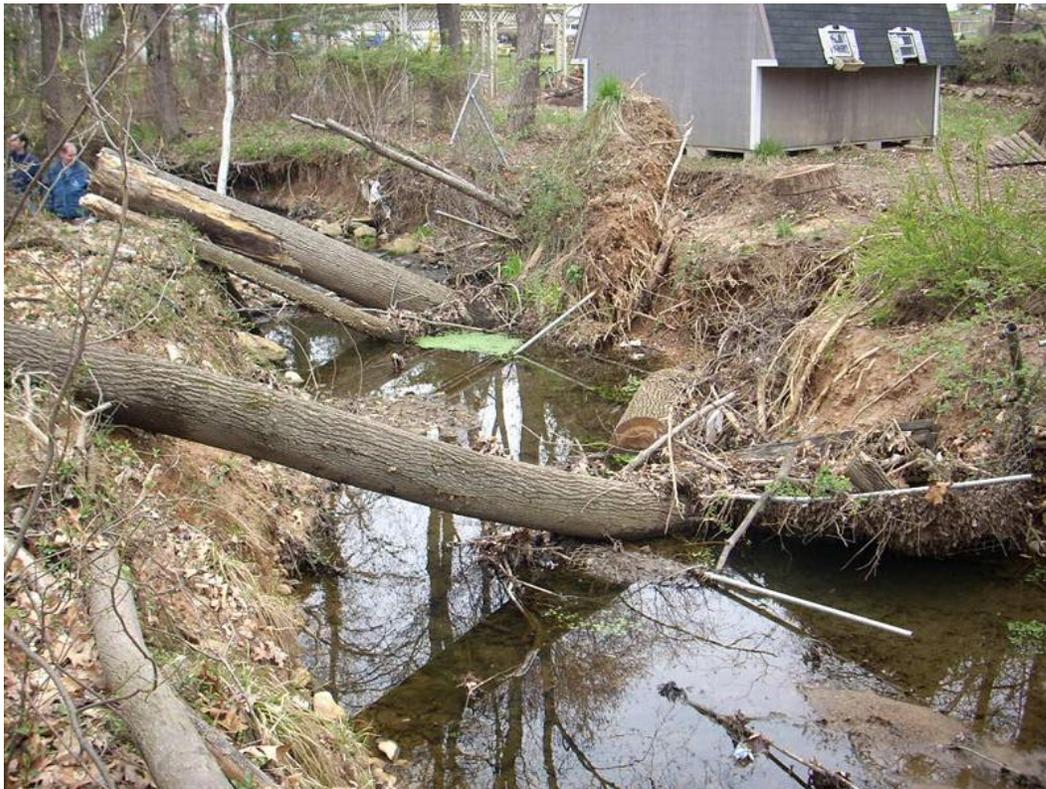
Figure III-F1 Example of Stream Conditions in Hollywood Branch

Hollywood Branch is located in the suburbs of eastern Montgomery County, Maryland, and is a second order tributary to Paint Branch (a tributary of the Anacostia River). Figure III-xx shows the drainage areas to various points along the 2.25-mile stream reach that was evaluated for the restoration project. .
