Technical Appendix:
Section 3. BMP Effectiveness

TA-3.1 2010 BMP Monitoring Status

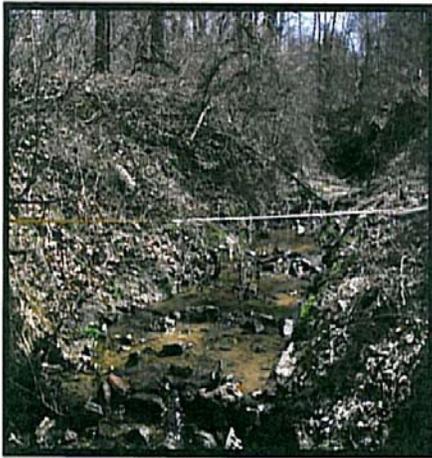
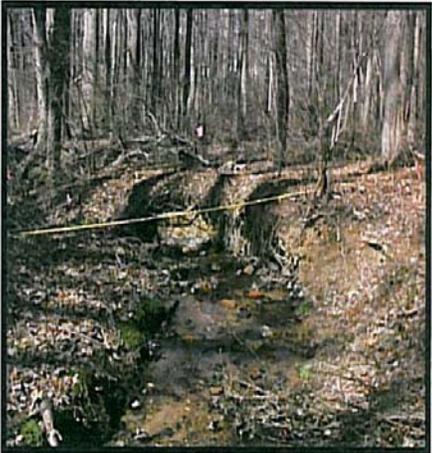
Cross-Section #1

Facing Upstream (March 18, 2010)

Facing Downstream (March 18, 2010)

Figure TA-3.2. Forest Ridge Cross Section #1 (ESA 2010). This cross section is the farthest upstream.

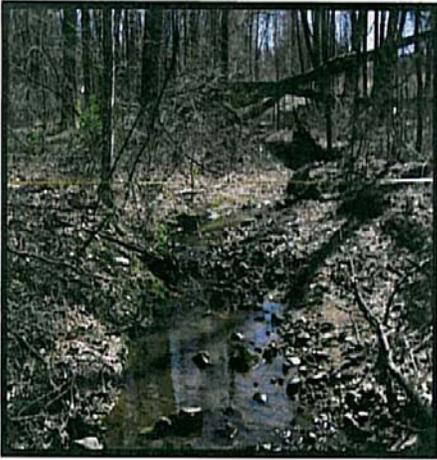
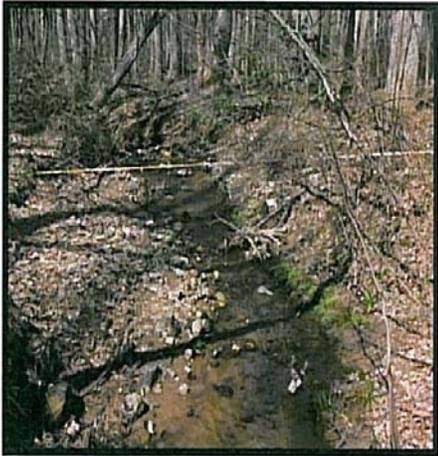
Cross-Section #2

Facing Upstream (March 18, 2010)

Facing Downstream (March 18, 2010)

Figure TA-3.3. Forest Ridge Cross Section #2 (ESA 2010).

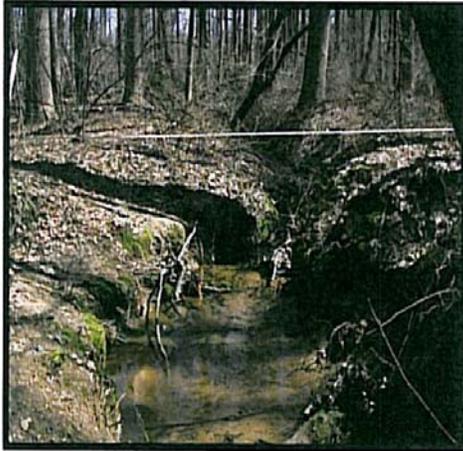
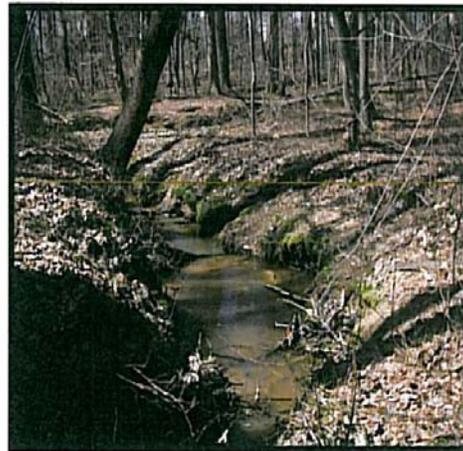
Cross-Section #3

Facing Upstream (March 18, 2010)

Facing Downstream (March 18, 2010)

Figure TA-3.4. Forest Ridge Cross Section #3 (ESA 2010).

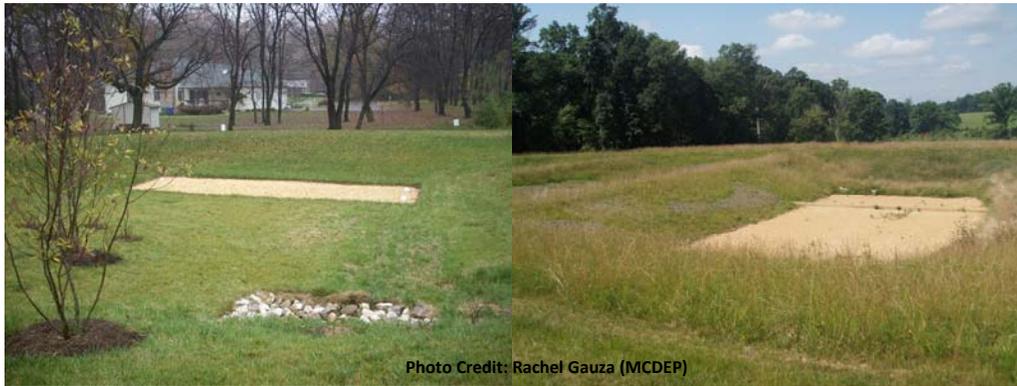
Figure TA-3.19. Photographs of two sand filters monitored for the Special Protection Area.

Left: Briarcliff Meadows in the Upper Paint Branch SPA; Right: Summerfield Crossing in the Clarksburg SPA.

Montgomery County Sand Filter (MCSF) design details are provided in Figure TA-3.18. Photographs of representative sand filters in Montgomery County Special Protection Areas are also featured (Fig TA-3.19).

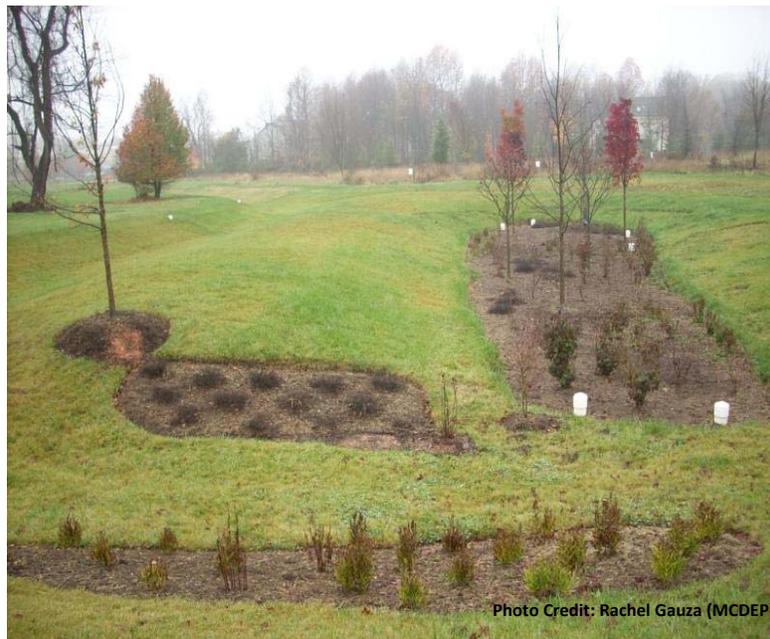
Figure TA-3.21. 2008 Photograph of the Briarcliff Meadows South Biofilter.

A diagram featuring components of a typical Montgomery County biofilter design is provided (Fig. TA-3.20). Fig. TA-3.21 features the biofilter monitored at Briarcliff Meadows South.

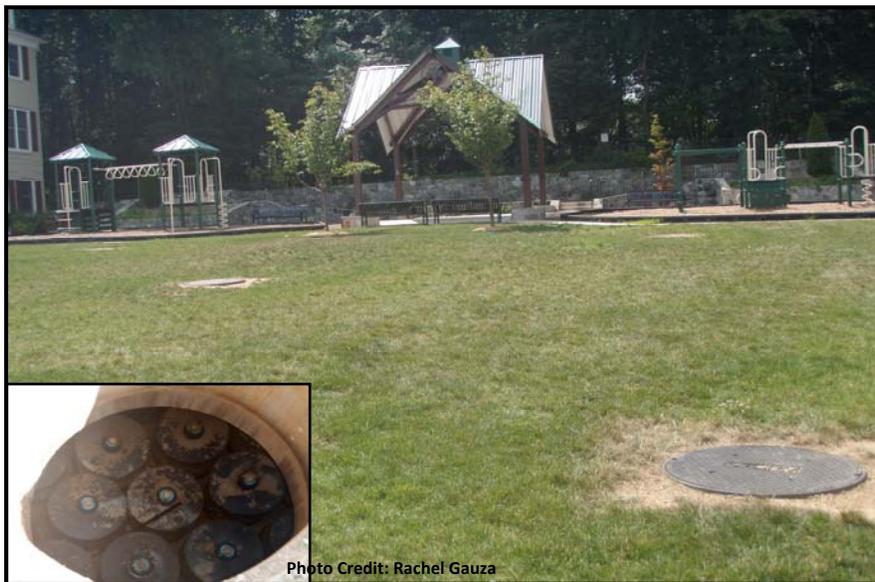
Figure TA-3.23. Summerfield Crossing Underground Stormfilter 1. Structure is located beneath open space near a playground. (Inset: Cartridge filters in manhole).

Contech Construction Products, Inc. is a distributor of the Stormfilter® and provides structure guidelines and configurations (Fig TA-3.22). Monitoring of a Stormfilter®, identified as “Underground Filter 1,” began in 2009 at the Summerfield Crossing Development in the Clarksburg SPA (Fig TA-3.23).

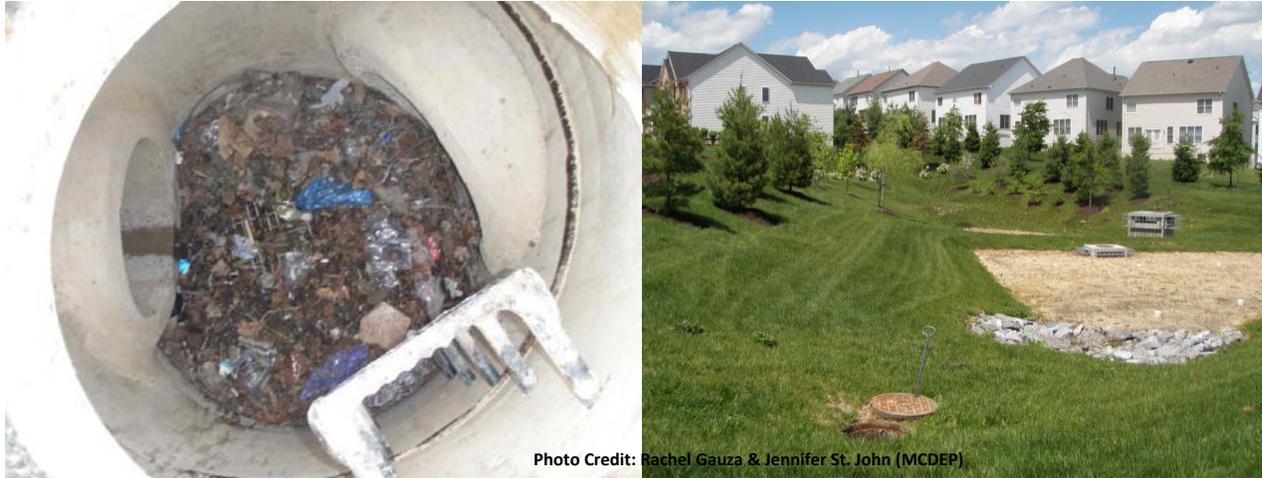
The BaySeparator is a hydrodynamic device that redirects the flow of water to remove pollutants (Figs TA-3.24 and TA-3.25). It functions as pre-treatment for other SWM BMPs in a treatment train; at Clarksburg Ridge, the BaySeparator serves as pretreatment to two sandfilters and a dry pond (Fig TA-3.26).
