# Montgomery County DEP, Watershed Management Division Monitoring Projects

June 9, 2014

# County Monitoring Overview

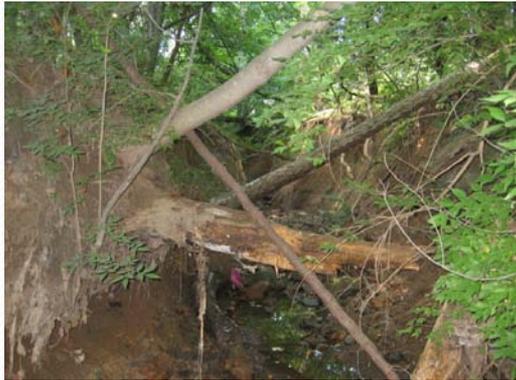
Stream Channel at University Boulevard

# Watershed Restoration Assessment- Breewood Tributary

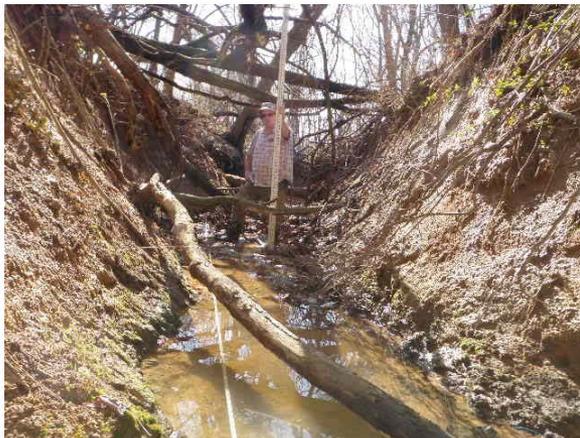
- Eroding stream banks
- Exposed sewer lines
- Large amount of untreated impervious area
- Land uses associated with pollutant issues
- Fish blockages and other habitat limitations

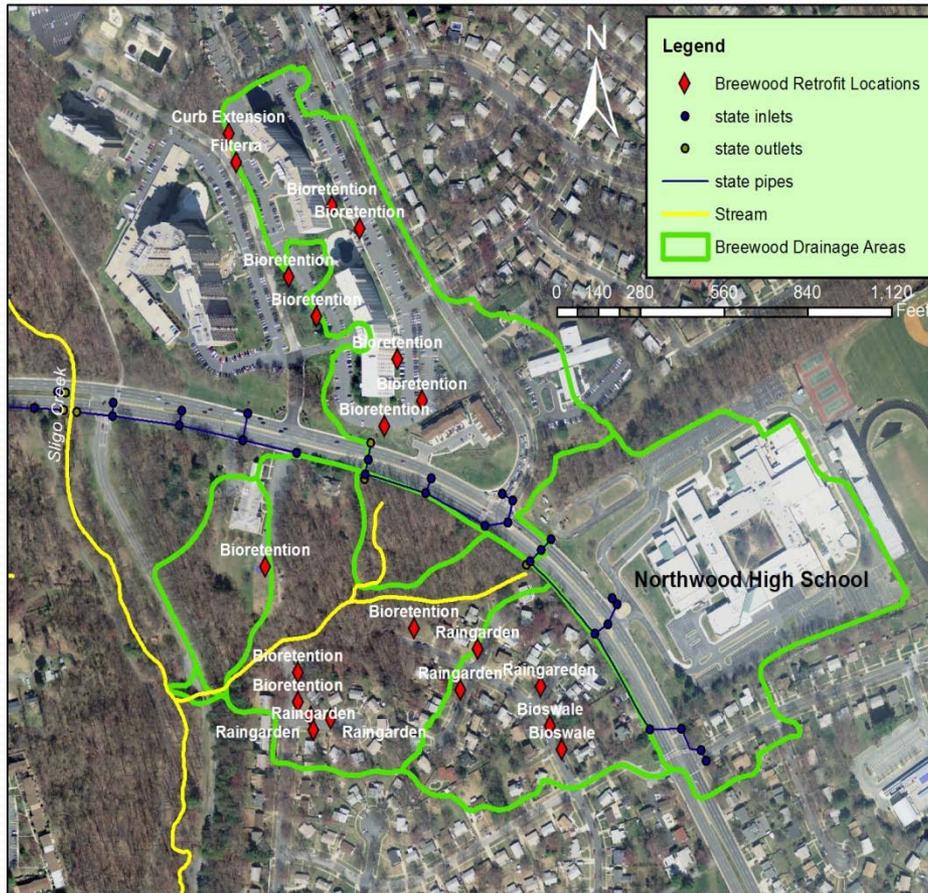
# Breewood Tributary Restoration

- Approximately 60 acres
- 33% imperviousness
- Mixed Use – Single Family Homes and High Rise Apartments
- Retrofits
  - Green Streets Stormwater Retrofits
  - RainScapes Neighborhood
  - Parking lot and tree box retrofits
  - Stormwater Wetland Retrofit-OF
- Stream Restoration
- Environmental Outreach and Litter Reduction
- Local Park Improvement – Weed Warriors

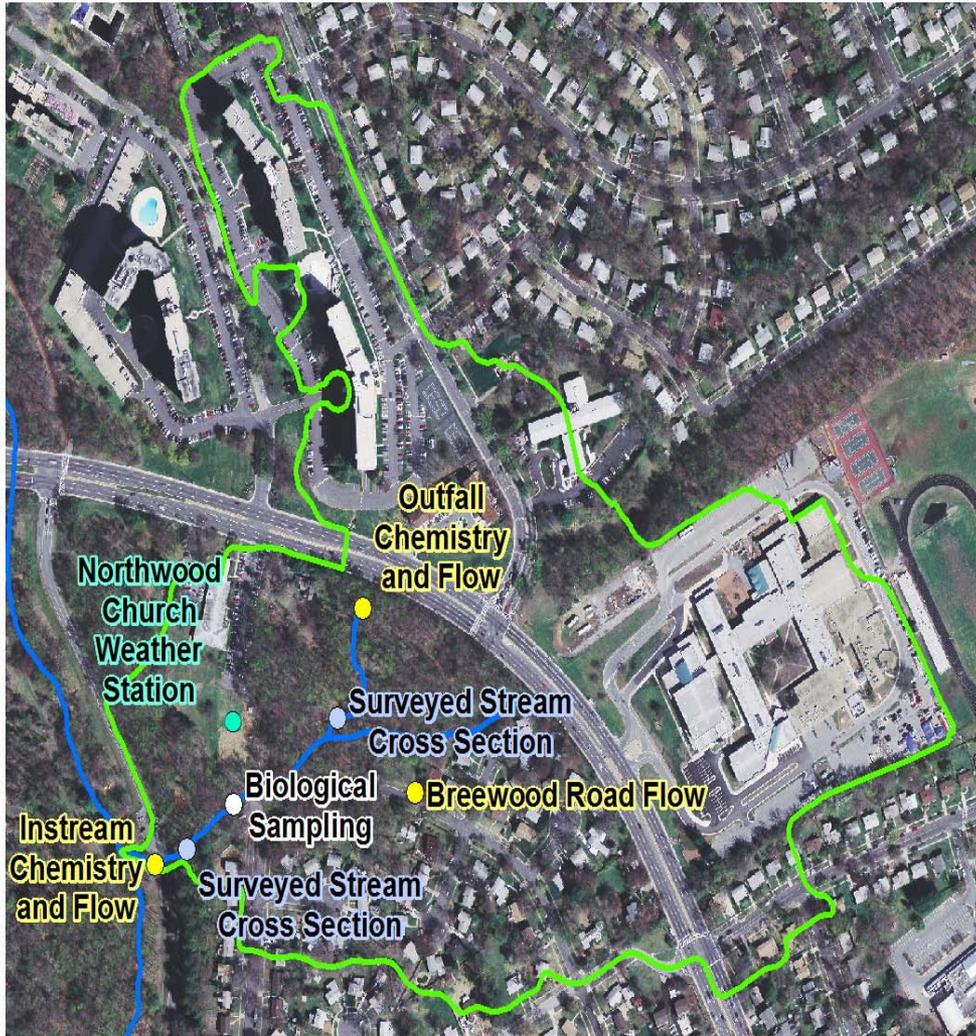
# Breewood Tributary Monitoring

One outfall and instream monitoring station- water chemistry and flow

Two stream geomorphology stations

One biological monitoring station

Weather station (rainfall)

Continuous physical water chemistry monitoring (new)

Two additional stations to monitor pre and post retrofit (RainScapes Neighborhoods) water quality and flow.

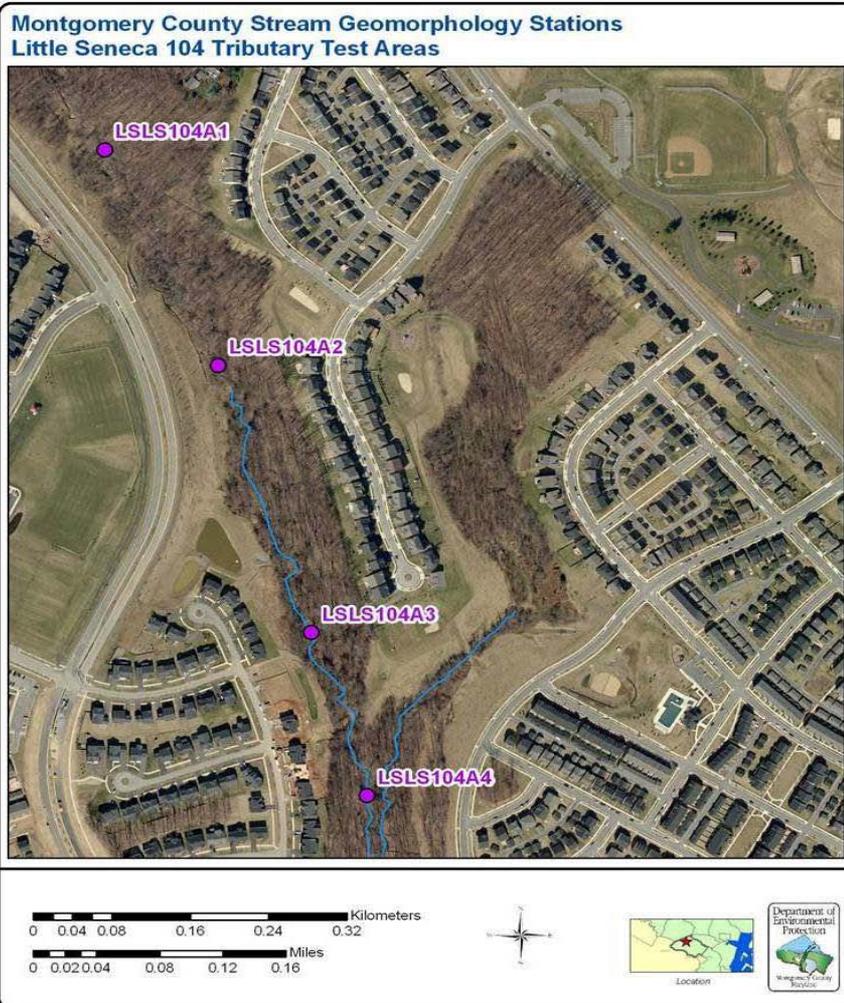
# Stormwater Management Assessment

Physical stream monitoring to determine effectiveness of stormwater management practices for stream channel protection

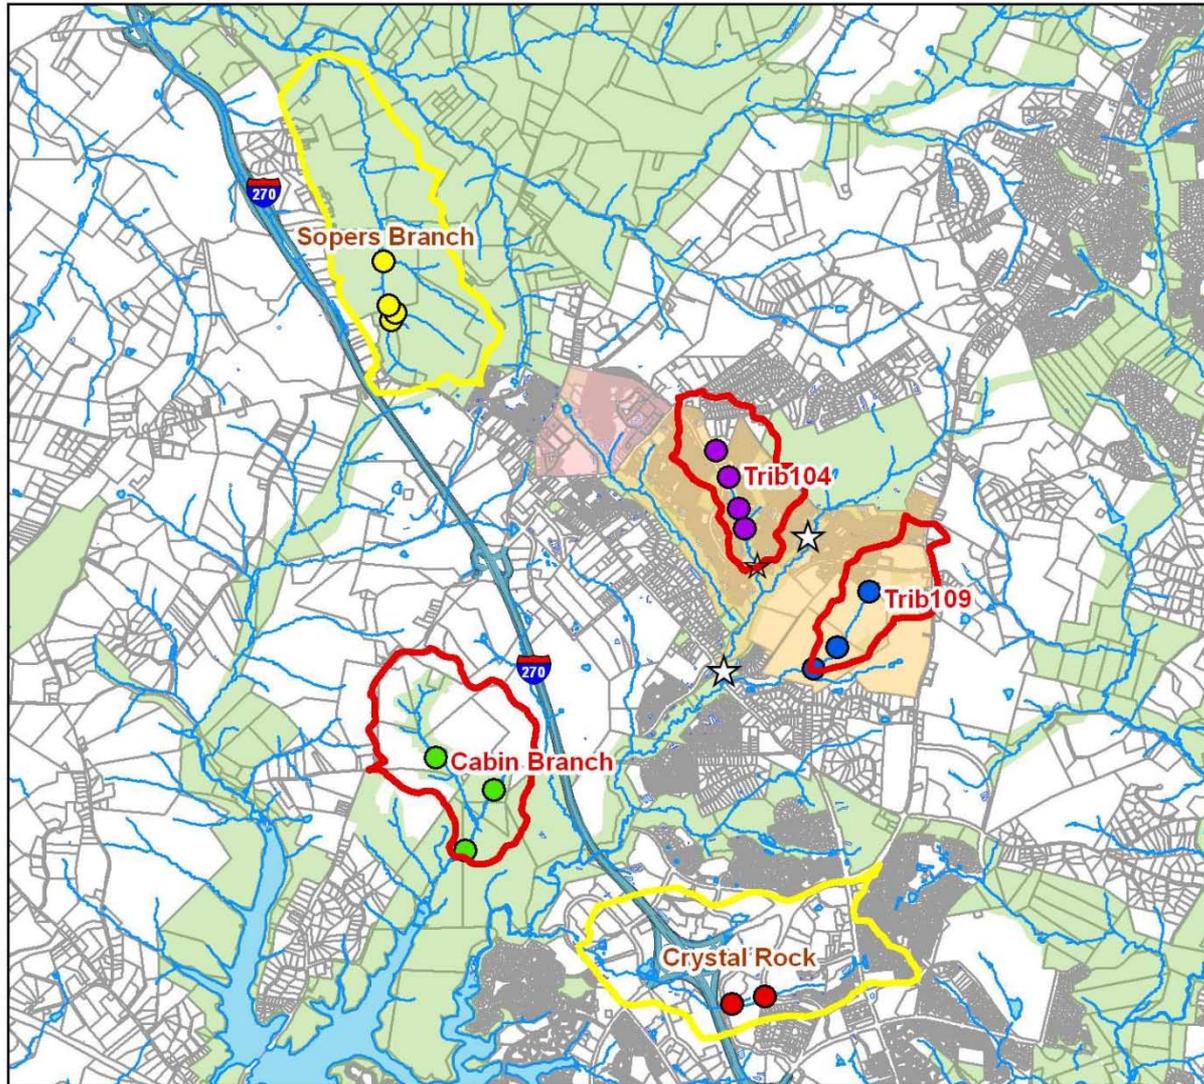
## Clarksburg Study Areas, Biomonitoring, & Geomorphology Stations

### Clarksburg Study Areas

- Test Areas
- Control Areas
- Clarksburg Town Center
- Newcut Road Neighborhoods

### ☆ Biomonitoring Sites

### Geomorphology Survey Areas

- Little Seneca 104 Tributary
- Little Seneca 109 Tributary
- Little Bennett Sopers Branch
- Cabin Branch
- Crystal Rock
