MEMORANDUM

SUBJECT: Safe Routes to School – School Walking Area Analysis

LOCATION: Dr. Martin Luther King Jr Middle School

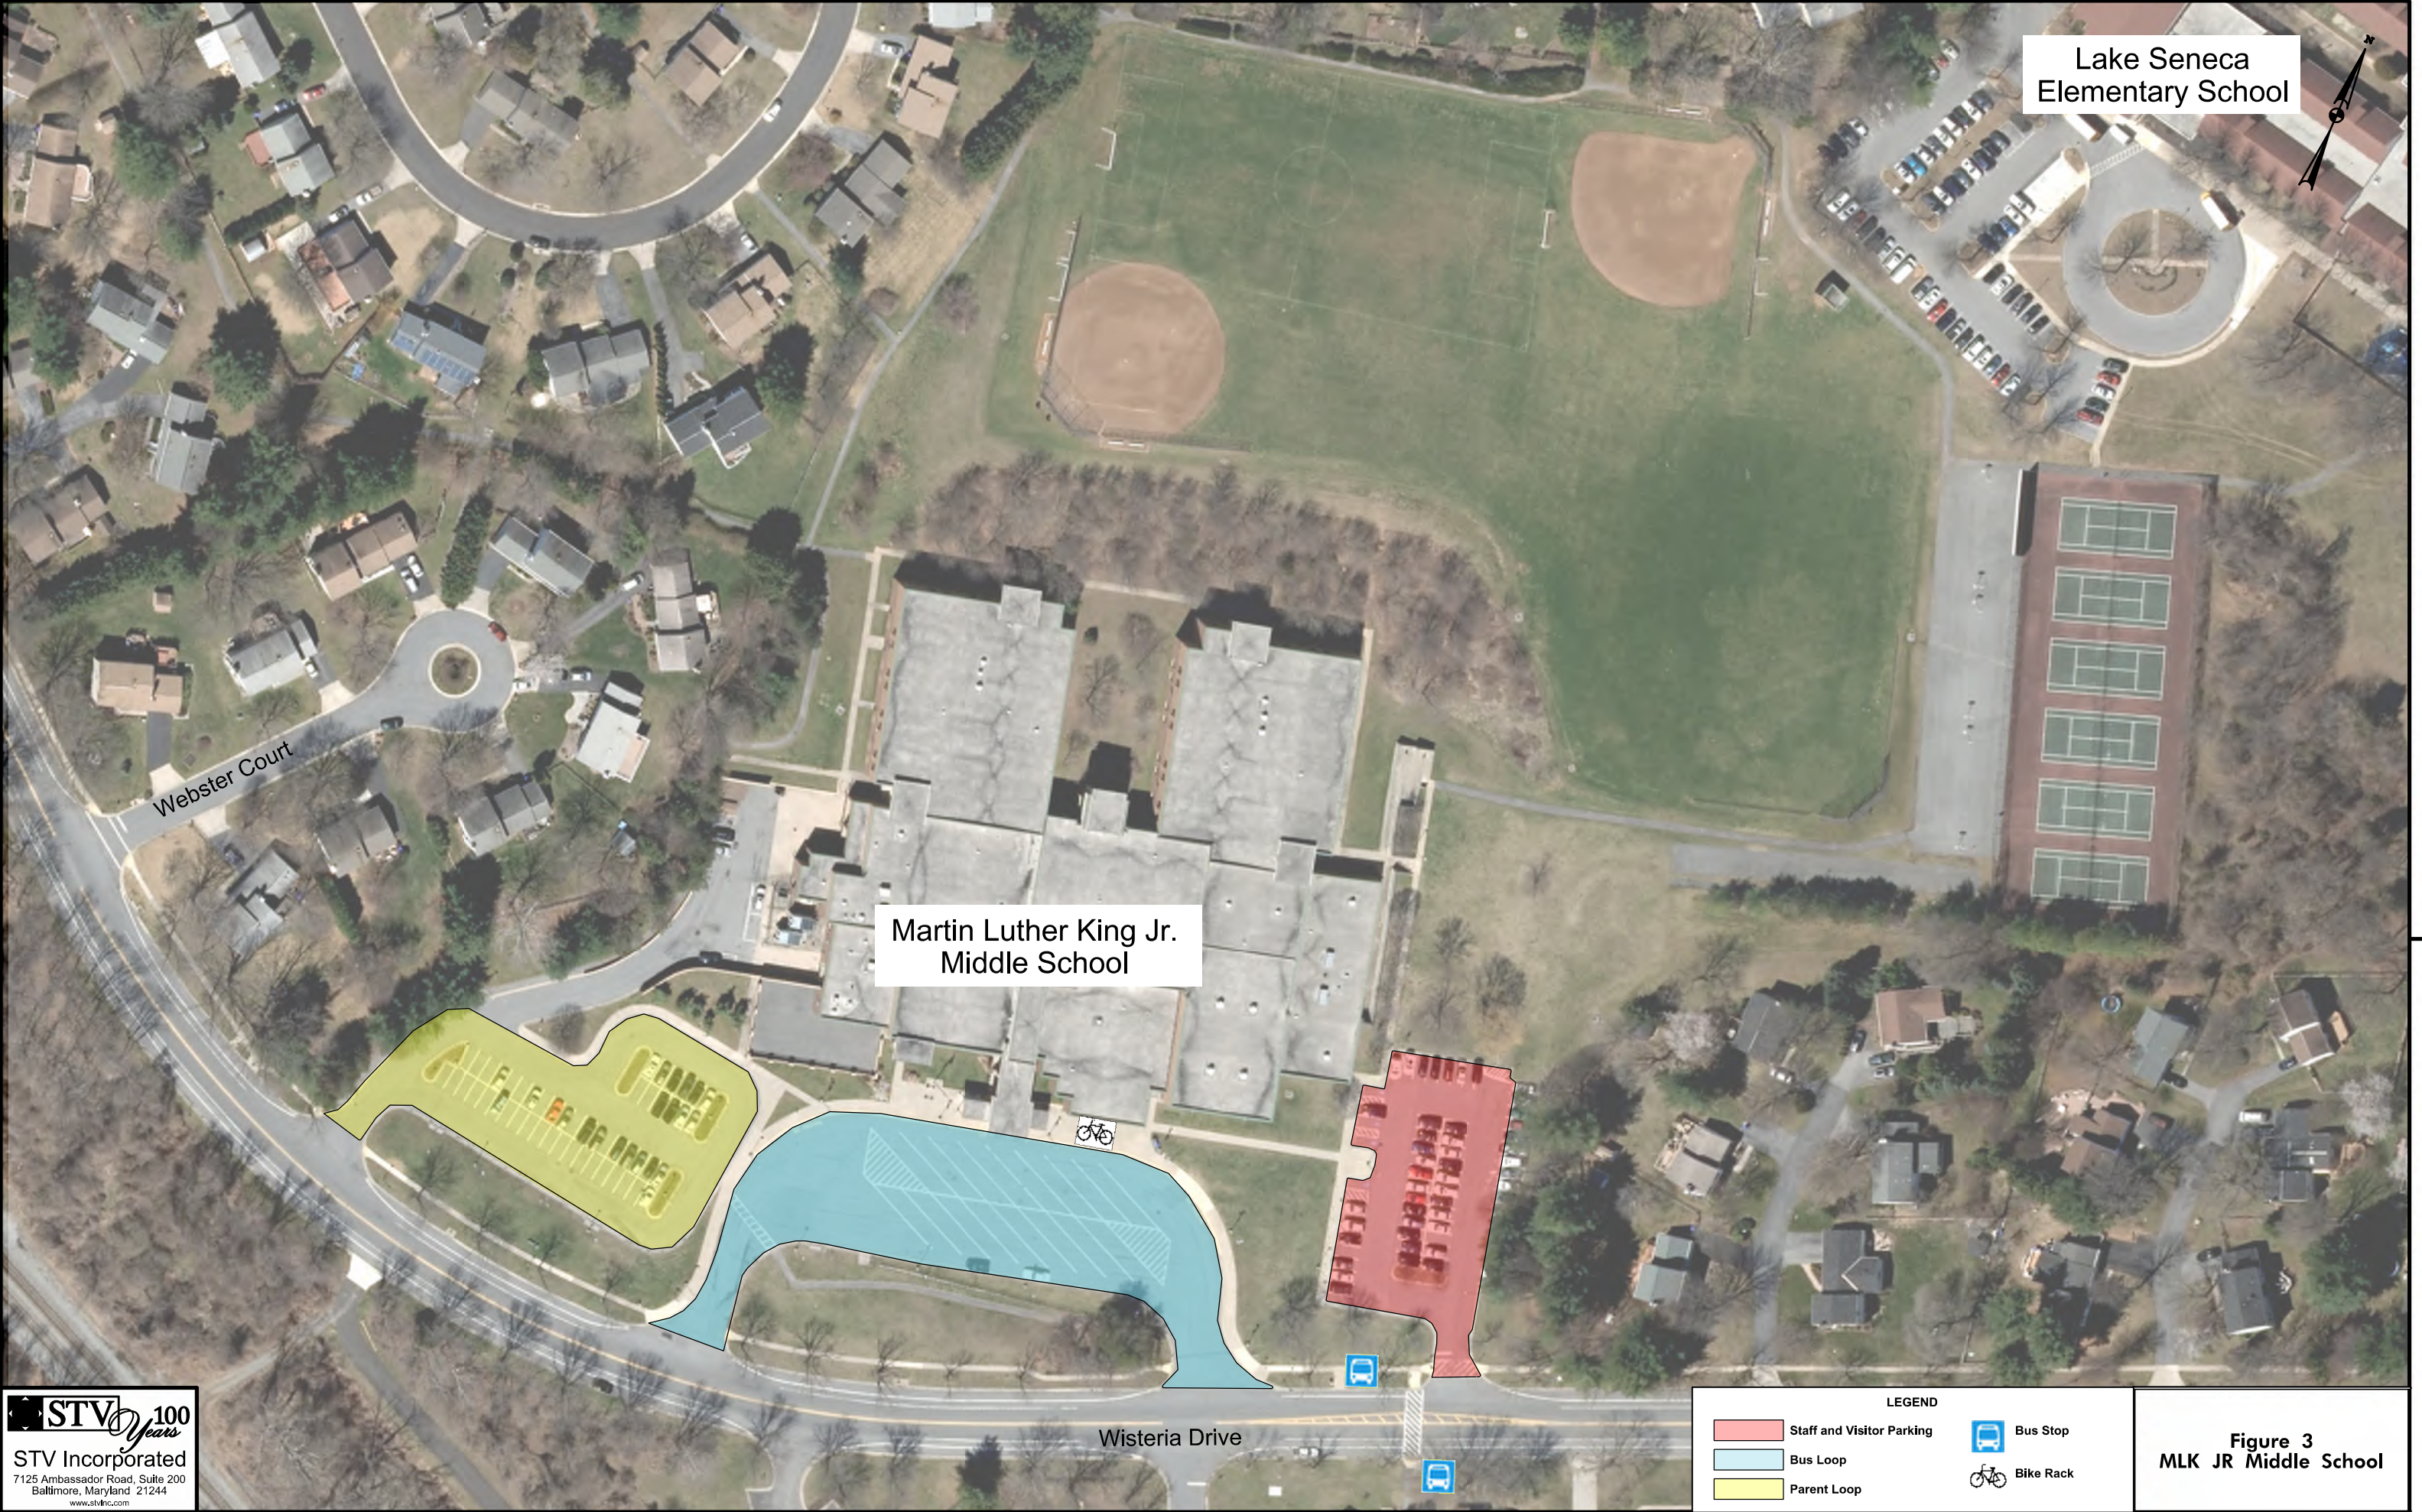
Figure 3
MLK JR Middle School

Observations for arrival and dismissal periods were conducted for each of the schools and reference points identified in the observations below are shown on **Figures 3-5**, respectively.

- Students were observed accessing the south entrance of the school and the east entrance near the stairwell adjacent to the staff and visitor parking during the arrival period. Additionally, during the dismissal period, the south side entrance near the bike rack was utilized.

- The majority of walkers approached the school from the east on the north side of Wisteria Drive. It should be noted that this is the only side of the roadway that has sidewalk. Some of the students also utilized the Ride On bus stops on the north and south side of Wisteria Drive. Nearly triple the number of students utilized the Ride On buses during the dismissal period than the arrival period. There were approximately three students who arrived at the school via Teakwood Lane; however, no students used Teakwood Lane during the dismissal period. It should be noted that Teakwood Lane does not have sidewalks that connect to Wisteria Drive, so students walked on either the grass or the roadway. Another sparsely used path during the arrival period was the paved path from the tennis courts east of the school between Dr. Martin Luther King, Jr. MS and Lake Seneca ES; however, this path was used heavily at 2:55 PM. This may have been a physical education class. A few students utilized the sidewalk on the north side of Wisteria Drive and walked west towards Webster Court.

- During the dismissal period, students walked over the grass from the bike rack near the south entrance to either the Ride On bus stop or the south side of the staff and visitor parking.

- Some motorists utilized the staff and visitor parking area to drop off and pick up the students; however, a majority of the drop offs occurred at the designated parent loop. There were no delays on Wisteria Drive during the arrival period; however, the road was impacted slightly on the east side of the school and heavily on the west side during the dismissal period. Furthermore, the loop in the staff and visitor parking area had a long queue as motorists waited at the stop sign to exit the school area. School security set up cones and stood guard at the bus loop preventing motorists from entering; however, prior to the security guard arriving, motorists utilized the bus loop as a drop off area. This also occurred after the security guard left at 8:15 AM. The sign posted stating “BUSES ONLY 7:00AM – 4:30 PM SCHOOL DAYS” was disregarded by motorists.

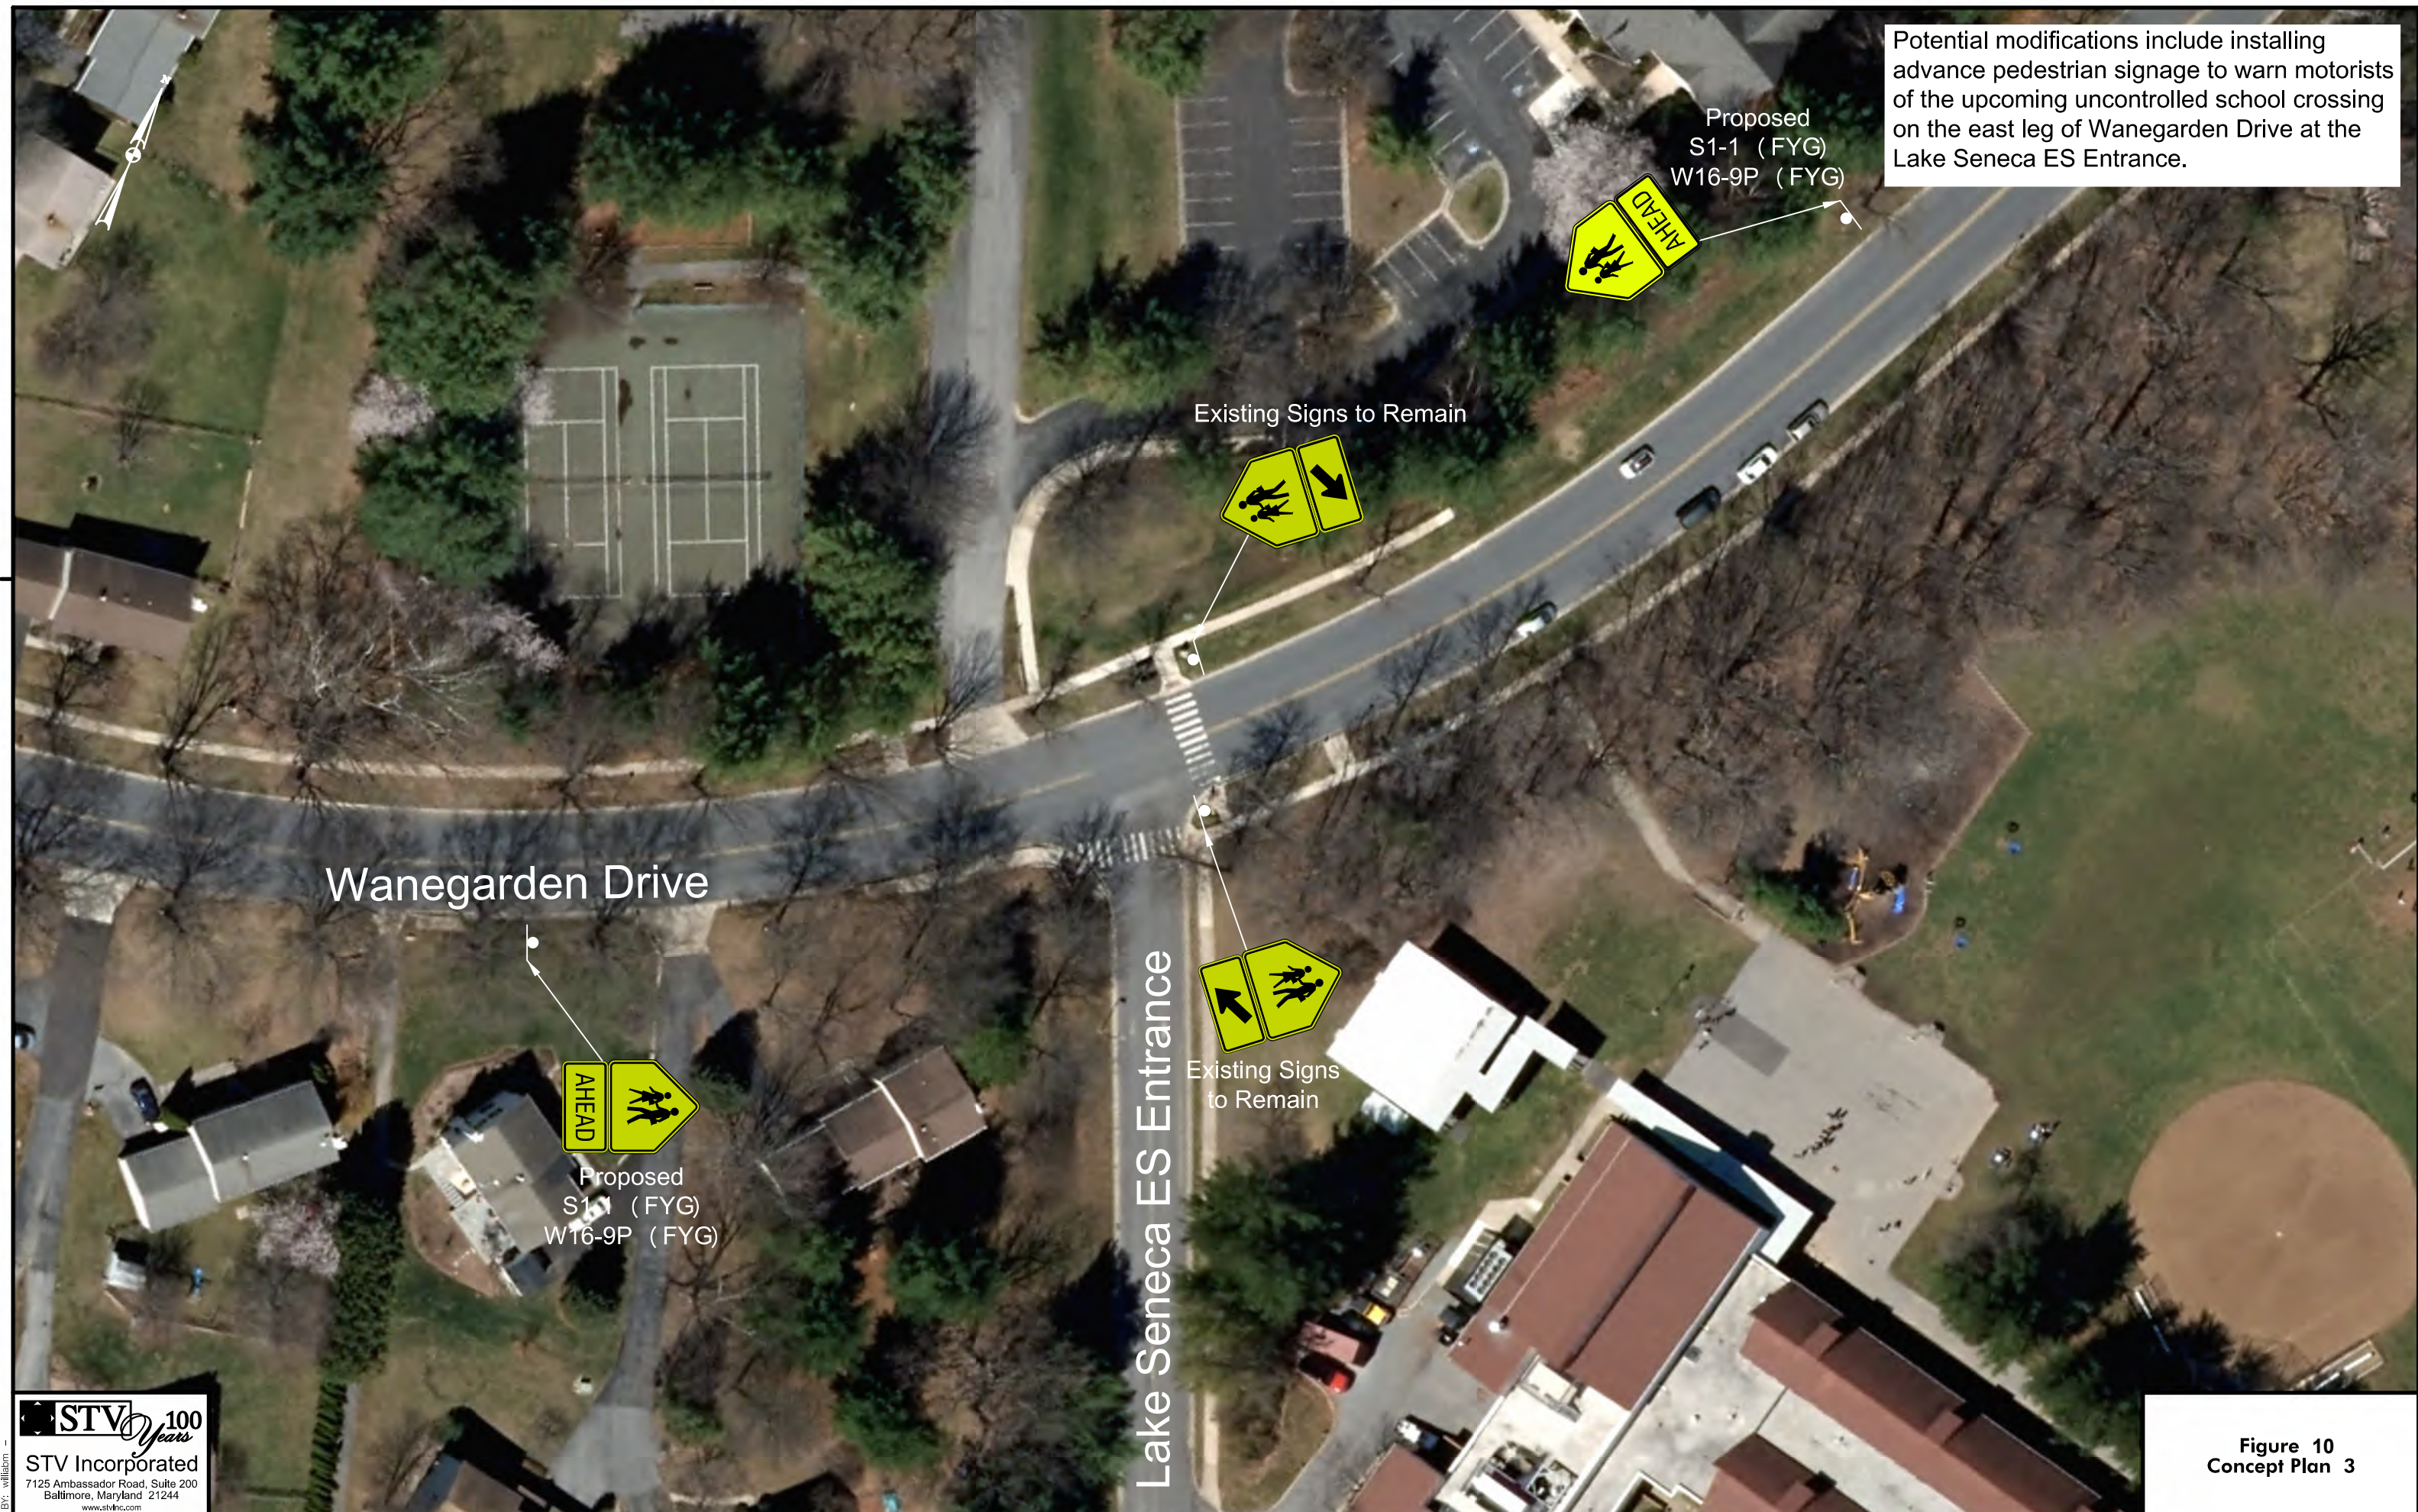
Figure 10
Concept Plan 3

Potential modifications include installing advance pedestrian signage to warn motorists of the upcoming uncontrolled school crossing on the east leg of Wanegarden Drive at the Lake Seneca ES Entrance.

Proposed
S1-1 (FYG)
W16-9P (FYG)
