# SAFE STREETS ACT 2023 – CRASH REVIEW

**Location:** Dennis Avenue at Julep Avenue

**Crash Date:** February 29, 2024

**Local Case No.:** 240009833

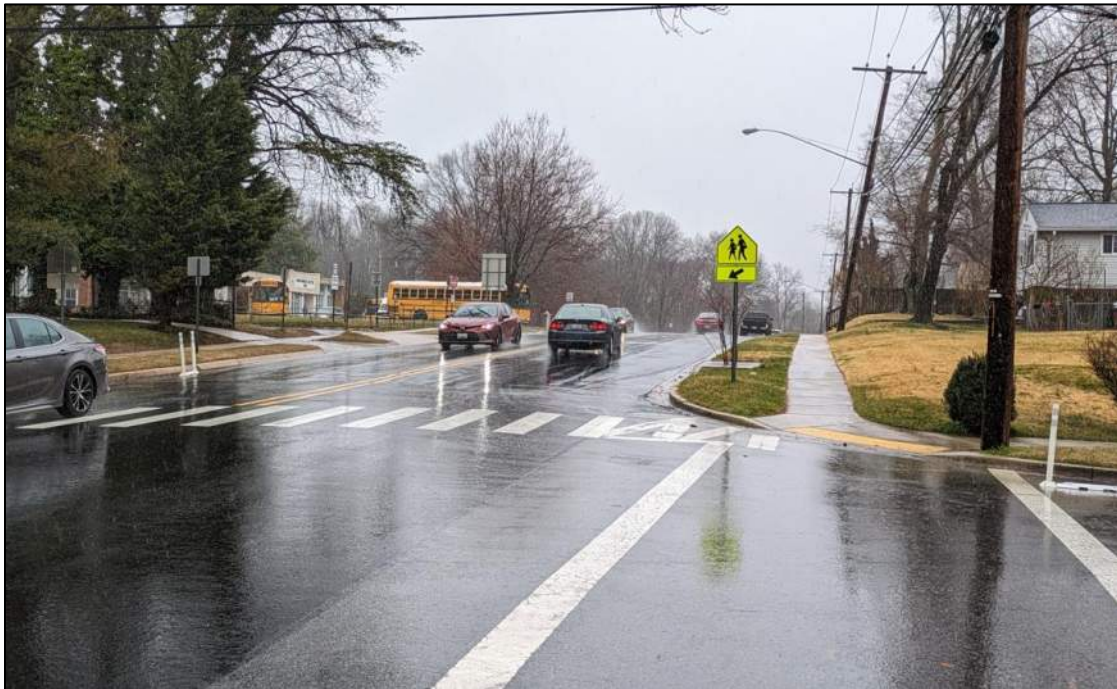
**Photo 1. Crosswalk Markings at Julep Ave**

Dennis Avenue at Julep Avenue is a four-leg intersection located west of Sligo MS. Julep Avenue is classified as a neighborhood yield street with its north leg having no outlet and serving less than 30 homes. ADA-compliant pedestrian ramps provide accessible crossings of the north, south, and east legs of the intersection. The crossing of the west leg is neither marked nor accessible. Ladder-style crosswalks are installed for the east and north legs of the intersection, while a transverse-style crosswalk is installed on the south leg of the intersection.

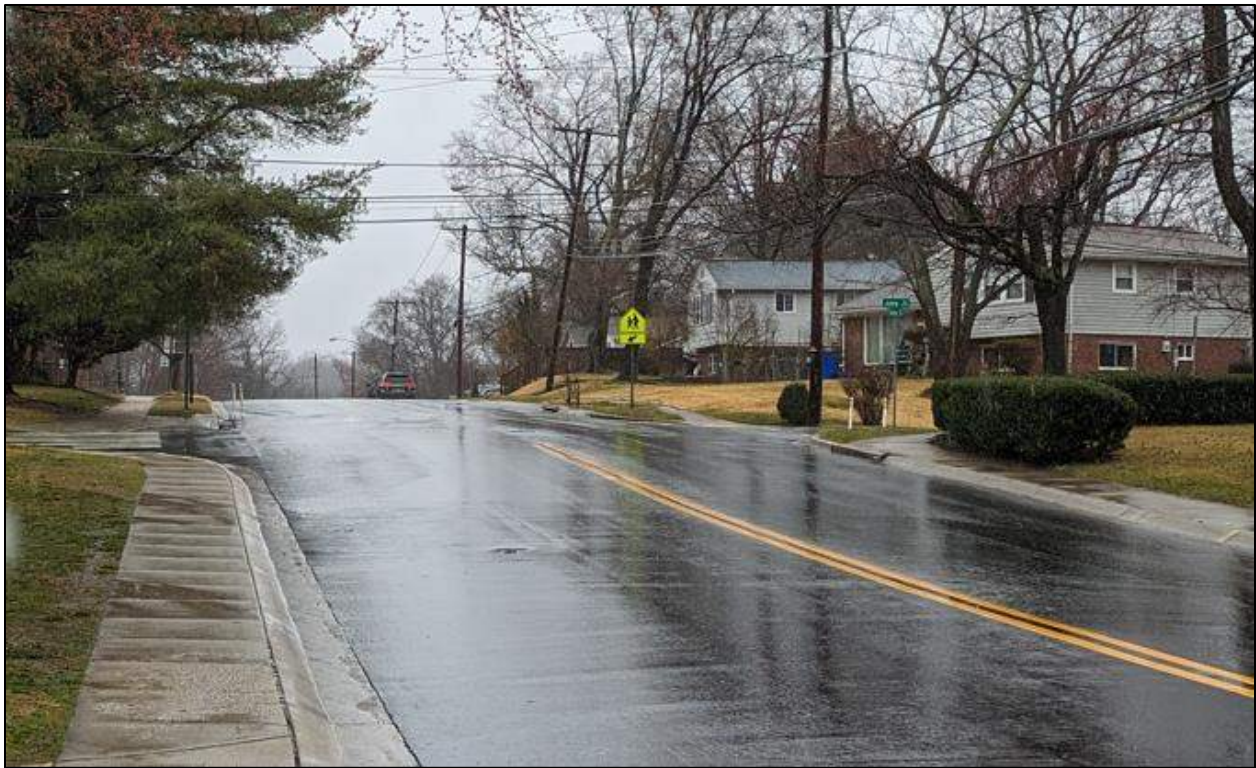
**Photo 5. Eastbound Approach to School Crossing**

During these observations, a crossing guard was interviewed at the end of the arrival period. While this crossing guard was not present at the time of the February 29, 2024, incident, they confirmed that glare from the sun affects visibility when traveling or looking east Dennis Avenue during the morning/arrival timeframe.

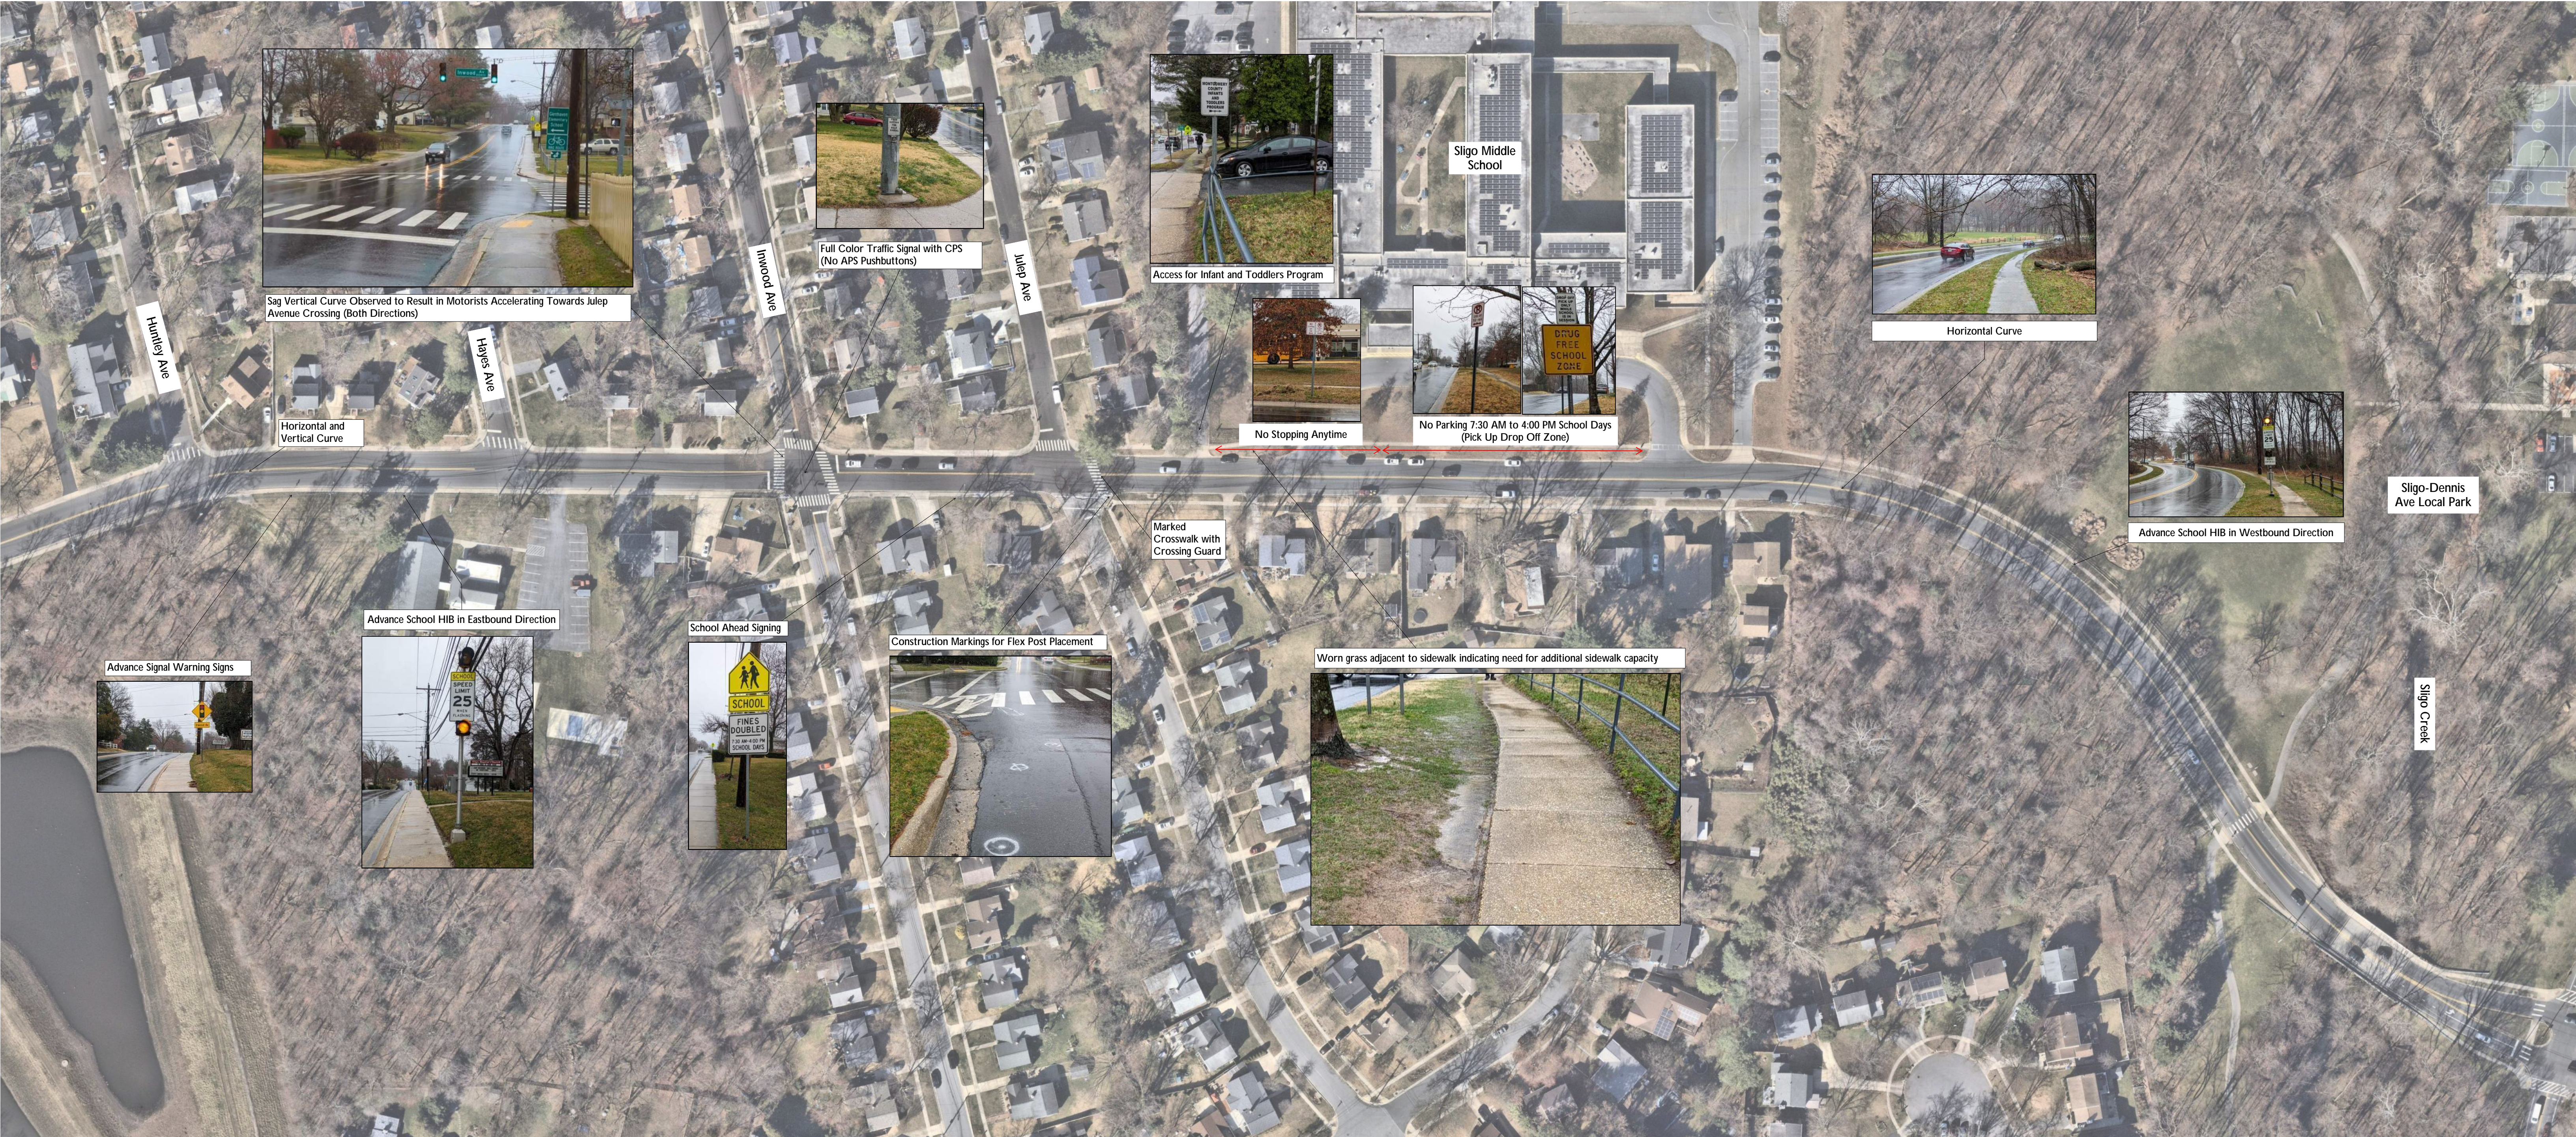
FIGURE 1 - DENNIS AVENUE CORRIDOR EVALUATION

Dennis Avenue is a two-lane area connector (previously classified as a minor arterial), is 35 feet wide, and is generally oriented in the east-west direction. East of Julep Avenue, Dennis Avenue has grass-buffered sidewalks with a nominal width of four feet along both sides of the street. West of Julep Avenue, Dennis Avenue has four-foot sidewalks, with no buffer. Dennis Avenue has a posted speed limit of 30 MPH and includes hazard identification beacons indicating a school zone speed limit of 25 MPH when flashing **(Photo 2)**. On-street parking is permitted along most of the segment, with the exception of the Sligo MS frontage. Refer to **Figure 1** in the attachments for additional details of the Dennis Avenue segment.

The Dennis Avenue corridor was evaluated to identify potential infrastructure, maintenance activities, and road user behaviors that contribute to increased safety risk at and in the vicinity of the school crossing. The Dennis Avenue corridor was reviewed between Huntley Avenue to the west and Sligo Creek to the east. There are two horizontal curves along this segment – one near Huntley Avenue and one east of Sligo MS. The segment also includes vertical curvature with a crest near Huntley Avenue, sag at Inwood Ave and another crest in front of Sligo MS. The horizontal and vertical curvature constrain lines of sight and observations show the grade changes result in variable acceleration and deceleration rates by motorists using the corridor. Please refer to **Figure 1** for additional information.

1. Consider upgrade existing school crossing assemblies to use 36"x36" S1-1 signs. Install S1-1 assemblies on both the left and right sides of the crossing for both eastbound and westbound approaches to improve conspicuity.
2. Consider installing R1-6c IN-STREET SCHOOL CROSSING signs in the vicinity of the crossing along the centerline.
3. Repair damaged LED signal head for school HIB east of school to improve motorist awareness entering the school zone.
4. Consider installation of curb extensions for all corners of the Dennis Avenue at Julep Avenue intersection to reduce crossing distances for pedestrians or a pedestrian refuge on the westbound

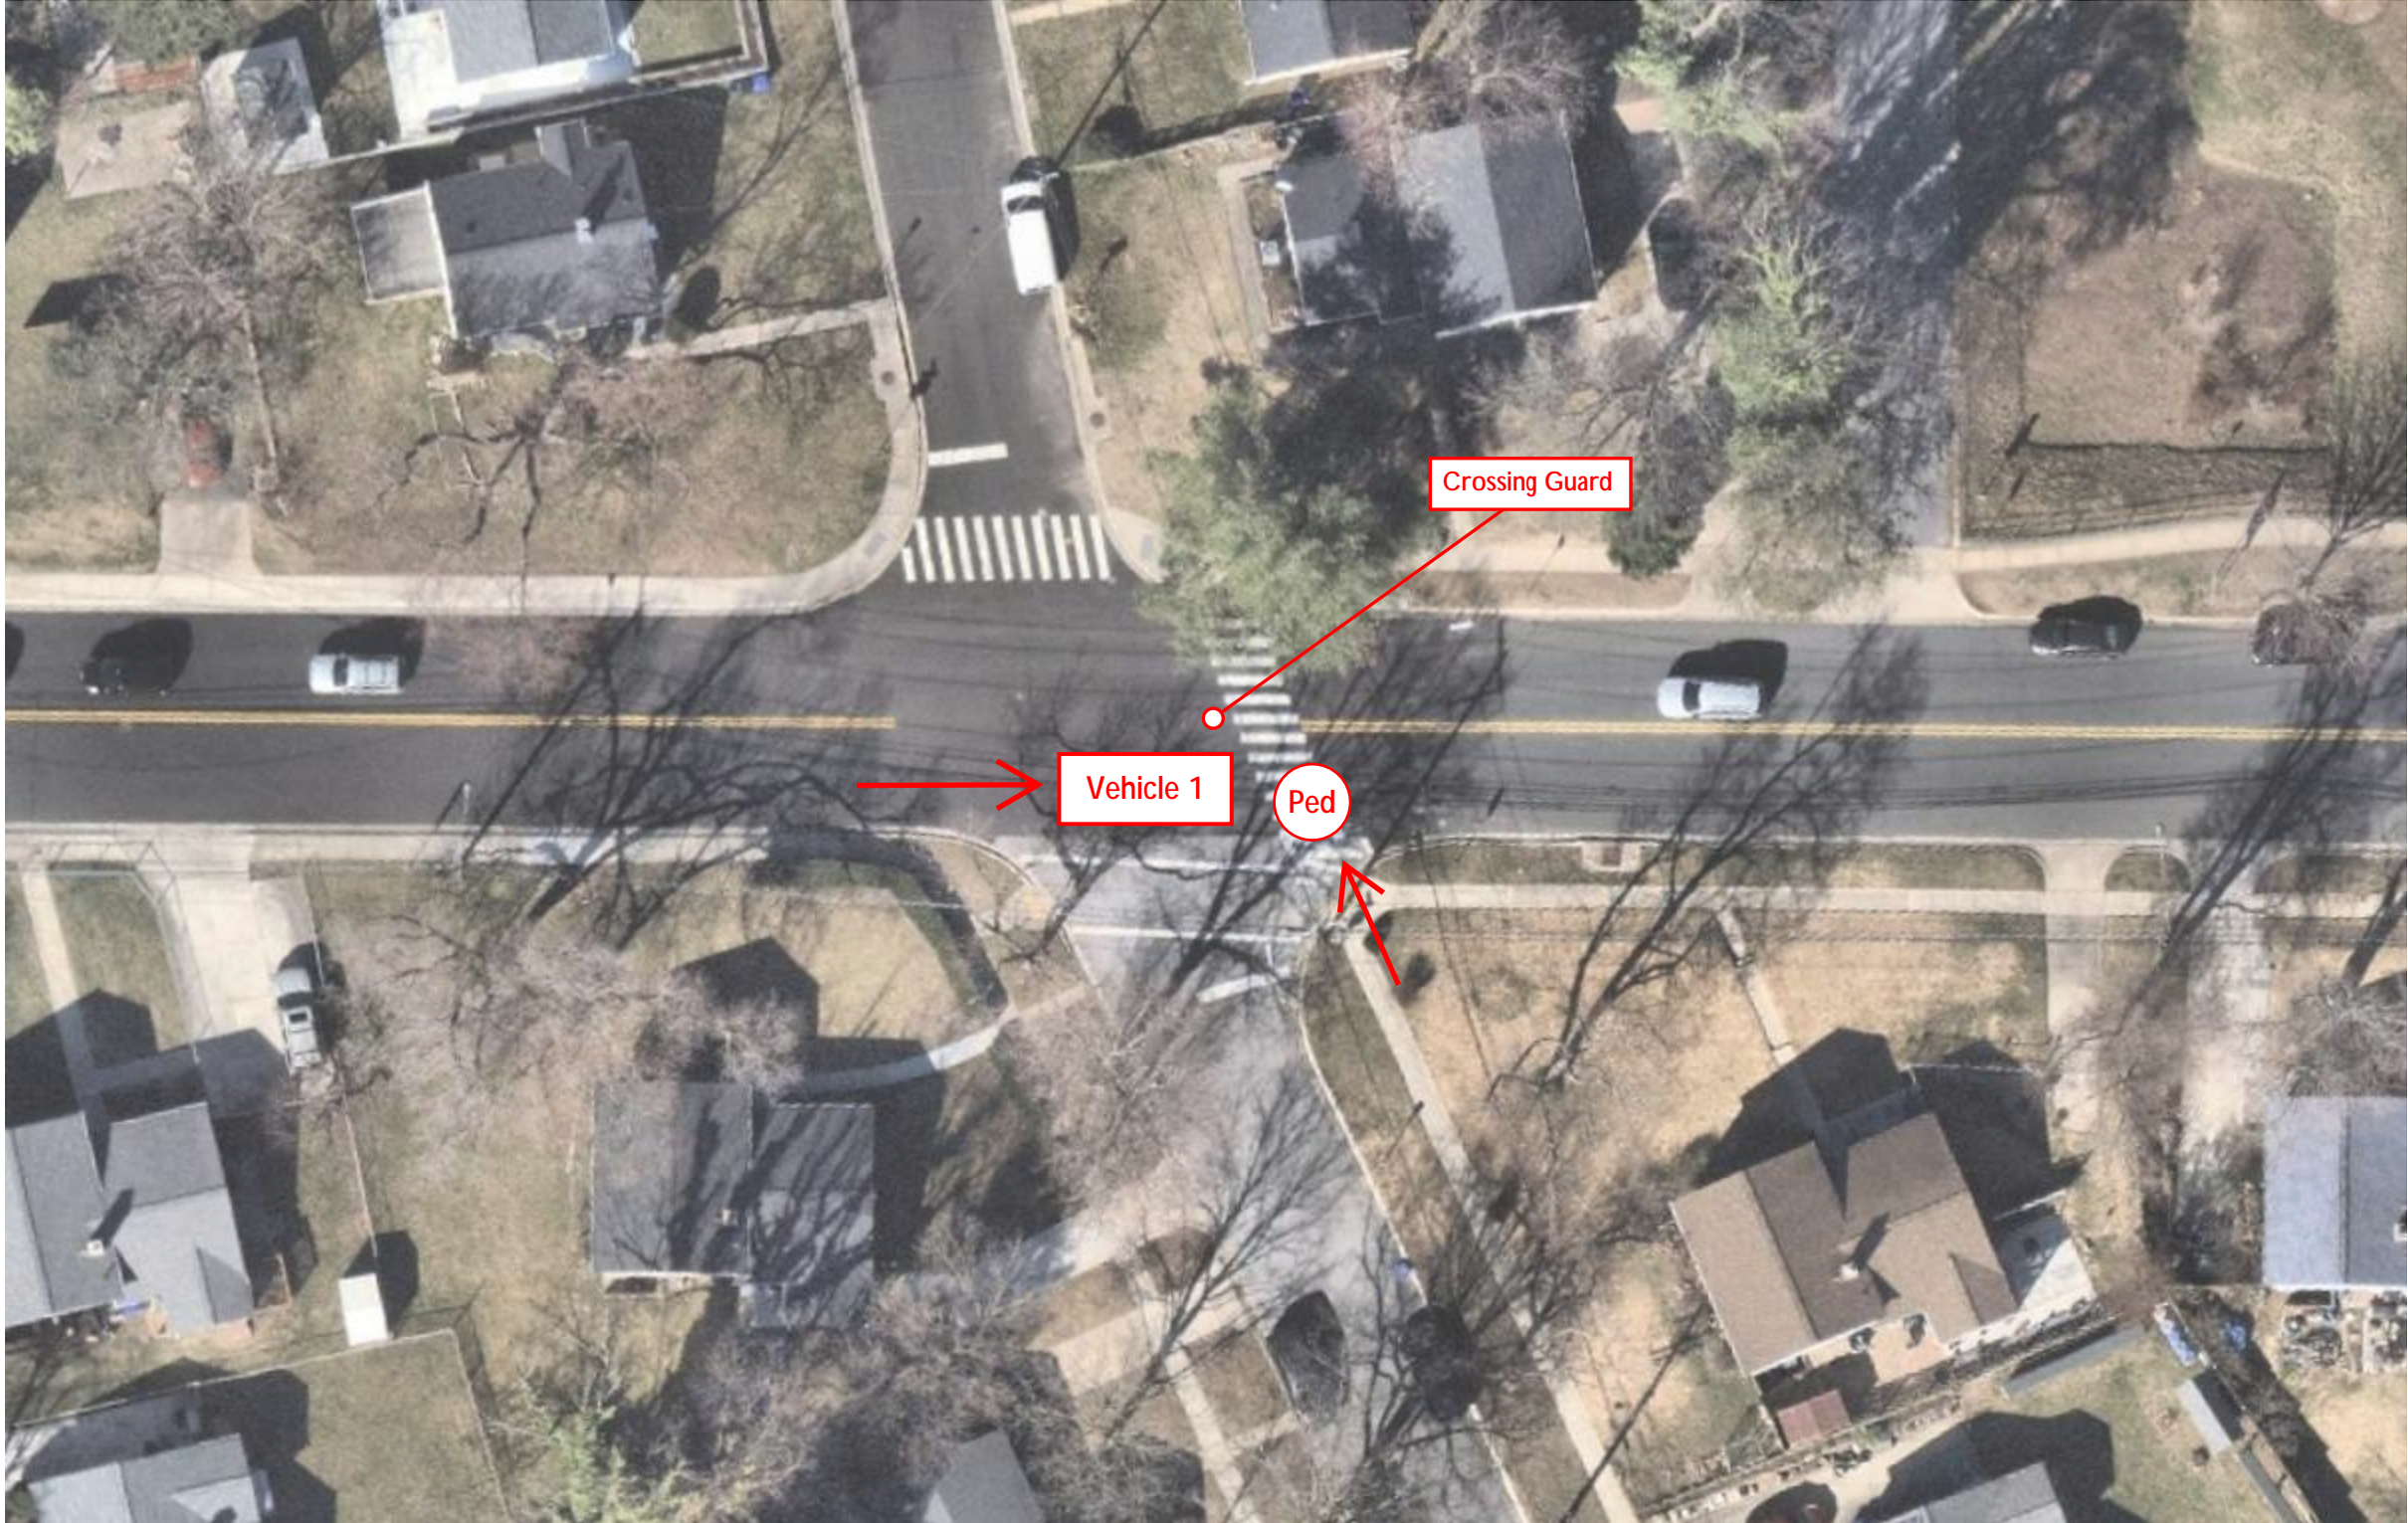
FIGURE 2 - DENNIS AVENUE AT JULEP AVENUE  
2024 FEBRUARY 29 PEDESTRIAN-INVOLVED CRASH

On Thursday, February 29, 2024, at approximately 8:03 AM, a motorist traveling eastbound along Dennis Avenue collided with a student in the crosswalk at the east leg of the intersection. According to the crash report, glare from the sun, limiting visibility, was considered as a factor in the collision. Weather conditions were clear, the roadway surface was dry, and it was daylight. The student suffered serious injuries.

**Figure 2** illustrates the crash location and direction of pedestrian and vehicle travel.
