# SCHOOL-RELATED CRASH REVIEW

**Location:** Little Seneca Parkway at Newcut Road

**Crash Date:** May 24, 2024

**Local Case No.:** 240024640

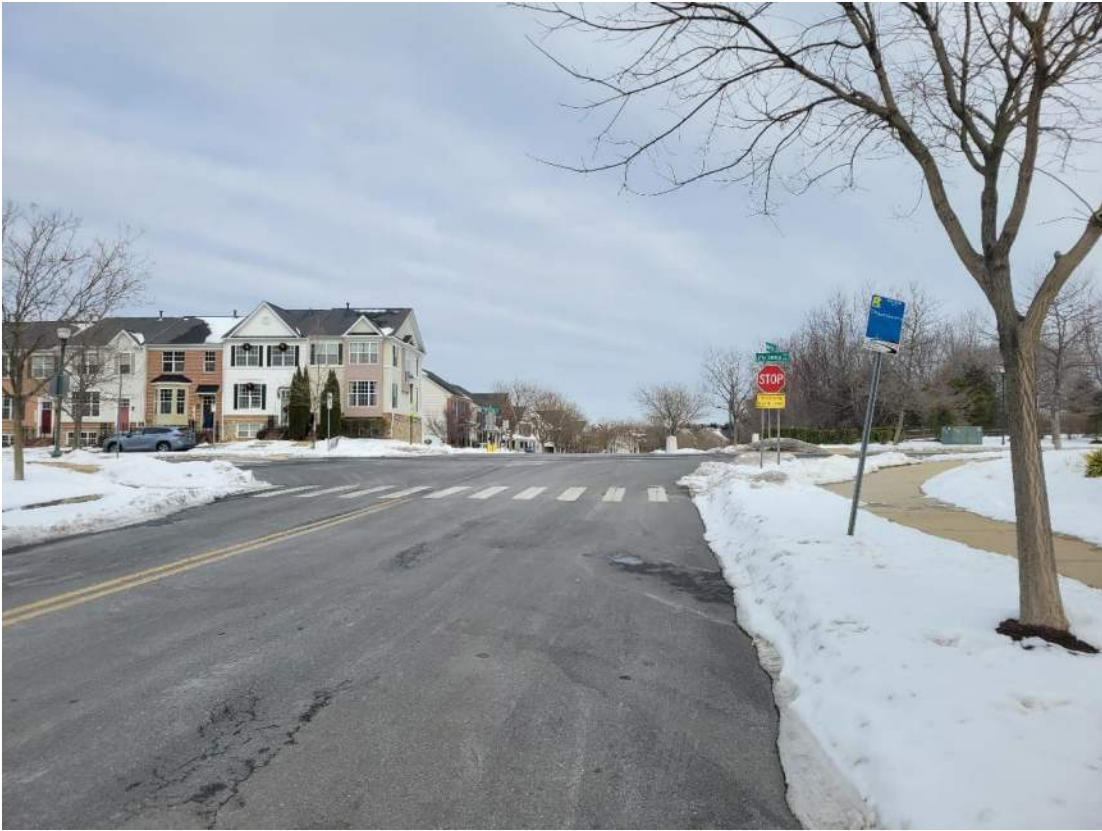
**Photo 1. Looking northbound along Newcut Road. Approximate crash location.**

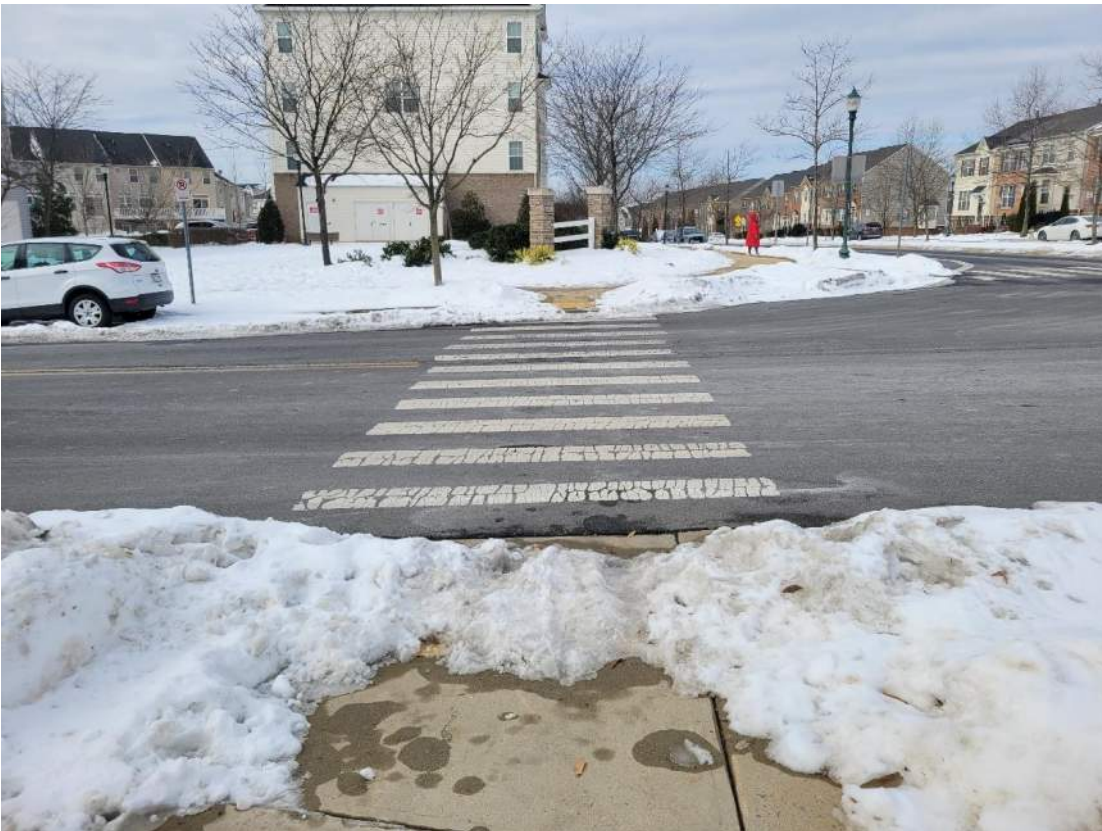
**Photo 2. Looking westbound along Little Seneca Parkway at south leg crossing. Approximate crash location.**

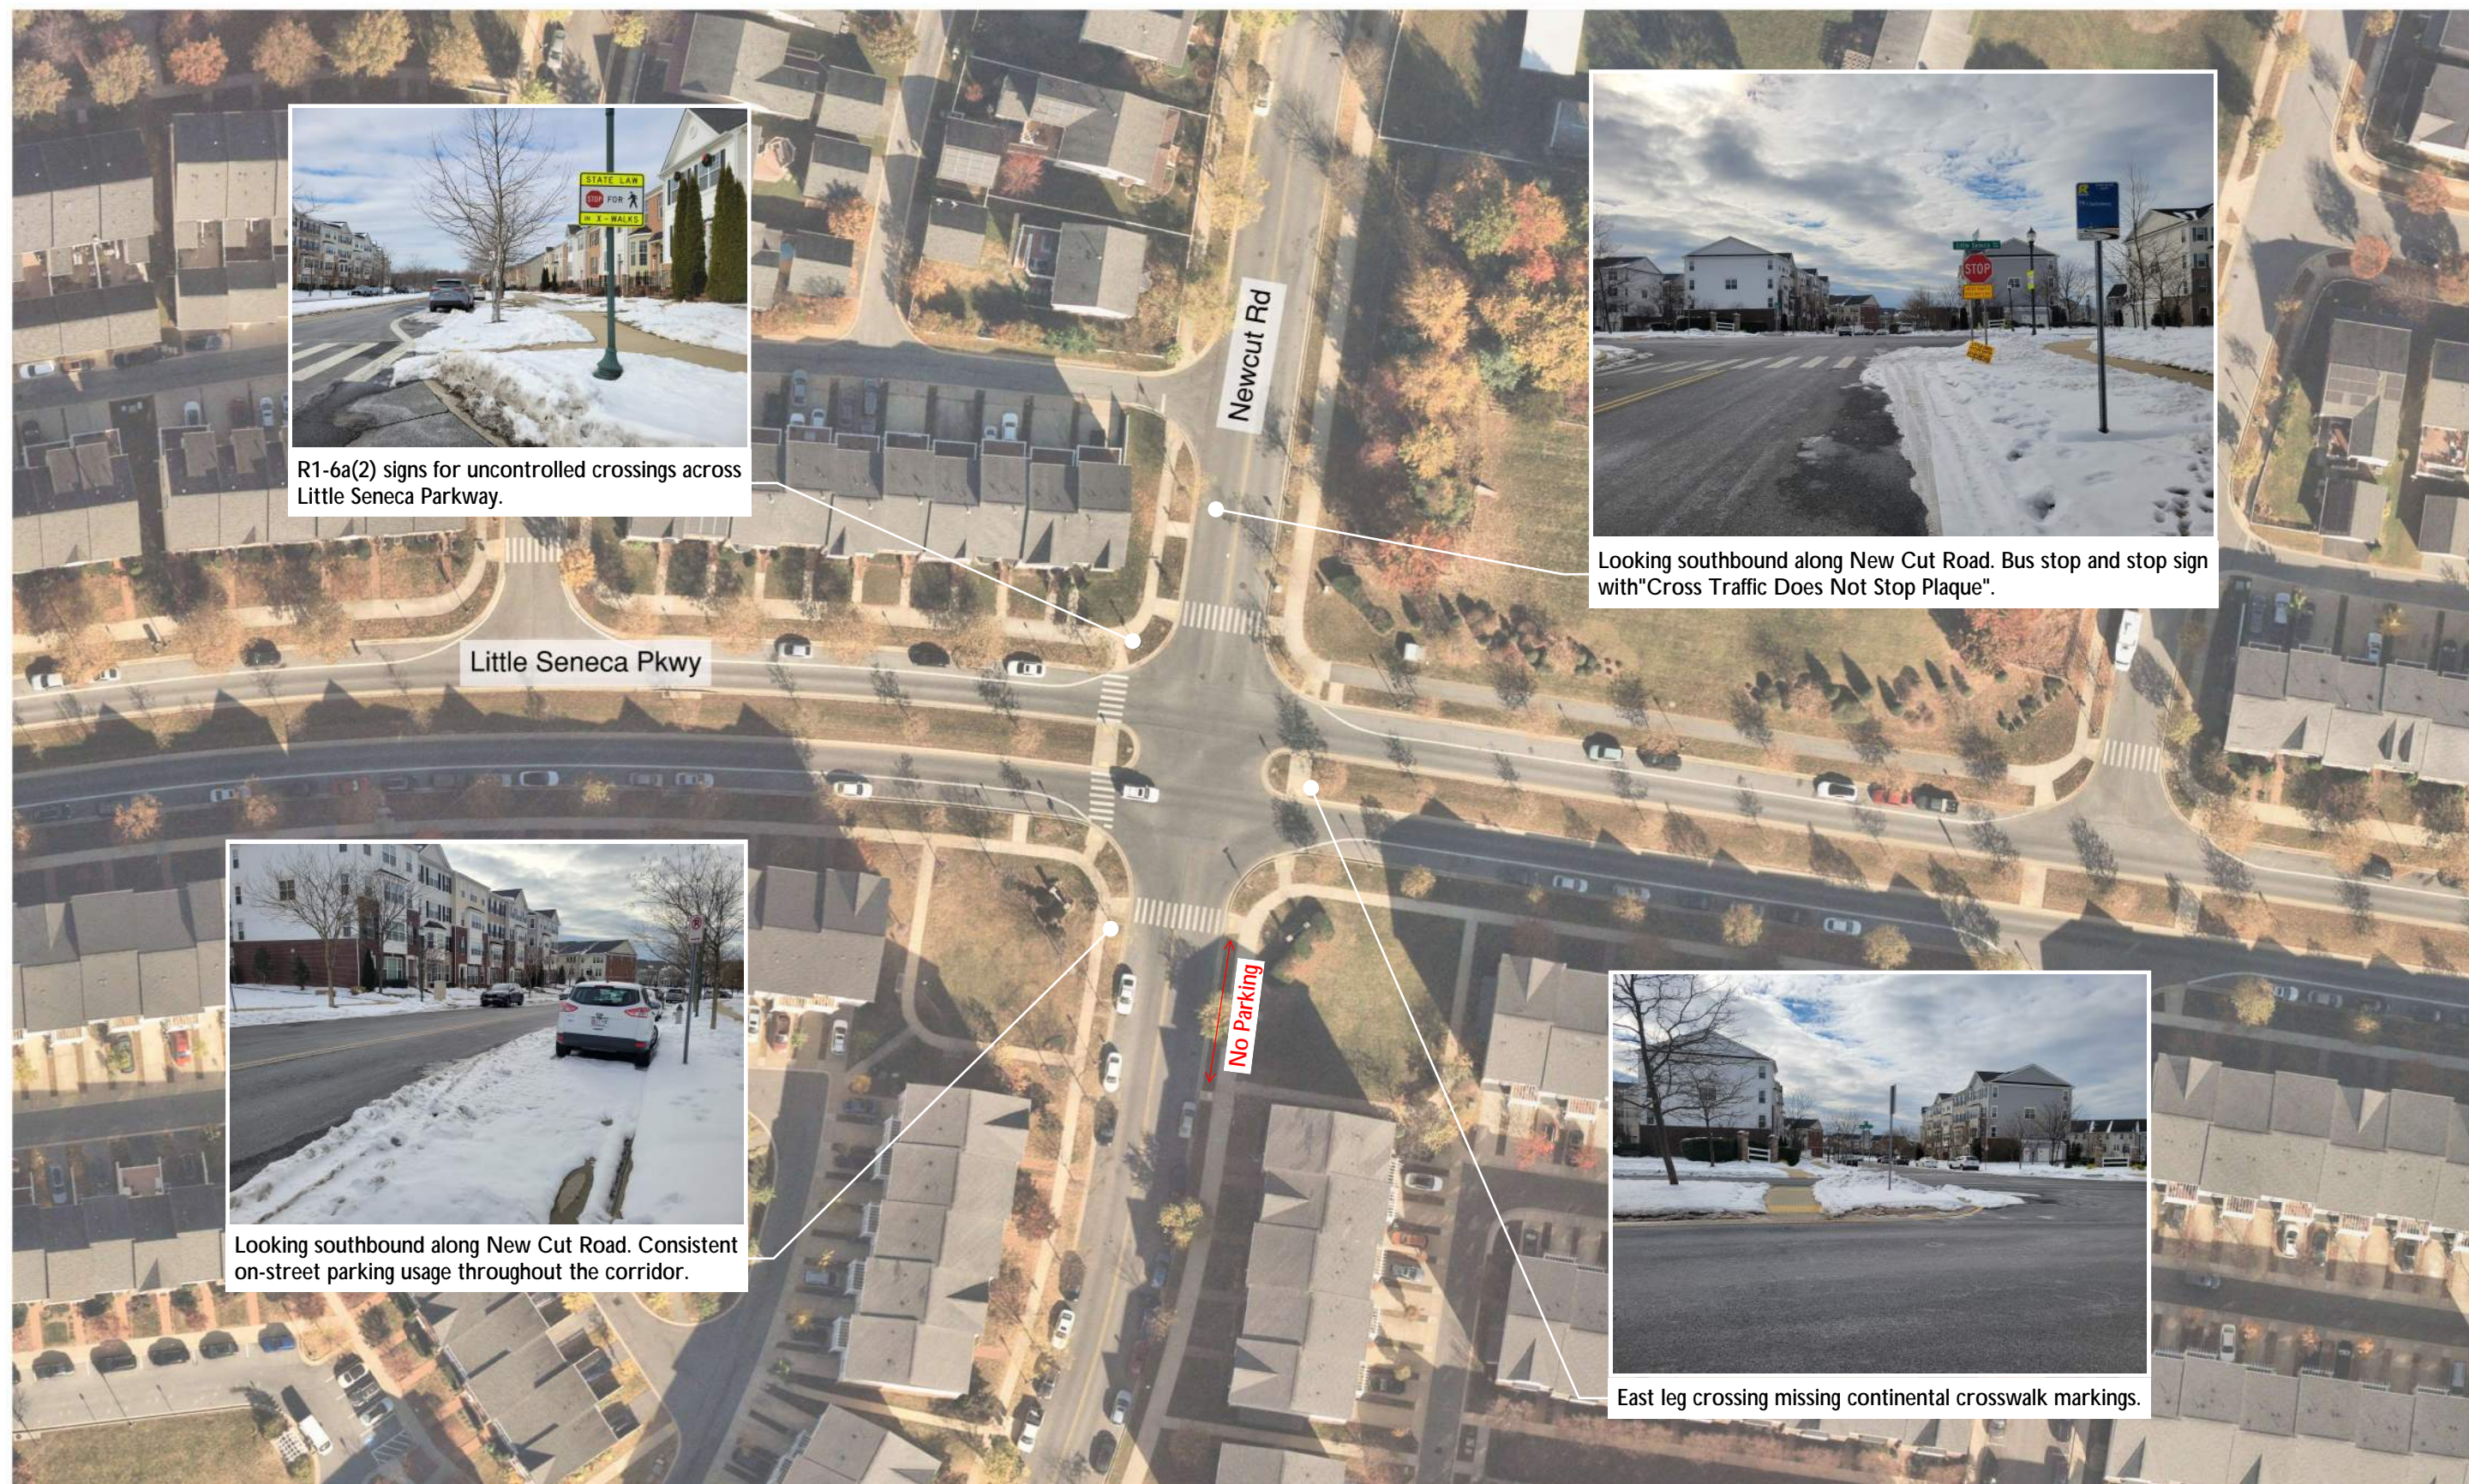
Figure 1 - Little Seneca Parkway Corridor Observations

The Little Seneca Parkway corridor was evaluated to identify potential infrastructure, maintenance activities, and road user behaviors that contribute to increased safety risk at and in the vicinity of the school-related crash location. The Little Seneca Parkway corridor was reviewed between Snowden Farm Parkway to the west and Meadow Mist Road to the east. Please refer to **Figure 1** for additional information.

Field observations were performed on Monday, January 13, 2025, at 11 AM. Weather conditions were clear, and the roadway surface was dry. However, conditions were cold, and snow cover remained from the previous weekend storm. Pedestrian activity was moderate with observations of pedestrians boarding/alighting the Montgomery County buses. Vehicular activity was moderate at the intersection during the observation period. Pavement markings across the intersection are in good condition.

1. Install continental style markings for the east leg crossing.
2. Install stop lines at the stop-controlled approaches along Newcut Road.
3. Collect traffic data and evaluate all-way stop control warrant criteria.

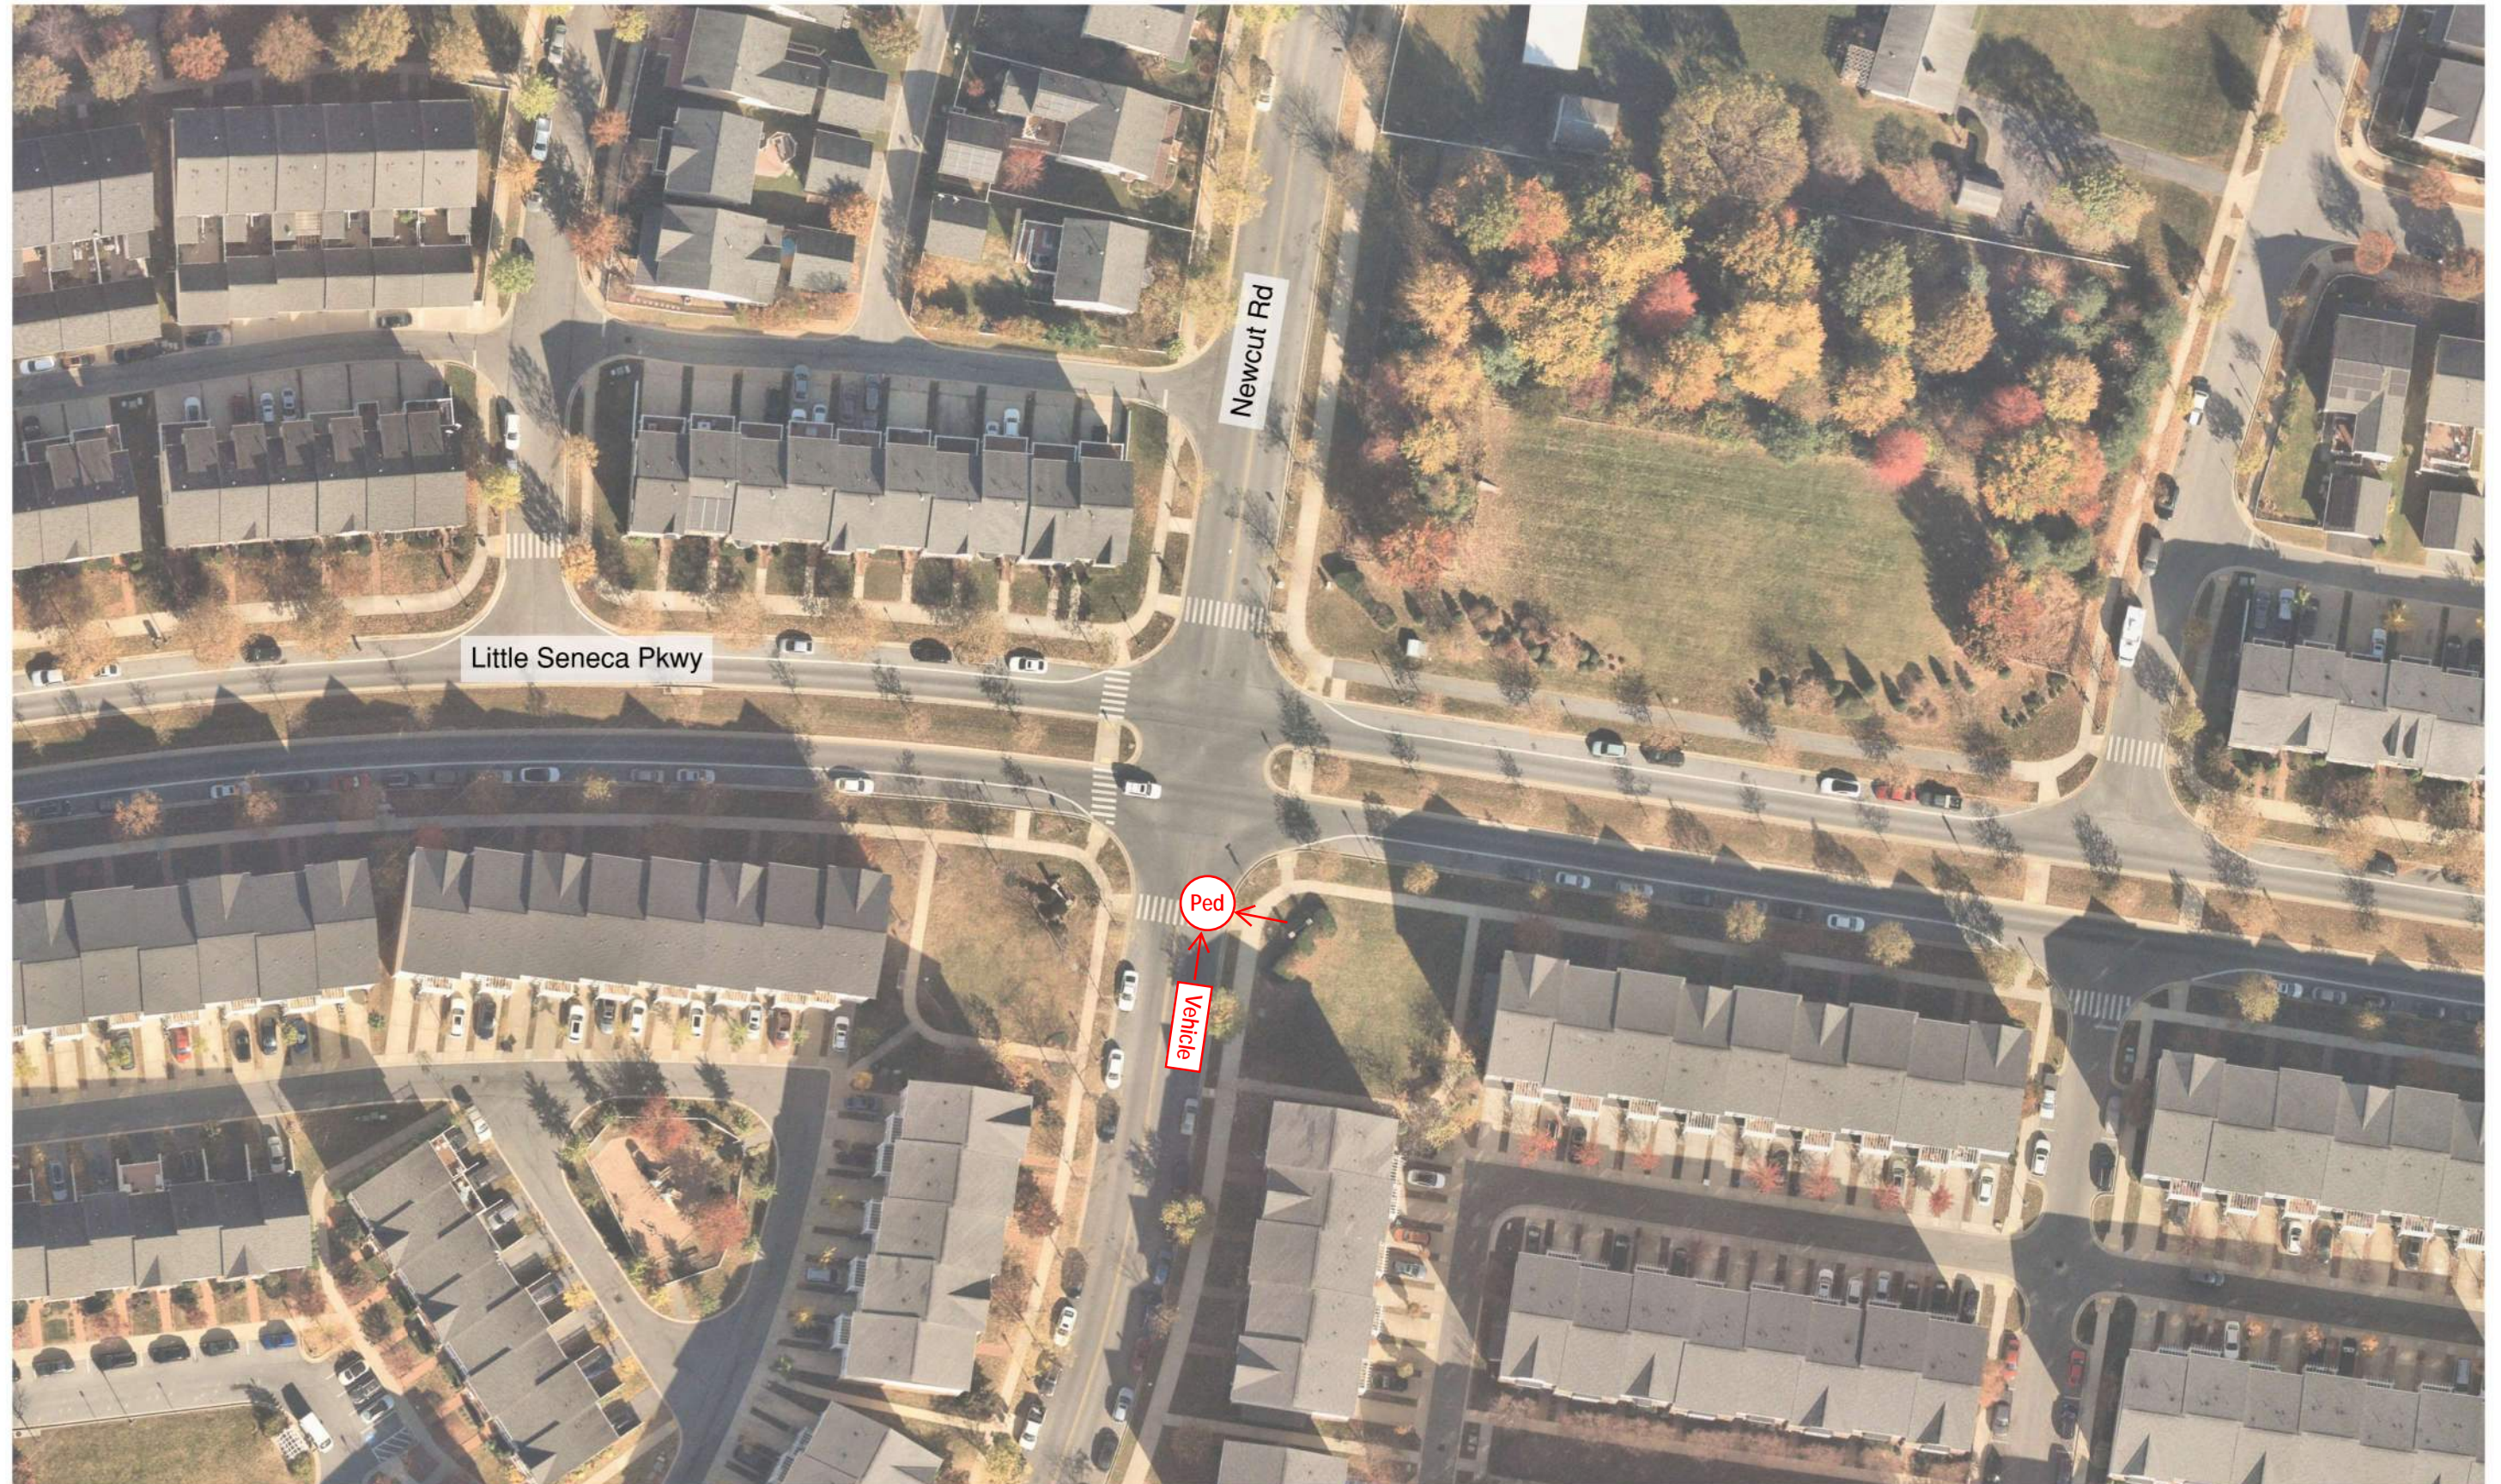
Figure 2 - Crash Diagram

On Friday, May 24, 2024, at approximately 3:41 PM, a motorist was traveling northbound on Newcut Road when a pedestrian traveling westbound entered the roadway from the sidewalk. According to the police report, the motorist was unable to stop for the stop sign and struck the pedestrian along the south leg of the intersection. The pedestrian possibly suffered injuries. Daytime weather conditions were clear, and the roadway surface was dry.

**Figure 2** illustrates the crash location and direction of pedestrian and vehicle travel.

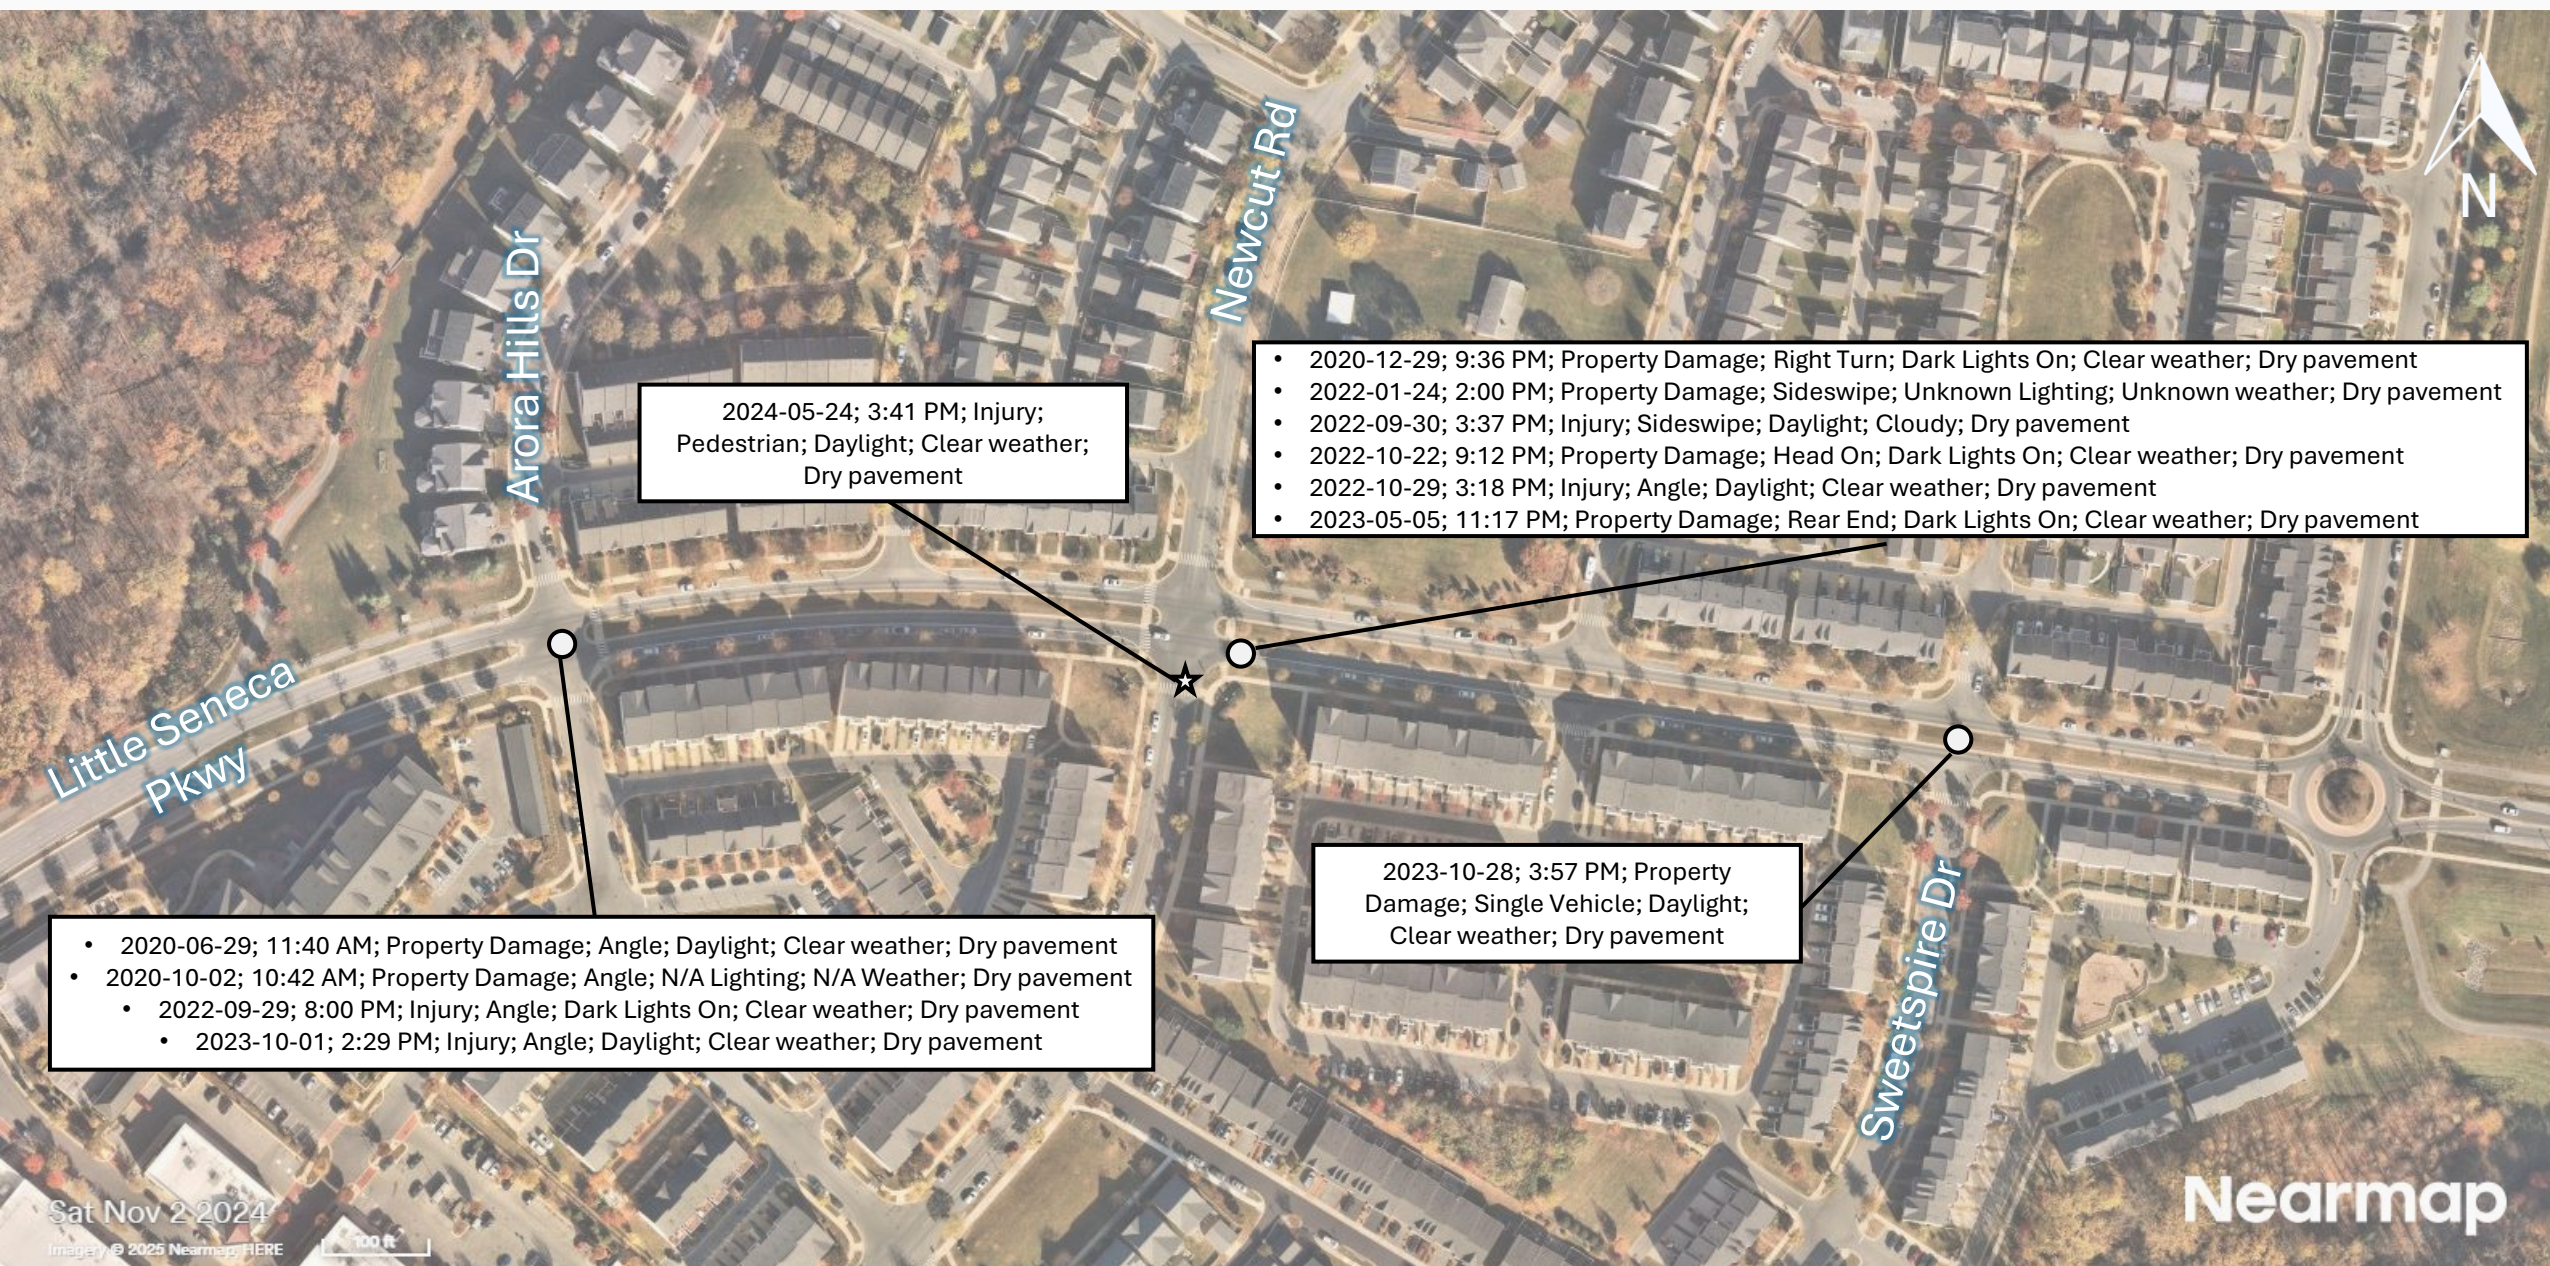
Figure 3 – Crash History (2021-2023)

Crash data obtained from dataMontgomery indicates that 11 incidents occurred within the vicinity of the crash site between January 2020 and December 2023. Of these 11 incidents, six (6) crashes occurred at the subject crash intersection of Little Seneca Parkway and Newcut Road. The other five (5) crashes occurred at the intersection of Arora Hills Drive to the west, or at Sweetspire Drive to the east. The 11 crashes reported included four (4) injury crashes, seven (7) property damage crashes, and the crash type consisted of five (5) angle collisions, two (2) sideswipe collisions, one (1) same direction right-turn collision, one (1) head on collision, one (1) rear end collision, and one (1) single vehicle collision. There were no pedestrian or bicycle-related crashes within the data collection period. No incidents occurred along wet pavement conditions, four (4) crashes occurred in the dark and two (2) crashes occurred in unknown lighting conditions. The incidents are illustrated on **Figure 3**.
