SAFE STREETS ACT 2023 - CRASH REVIEW

Location: Heritage Hills Drive at Briars Road/Gold Mine Road

Crash Date: August 29, 2024

Local Case No.: 240040952

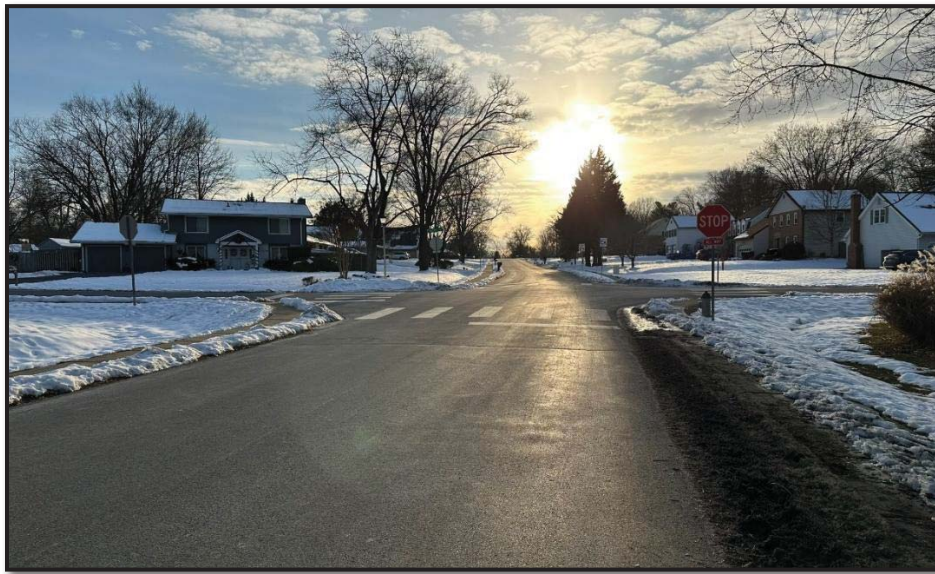
Photo 1. Westbound approach towards Briars Road intersection with Heritage Hills Drive

Based on the crash report and crash data, the subject scooter-involved incident appears to be an isolated occurrence. Field verification confirms that the westbound approach provides adequate sight distance, meeting the AASHTO minimum stopping sight distance requirement of 155 feet for 25 mph. Additionally, the motorist came to a complete stop at the intersection. No improvements are recommended at this location to MCDOT.

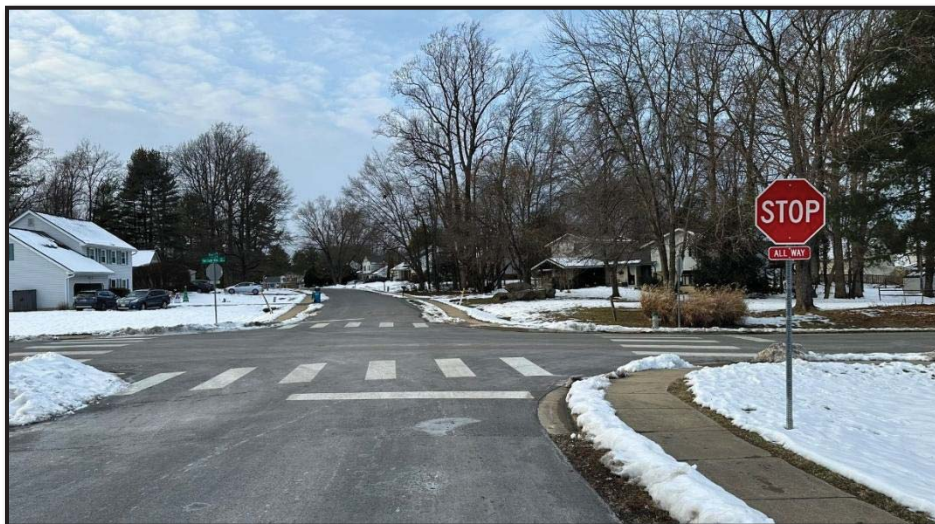
Photo 2. Northbound approach towards Briars Road intersection with Heritage Hills Drive

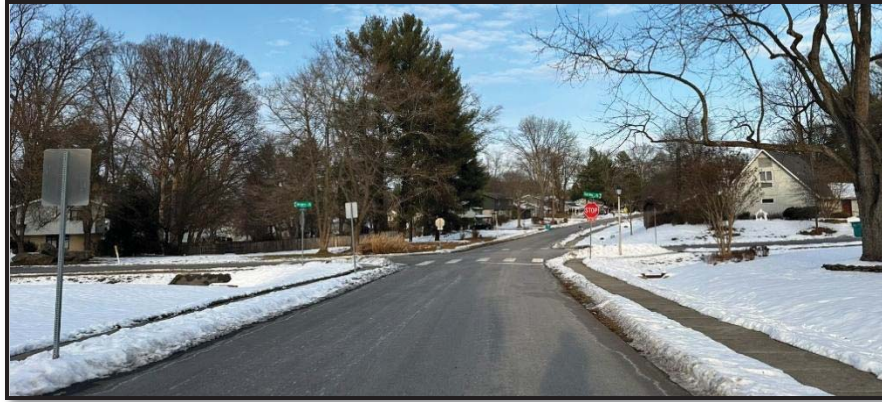
Photo 3. Eastbound approach towards Briars Road intersection with Heritage Hills Drive

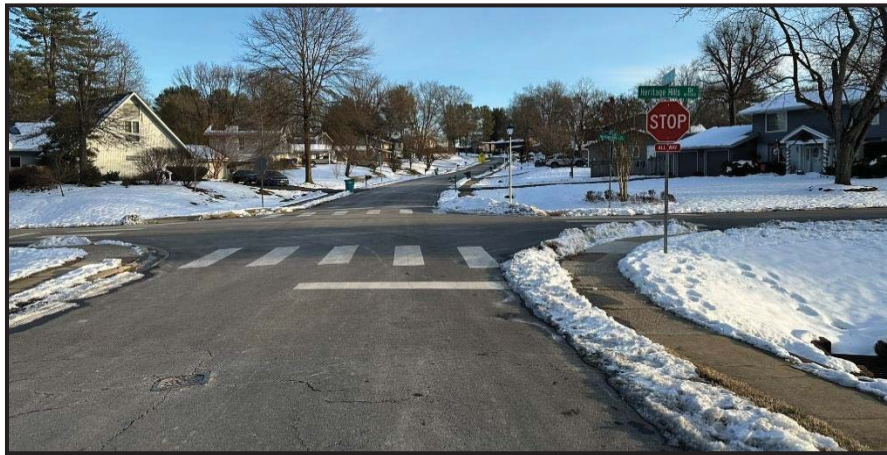
Photo 4. Southbound Approach towards Briars Road intersection with Heritage Hills Drive

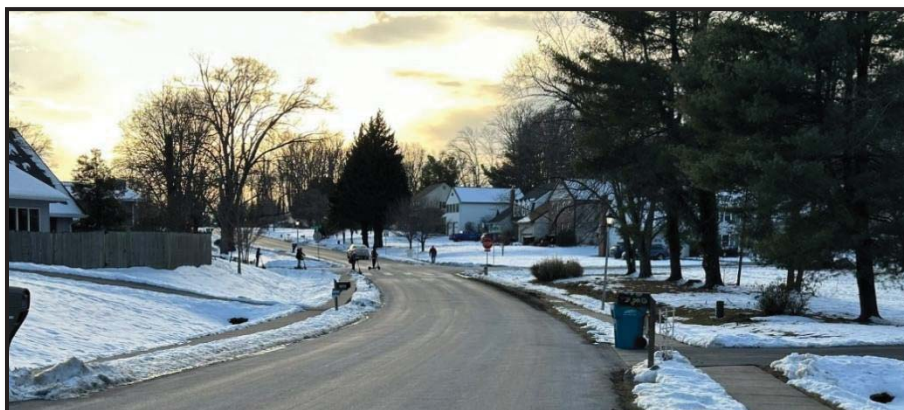
At approximately 4:00 pm, four students were observed riding non-motorized scooters to cross the intersection of Heritage Hills Drive and Briars Road/Gold Mine Road from south to north. Notably, this is around the same time of day as the subject incident.

Photo 5. Students on non-motorized scooters
