SCHOOL-RELATED CRASH INFRASTRUCTURE REVIEW

MONTGOMERY COUNTY DEPARTMENT OF TRANSPORTATION (MCDOT)

- **Location:** Cross Laurel Drive at Blunt Road
- **Crash Date:** May 5, 2025
- **Crash Time:** Approximately 6:15 PM
- **School Name:** Captain James Daly Elementary School
- **School Walkshed Boundary:** Outside
- **Local Case No:** 250019778
- **Review Date:** January 30, 2026

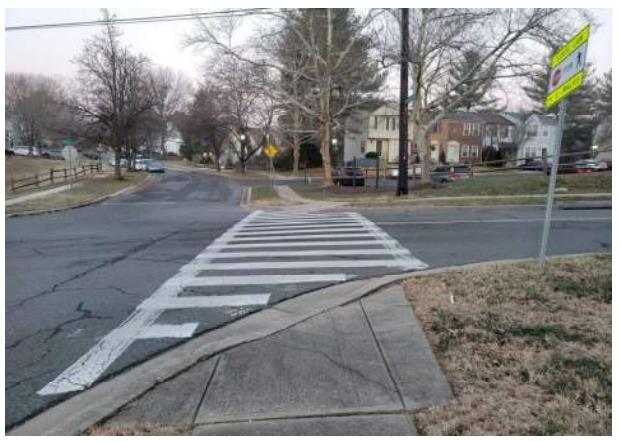
- **Crosswalk Visibility**
The crosswalk markings are in good condition along both north leg.
- **Lighting at Location**
A 150 HPS leased light is located in the southwest corner of the intersection over the southbound Blunt Road travel lane.

Marked Crosswalk in good condition

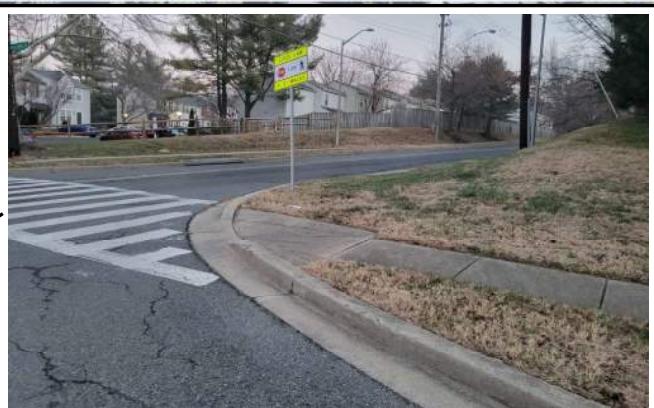
Sight Distance looking at SB Blunt Rd

- **Maintenance:** Install a combination horizontal alignment/intersection warning sign for the southbound Blunt Road approach, alerting drivers of Cross Laurel Drive. Trim vegetation along northbound Blunt Road approaching Cross Laurel Drive when trees are full (likely spring or summertime) (see **Photo 1** below).

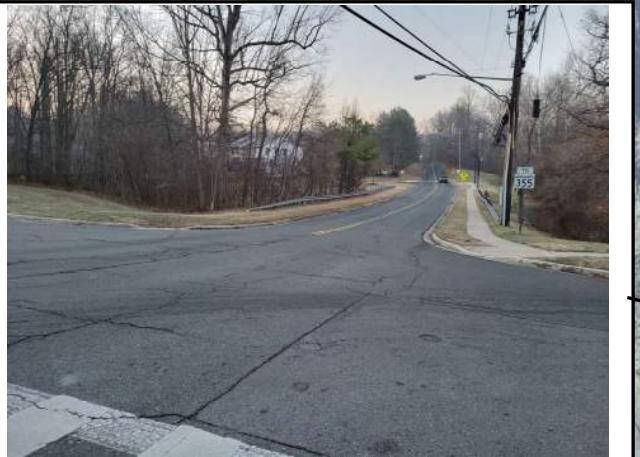
- **Sidewalk Coverage**
There is continuous sidewalk coverage on the west side of Blunt Road, along both sides of Cross Laurel Drive on the west leg, and along the north side of Cross Laurel Drive on the east leg. All sidewalks are buffered from the roadway. The sidewalk along Blunt Road continues southerly to the crossing at Red Buckeye Court.

Looking south – lighting and sidewalk connection to crosswalk at Red Buckeye Ct

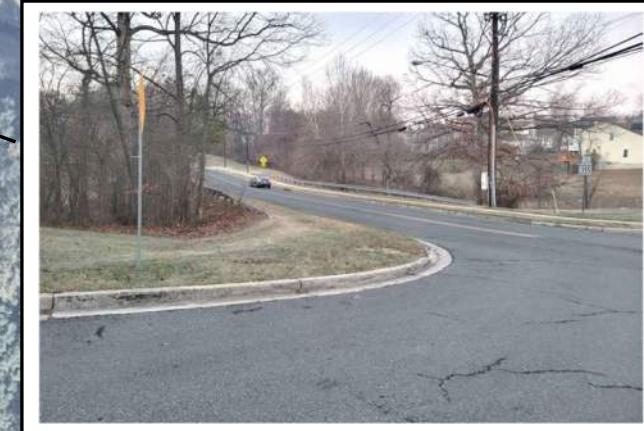
- **Vehicle Activity:** Light.
- **Drop-off / Pick-up Operations**
No drop-off or pick-up patterns observed at the crash location.
- **Visibility / Obstructions**
Trees line Blunt Road to the south of Cross Laurel Drive. During observations, the trees are bare and do not obstruct, but may limit sight distance for motorists exiting Cross Laurel Drive when trees are full. To the north of Cross Laurel Drive, a horizontal curve and vertical crest limits reaction times for pedestrians and motorists crossing Blunt Road.

Sight Distance looking at NB Blunt Rd – trees may limit sight distance when full

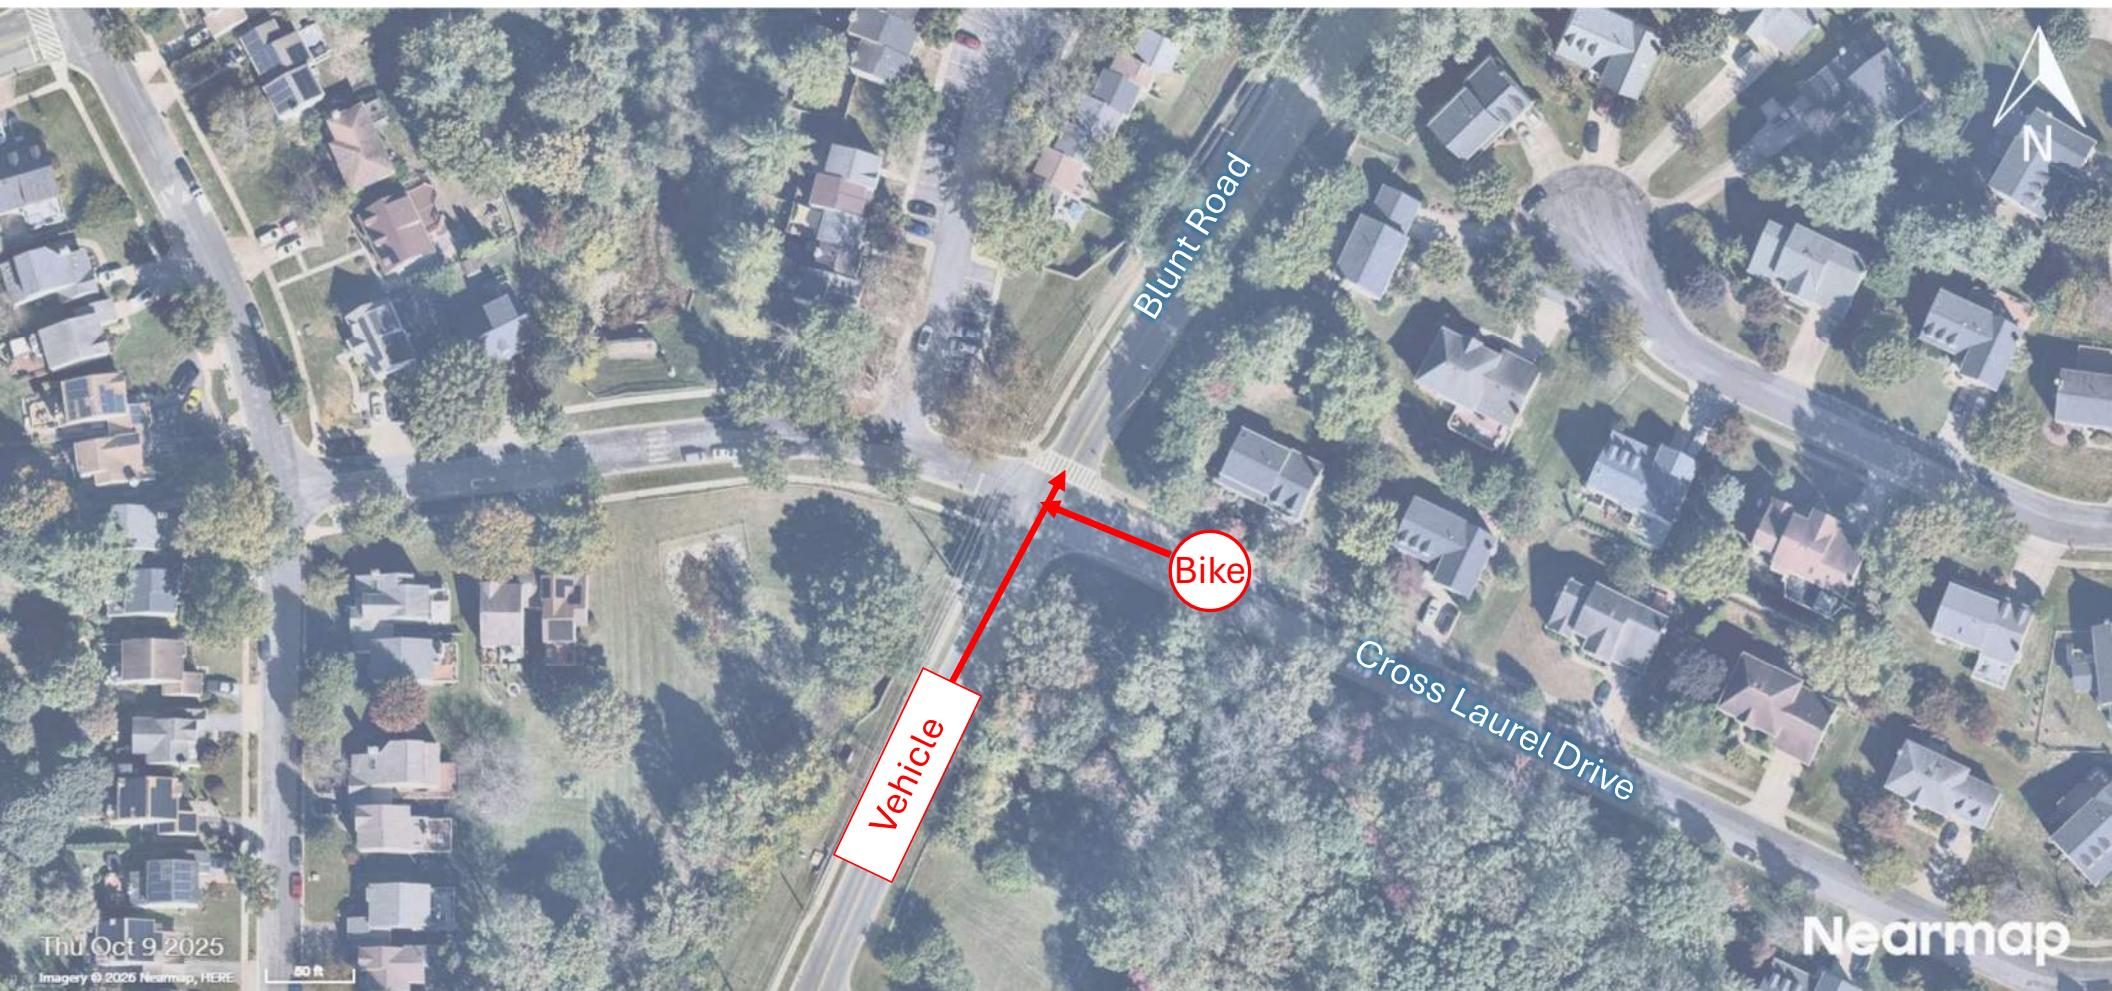
Figure 2 – Crash Diagram

On Monday, May 5, 2025, a motorist was driving northbound along Blunt Road when a bicyclist was driving along Cross Laurel Drive and did not stop at the stop sign, running into the side of the vehicle. The bicyclist suffered a possible injury. The weather was clear, and the roadway was dry. Figure 2 illustrates the crash location and the direction of pedestrian and vehicle travel.

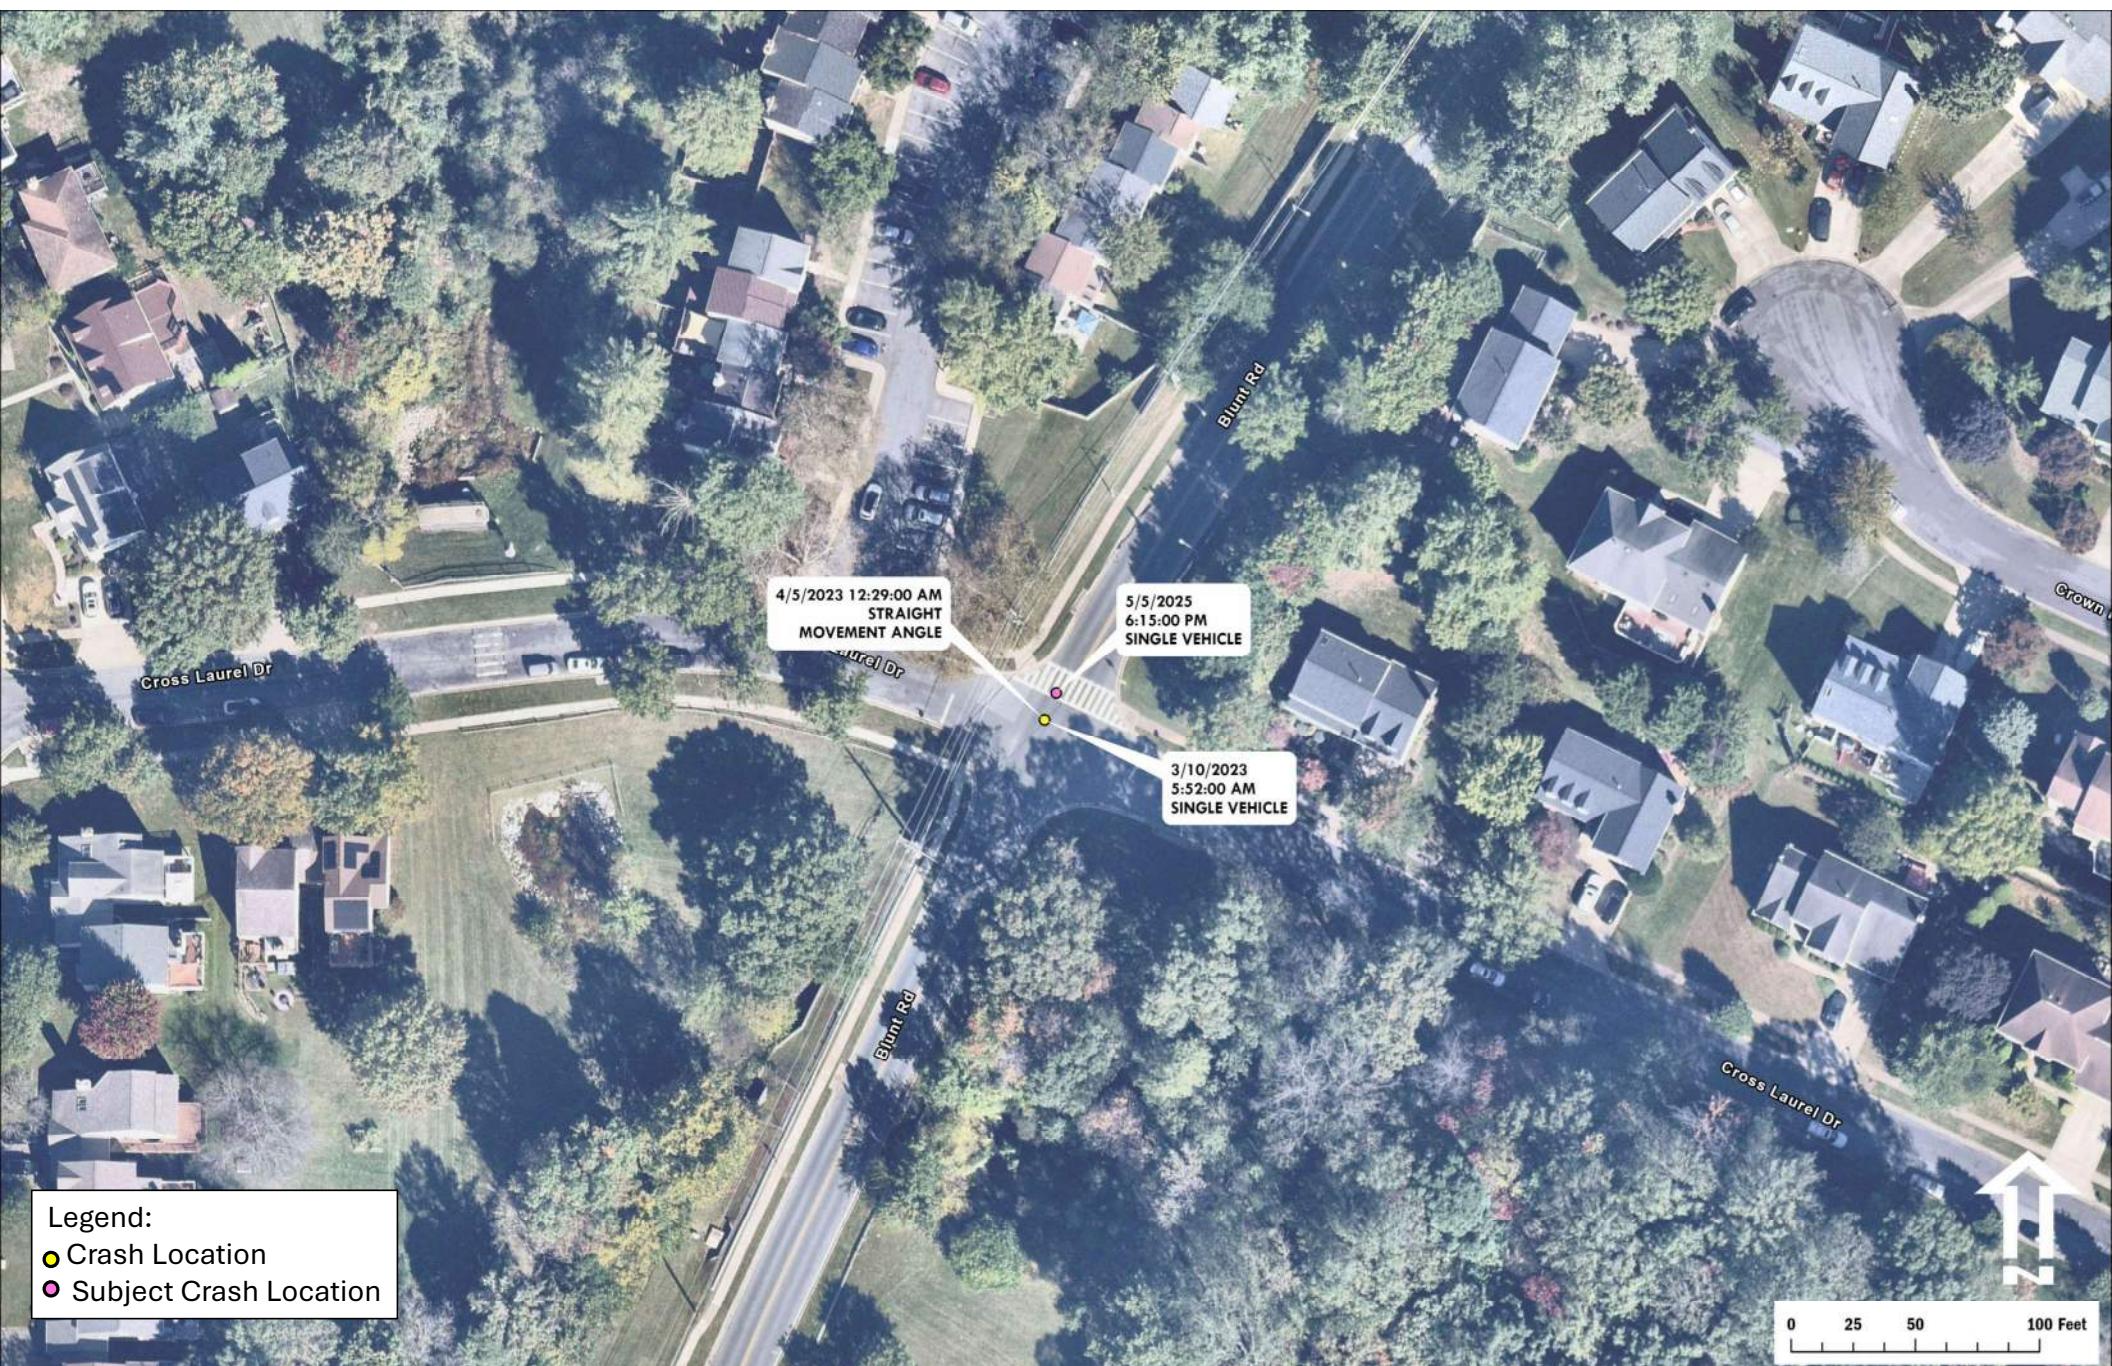
Figure 3 – Crash History (2020-2025)

- **Total Crashes (Last 5 Years):** A total of three (3) crashes occurred at the subject crash location between January 1, 2020 and November 30, 2025.
 - **Pedestrian/Bicycle Involved:** Only the subject crash involved a non-motorist.
 - **Student-Involved Crashes:** The only known student-involved crash included the subject crash.
 - **Crashes During School Hours:** None of the crashes occurred during school hours.
 - **Recurrent Patterns (Time/Type):** There is no recurrent pattern of crashes. One crash occurred between a motorist and an animal in the dark along a wet surface, one angle crash occurred in the dark (midnight), and the subject crash occurred between a bicyclist and motorist in the daylight.
