## Fatal Crash Review

Location: Gridley Road at Selfridge Road

Accident Date: Friday, June 3, 2022

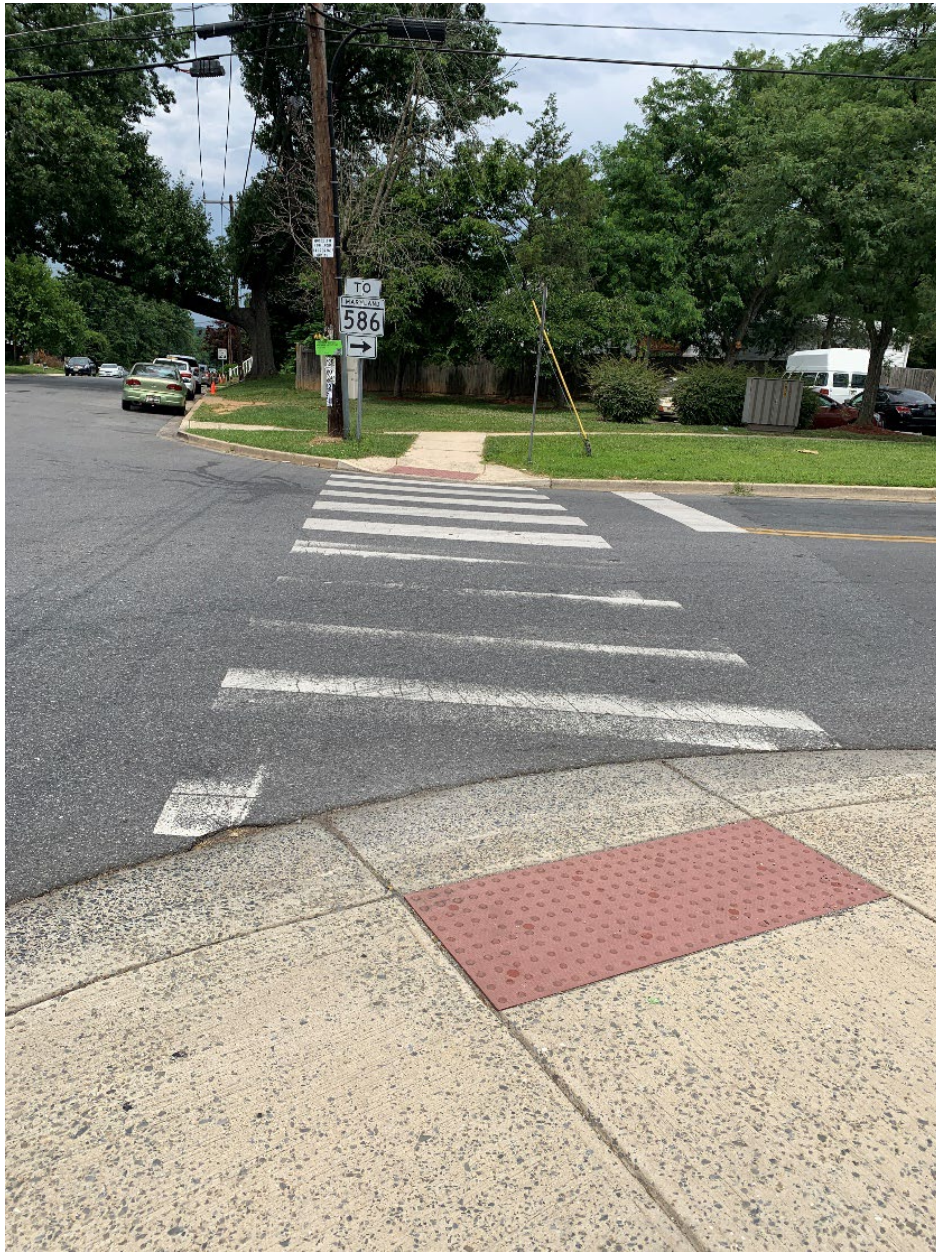
A field investigation was conducted at the crash location on June 21, 2022. All required signs and pavement markings at this intersection are in place and in good condition with the exception of the southern portion of the crosswalk on the east leg, which is partially faded. A check of the Montgomery County Streetlights website showed that the lighting fixtures are operational.

Faded Crosswalk – East Leg – Gridley Road

Refresh the ladder bar pavement markings on the east leg.
