Fatal Crash Review

Location: Good Hope Road at Good Hope Drive

Crash Date: Friday, December 12, 2025

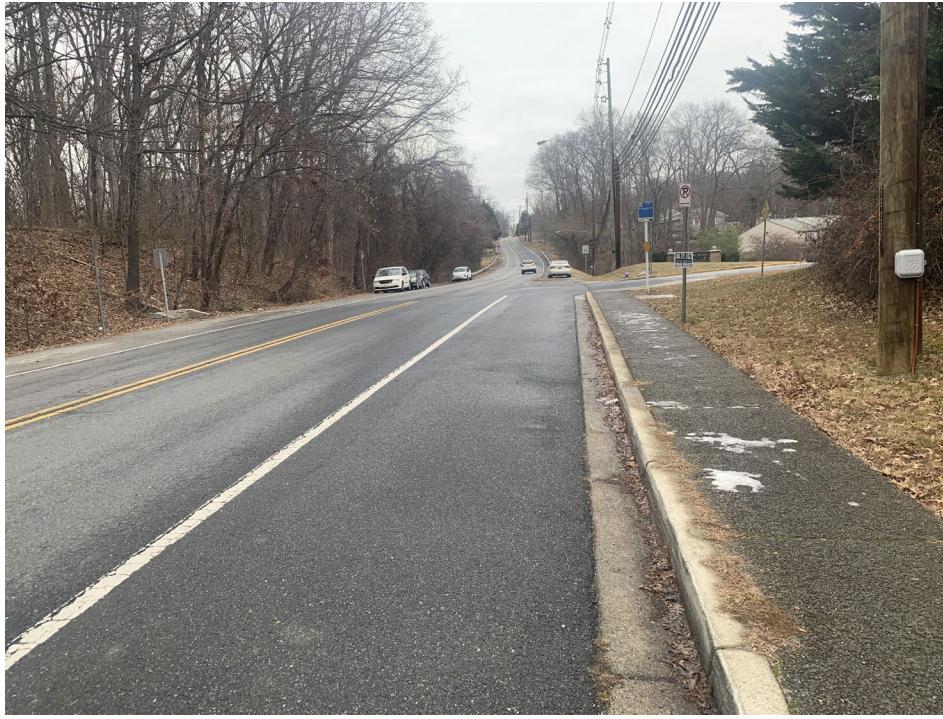
Eastbound Good Hope Road approaching Good Hope Drive

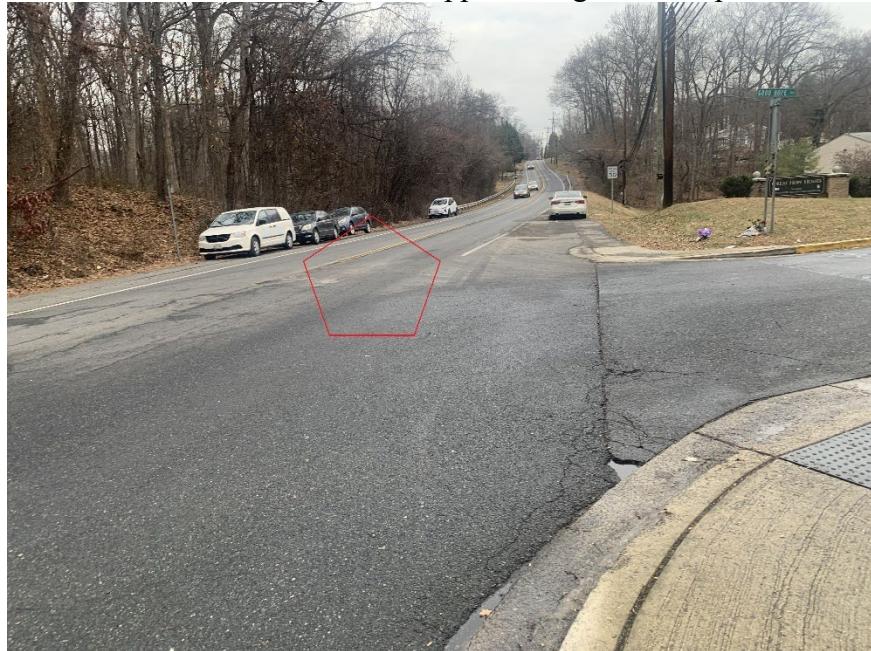
Eastbound Good Hope Road at crash location

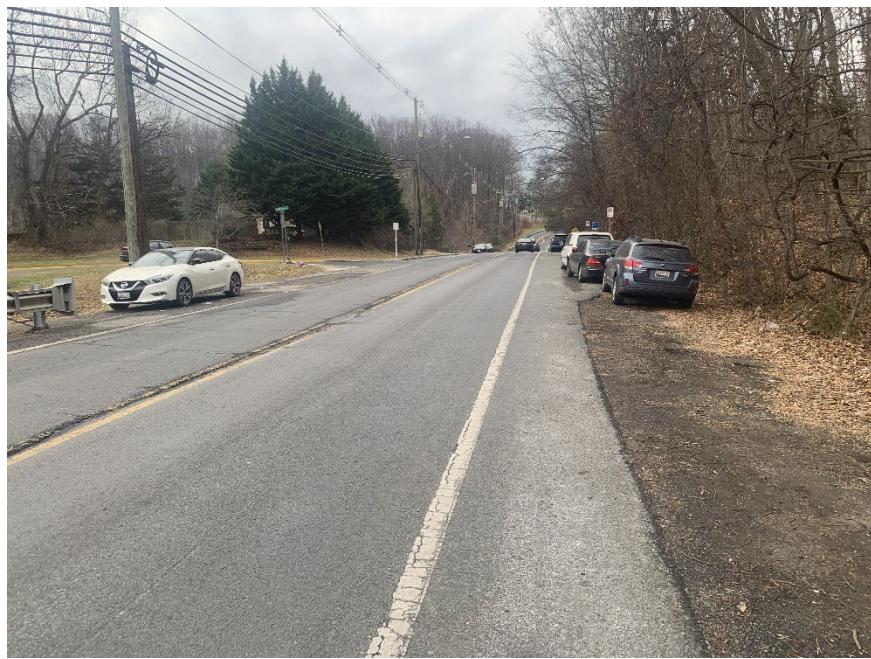
Westbound Good Hope Road east of Good Hope Drive
