## **Welcome to Wheaton Revitalization News!**

## **Look Ahead - Week of December 10 to December 16**

### **Installation of Tie-Back Anchors & Support of Excavation System (SOE)**

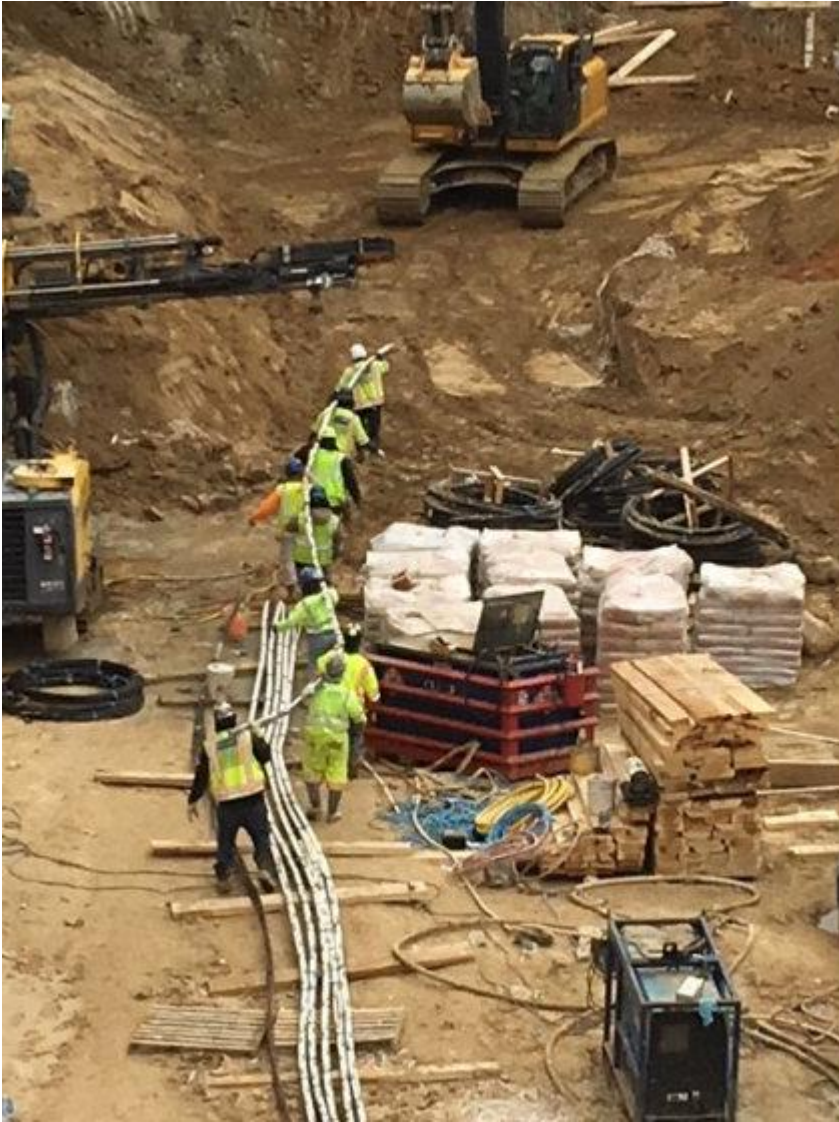
**Workers Carrying Tie-Back Anchor to Installation Point**

Installation of tie-back anchors (see photo) is complete at the south end of the site where the bottom of the hole has been reached and is advancing towards the north end of the site where 10-feet of excavation remains.

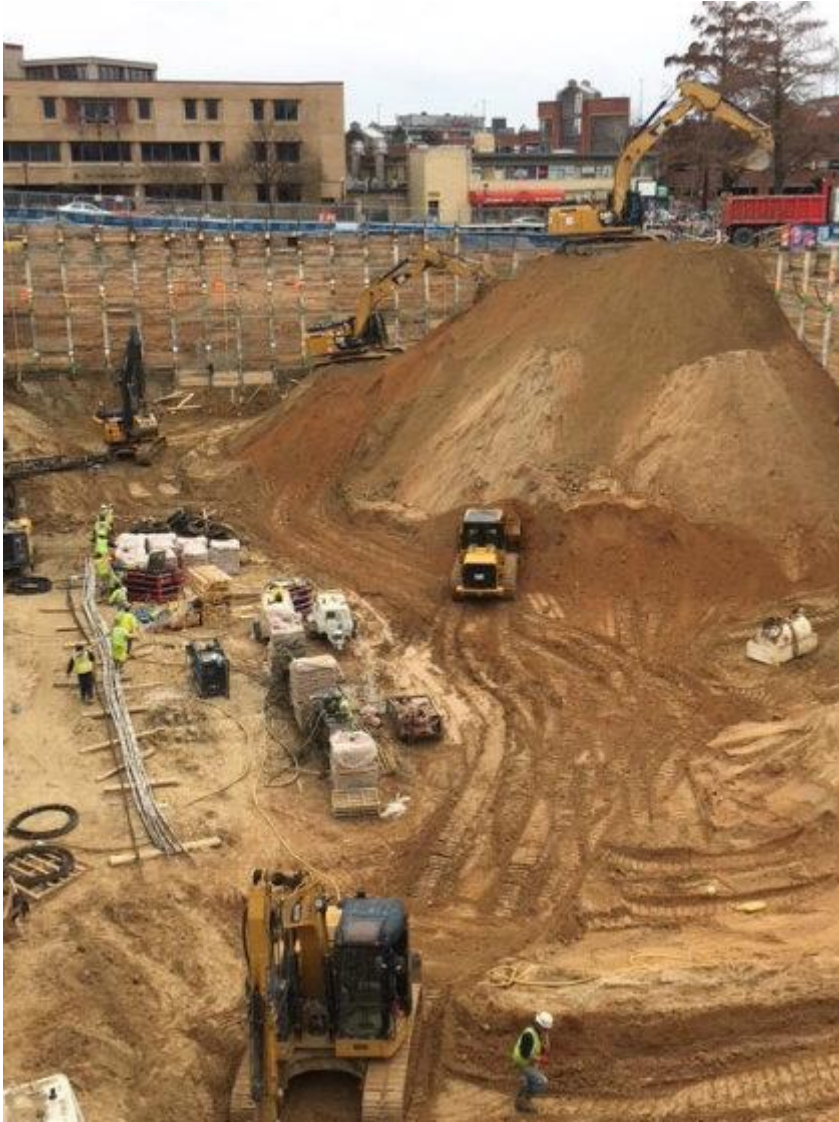
**Excavators Working Together to Remove Excavated Material Uphill**

The contractor has reached the bottom of the hole on the south end of the site (adjacent to Reddie Drive) and is working northward to remove the remaining 10-feet of excavation. (See photo) Excavation is now proceeding with the use of 4-excavators and one-loader "feeding" excavated material (dirt) to each other advancing the material "up-the-ramp". (See photo)

In order to excavate the entire hole, the contractor must continually "move the access ramp around" to complete the excavation in rectangular fashion. The access ramp was recently moved from the north end of the site to mid-block along Grandview Avenue as shown in the photo. This allowed access to the north end of the site previously occupied by the ramp.
