## **Welcome to Wheaton Revitalization News!**

### **Look Ahead - Week of December 17 to December 23**

#### **Demolition of the Mid-County Regional Services Center Building**

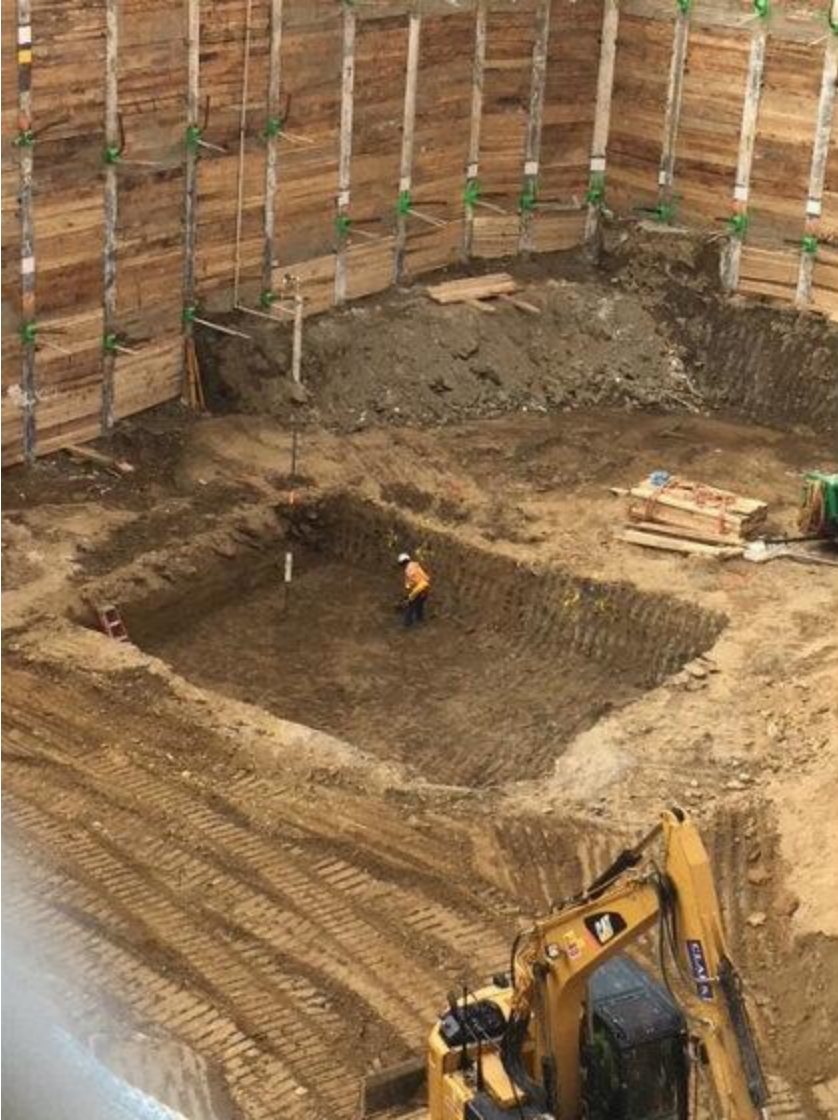
Footer for South Tower Crane

Excavation for the south Tower Crane footer is complete and the concrete foundation will be placed during the upcoming week (see photo). The Tower Crane itself will be delivered and erected January 6, weather permitting.

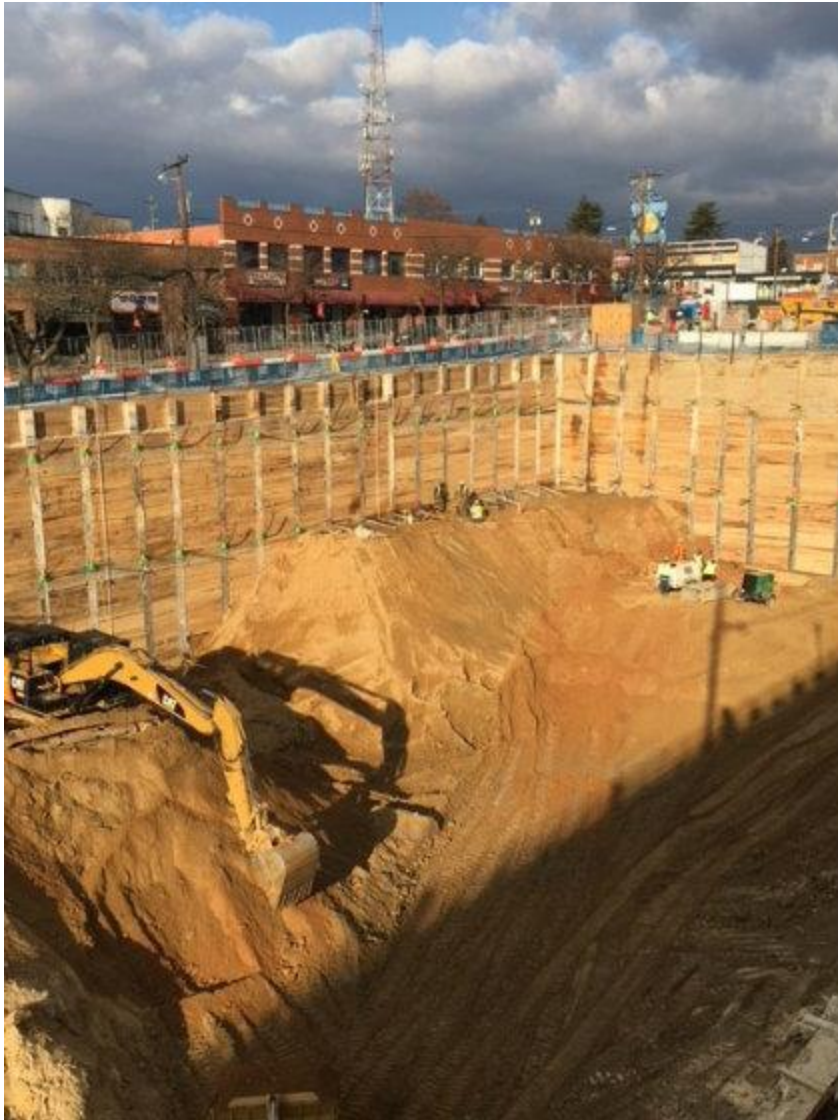
### Excavating to Bottom of the Hole at the North End of Site

The contractor has reached the bottom of the hole on the south end of the site (adjacent to Reddie Drive) and is working northward to remove the remaining 5 feet of excavation (see photo). Excavation is now proceeding with the use of 4 excavators and one loader as they transfer material one-to-another advancing the material “up-the-ramp” and into trucks (see photo).
