Welcome to Wheaton Revitalization News!

Look Ahead - Week of November 12 to November 18

Installation of Tie-Back Anchors & Support of Excavation System (SOE)

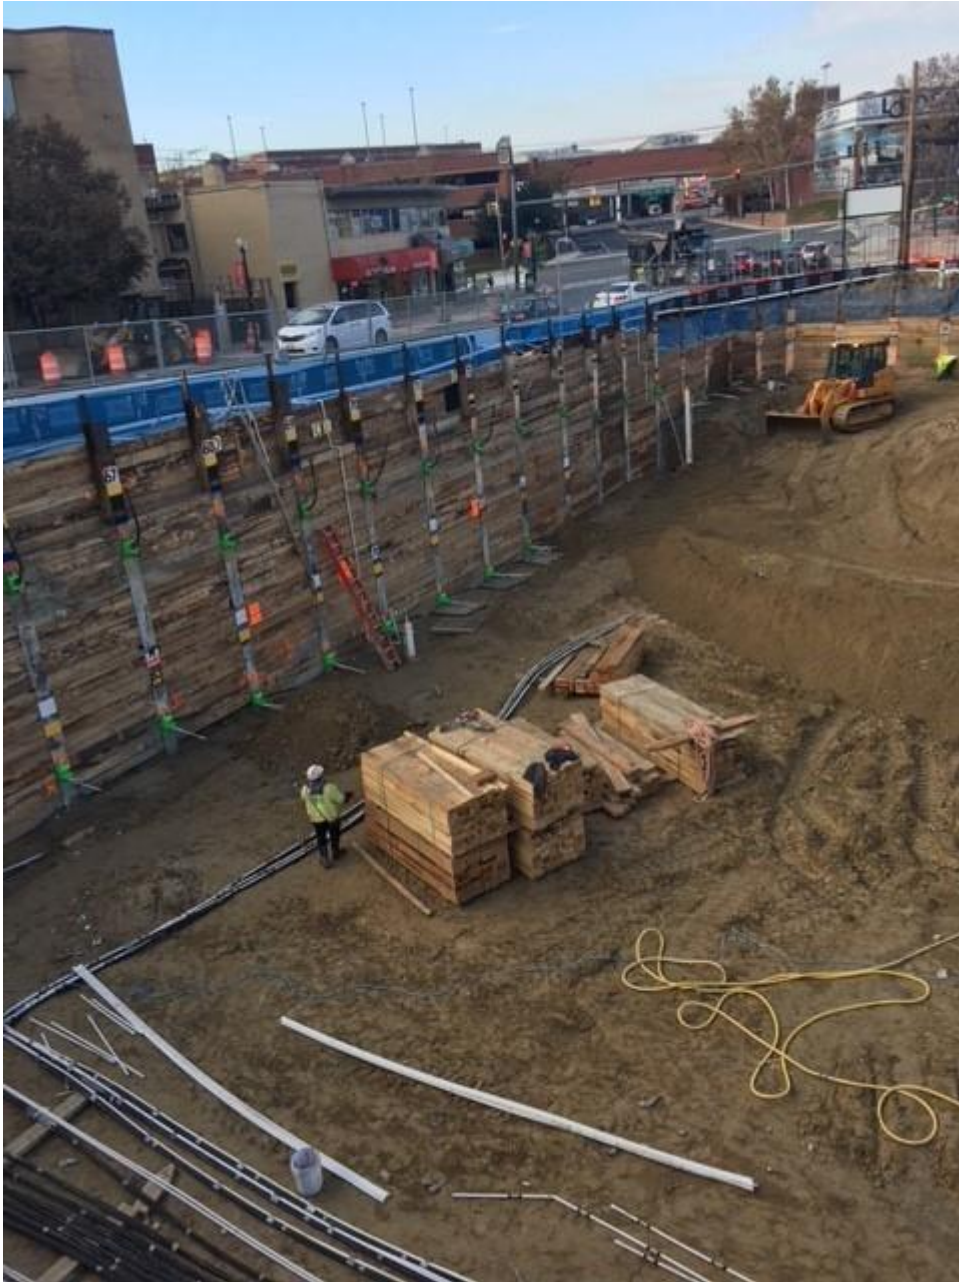
Excavation Advances along Triangle Lane

Mass excavation for the building foundation continues. Currently, the contractor has excavated upwards of 40 feet deep in places (see photo) and continues excavating daily. The bottom of the hole is expected to be reached in early-January 2018, weather permitting.

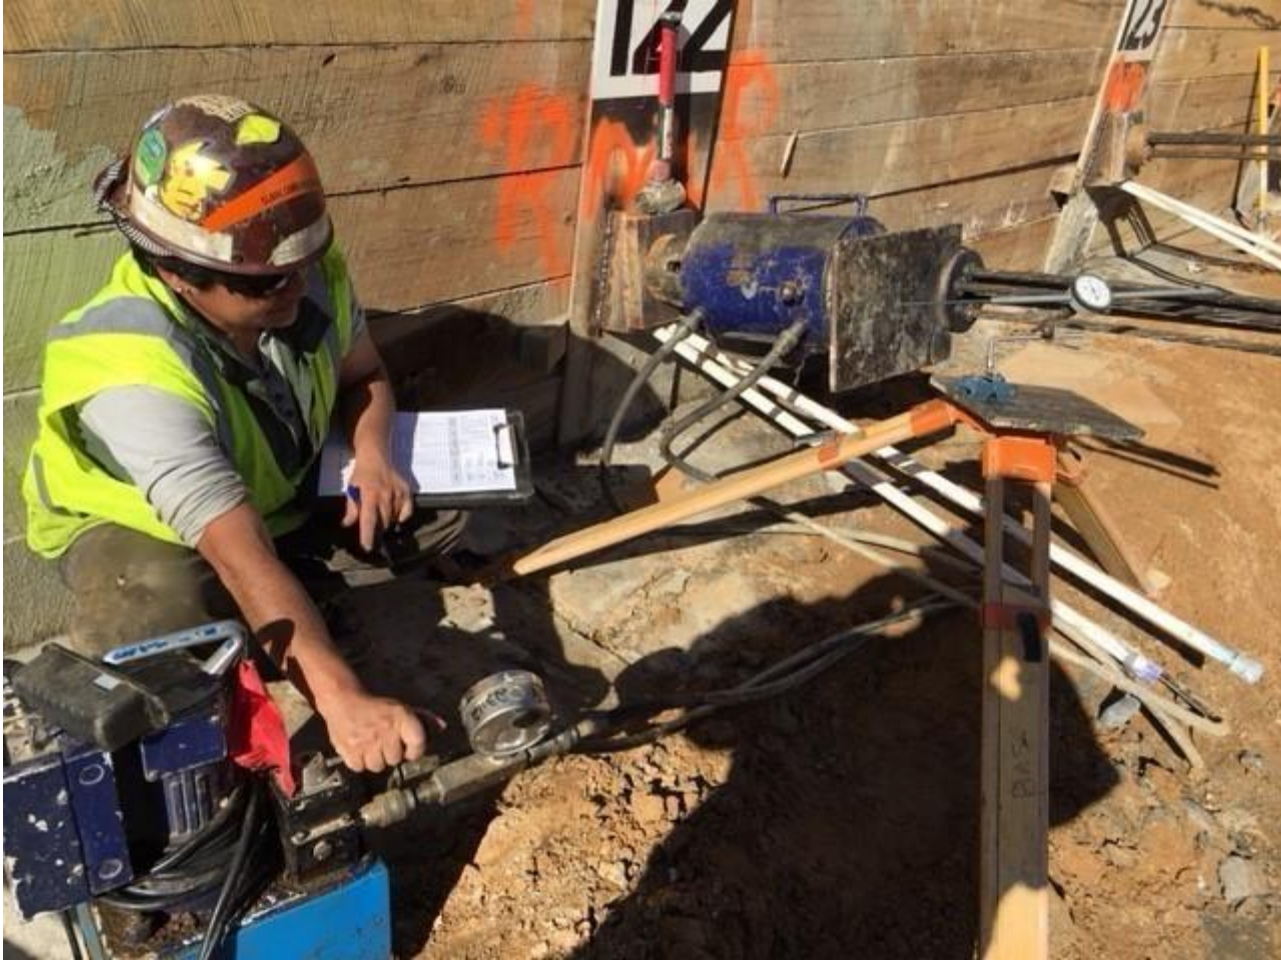
Hydraulic Testing of Embedded Tie Back Anchor

The Support of Excavation (SOE) continues to advance with the depth of excavation. Installation of tie-back anchors (see photo) continue as the excavation deepens. To further ensure safety, hydraulic "pull-out" testing of tie back anchors continues (see photo). The tie back anchors are tested with the use of a hydraulic jack that is calibrated to

exert a specified “pull-force” on the grouted tie-back anchor. Elongation of the anchor cables is measured and recorded and compared to “allowable and expected elongation” to determine whether the anchor has properly and sufficiently engaged. This test ensures embeddedness and the subsequent integrity of the anchor.
